MINERALS PROGRAM INSPECTION REPORT
PHONE: (303) 866-3567

MINE NAME: Mountain View Pit	MINE/PROSPECTING ID#: M-1981-002	MINERAL: Sand and gravel	COUNTY: Gunnison
INSPECTION TYPE: Monitoring	WEATHER: Clear	INSP. DATE: April 28, 2025	INSP. TIME: 15:00
OPERATOR: Town of Crested Butte	OPERATOR REPRESENTATIVE: None	TYPE OF OPERATION: 110c - Construction Limited Impact	
REASON FOR INSPECTION: Normal I&E Program	BOND CALCULATION TYPE: None	BOND AMOUNT: \$0.00	
DATE OF COMPLAINT: NA	POST INSP. CONTACTS: None	JOINT INSP. AGENCY: None	
INSPECTOR(S): Dustin Czapla	INSPECTOR'S SIGNATURE:

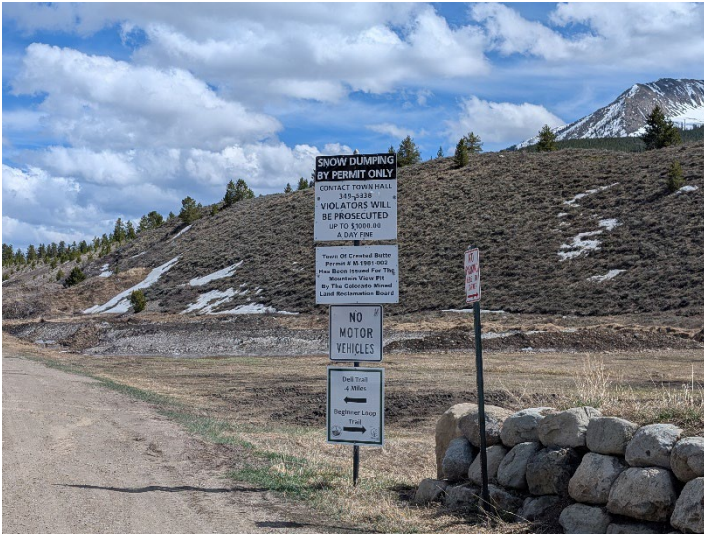
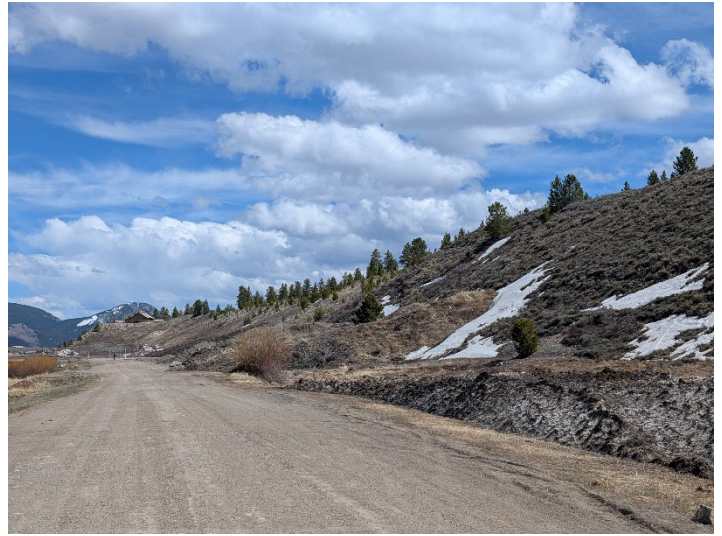
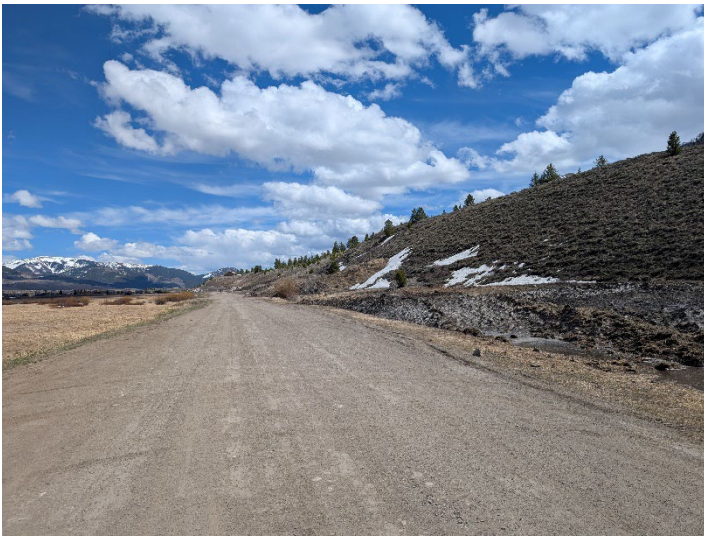
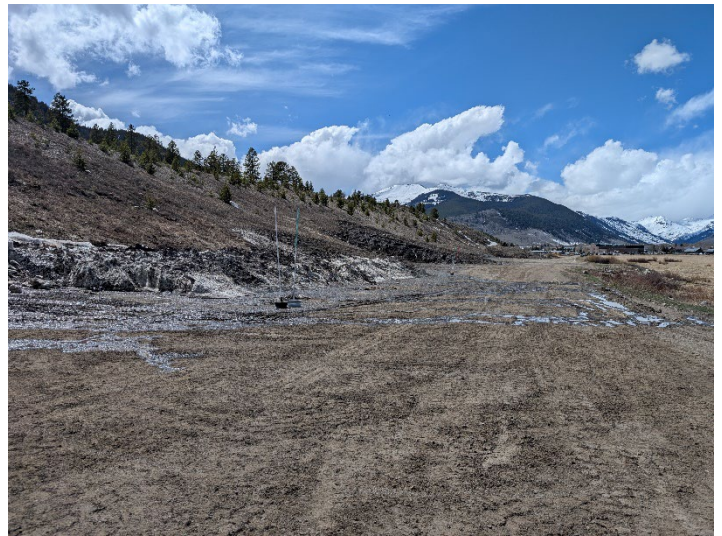
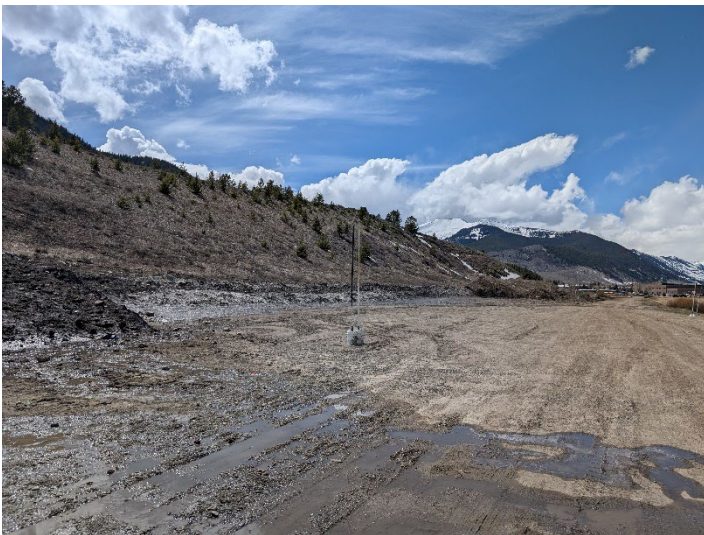
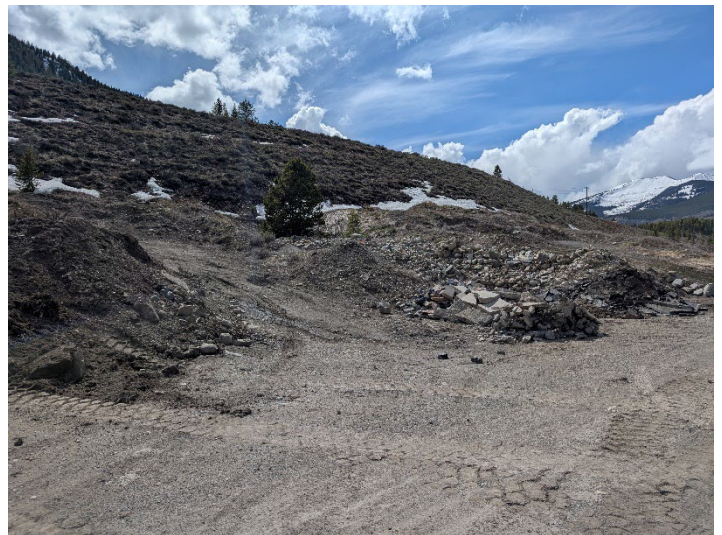
The site is in final reclamation. Grading of the highwall is complete. The slope blends well with the surrounding topography, appears stable, and is well vegetated. The flat area at the base of the highwall is currently used by the town of Crested Butte for snow dumping. There is a bike trail that runs through this area.
