MINERALS PROGRAM INSPECTION REPORT
PHONE: (303) 866-3567

MINE NAME: Chambers Pit	MINE/PROSPECTING ID#: M-1979-205	MINERAL: Sand and gravel	COUNTY: Garfield
INSPECTION TYPE: Monitoring	WEATHER: Clear	INSP. DATE: May 27, 2025	INSP. TIME: 10:00
OPERATOR: Oldcastle SW Group, Inc. dba United Compas County	OPERATOR REPRESENTATIVE: Jesse Farmer	TYPE OF OPERATION: 112c - Construction Regular Operation

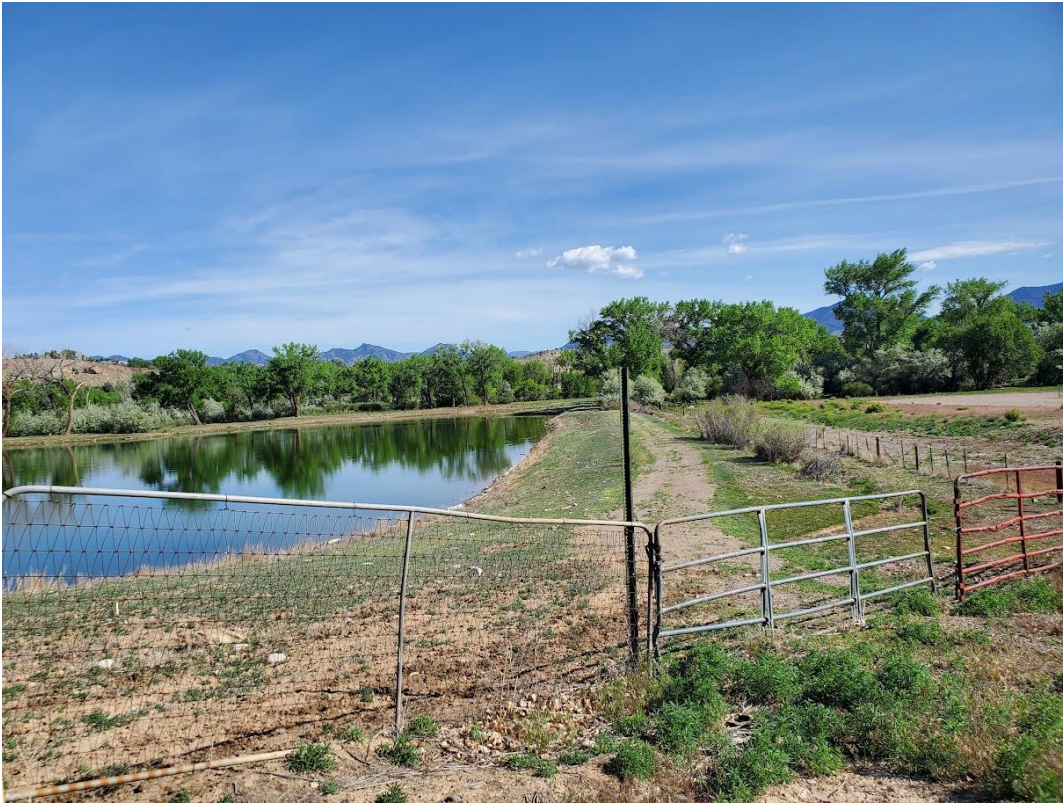
The Scott Pit section of the permit area is being reclaimed. The shores of the pond are at reclamation grade and topsoil has been spread. Vegetation has begun to grow, but is not yet self-sufficient.

Photo 1: View to the north of partially reclaimed pond in Scott Pit portion of permit area.

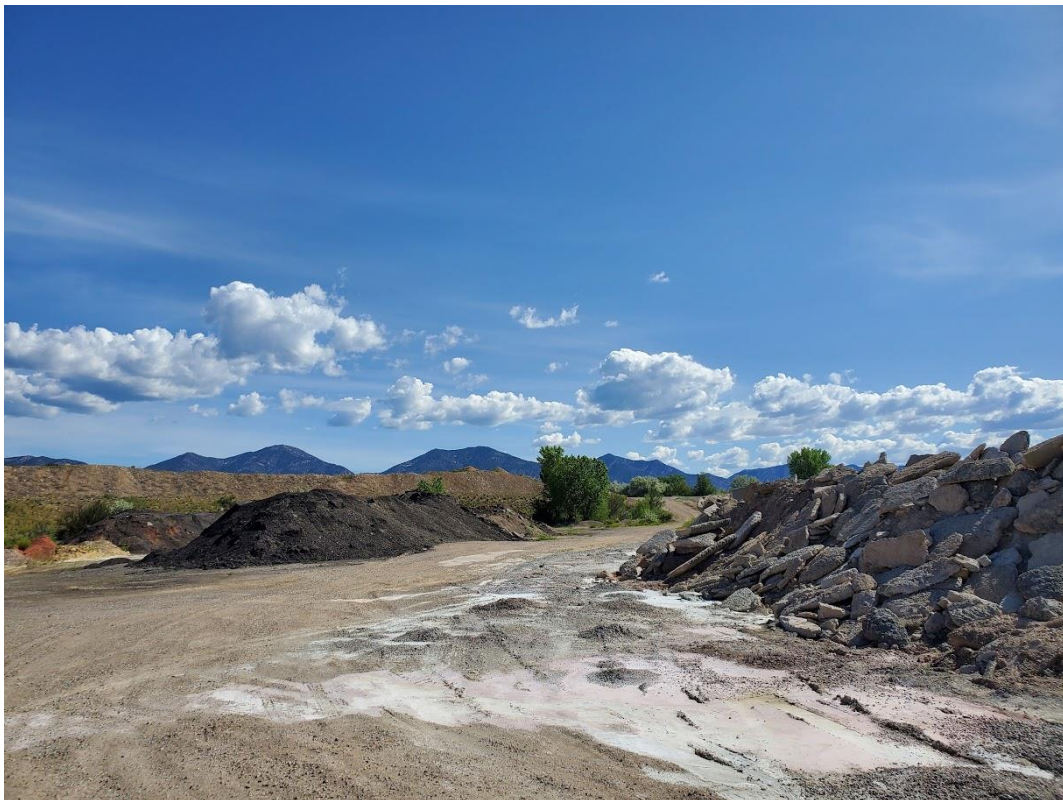
The permit is broken into two different areas. The main Chambers Pit is located on the north side of the river and borders the Dick Casey Pit. Stockpiles are located in this area.

Photo 2: View to the north of stockpiles in Chambers Pit

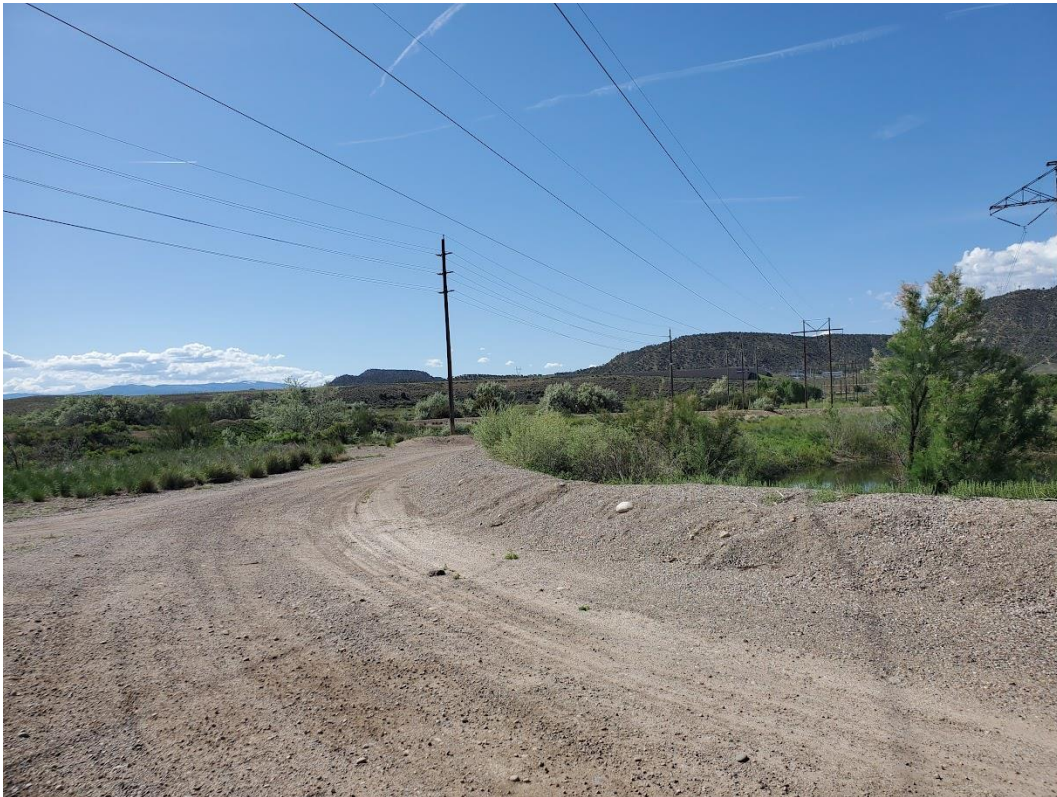
Photo 3: View to the south of power lines transversing permit area.

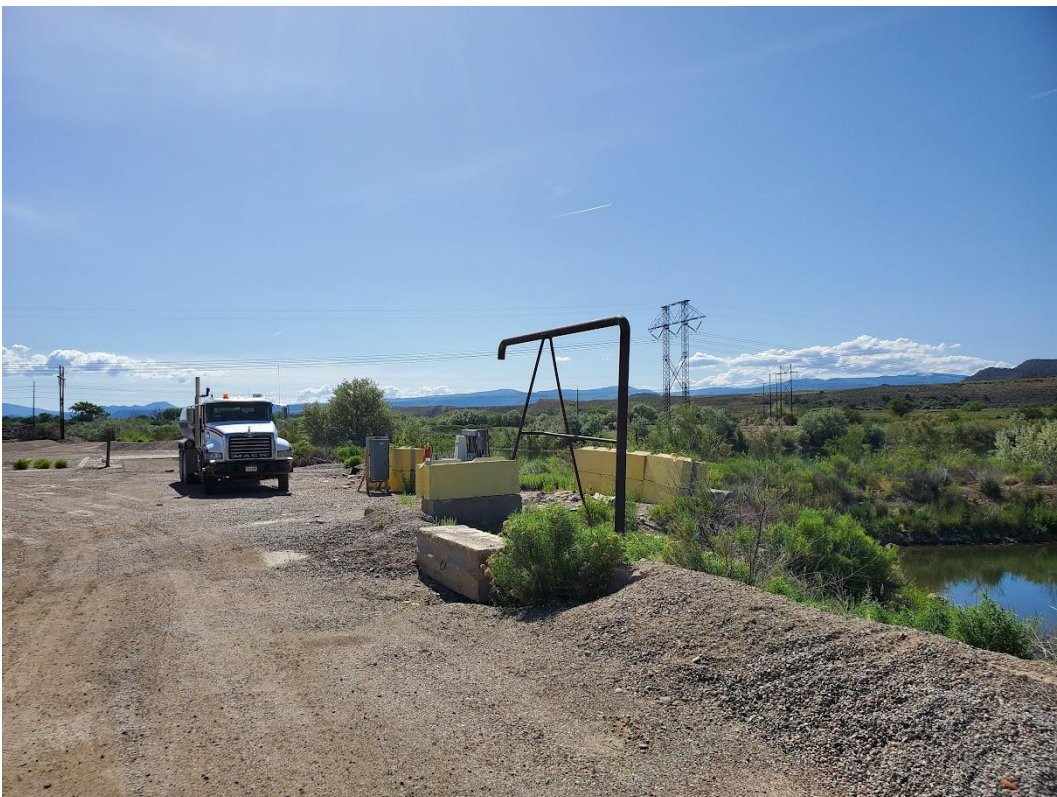
There was no sign present. A sign was noted in previous inspection reports, but is no longer present. Please place a sign at the entrance to the permit area. Boundaries are marked by berms and fence line that are easily identifiable.

Photo 4: View to the east of water truck at entrance to permit area.

CORRECTIVE ACTIONS: The operator shall, at the entrance of the mine site, post a sign which shall be clearly visible from the access road with the following: the name of the operator, a statement that a reclamation permit for the operation has been issued by the Colorado Mined Land Reclamation Board; and the permit number. The operator shall submit photo documentation that a proper sign has been posted by the corrective action date.
