Job Number: 99-3983

Subject: Quarterly Observation Report,
Refuse Pile, Foidel Creek Mine, Routt
County, Colorado.

Project:	Refuse Pile	Project No.:	99-3983	Date:	3/31/25
Location:	Foidel Creek Mine	Report No.:	115	Time:	2.0
Client:	Twentymile Coal Co.			Mileage:	45
				Engr. /Tech:	TT

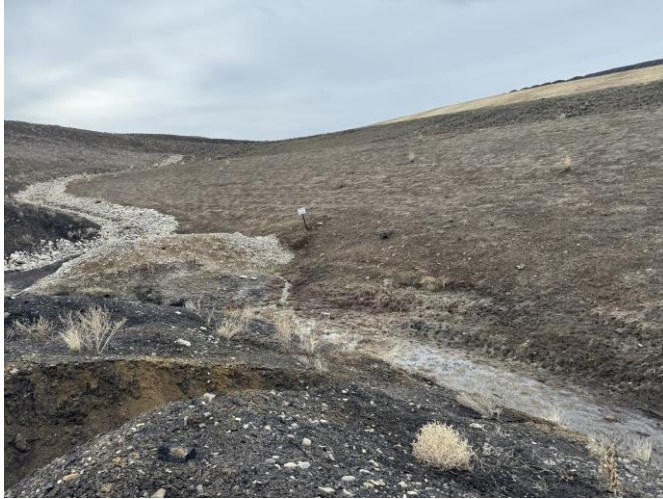
A seepage area at the toe of the northeast end of the refuse pile expansion area, approximately 30 feet northwest of the outlet of the underdrain, developed in fall 2014. At the time of our observations, the seepage was surfacing at the toe of the slope and flowing into the drainage from the undrain outlet then into the existing pond east of the Refuse Pile Expansion Area. The discharge was clear, with no evidence of sediment. No signs of washout, slumps or slope instability were observed at this time. The seepage area will be monitored during future inspections and noted in our inspection reports. Photographs of the seepage area taken at the time of our inspection on March 31, 2025 are attached.

March 31, 2025-Drain Outlet and Seepage Area

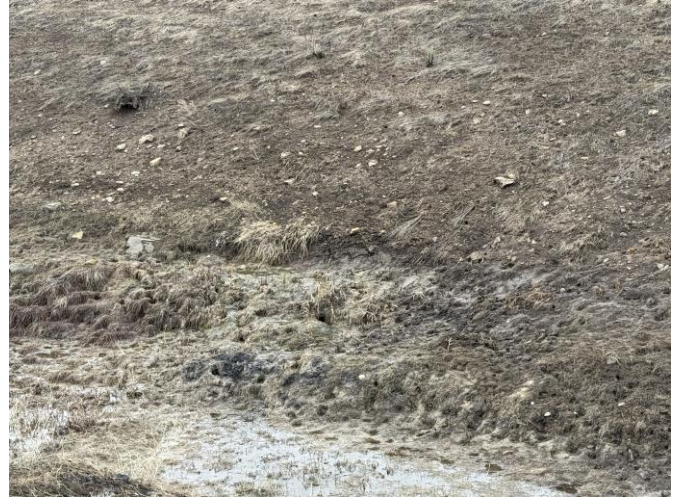
March 31, 2025-Seepage Area

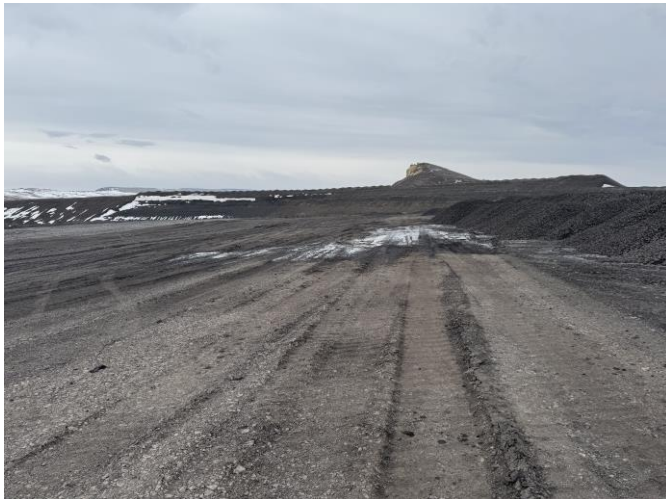
March 31, 2025- Areas 2, 3 and 4 from Expansion Area

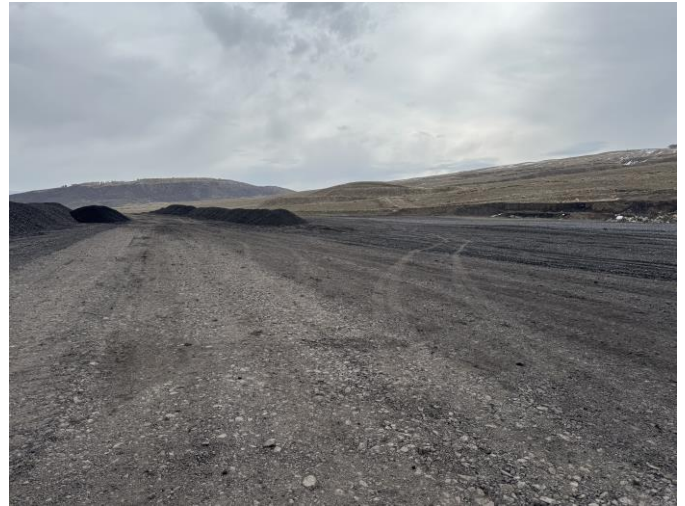
At the time of our site visit on March 31, 2025, NWCC completed a site inspection of the existing refuse pile. Based on our observations made during this visit, it appeared that the contractor was presently stockpiling, grading and compacting refuse coal in the new Expansion Area. At the time of our site visit, the refuse coal had been placed and compacted to an elevation above the third bench situated along the east side of the stockpile.

March 31, 2025- Expansion Area

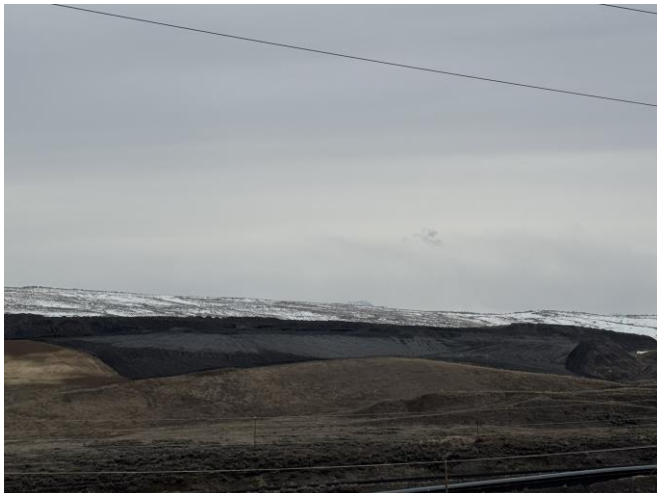
The internal roadways in the new expansion area of the pile are in good condition. The upper haul road to Areas 2, 3 and 4 of the refuse pile was not accessible due to recent snow melt and precipitation.

March 31, 2025- Road to Area 2, 3 and 4

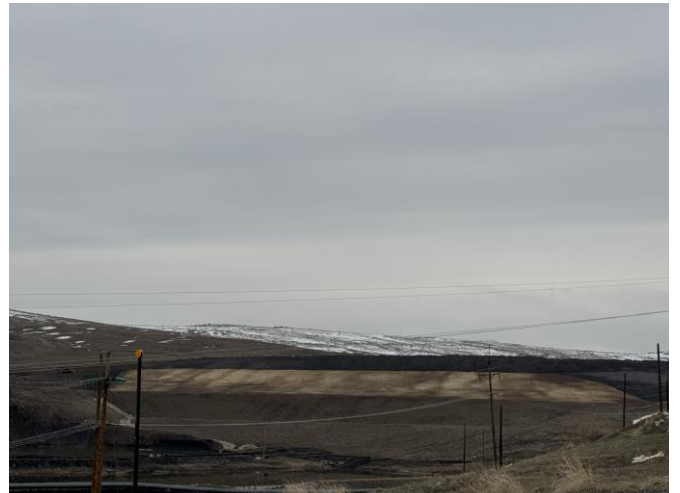
March 31, 2025- East End of Expansion Area
