MINERALS PROGRAM INSPECTION REPORT

MINE NAME: Eikermann	MINE/PROSPECTING ID#: M-2002-108	MINERAL: Sand and gravel	COUNTY: Lincoln
INSPECTION TYPE: Monitoring	WEATHER: Clear	INSP. DATE: July 2, 2025	INSP. TIME: 10:30
OPERATOR: Lincoln County	OPERATOR REPRESENTATIVE: Ty Stogsdill	TYPE OF OPERATION: 110c - Construction Limited Impact

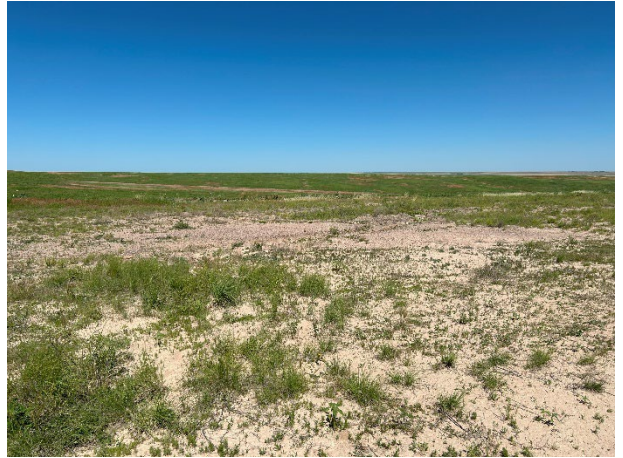
As mentioned, this site is currently in reclamation. Reclamation on the slopes surrounding the former pit floor is well established and adequate, however the central pit area is sparse. Evidence of drill seeding was observed but is not adequate to release at this time. Additional seeding is likely required in this area to push the site toward complete reclamation.

Photo 2: Seeded area with limited vegetation.

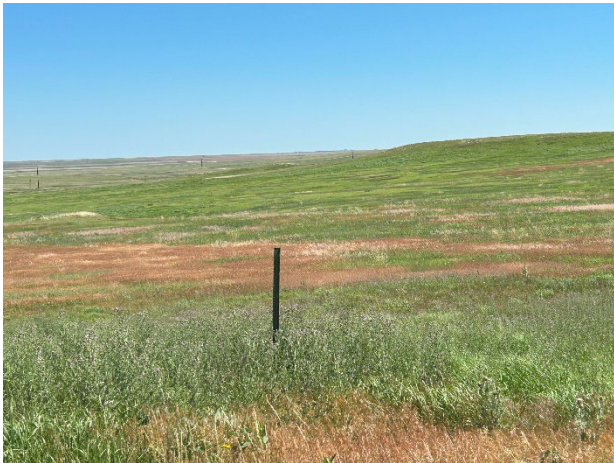
Per conversation with the operator, this site has been inactive for some time and is in reclamation. The site is currently surrounded by a wind farm, and the boundaries surrounding the adjacent farmland is clearly marked. No markers were observed near the roadway, which has been cited as a problem in this report. Please provide evidence of replacement markers within 60 days of this report.

Photo 3: Example boundary marker located toward the adjacent wind farm.

CORRECTIVE ACTIONS: The operator shall conduct a survey and replace the boundary markers in the correct location(s). The operator shall provide proof to the Division that this has been done by the corrective action date.

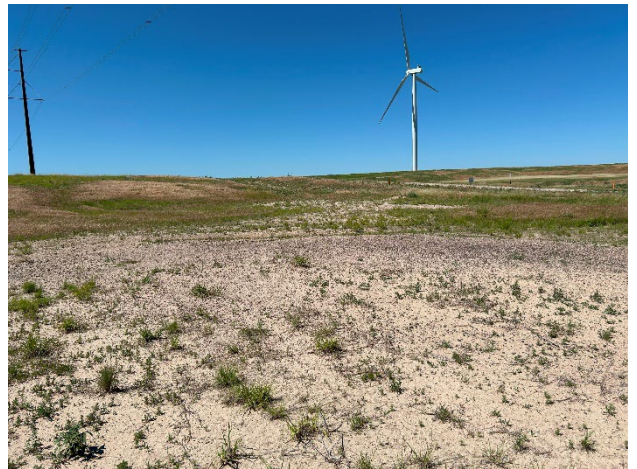
Photo 4: Additional example of bare pit floor.
