MINERALS PROGRAM INSPECTION REPORT

MINE NAME: E 8th Street Operation	MINE/PROSPECTING ID#: M-2000-082	MINERAL: Sand and gravel	COUNTY: Weld
INSPECTION TYPE: Monitoring	WEATHER: Clear	INSP. DATE: May 28, 2025	INSP. TIME: 09:00
OPERATOR: Superior Oilfield Services Co., LTD	OPERATOR REPRESENTATIVE: Jim McFarland	TYPE OF OPERATION: 112c - Construction Regular Operation

The 8th Street gravel mine was inspected by Nikie Gagnon, representing the Division of Reclamation, Mining and Safety (Division), as part of the Division's normal monitoring inspection program. Jim McFarland, representing Superior Oilfield Services (Operator), accompanied the Division during the inspection. The site is located half a mile east of Greeley on 8th Street, just east of Highway 85. A mine sign was posted at the entrance to the site, as required by Rule 3.1.12(1), and metal posts mark the permit boundary in the corners. The Cache La Poudre River flows adjacent to the site, on the south side. The permit area is 48.75 acres and the post mining land use is recreation.

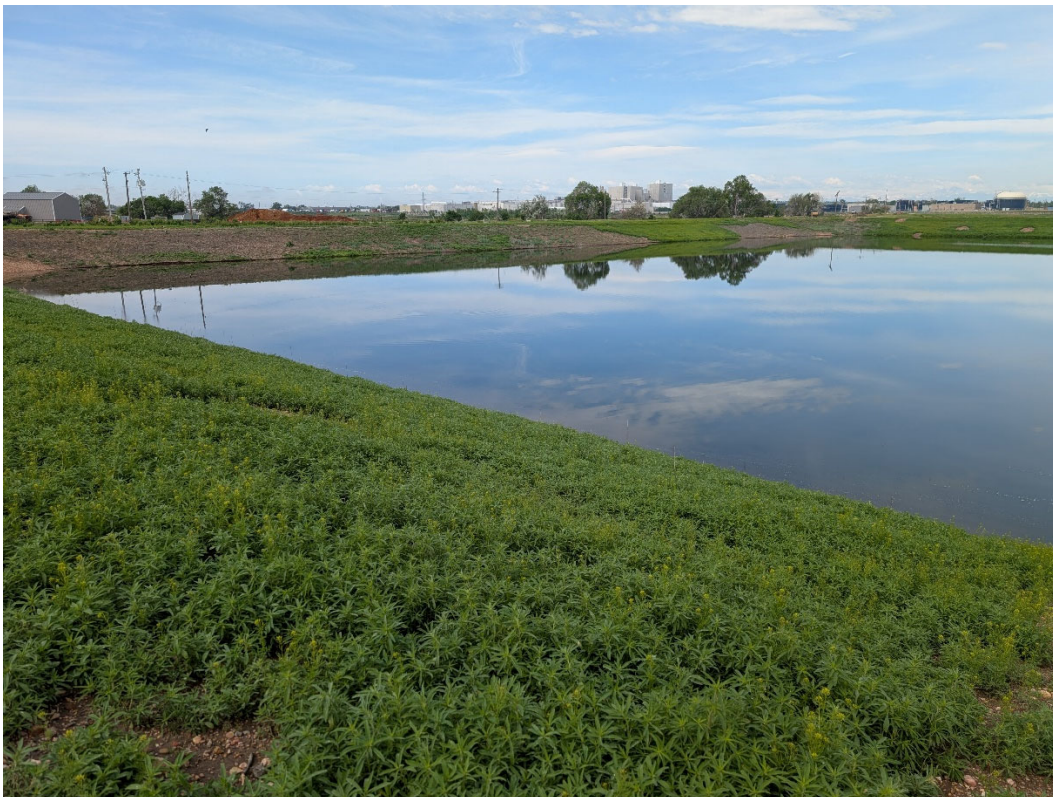
Photo 2: Looking at the shoreline of the Phase III Pond. The slopes are graded 3H:1V. Annual weeds dominate the slopes.

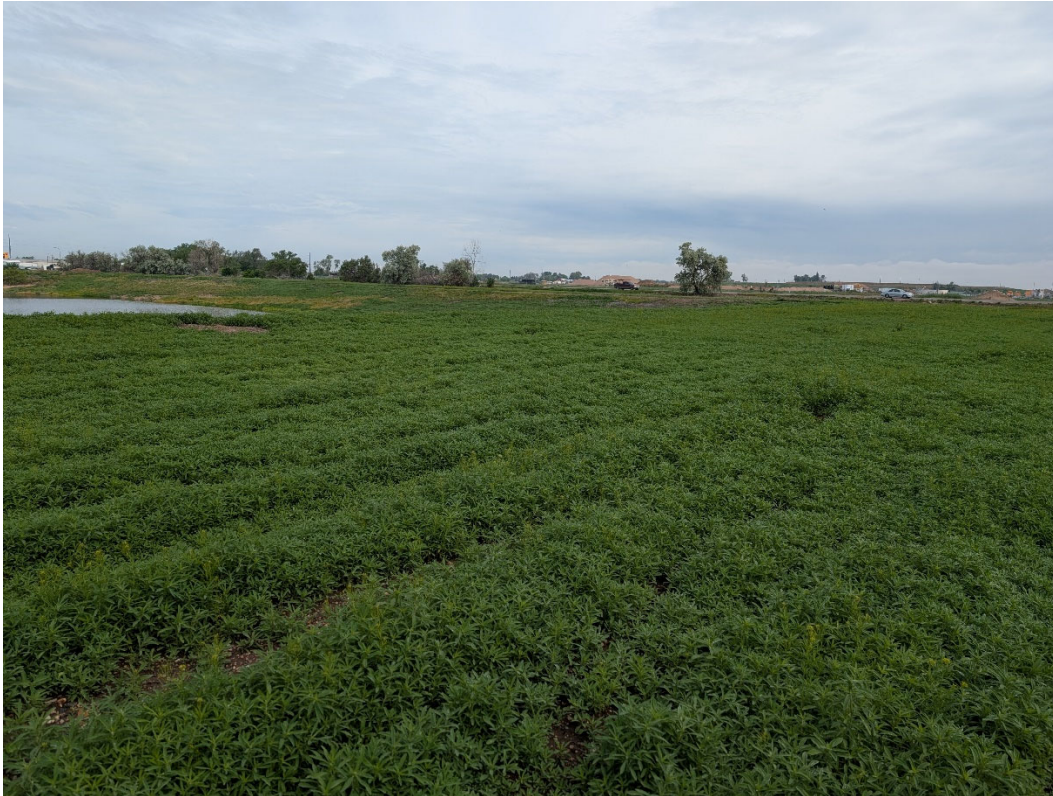
The operator is working on revegetation of the site. Initial topsoiling and seeding were completed in 2021. During the inspection, the Operator stated that they have re-seeded some of the areas four times and the desired vegetation is not yet established. During the inspection, the Division observed dense annual weeds, primarily kochia, growing in rows across the site (Photos 1-3). The kochia provides temporary cover and minimizing erosion, however, the desired native grasses are not filling in across the site. Additionally, some areas are still bare ground. According to the operator, the site was previously utilized as a cattle feedlot. Based on the vegetation patterns and density, high levels of nitrogen and salts in the soil are likely helping the annual weeds thrive.

Photo 3: Looking north across the upland area adjacent to the Phase III Pond on the east side of the permit area. Dense kochia is growing in rows in this area.

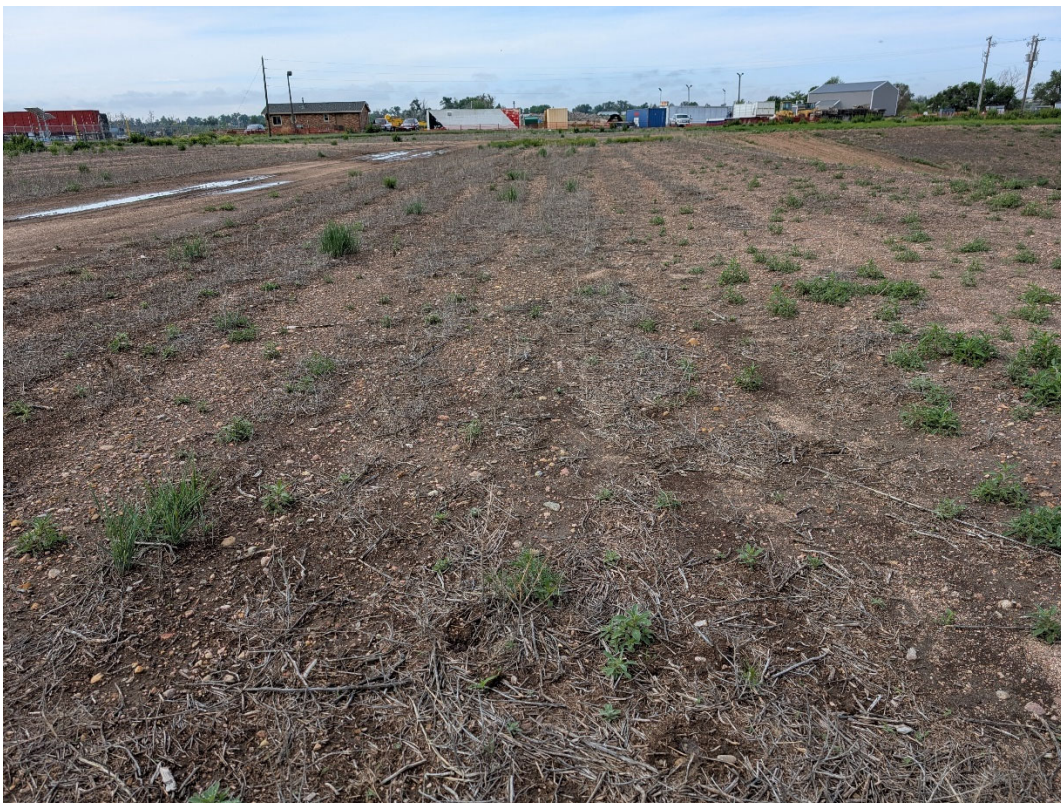
Although much of the site is kochia, some desired grasses were observed within the weeds, particularly on the south side of the ponds, along the river. The east end of the site is drier and more bare ground was observed near the entrance to the site where the former stockpiles were located (Photo 4). According to the approved reclamation plan, two seed mixes are approved for the shoreline and upland areas, a Wet Meadow Range mix and Overflow Gravel Breaks Range mix. Additionally, the reclamation plan calls for planting Reed Canary grass along the shorelines of the ponds. The Division recommended that the operator contact the local soil conservation service to determine the best reclamation seed mix and other elements that may need to be incorporated into the soil to ensure revegetation success. **Once the best management practices for reestablishing vegetation across the site are determined, the Operator will need to submit a Technical Revision to the Division to update the reclamation plan.**

Photo 4: Looking south across the former stockpile near the entrance on the east side. Bare ground observed here.

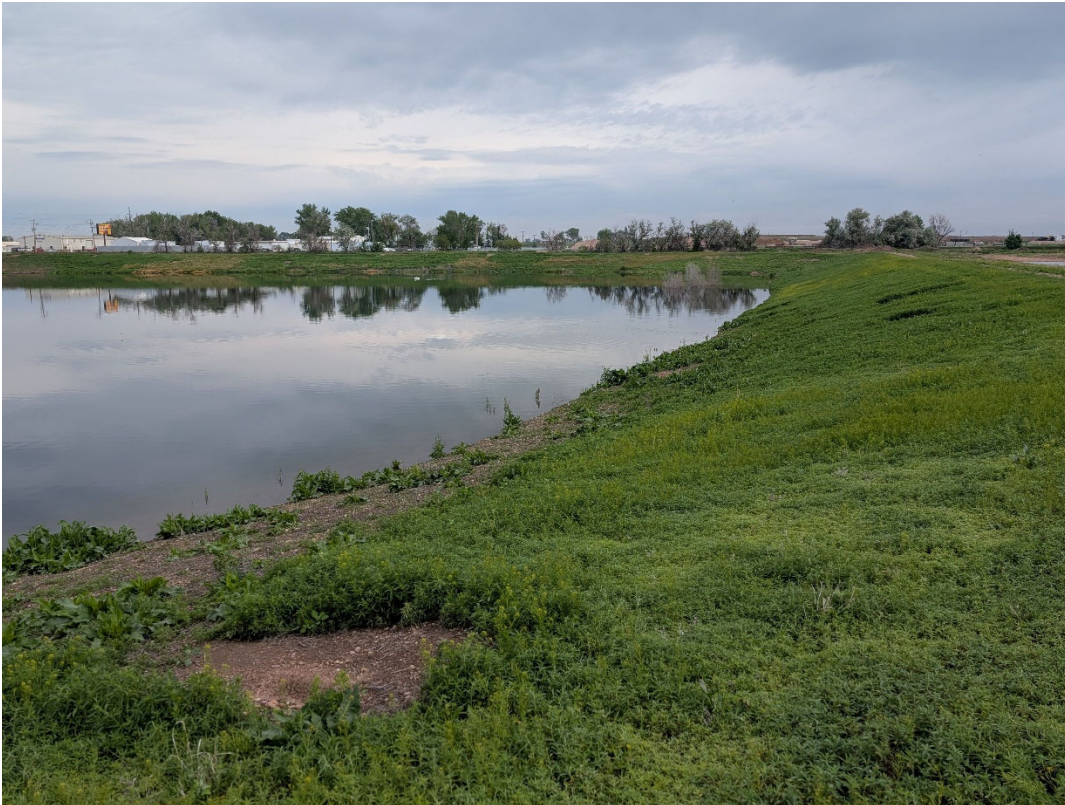
Photo 6: Looking north down the shoreline of the Phase II Pond on the west side of the permit area. Shoreline vegetation is primarily kochia and other annual weeds.

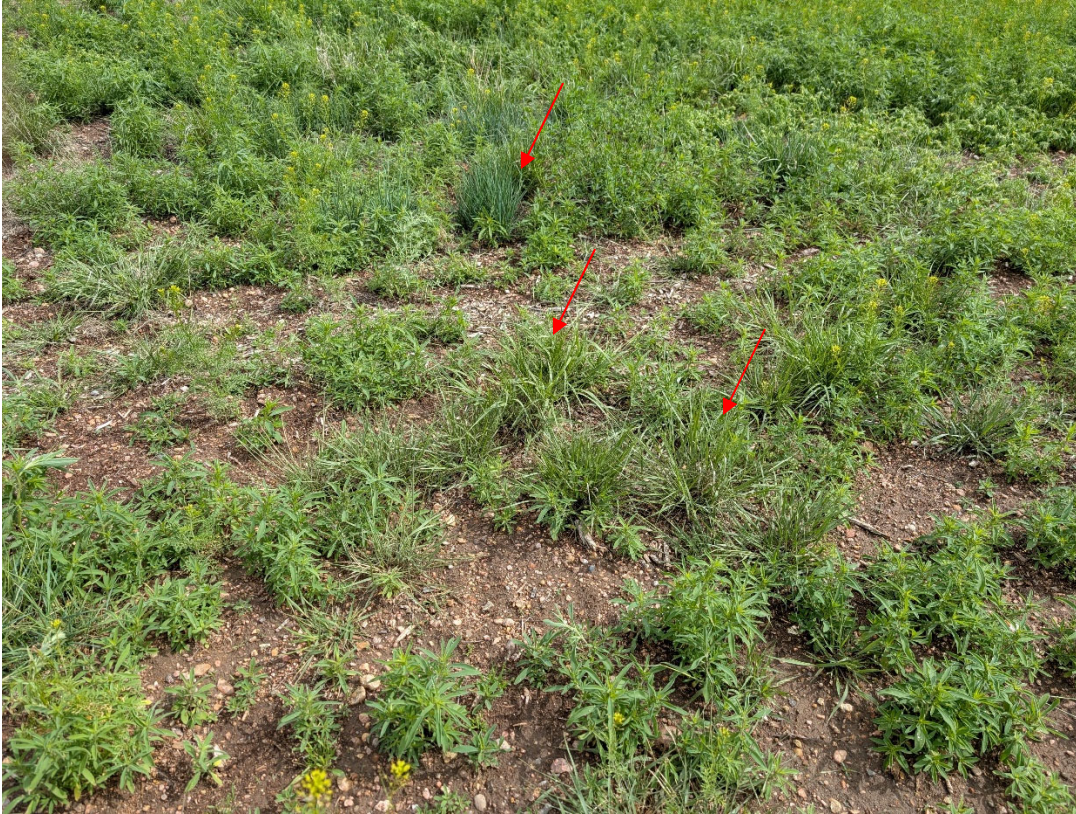
Photo 9: Some native grasses observed growing within the weedy vegetation.

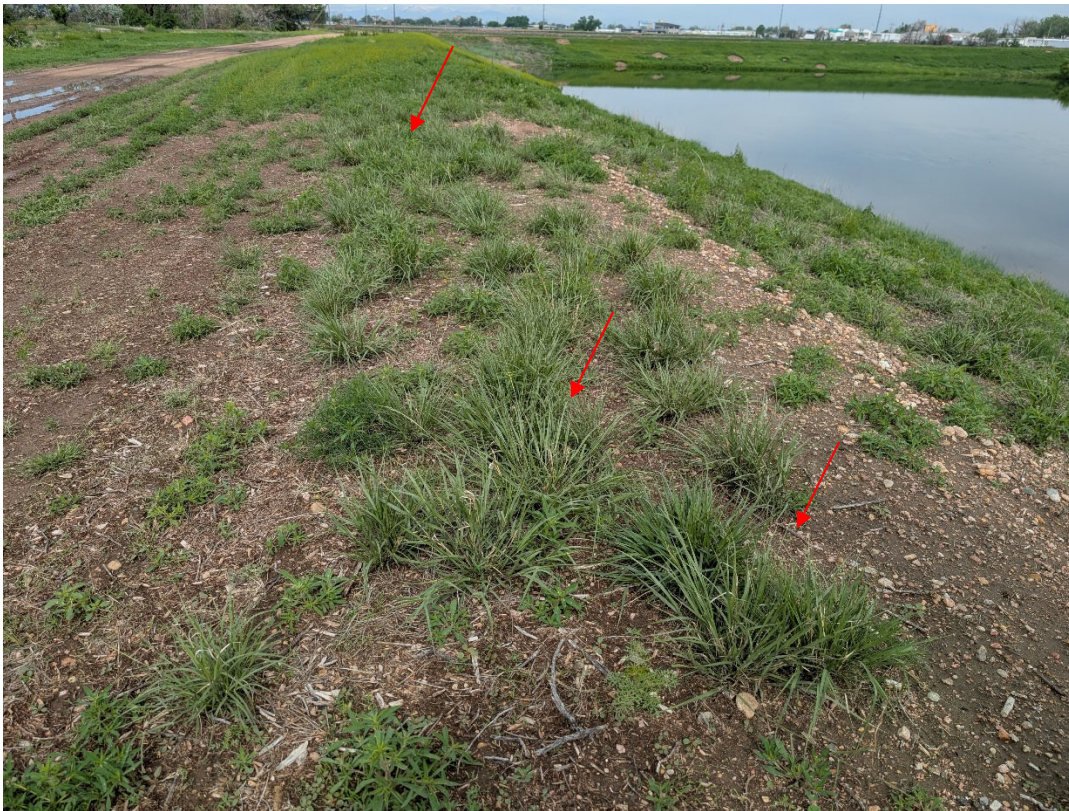
Photo 10: Native grasses observed growing along the south side of the Phase II Pond.

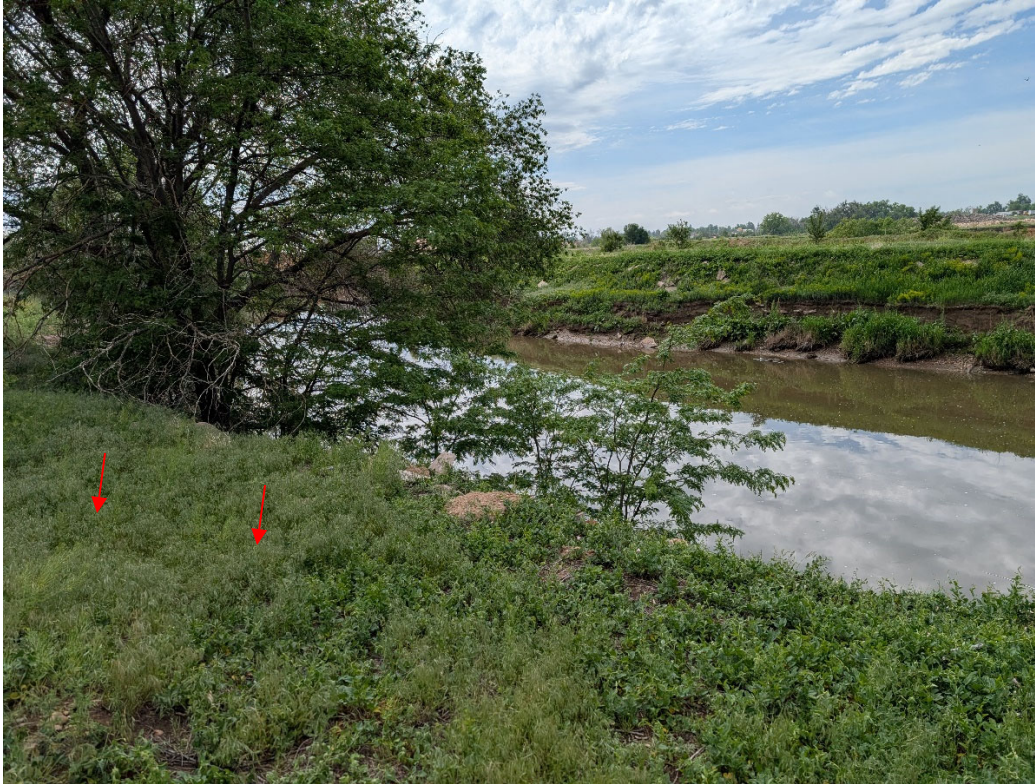
Additionally, the approved reclamation plan describes a Cache La Poudre Trail corridor which runs along the south side within the permit area. This corridor is preserved as a buffer zone along the northern shore of the river. **According to the plan, trees and shrubs will be planted to enhance riparian habitat and preserve the trail corridor along the river. As of the date of this inspection, the trees and shrubs have not been planted.**

Photo 11: Cache La Poudre River adjacent to the south side of the permit area. Riparian buffer area observed here. Downy brome (cheatgrass) noted here (red arrow).

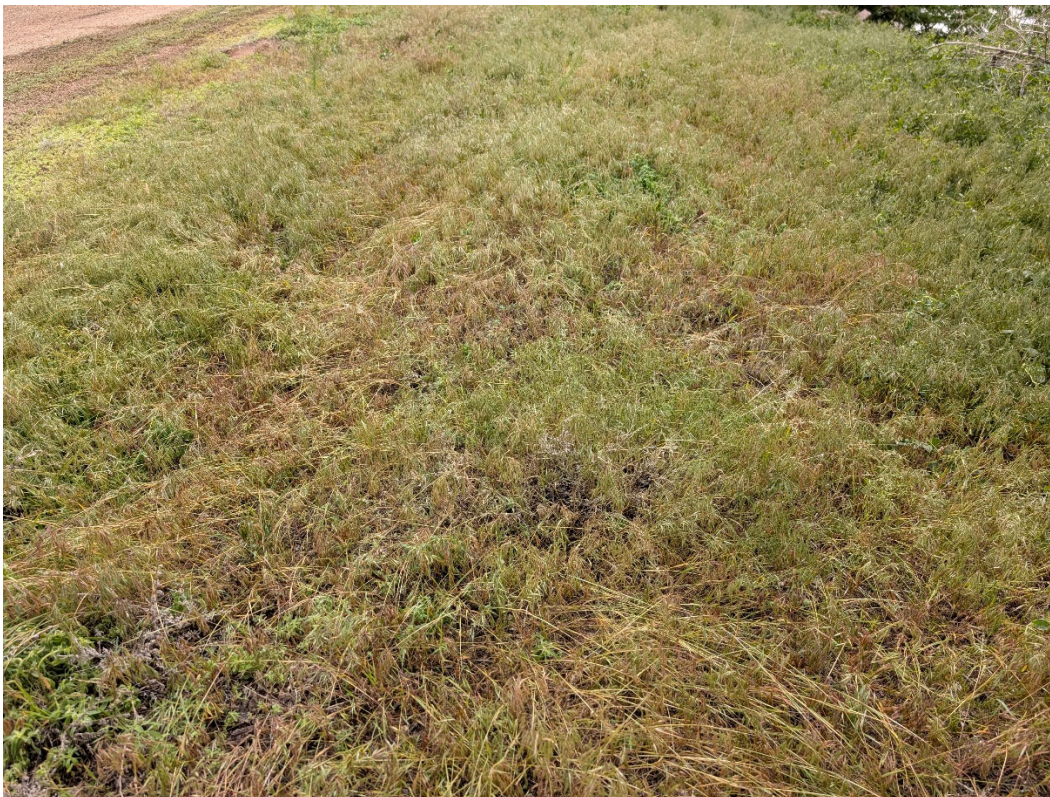
PROBLEM 1: There are state-listed noxious weeds present on site. This is a problem for failure to employ weed control methods for state listed noxious weed species within the permitted area, and to reduce the spread of weeds to nearby areas as required by Section 3.1.10 (6) of the rule.

The approved reclamation plan states that weeds will be mowed and controlled, however, no specific weed control plan was found in the permit file. During the inspection, the Division observed annual weeds dominating the entire site. Areas of downy brome (cheatgrass) were observed along the bank of the river and on the south sides of the reservoirs within the permit area (Photos 11-12). **Downy brome is a list C species requiring treatment. As stated above in Problem #1 above, the operator shall develop a weed control and management plan in accordance with Section 3.1.10 (6) of the Rule. This plan should be developed in consultation with the county extension agency, or weed control district office and should include specific control measures to be applied, a schedule for when control measures will be applied and a post-treatment monitoring plan. This weed control plan shall be submitted to the Division as a Technical Revision to the approved plan with the appropriate Technical Revision fee of \$216.00 by the corrective action date.**

Photo 12: Downy brome (cheatgrass) observed along the perimeter road on the south side.

CORRECTIVE ACTIONS: The operator shall develop a weed control and management plan in accordance with Section 3.1.10 (6) of the Rule. This plan should be developed in consultation with the county extension agency, or weed control district office and should include specific control measures to be applied, a schedule for when control measures will be applied and a post-treatment monitoring plan. This weed control plan shall be submitted to the Division as a Technical Revision to the approved plan with the appropriate Technical Revision fee of \$216.00 by the corrective action date.
