## Rio Grande Bentonite- June 2025 Inspection Report and Cost Estimate

**MINERALS PROGRAM INSPECTION REPORT**  
**PHONE: (303) 866-3567**

<b>MINE NAME:</b> Rio Grande Bentonite	<b>MINE/PROSPECTING ID#:</b> M-2002-106	<b>MINERAL:</b> Bentonite	<b>COUNTY:</b> Conejos
<b>INSPECTION TYPE:</b> Monitoring	<b>WEATHER:</b> Clear	<b>INSP. DATE:</b> June 16, 2025	<b>INSP. TIME:</b> 13:30
<b>OPERATOR:</b> Larry Mondragon,	<b>OPERATOR REPRESENTATIVE:</b> Larry Mondragon	<b>TYPE OF OPERATION:</b> 110c - Construction Limited Impact	
<b>REASON FOR INSPECTION:</b> Normal I&E Program	<b>BOND CALCULATION TYPE:</b> Complete Bond	<b>BOND AMOUNT:</b> \$7,345	
<b>DATE OF COMPLAINT:</b> NA	<b>POST INSP. CONTACTS:</b> None	<b>JOINT INSP. AGENCY:</b> None	
<b>INSPECTOR(S):</b> Chris Girardi	<b>INSPECTOR'S SIGNATURE:</b>

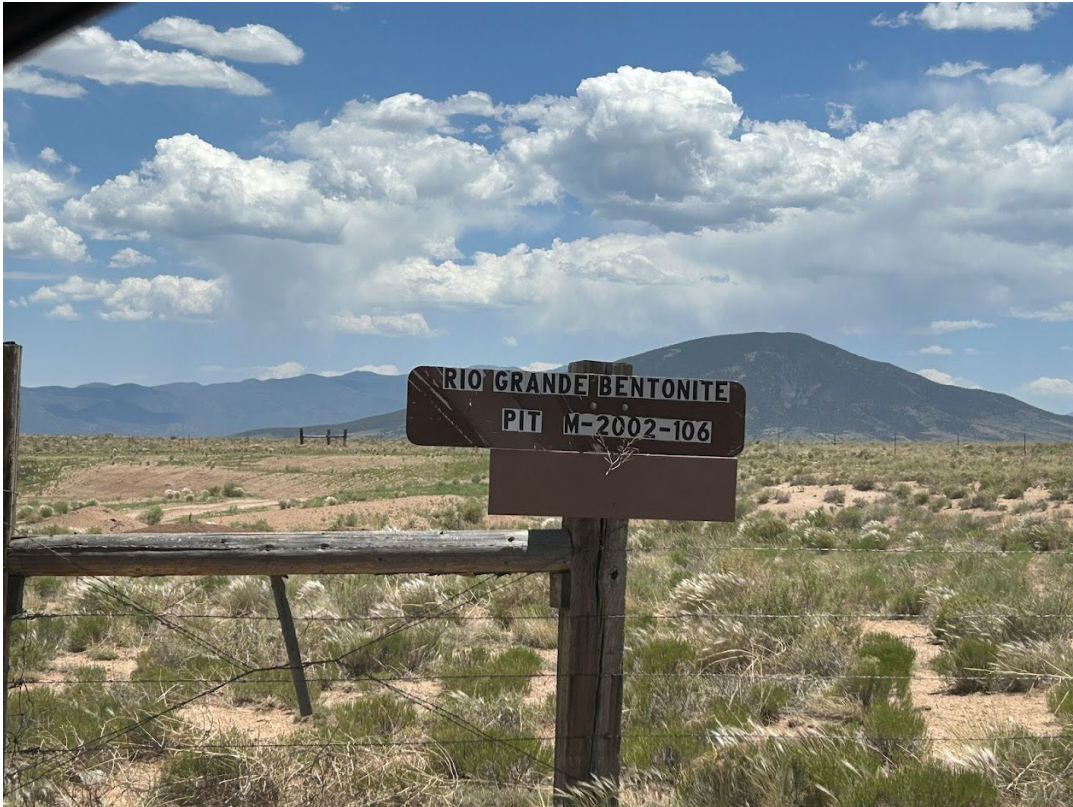
The site is accessed using Punche Valley Road, then turning east using an access road. The site is then accessed using a gate. A mine identification sign was located at the entrance to the site in compliance with Rule 3.1.12 (see Photo 1). The permit boundary is enclosed with a fence on the south and west sides and delineated using metal barrels on the north side.

Photo 1: Mine entrance sign, facing east.

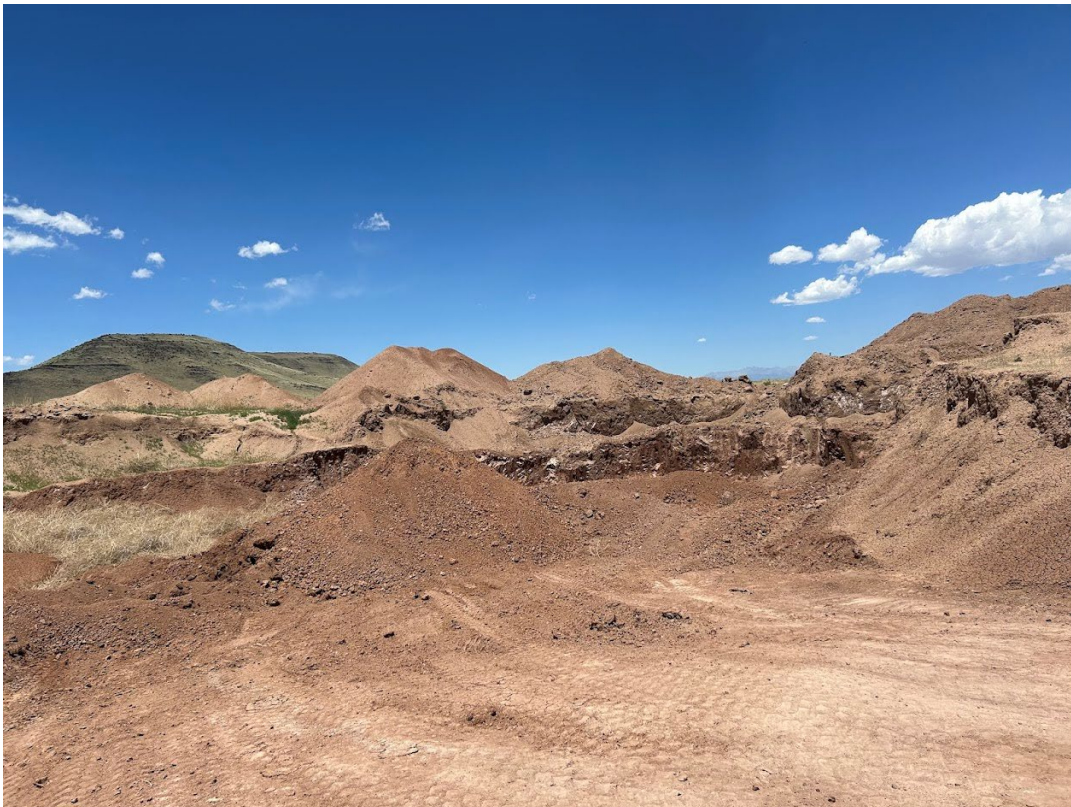
The site is located within Punche Valley and located approximately a half mile west of the Rio Grande River. At the time of the inspection, the Operator was actively mining the pit slope. The site consists of a small pit less than one acre in size and approximately 8-10 feet in depth, with material stockpiles located on the pit floor (see Photo 2). Overburden material is stockpiled north of the pit. The pit maintains an almost vertical highwall at 1:1 horizontal/vertical configuration, although the toe of the pit slope is more relaxed. No erosion of the pit was observed. Topsoil is stockpiled along the eastern permit boundary. The undisturbed portion of the permit area contains dense vegetative cover, consisting of Indian ricegrass, Bottlebrush squirreltail, Sagebrush, and Kochia (see Photos 5-7). Kochia is an invasive species, but not a noxious weed and not considered a problem at this time. No fuel is being stored within the permit area.

Photo 2: Active pit area with material stockpiles on the pit floor, facing west.

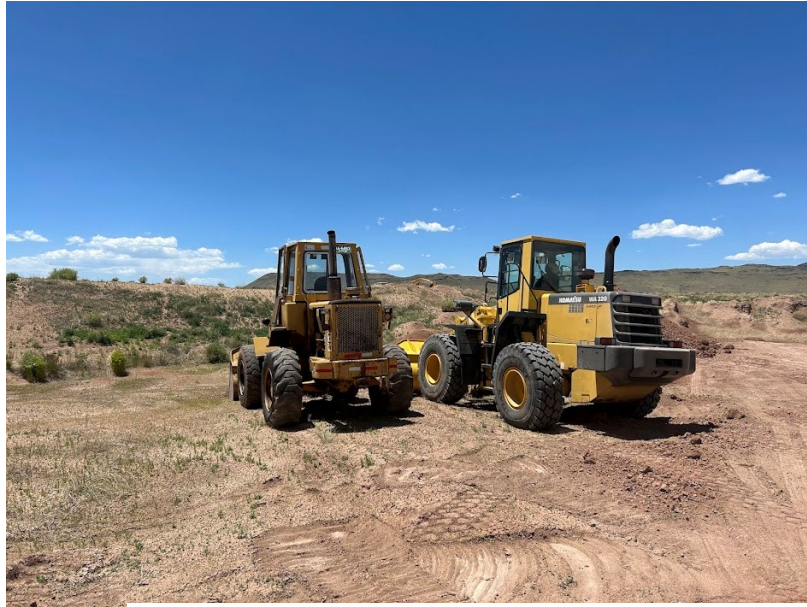
A pair of wheel loaders were located near the pit (see Photo 3). The Operator has also begun reclaiming a former pit along the southeast portion of the permit area, which has been graded and seeded (see Photo 4). Revegetation has moderately established on the former pit floor, but the slope has struggled to regrow vegetation. In addition, minor rilling erosion of the reclaimed pit slope was observed. The DRMS noted that if increased erosion of the south pit slopes occurs, then stabilization measures will be necessary to remain in compliance with Rule 3.1.6(3) of the Construction Materials Rules and Regulations governing erosion of affected land.

Photo 3: View of mining equipment.

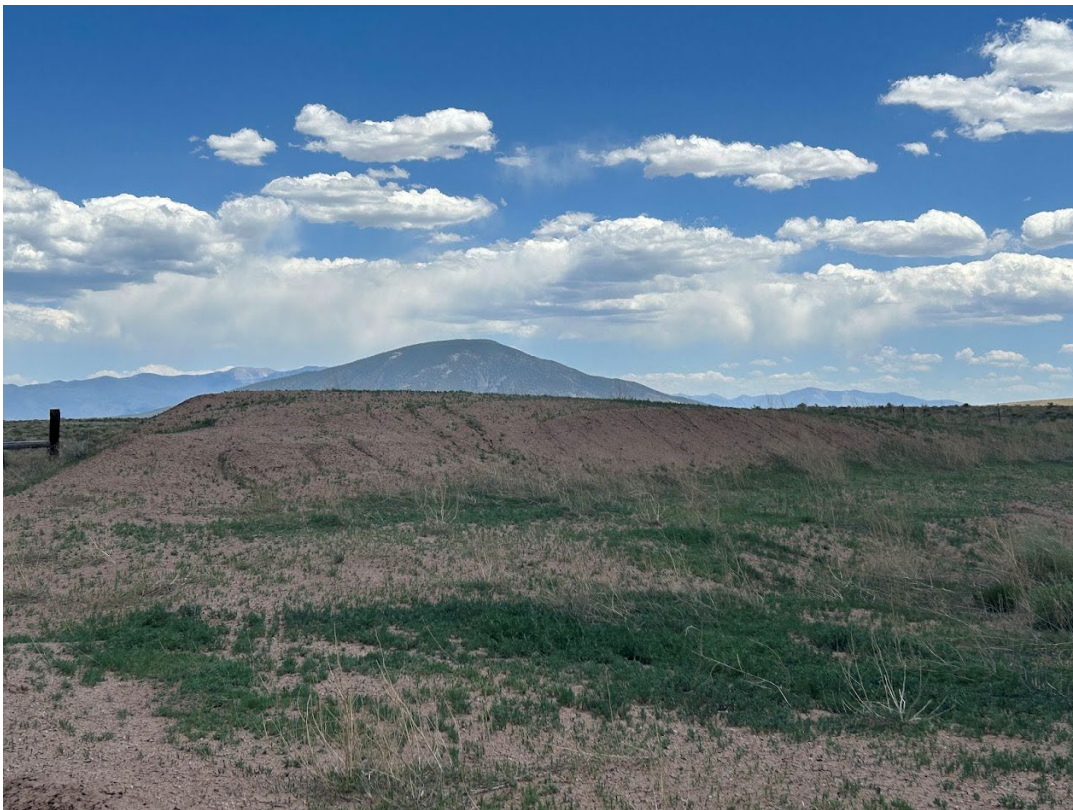
Photo 4: View of reclaimed pit slope in the southeast portion of the permit, facing south.

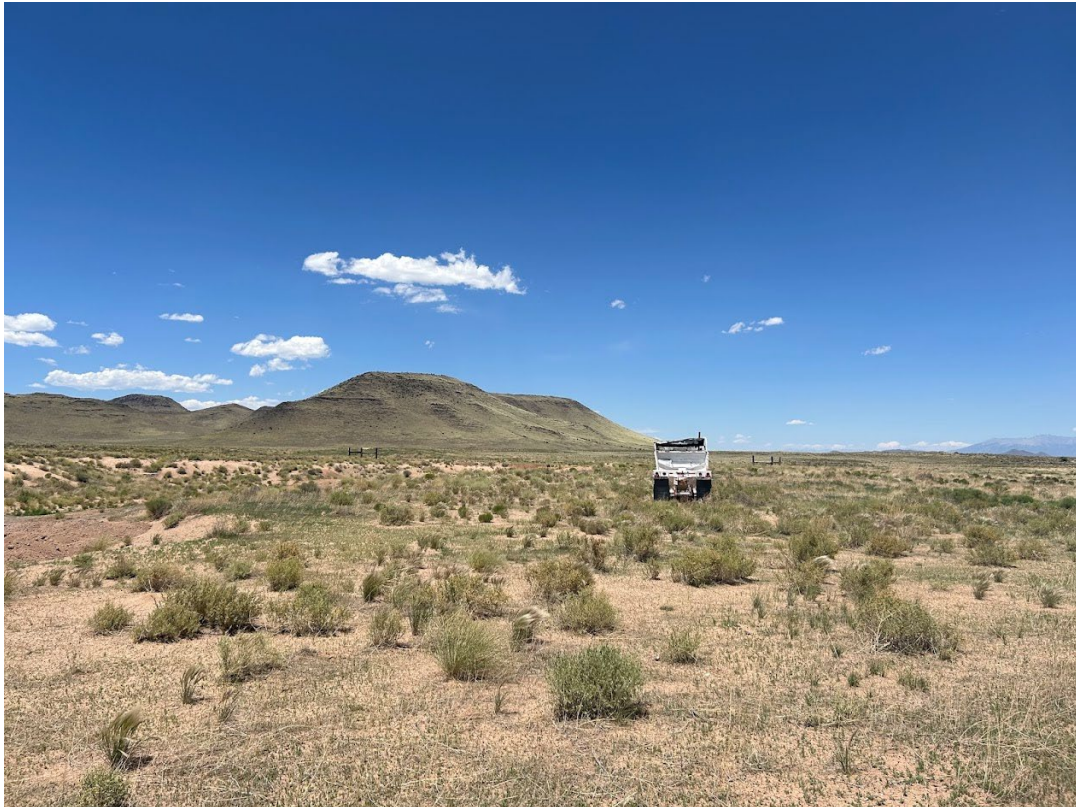
Historical Google Earth Imagery indicates the Operator had previously been mining a pit to the east and has been mining to the west since 2019. Previous inspection reports have indicated the presence of pre-permit and historic disturbances directly to the north and southwest of the permit area. However, this area exhibits significant vegetative cover and is not easily discernable from unaffected lands outside the permit area (see Photo 5 and Figure 1).

Photo 5: View of undisturbed portion of parcel and potential amendment expansion area, facing north.

According to the Operator, they intend to submit an amendment application to increase the permit acreage from 4 acres to around 9 acres. They are in the process of hiring a consultant to conduct a survey of the expansion area, which would expand the permit area to the east and northeast, where overburden thickness is only one (1) to three (3) feet, as opposed to the current permit area where overburden thickness is

approximately six (6) feet in thickness. An amendment application should also consider a change of the reclamation plan and post-mine land use, which is currently developed water resources.

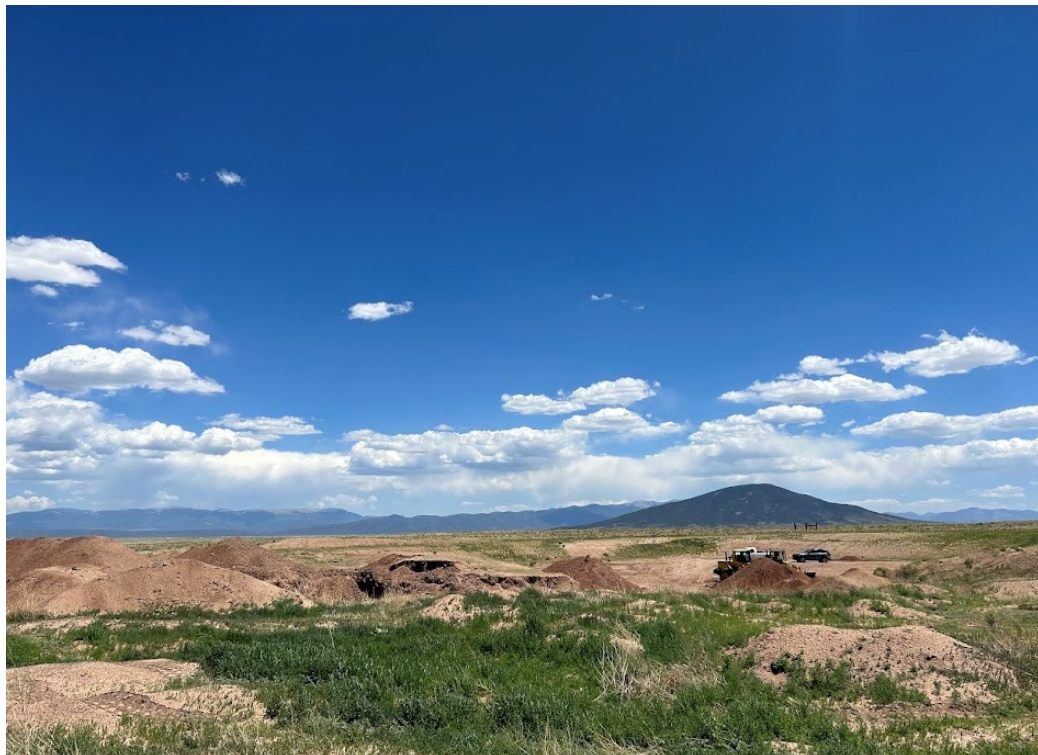
Photo 6: View of undisturbed portion of permit containing vegetation, as well as the disturbed portion of the permit area, facing southeast.

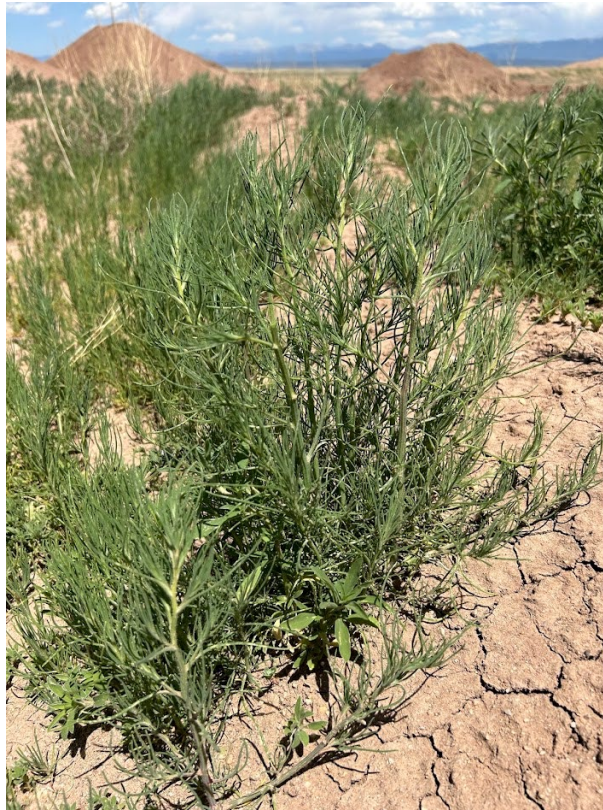
Photo 7: Kochia weed within the undisturbed portion of the permit area.

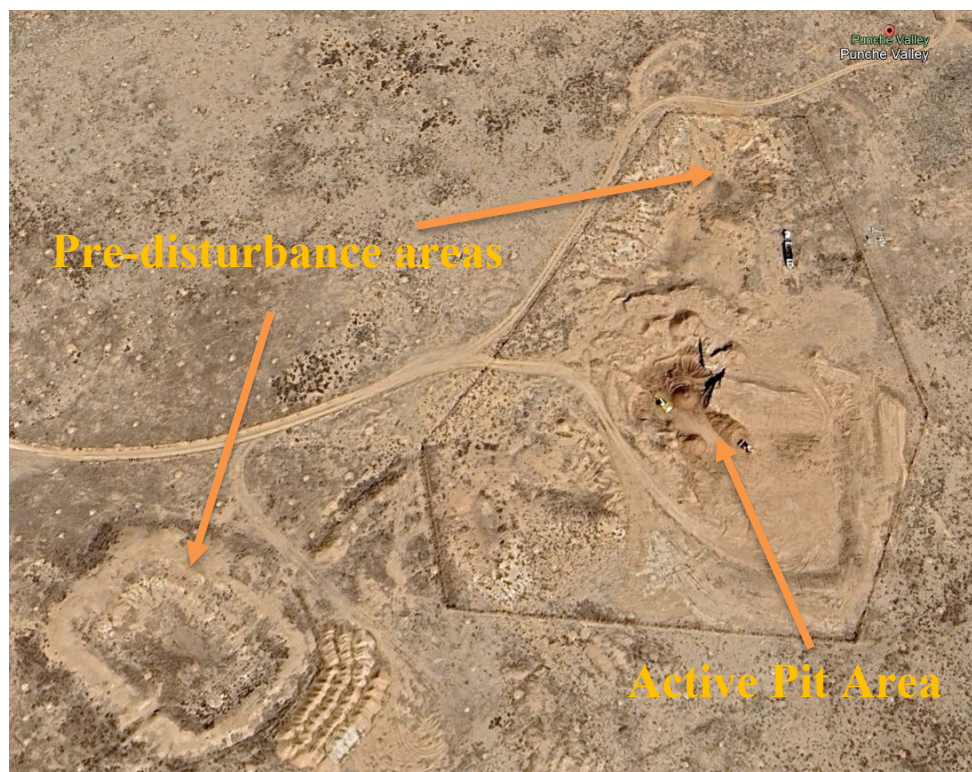
Figure 1: This map was generated using Google Earth to show areas of pre-disturbance unrelated to the current mining plan.
