## Pit 29 Inspection Report

### MINERALS PROGRAM INSPECTION REPORT

| <b>MINE NAME:</b><br>Pit 29 | <b>MINE/PROSPECTING ID#:</b><br>M-1980-183 | <b>MINERAL:</b><br>Sand and gravel | <b>COUNTY:</b><br>Adams |

Brannan Sand and Gravel Pit #29

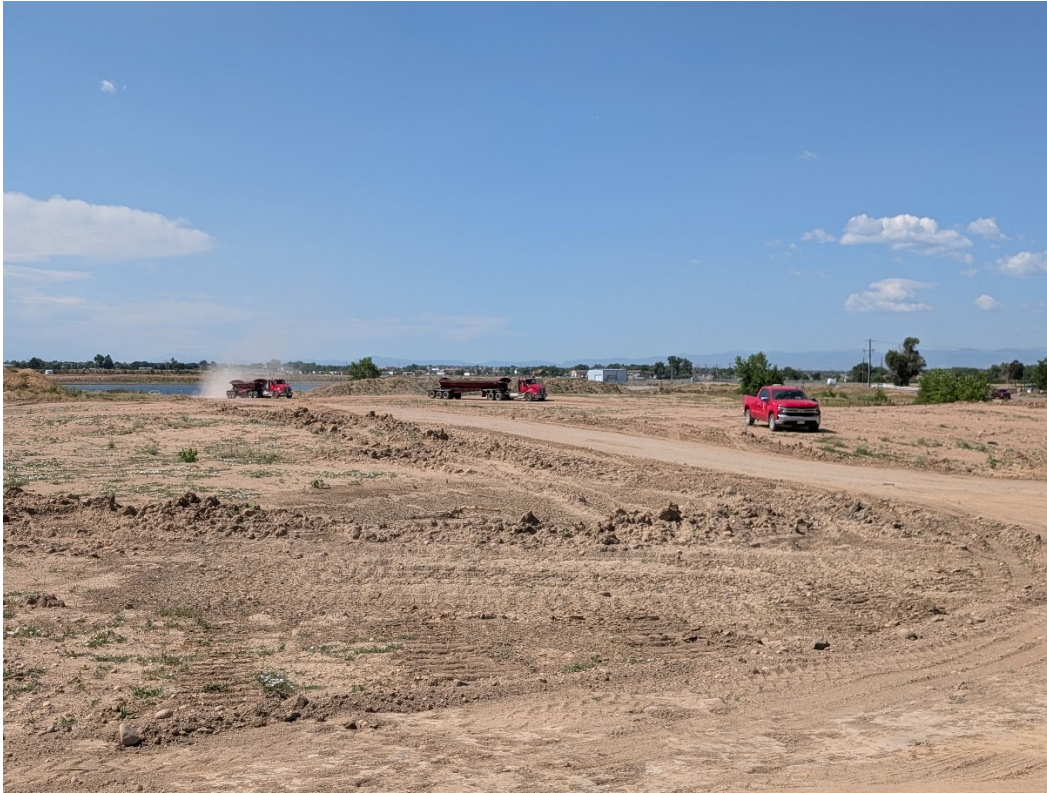
Photo 1: Looking south across Mining Area III. Haul trucks entering site.

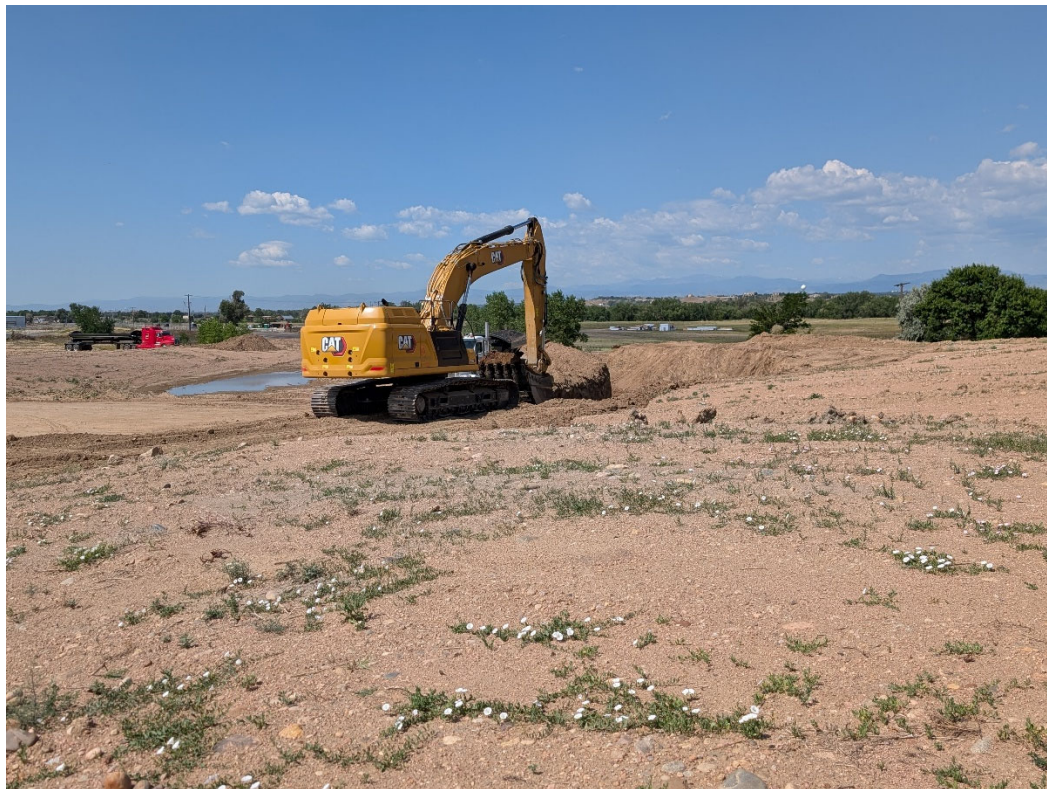
Photo 2: Excavator working at the south end of the large stockpile in Mining Area III.

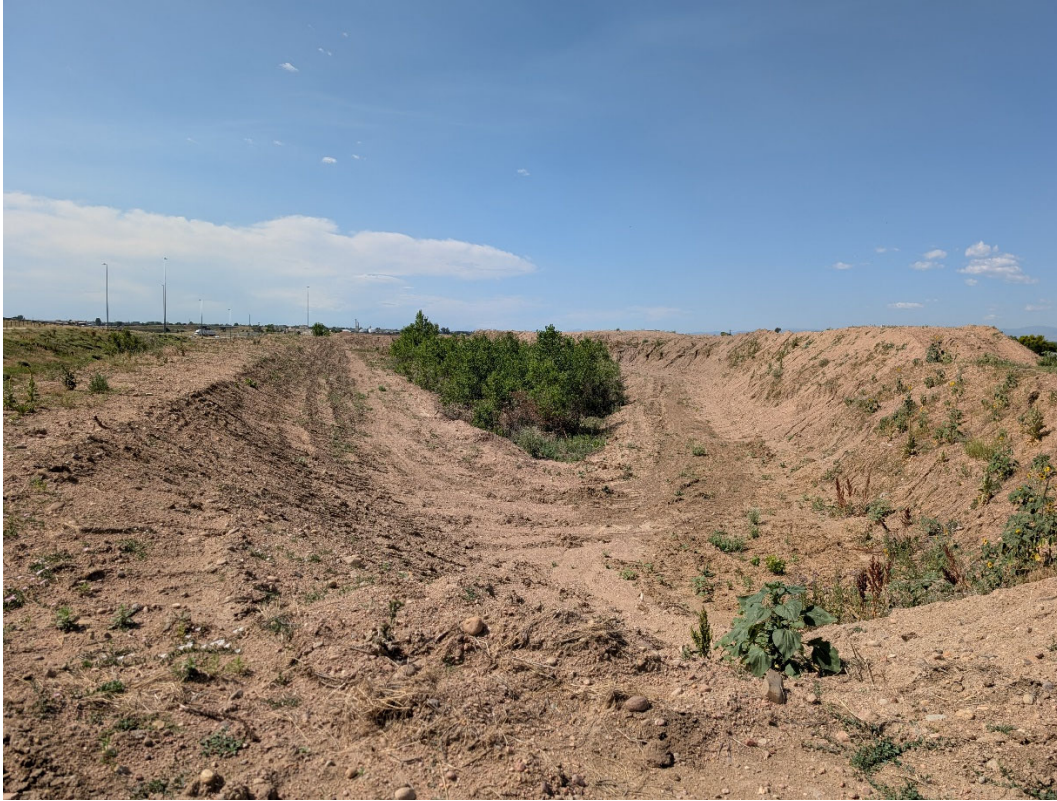
Photo 5: Looking south from the north end of the stockpile. Trees growing in a low spot between the stockpile and the topsoil berm that runs along the eastern perimeter of the permit area.

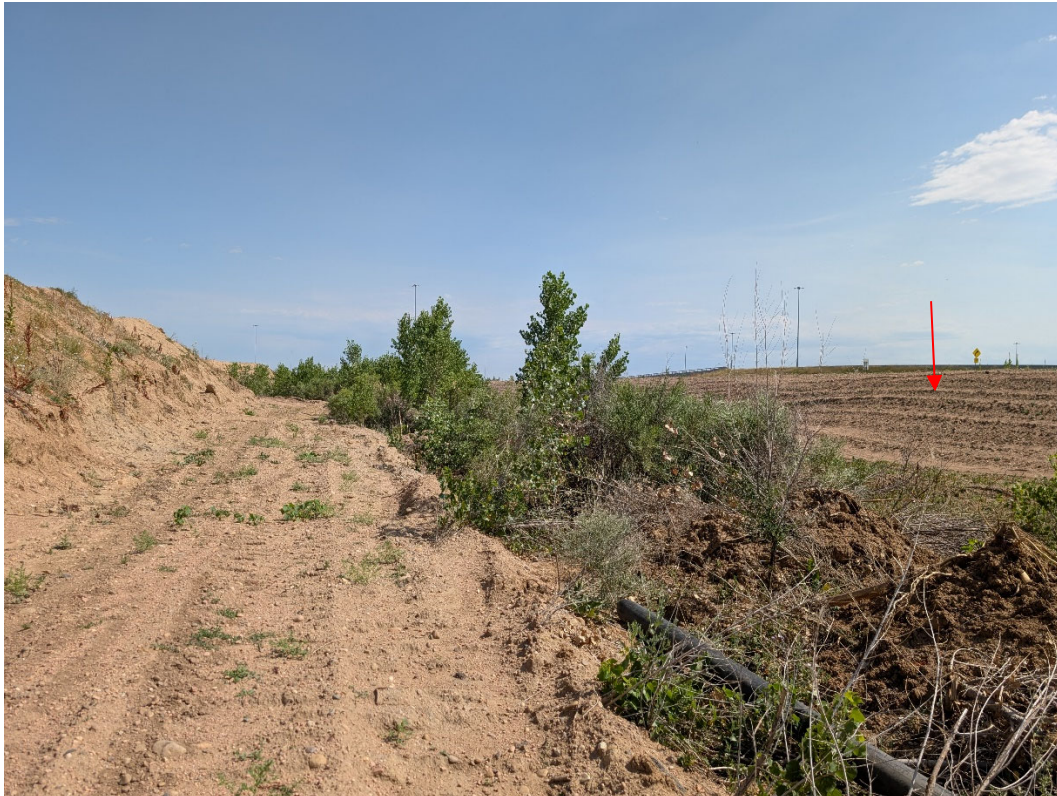
Photo 6: Looking north at a low spot on the eastern side of the large stockpile in Mining Area III. Topsoil berm was observed in a berm on the right (red arrow).

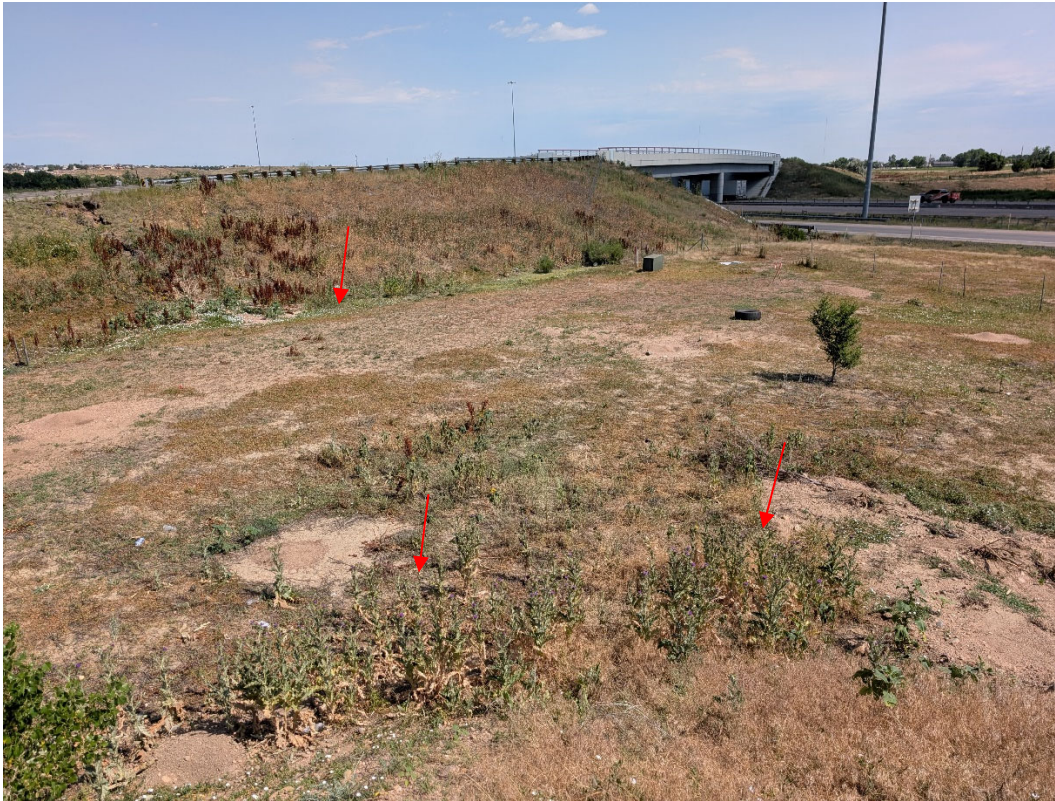
The Division observed state-listed noxious weeds (field bindweed, downy brome (cheatgrass), common mullein and thistle) in Mining Area III, and on the shorelines of the reservoirs. As noted above, this is a problem for failure to employ weed control methods for state listed noxious weed species within the permitted area, and to

Photo 7: Looking north at the northeast corner of Mining Area III. Thistle and bindweed plants observed here.

reduce the spread of weeds to nearby areas as required by Section 3.1.10 (6) of the rule. The operator shall implement the approved weed control plan for the permit area (enclosed) and provide proof to the Division that this has been done. Proof can be in the form of receipts and photographic evidence of the weed management work being conducted.

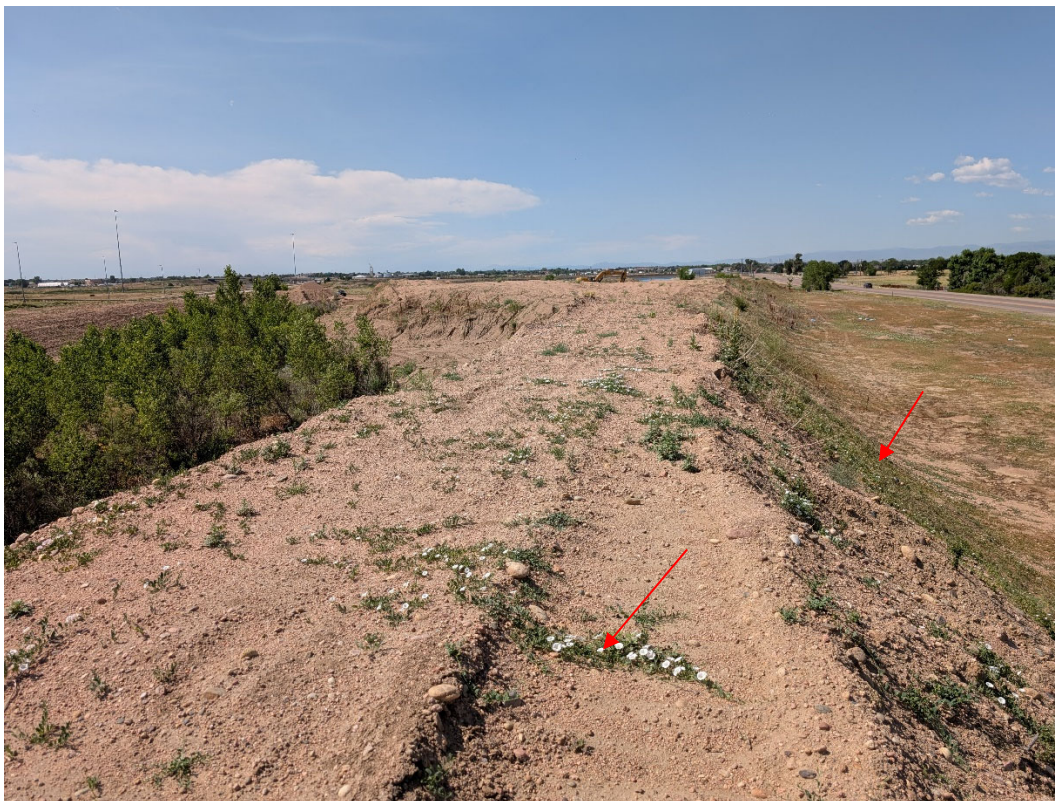
Photo 8: Looking south along the top of the stockpile in Mining Area III. Bindweed plants observed along the sides and top of the pile.

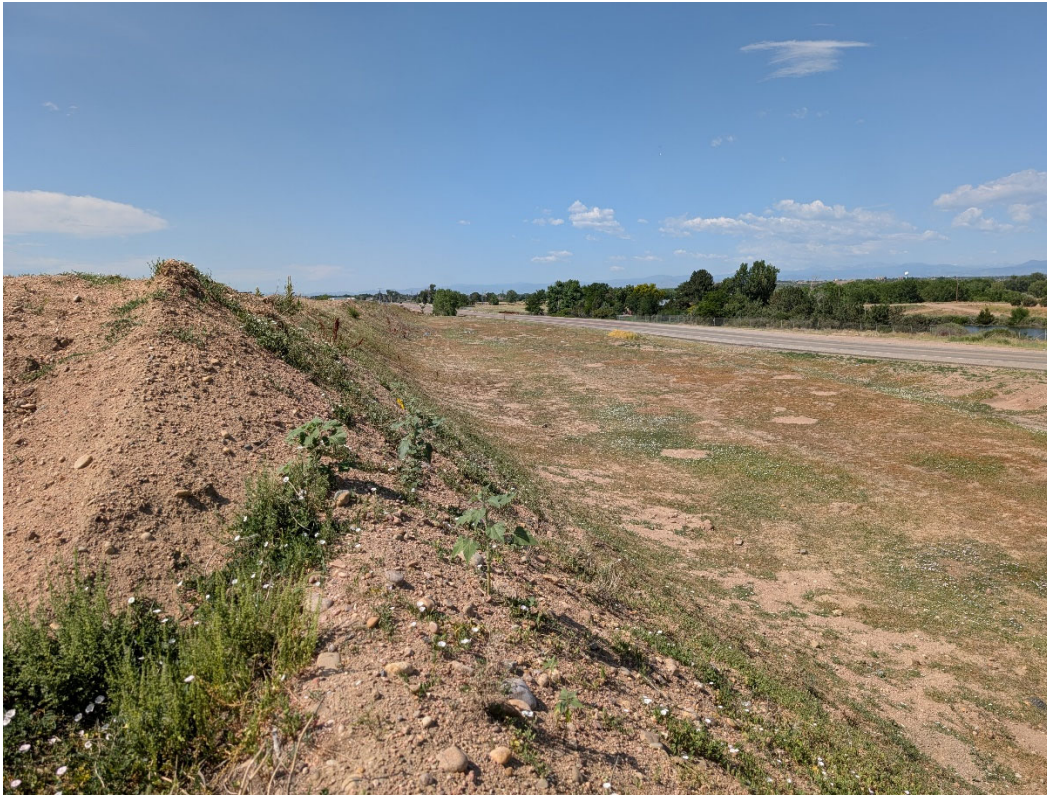
Photo 9: Looking south down the west side of the stockpile. Brighton Rd is on the right (red arrow).

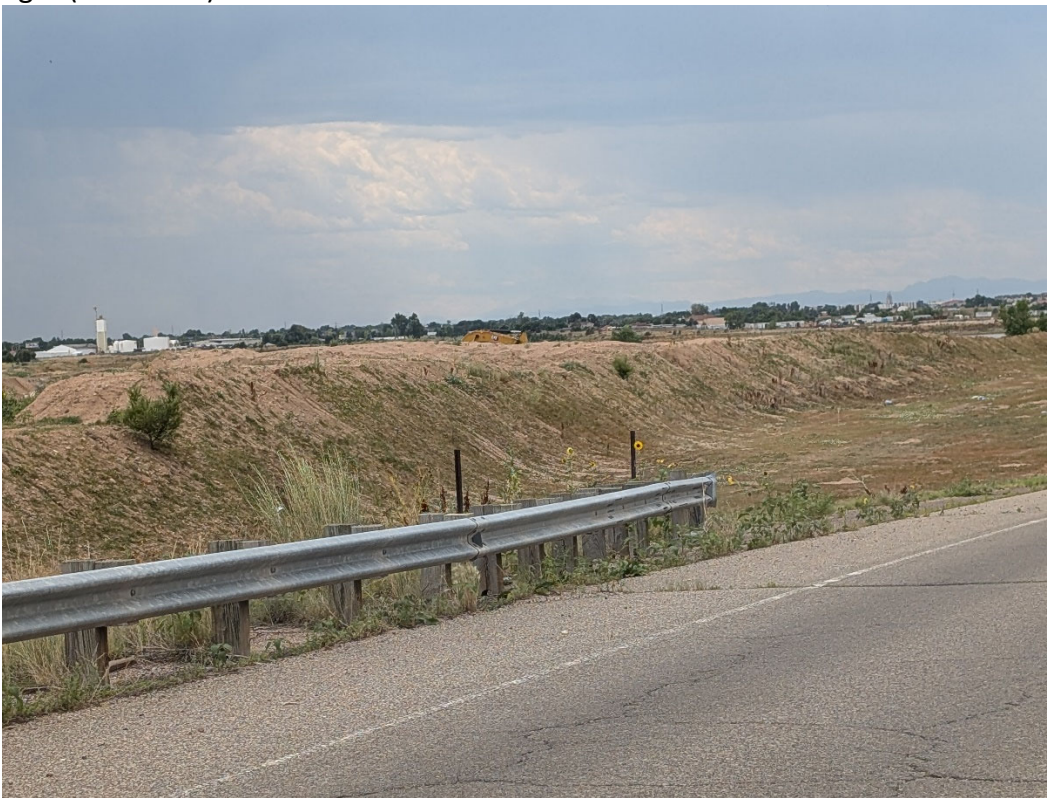
Photo 10: Looking at the western side of the large stockpile in Mining Area III from Brighton Road. The stockpile is approximately 8-10 feet above the road grade.

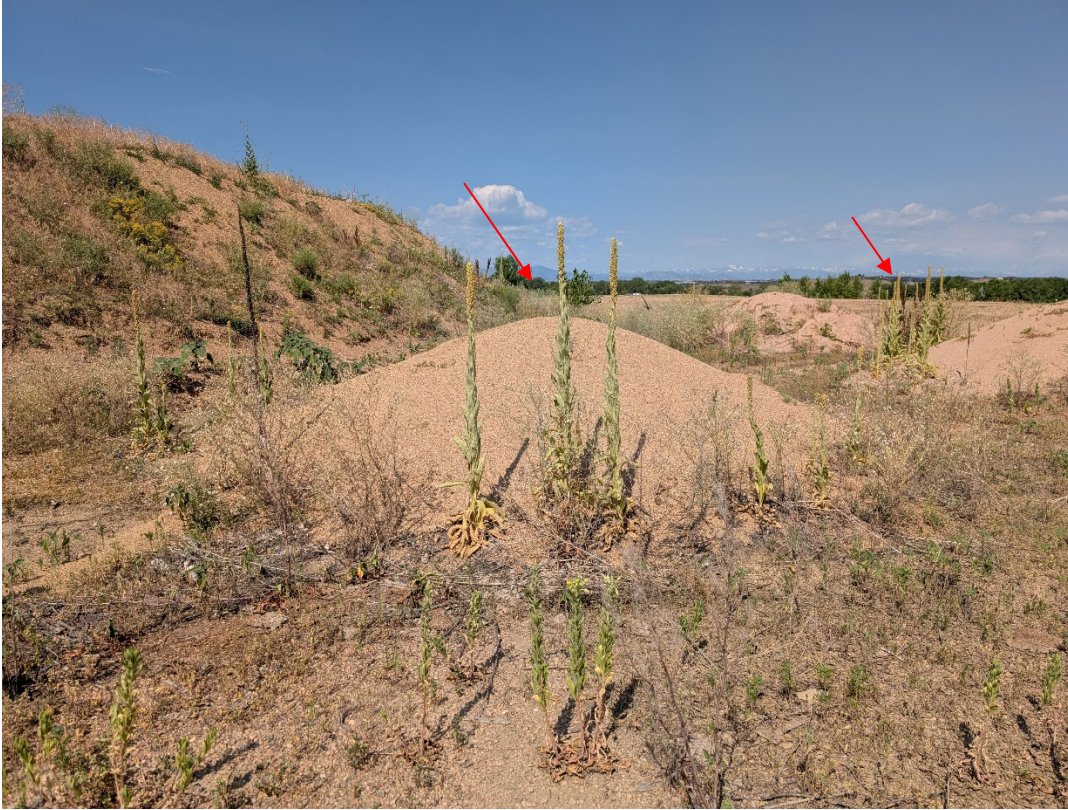
Photo 11: Common mullein observed around the small stockpiles on the south end of the mining area.

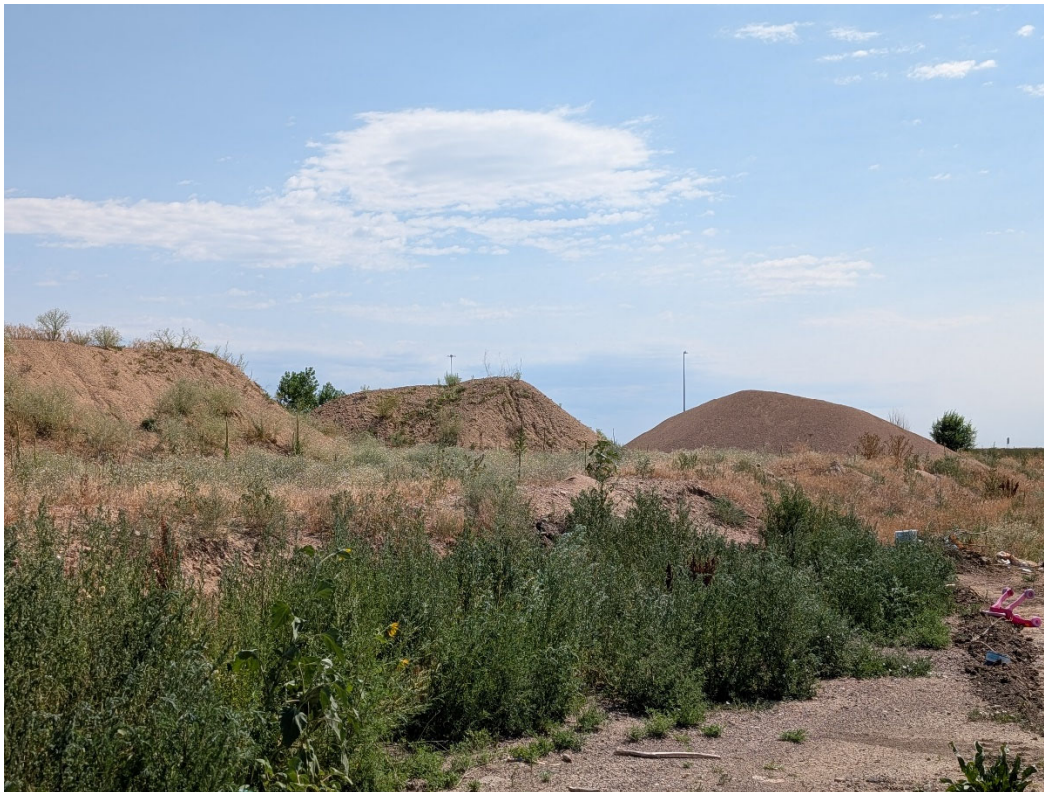
The complaint from Adams County stated that the stockpiles in Mining Area III have not been properly seeded or maintained. During this inspection, the Division observed the Operator actively removing the northern stockpile, however, the stockpiles on the south end of the parcel haven't changed size since the last DRMS inspection in 2023 and weeds growing in and around them. The Division reminds the Operator that in accordance with Rule 3.1.6(3), if activity ceases at the site, all surface areas of the affected land, including spoil piles, shall be stabilized and protected so as to effectively control wind and water erosion.

Photo 12: Stockpiles of mined material on the south end of the Mining Area III. Weeds observed around the stockpiles here.

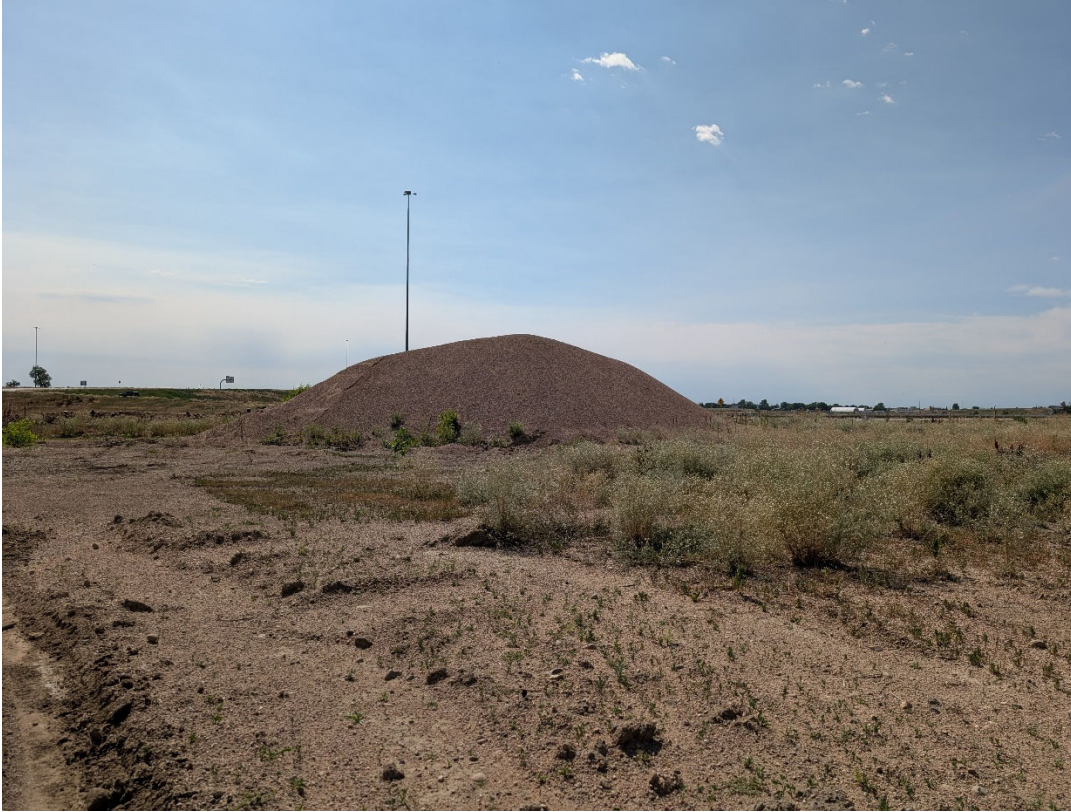
Photo 13: Stockpile of sand in the southeast corner of Mining Area III. Downy brome (cheatgrass) and mullein observed around the pile.

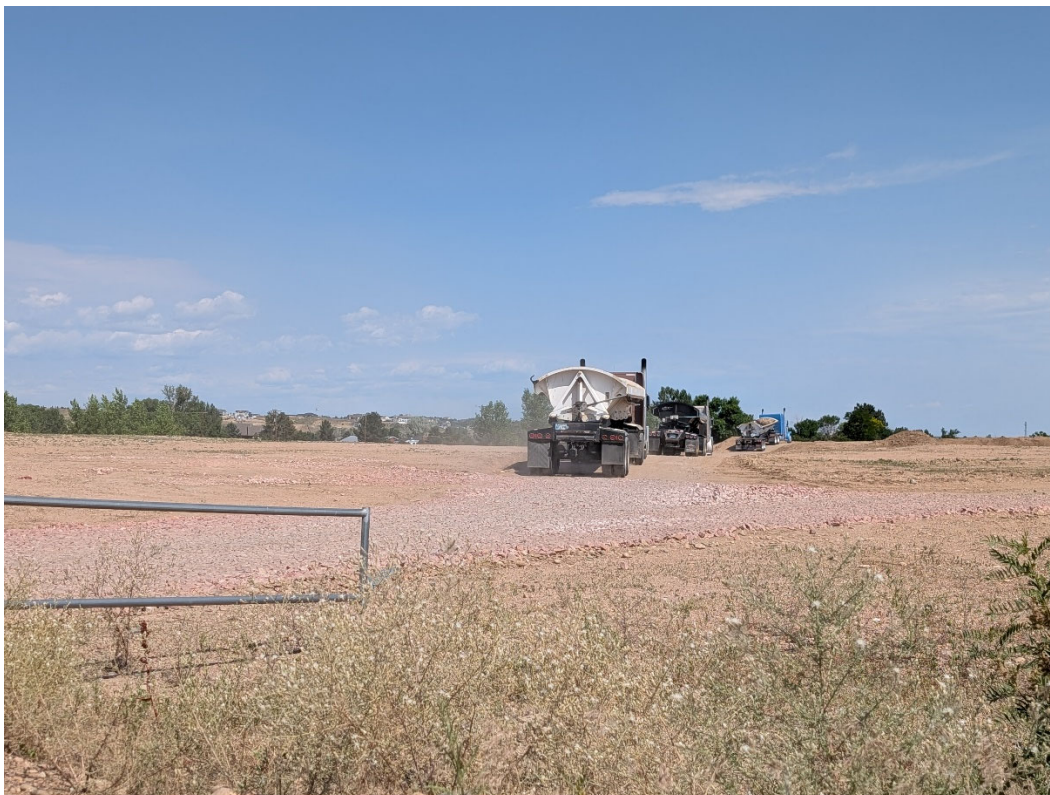
Photo 14: Standing at the entrance to the site. Multiple haul trucks entering the site during the inspection.

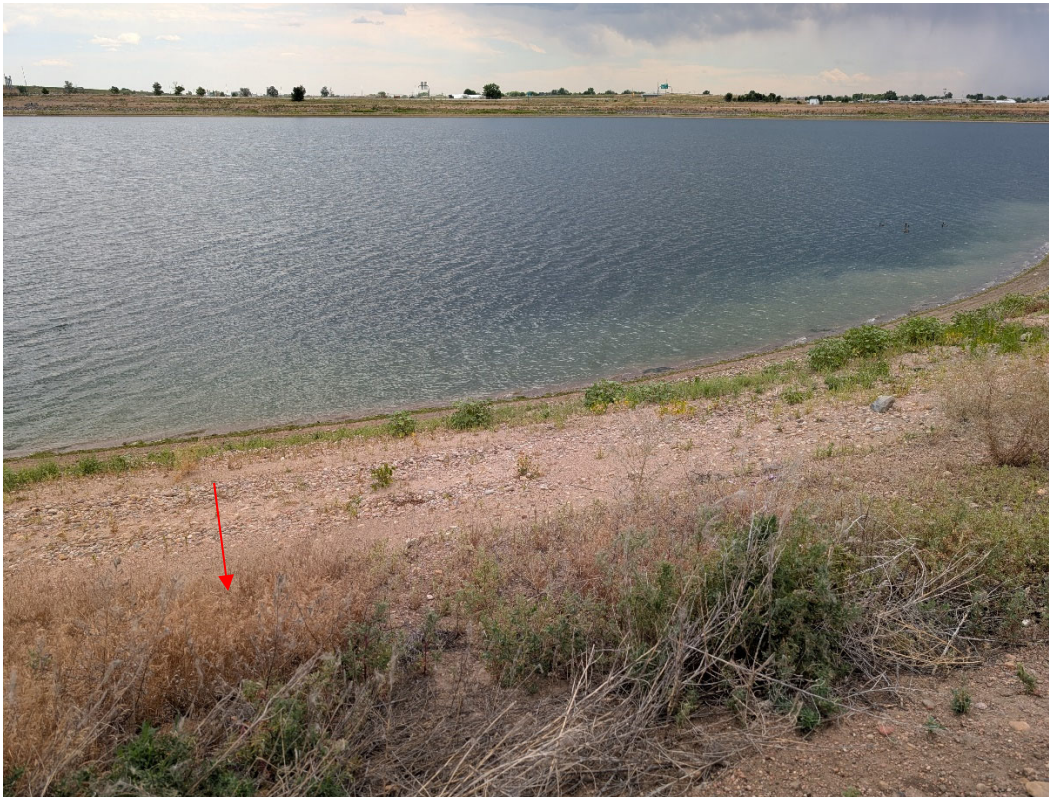
Photo 15: Cheatgrass observed along the shoreline of the north reservoir. Photo taken from outside the fence.

Once you complete weed control around the site, I recommend overseeding the shorelines around the reservoirs this fall. If you let me know when this work is done, I would be happy to revisit the site to consider releasing the reservoirs. While the revegetation in the Phase III area will take a bit longer, the reservoirs just need a little maintenance and they'll be ready for release.
