MINERALS PROGRAM INSPECTION REPORT
PHONE: (303) 866-3567

MINE NAME: Klement Pit	MINE/PROSPECTING ID#: M-2007-076	MINERAL: Gravel and sand	COUNTY: Cheyenne
INSPECTION TYPE: Surety Release Inspection	WEATHER: Cloudy	INSP. DATE: June 25, 2025	INSP. TIME: 12:00
OPERATOR: Cheyenne County	OPERATOR REPRESENTATIVE: Jim Brown	TYPE OF OPERATION: 110c - Construction Limited Impact	
REASON FOR INSPECTION: Surety Release Requested	BOND CALCULATION TYPE:	BOND AMOUNT: \$0.00	
DATE OF COMPLAINT: NA	POST INSP. CONTACTS: None	JOINT INSP. AGENCY: None	
INSPECTOR(S): Joel Renfro	INSPECTOR'S SIGNATURE:

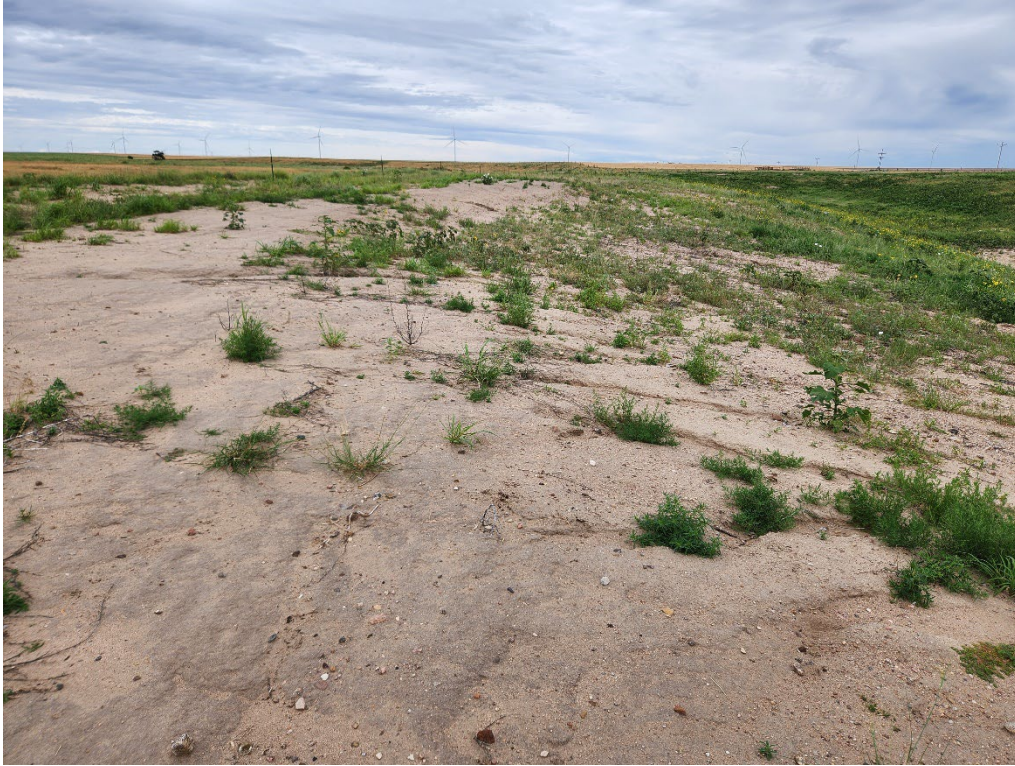
Photo 3. Bare ground on the western edge of the site, looking north.

Reclamation work for this site included the completion of all earthwork, topsoil placement, and seeding about two years ago. During the inspection, it was observed that the current vegetation consists mostly of annual forbs such as sunflowers and kochia. Most of the site is well vegetated with only a few bare areas observed in the pit floor and western edge. Some noxious weeds were observed on site, including puncturevine, bindweed, scotch thistle, and downy brome (cheatgrass). The cheatgrass in particular was observed creeping into the site from the side of the road of Co Rd 53.

Overall, some more work will need to be done before this site is ready for a full release. After 2-3 more growing seasons, or when a long-lasting vegetative cover is established, this site might be ready to be released. In the meantime, it is recommended to continue to follow the reclamation plan, manage noxious weeds, and control stormwater.
