CDR Pit M2006059- June 2025 Inspection Report and Cost Estimate

MINERALS PROGRAM INSPECTION REPORT

MINE NAME: CDR Pit	MINE/PROSPECTING ID#: M-2006-059	MINERAL: Gravel	COUNTY: Archuleta
INSPECTION TYPE: Monitoring	WEATHER: Clear	INSP. DATE: June 17, 2025	INSP. TIME: 08:00am
OPERATOR: Continental Divide Ranch, LLC	OPERATOR REPRESENTATIVE: None	TYPE OF OPERATION: 110c - Construction Limited Impact

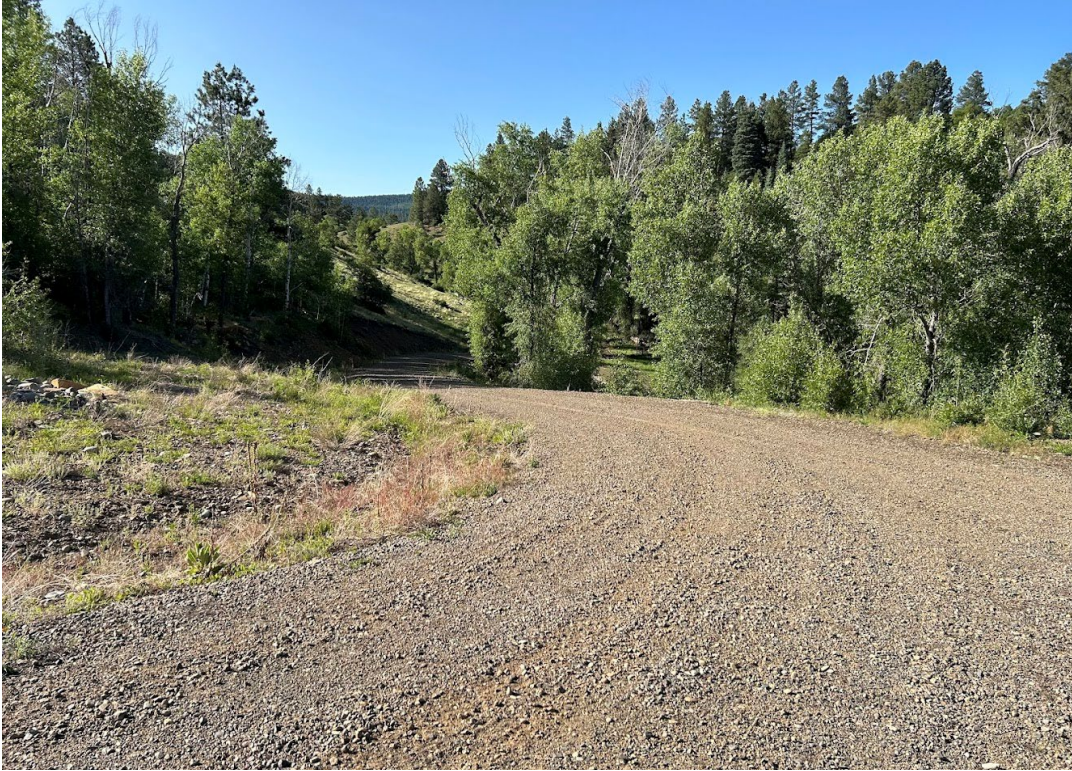
Photo 1: Access road leading to the permit from the south along Chama Road, facing south.

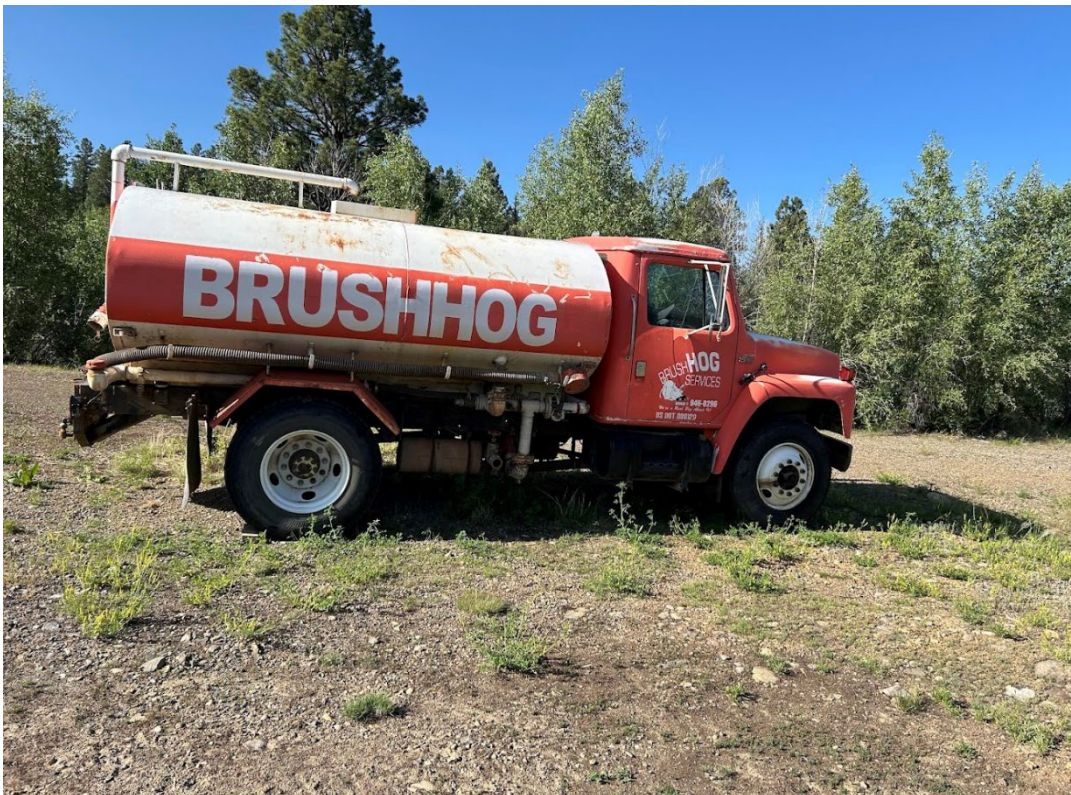
The site is located on a large hill that overlooks Navajo River to the north. The site was inactive at the time of the inspection. The only equipment observed was a truck from Brush Hog Services (see Photo 2). The site consists of a small clearing with two stockpiles of material and sporadic volunteer vegetation, predominantly Western wheatgrass, Smooth meadow-grass, Yellow sweet clover (see Photos 2-5). The permit area also contained a minor amount of Cheatgrass and Common mullein. A stockpile of several boulders was observed along the access road on the northeast side of the permit (see Photo 4). One stockpile on the western portion of the site contained what appeared to be topsoil with a very minimal amount of vegetation on it (see Photo 3). This has been cited as problem, as Rule 3.1.9(1) states if topsoil is not replaced into the backfill area within a time short enough to avoid deterioration of the topsoil, vegetative cover or other means shall be employed so that the topsoil is protected from erosion. The corrective action the Operator should employ to combat erosion of the topsoil stockpile is to seed the stockpile with the seed mix that was submitted as part of the approved Reclamation Plan. The Operator shall demonstrate the corrective action has been completed by submitting seed tags, a bill of sale or photographs of seeding activities. In addition, the topsoil stockpile had a nearly vertical configuration, putting it at further risk of erosion. In tandem with seeding of the stockpile, the Operator should grade the stockpile side slopes to a gentler angle, closer to a 3:1 horizontal to vertical configuration.

Photo 2: View of truck within permit area, facing south.

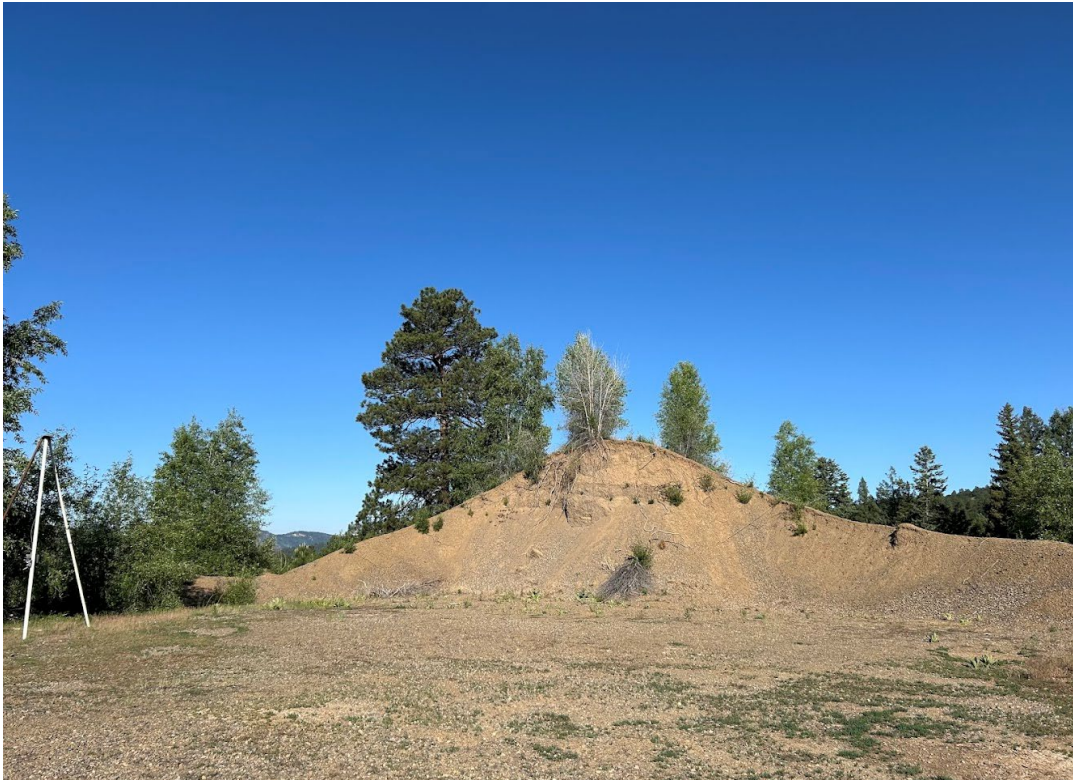
PROBLEM: The topsoil stockpile does not have established vegetation on it and therefore is susceptible to erosion. Rule 3.1.9(1) states if topsoil is not replaced into the backfill area within a time short enough to avoid deterioration of the topsoil, vegetative cover or other means shall be employed so that the topsoil is protected from erosion. In addition, the stockpile had a nearly vertical configuration, putting it at further risk of erosion.

Photo 3: View of topsoil stockpile on the western side of the permit, facing west.

CORRECTIVE ACTIONS: The operator shall seed the stockpiles with the seed mix that was submitted as part of the approved Reclamation Plan. If no seed mix has been provided, the operator shall submit a seed mix for approval as a technical revision to the permit along with the appropriate \$216 revision fee to the Division by the corrective action date. The Operator shall demonstrate compliance by submitting seed tags, a bill of sale or photographs of seeding activities. In addition, the operator should grade the stockpile side slopes to a gentler angle, closer to a 3:1 horizontal to vertical configuration. The Operator may also request a follow-up inspection.

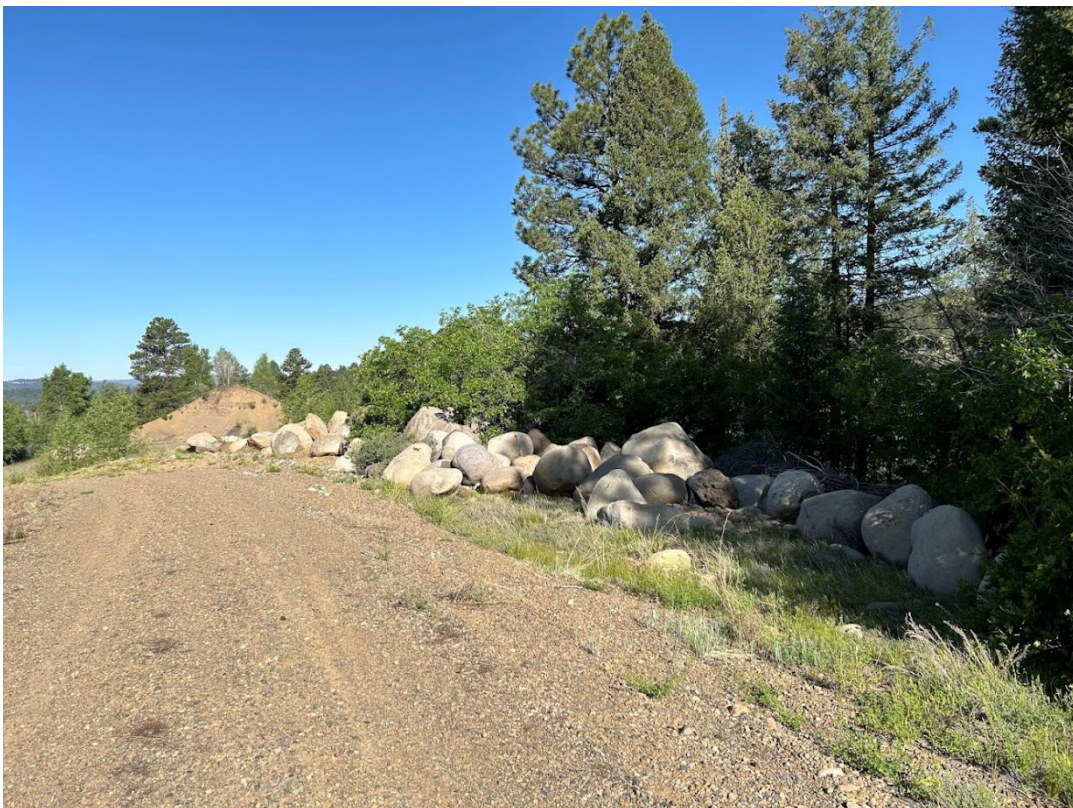
Photo 4: View topsoil stockpile and of several boulders along the access road on the north side of the permit, facing west.

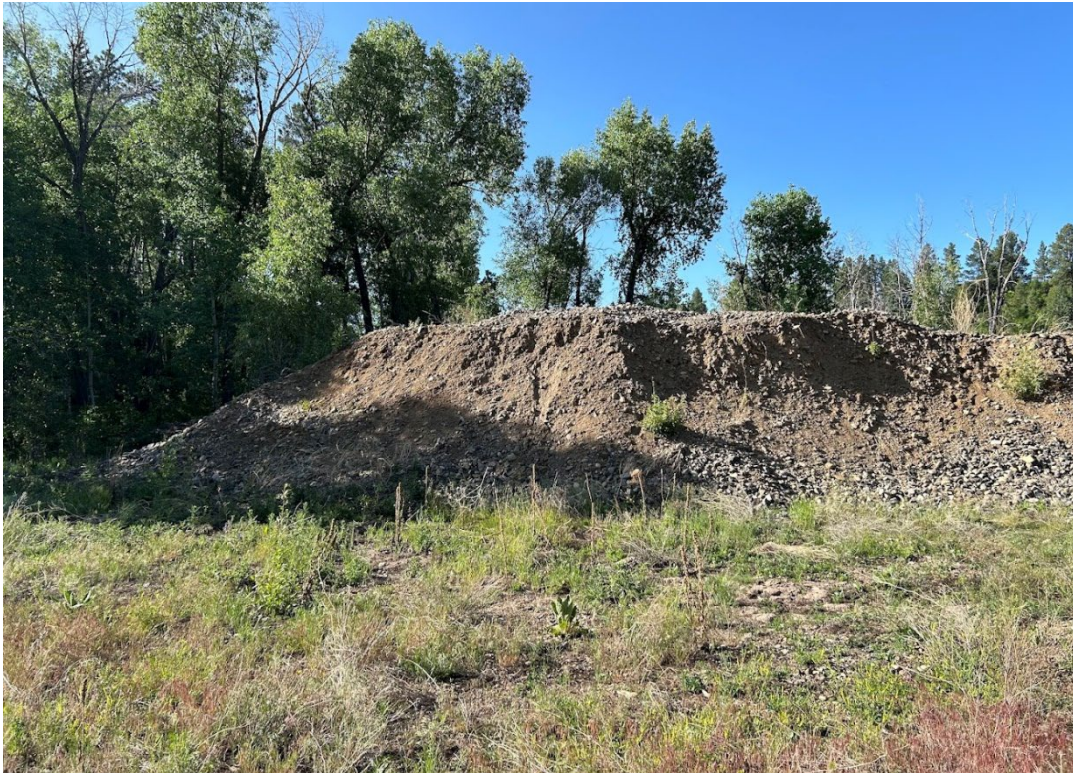
The stockpile on the southeastern portion of the site was predominantly sand and gravel, and appears to be either salable material or overburden, which is corroborated by the mining plan map submitted in the original application (see Photo 5). Historical Google Earth Imagery indicates that approximately three (3) acres have been disturbed (see attached Figure 1).

Photo 5: Stockpile of mostly gravel, facing south.

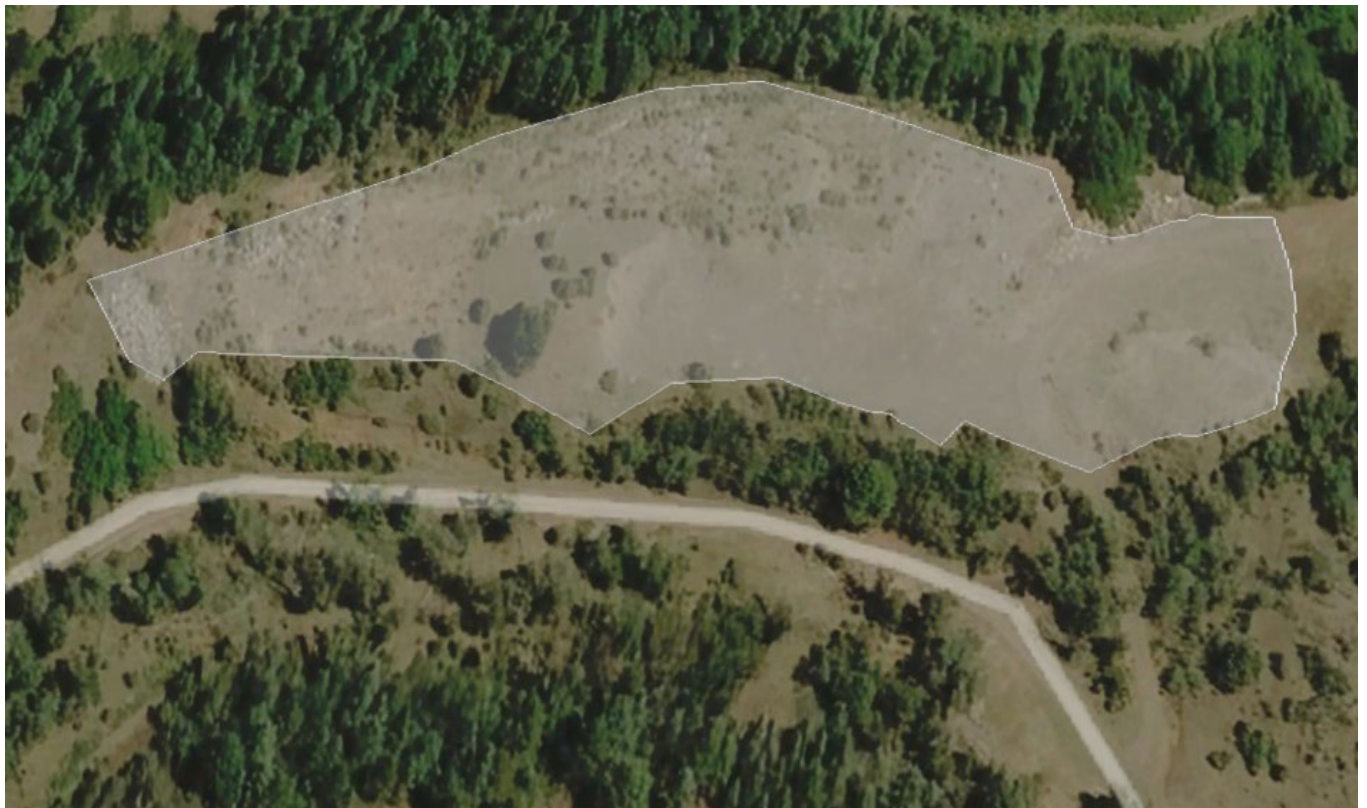
Figure 1: This map was generated in Google Earth to show the permit location along Old Chama Road as of June 29, 2022. The white shaded region indicates the approximate affected area, equaling approximately 3 acres of the 4.51-acre permit
