Reference: Second Quarter 2025 Geotechnical Monitoring Summary Pikeview Quarry

Client/Project
CASTLE AGGREGATE
PIKEVIEW QUARRY SLOPE
MONITORING

OBSERVATIONS FROM
SECOND QUARTER
INSPECTIONS

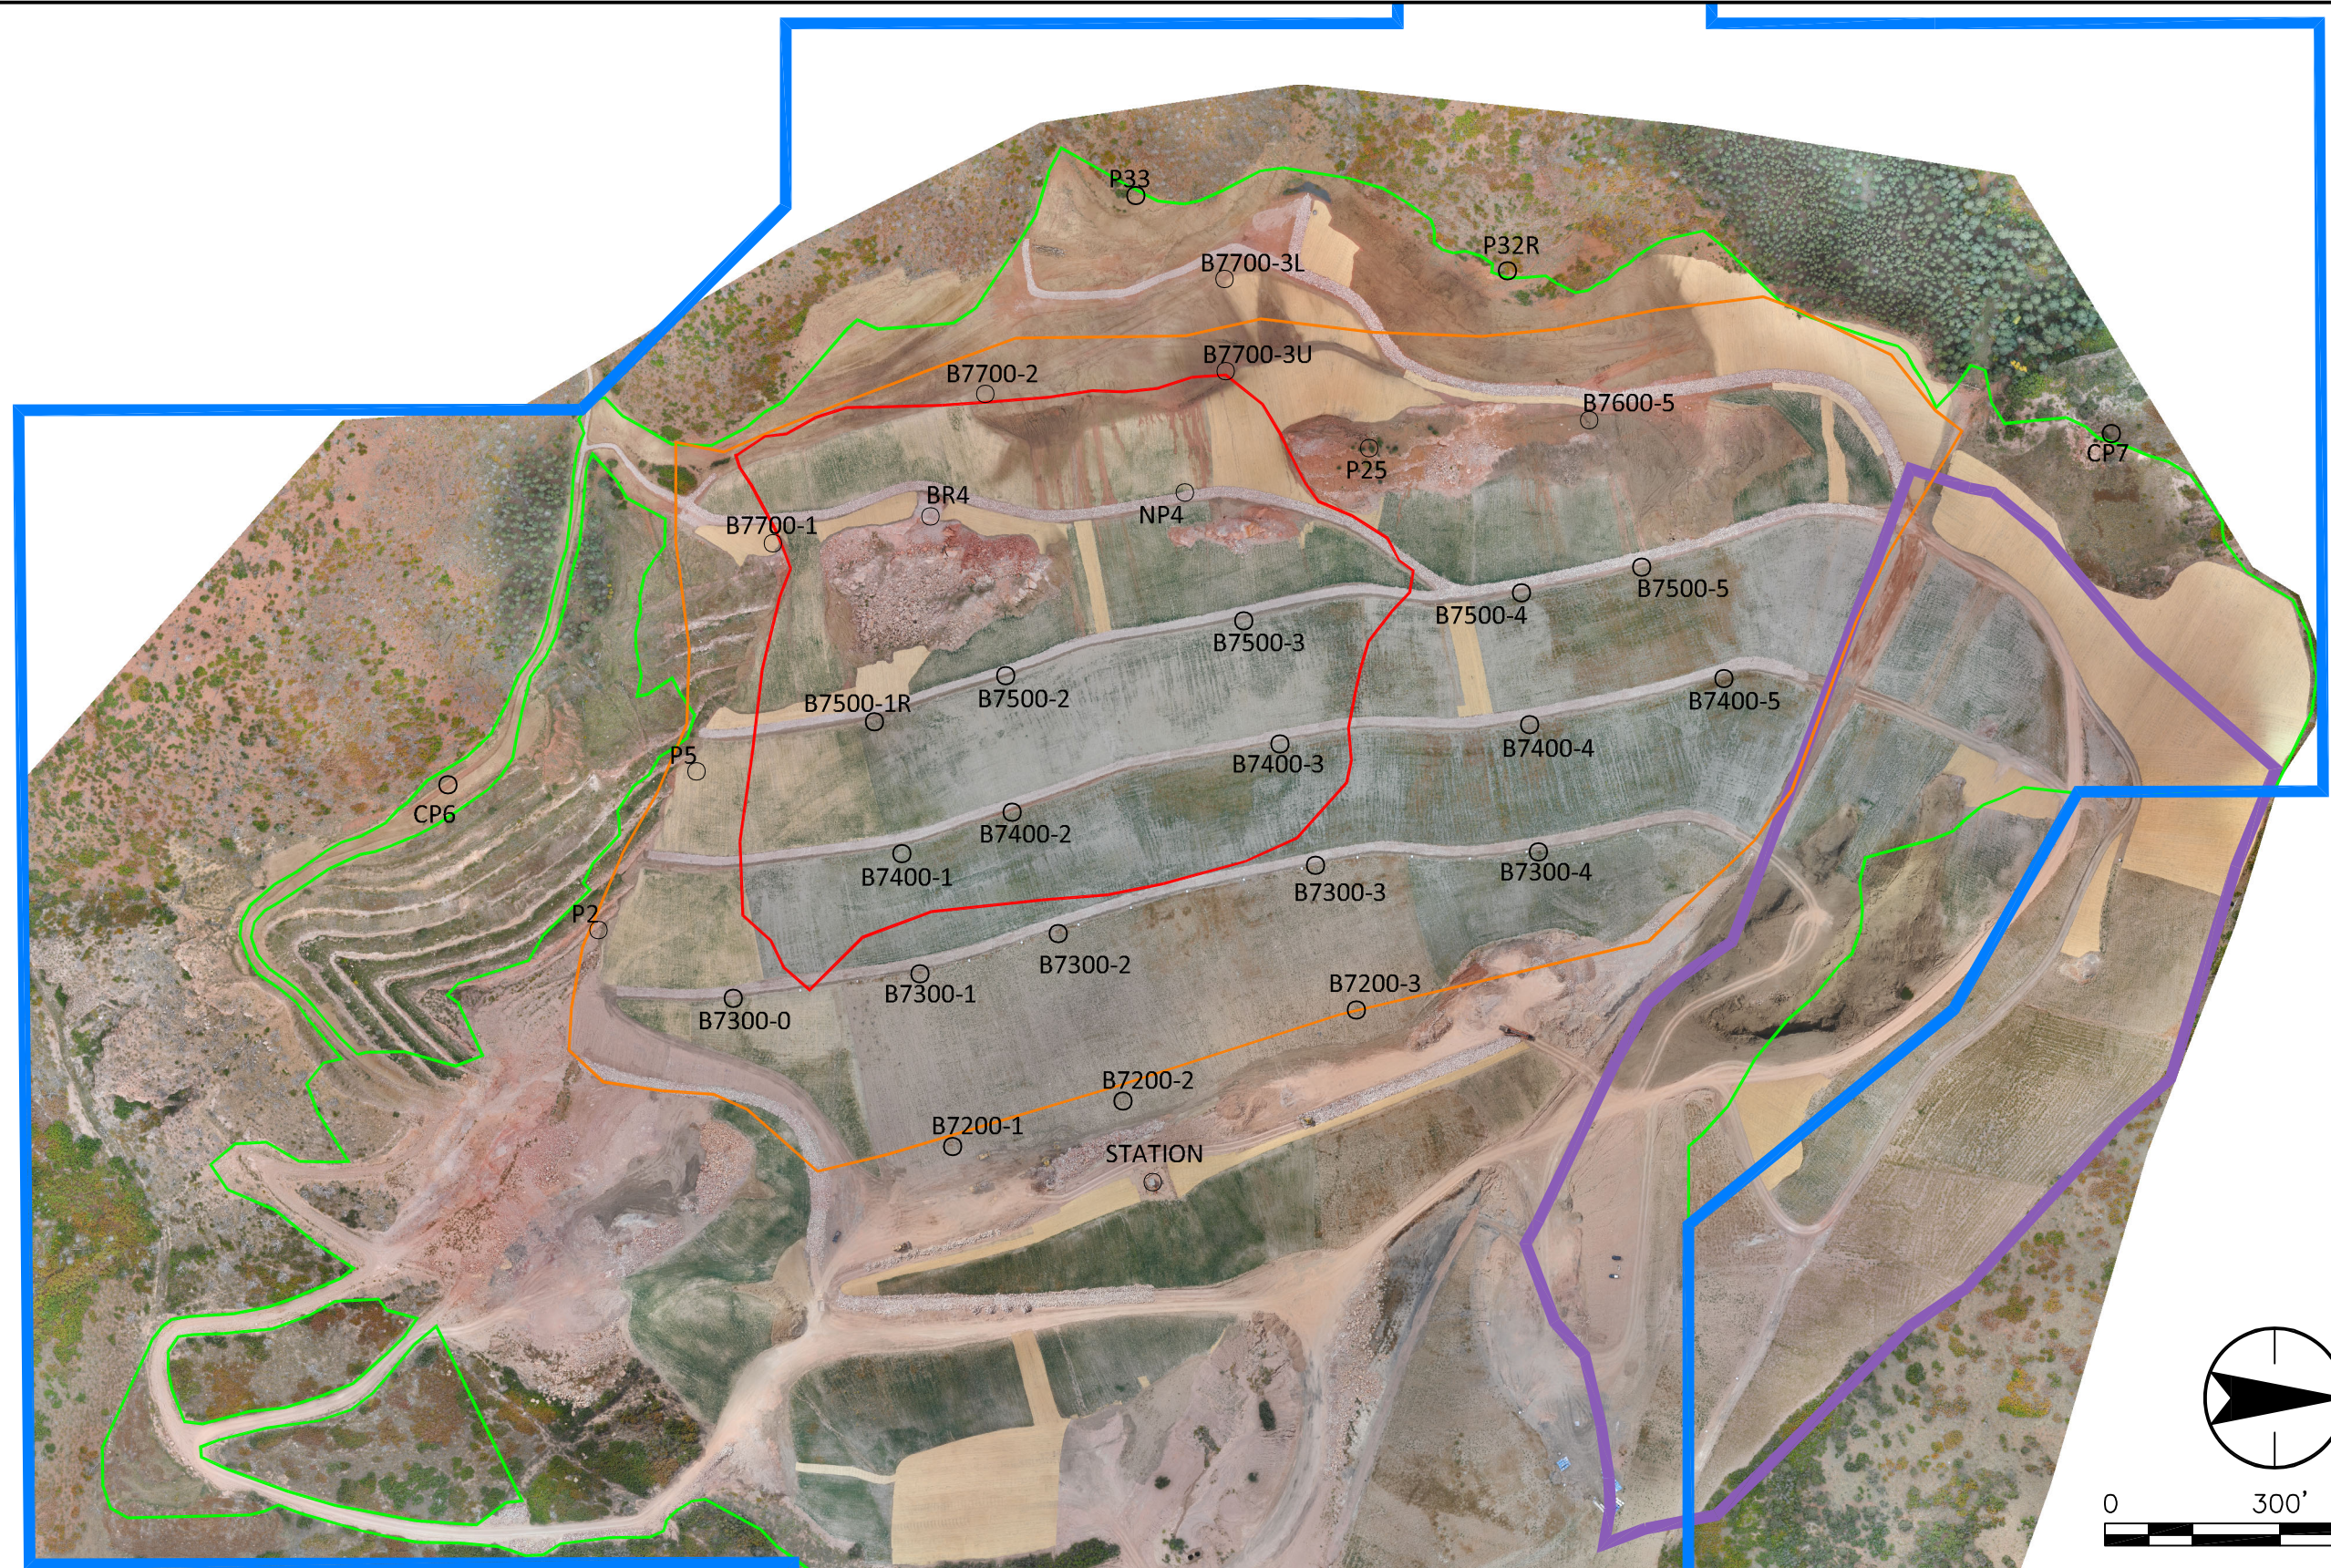
Revision #	Date
Drawn By PK	2025.07.31
	Figure No. 1

1. AERIAL IMAGERY FROM SEPTEMBER 30, 2024 DRONE SURVEY.

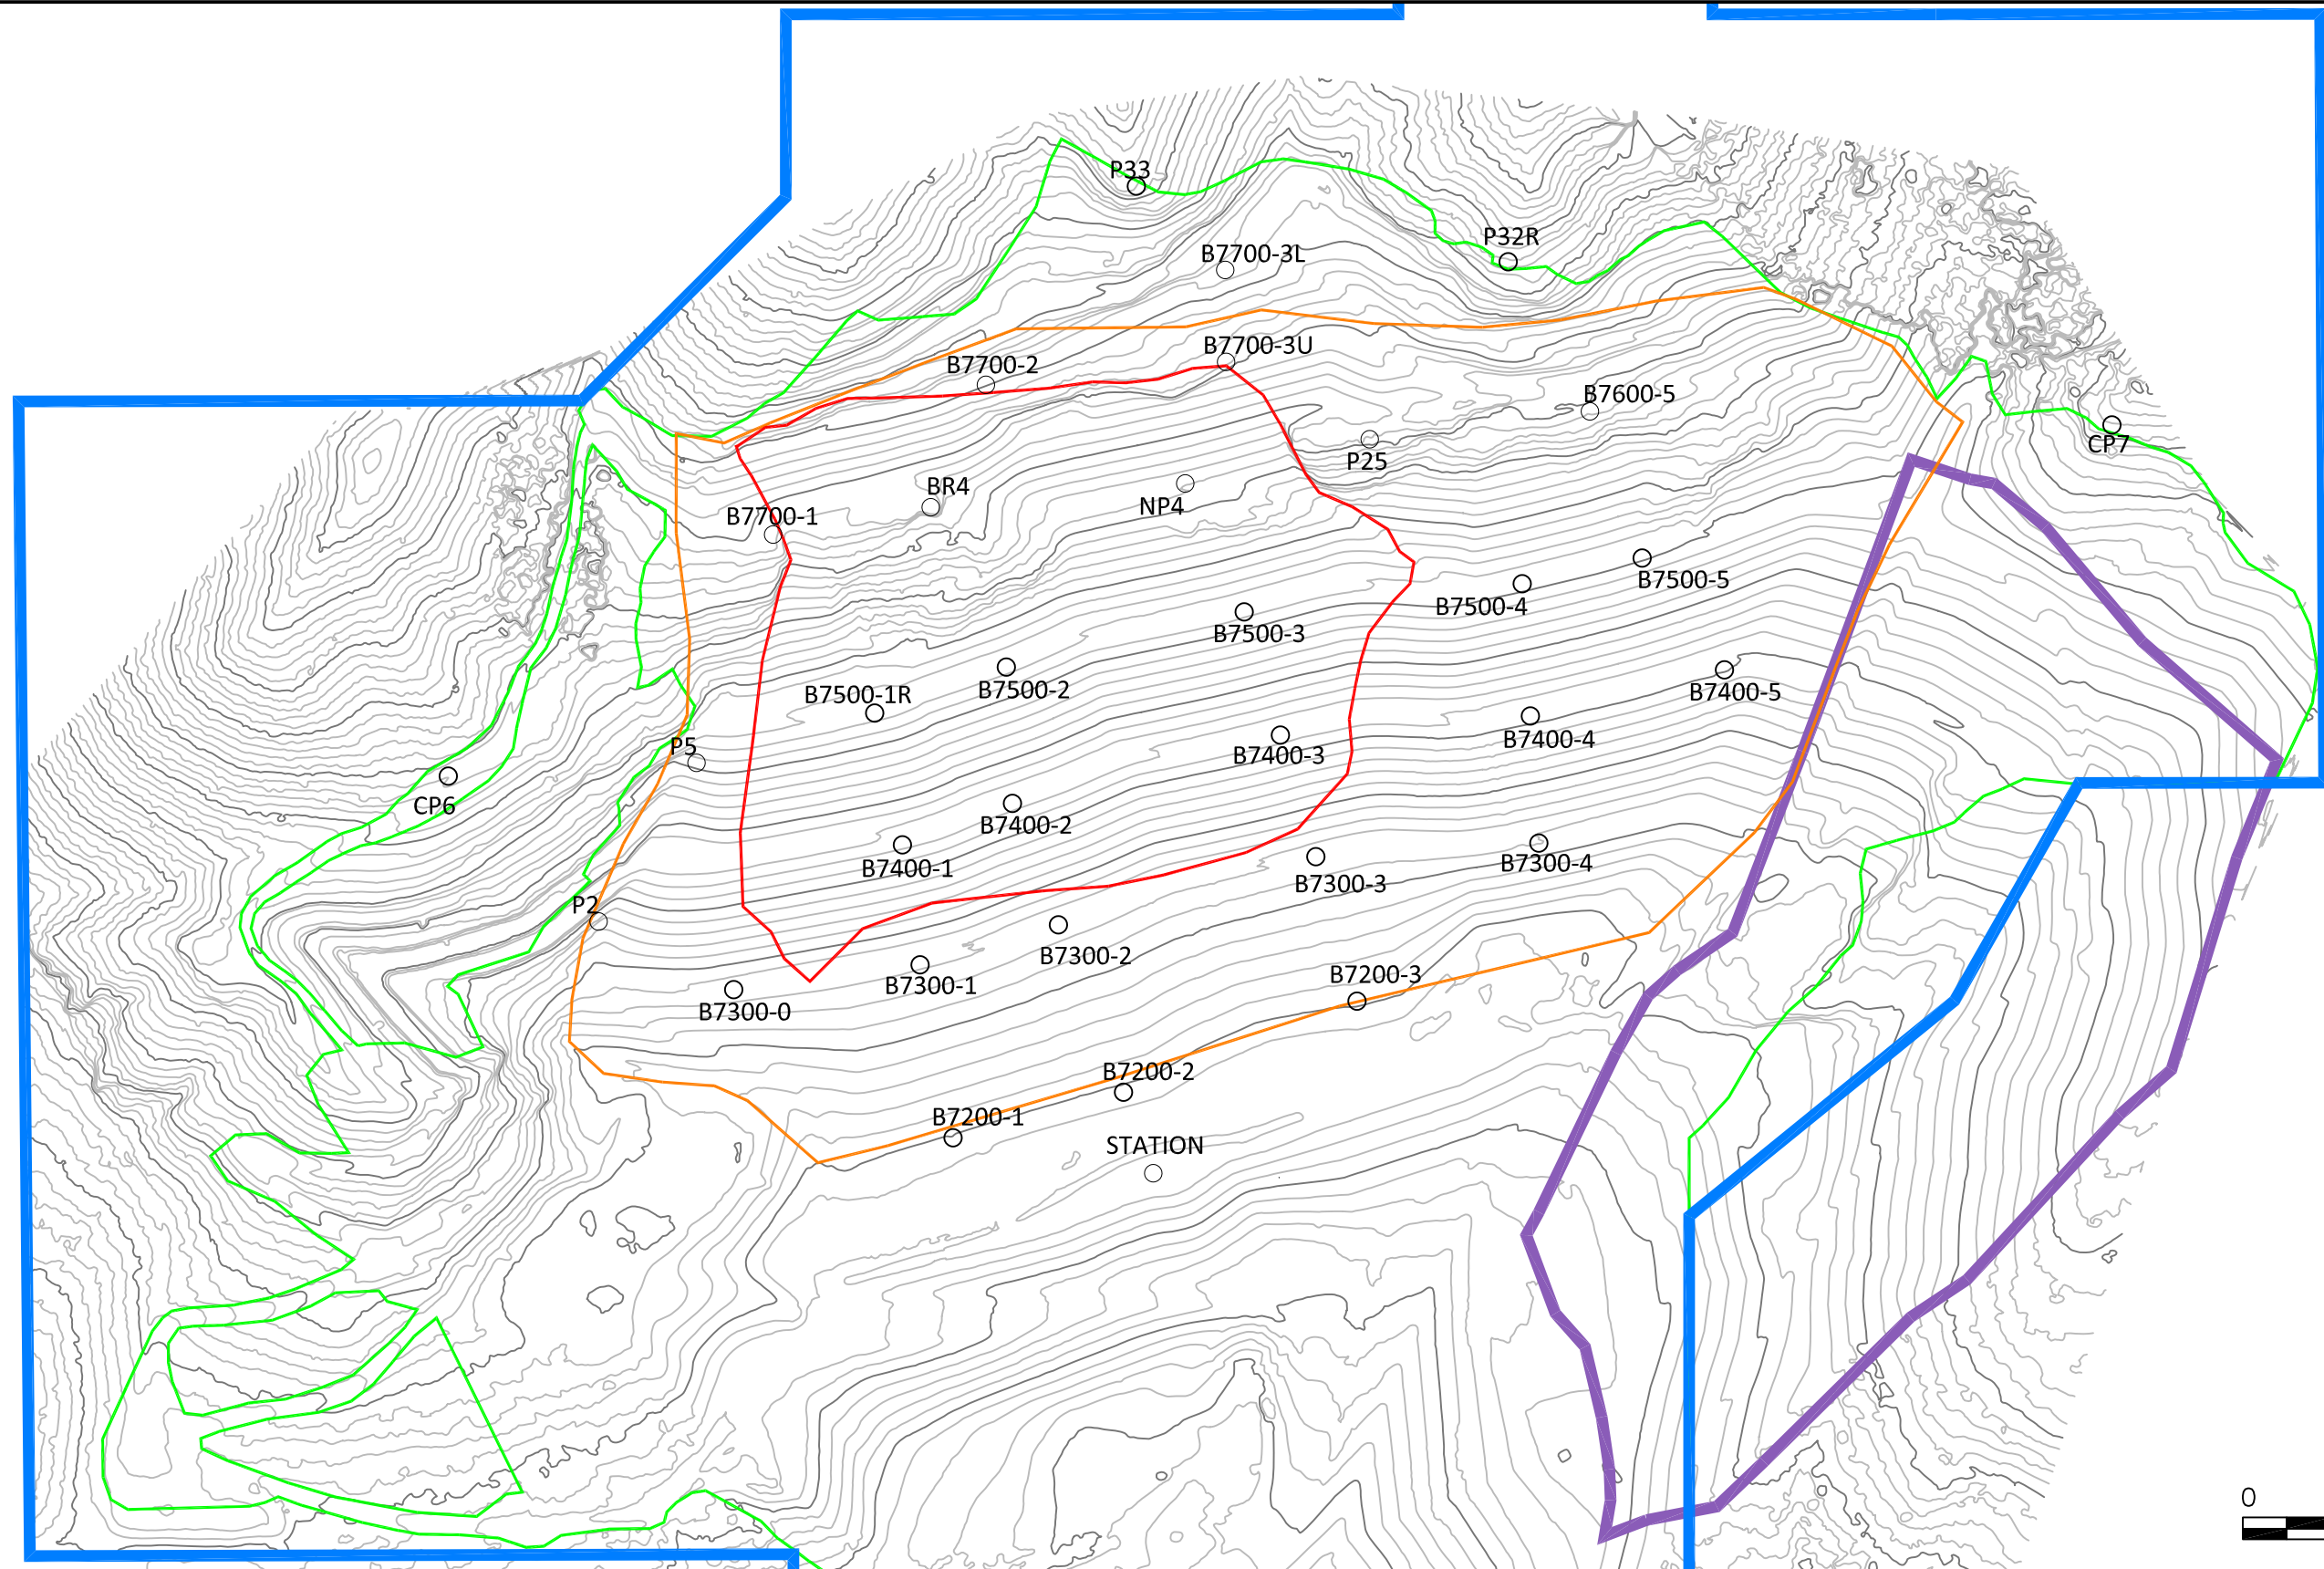
Title EXISTING PRISMS WITH CURRENT SURFACE	
Revision #	Date 2025.07.31
Drawn By PK	Figure No. 2

1. TOPOGRAPHY FROM SEPTEMBER 30, 2024 DRONE SURVEY.
2. CONTOUR INTERVAL IS 10 FEET

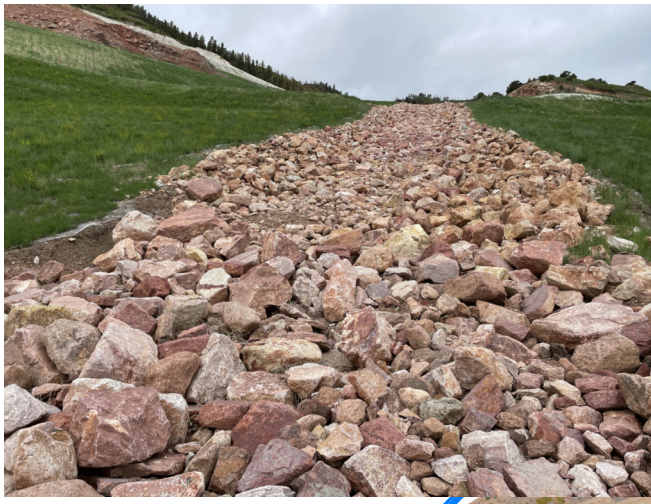
6. RECLAMATION VEGETATION.

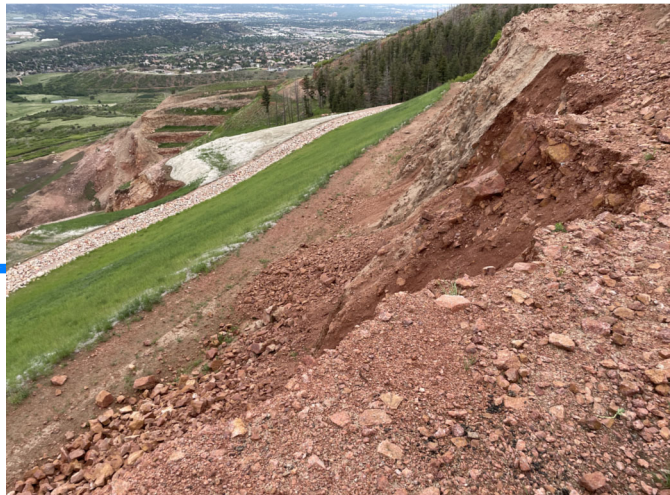
3. ROCK RAVELLING ON EXCAVATED BENCH. PHOTO TAKEN AT 3A. 3B SHOWED SIMILAR RAVELLING.

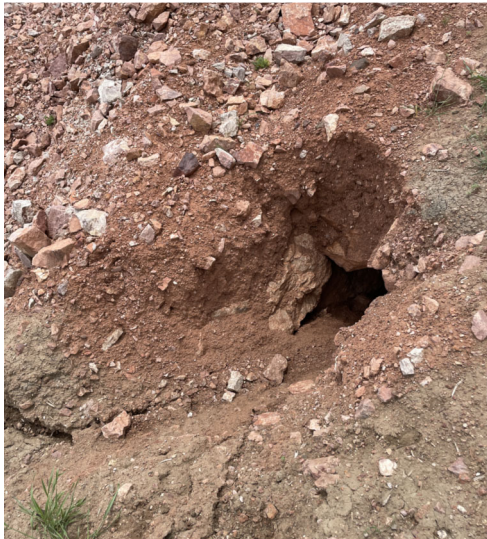
- Settlement cracks were noted on the southern slope adjacent to the main channel. This area on the edge of the buttress is in a fill area between cut areas, and the cracks are believed to be related to the fill settling (See Photo 1 on Figure 3).
- Settlement cracks were noted along the edges of the terrace benches. These settlement cracks are believed to be related to the topsoil and surficial material consolidating (See Photo 2 on Figure 3).
- Rock raveling occurred in two areas of bedrock outcropping (See Photo 3 on Figure 3). These areas are believed to be related to drastic temperature changes combined with heavy moisture.
- Water infiltration above a bedrock outcrop eroded a hole in two locations of fill placed against the bedrock. No erosion or debris was observed downhill from the hole (See Photo 8 on Figure 3).

8. WATER INFILTRATION ABOVE OUTCROP.

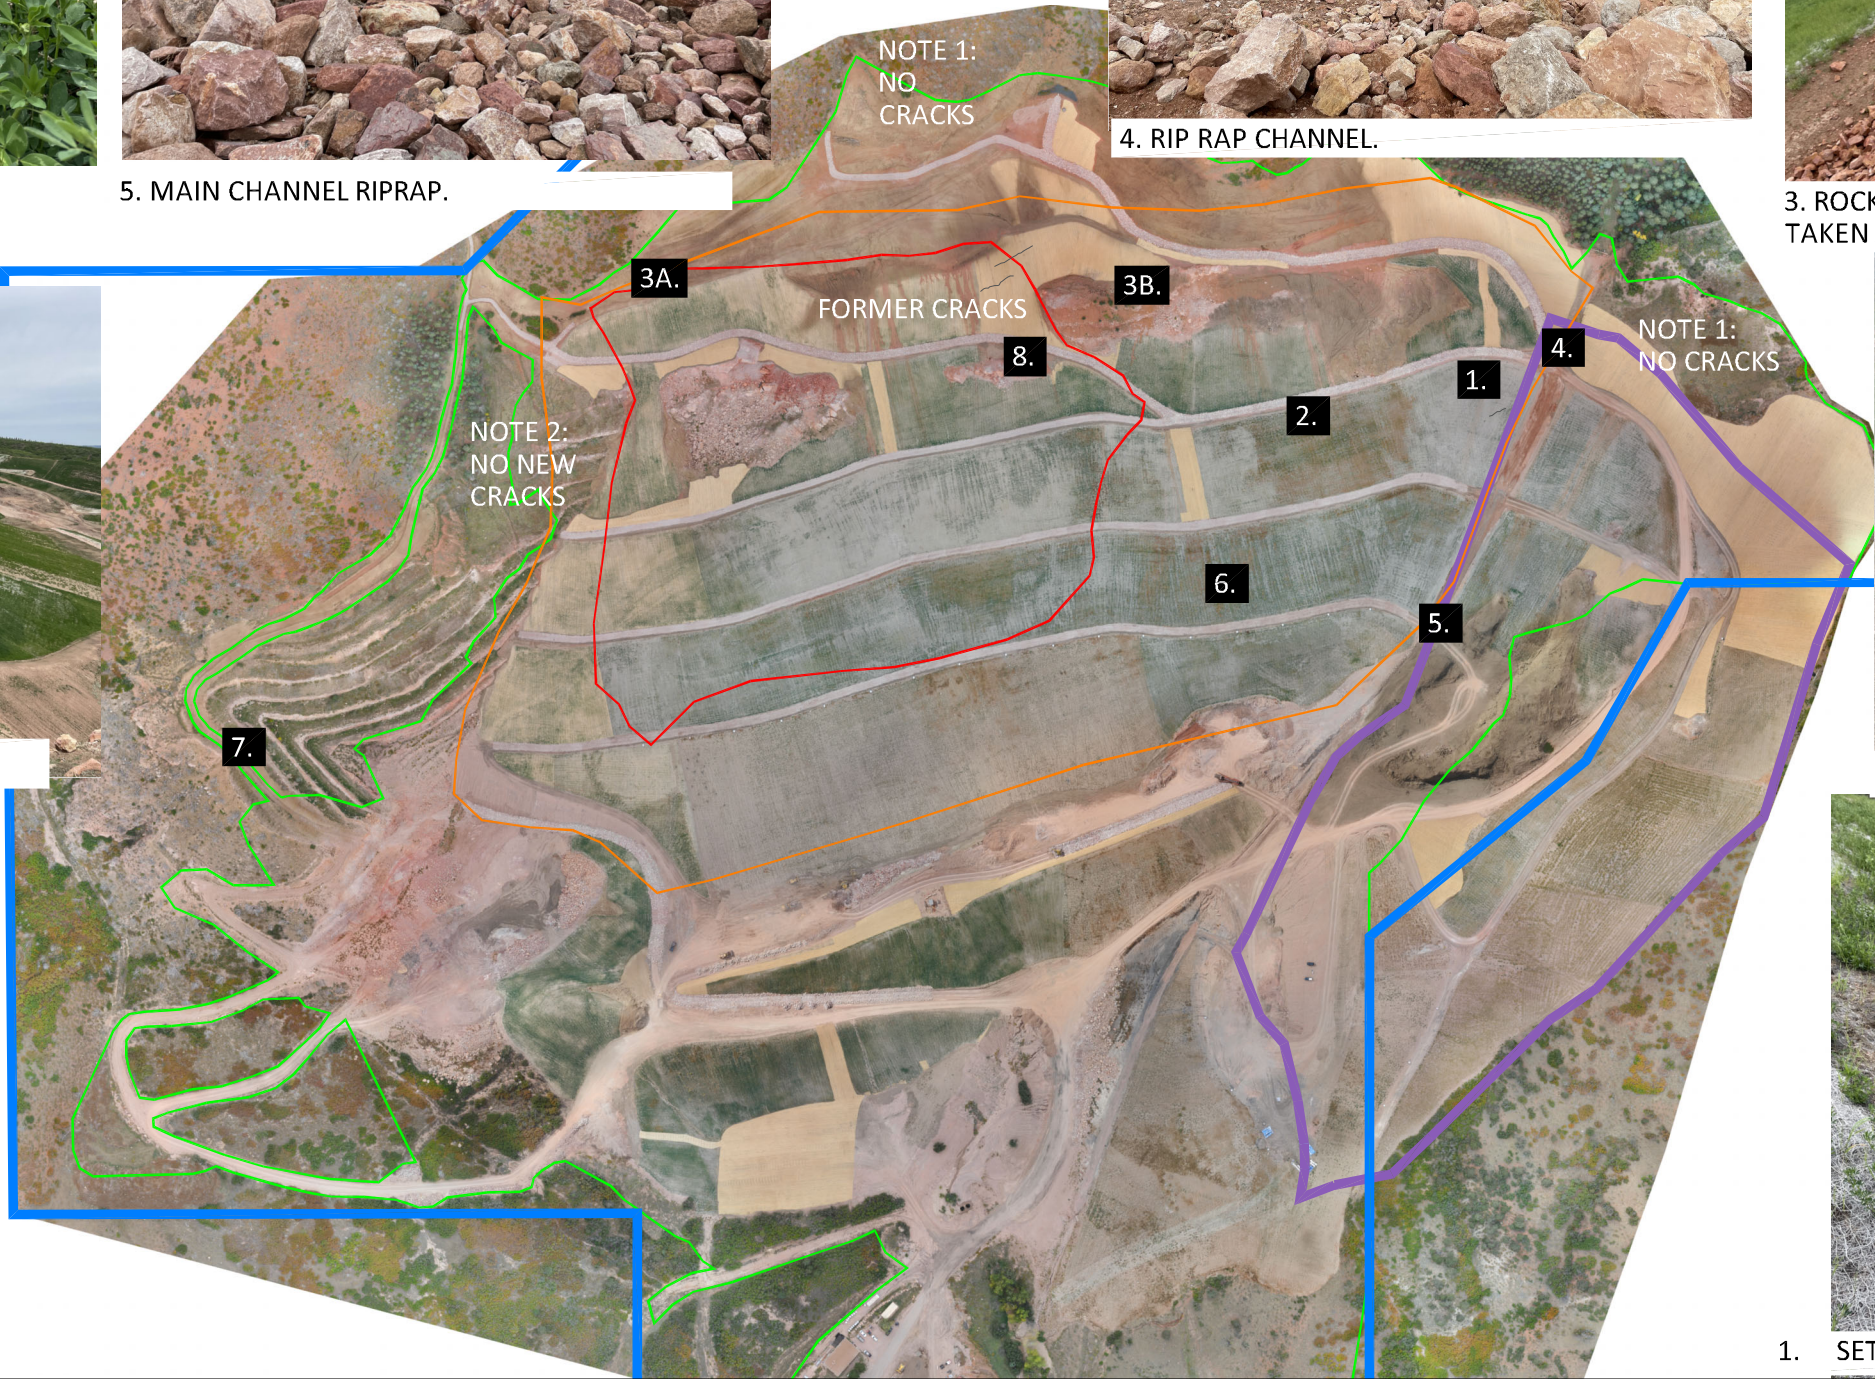
7. SITE OVERVIEW FROM SOUTH.

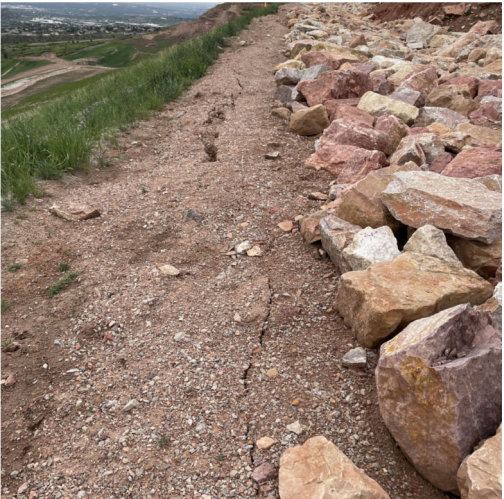
2. SETTLEMENT CRACKS ON EDGE OF BENCH.

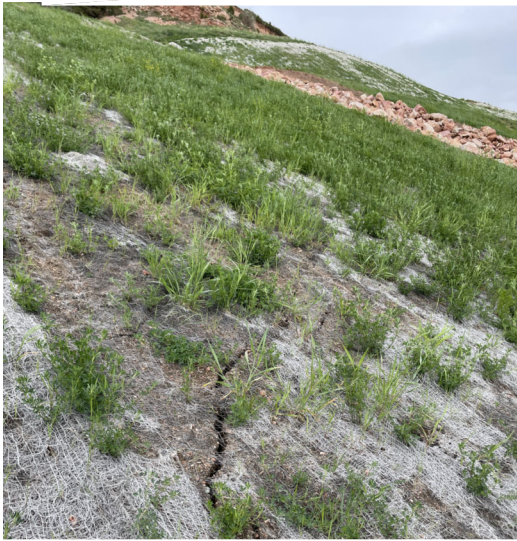
1. SETTLEMENT CRACK AT EDGE OF FILL.

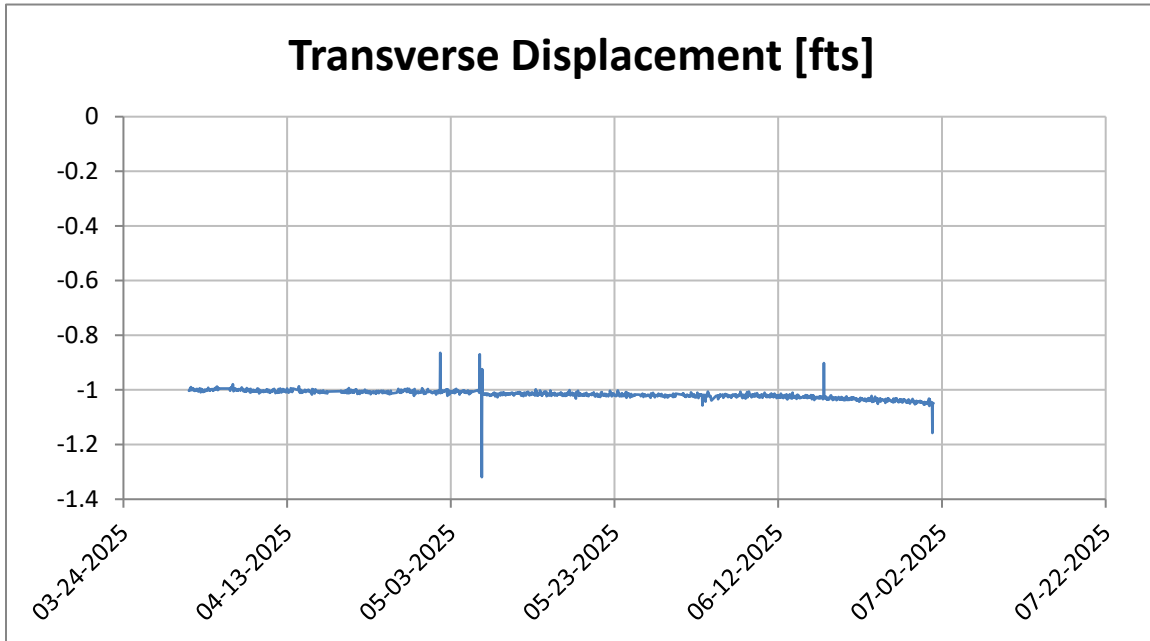
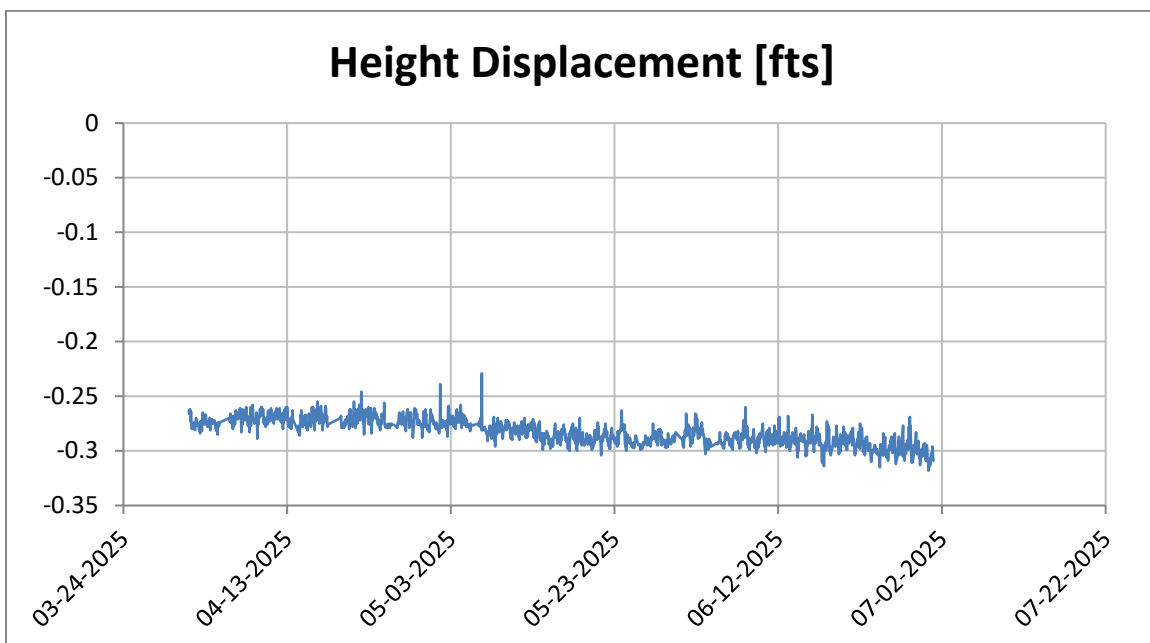
Prism B7300-0

1. Survey accuracy is ± 0.016 feet.
2. Alert threshold is ± 0.35 feet.
3. Transverse displacement is in the horizontal direction. Positive direction means closer to the robotic total station.
4. Height displacement is in the vertical direction. Positive direction means higher in elevation.

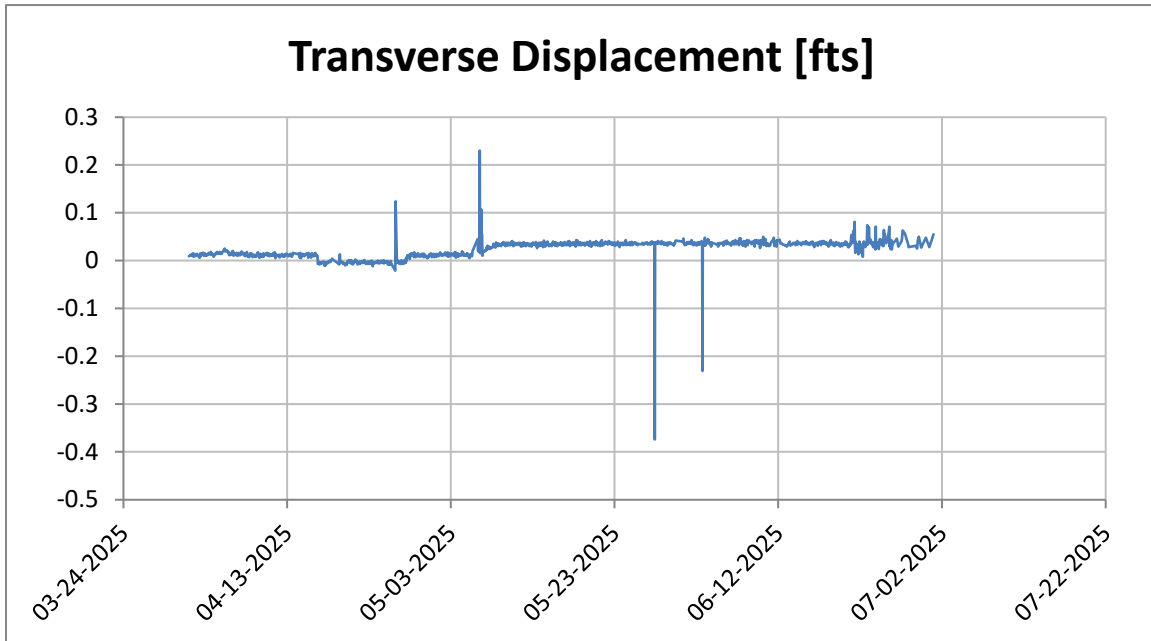
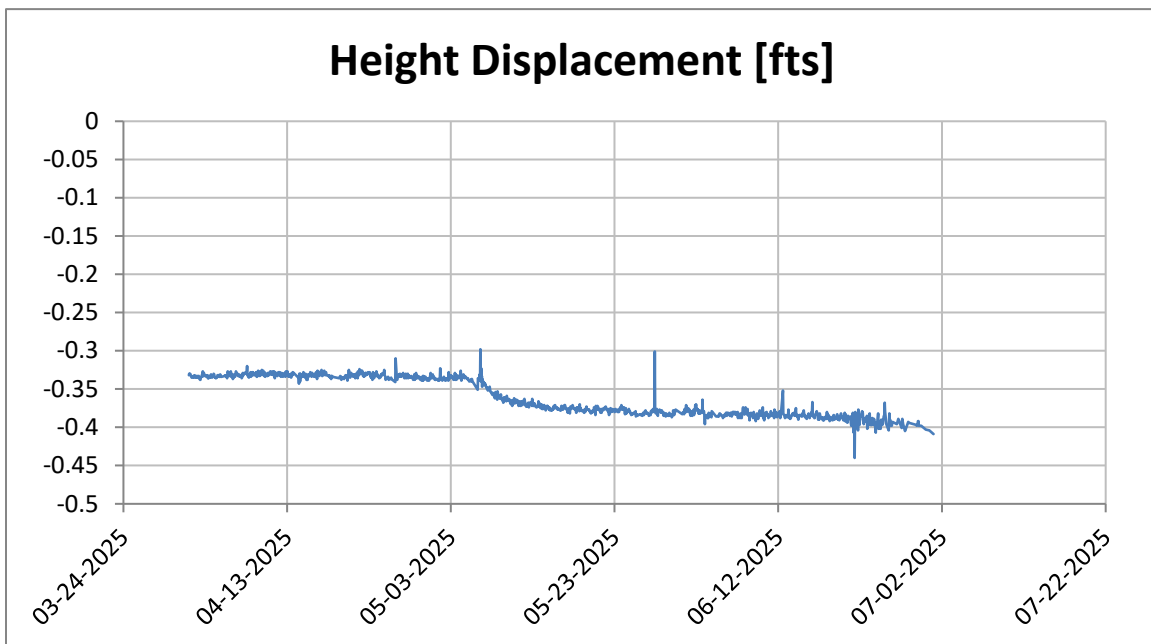
Prism B7300-2

1. Survey accuracy is ± 0.016 feet.
2. Alert threshold is ± 0.35 feet.
3. Transverse displacement is in the horizontal direction. Positive direction means closer to the robotic total station.
4. Height displacement is in the vertical direction. Positive direction means higher in elevation.
5. No readings from June 25 to July 7.

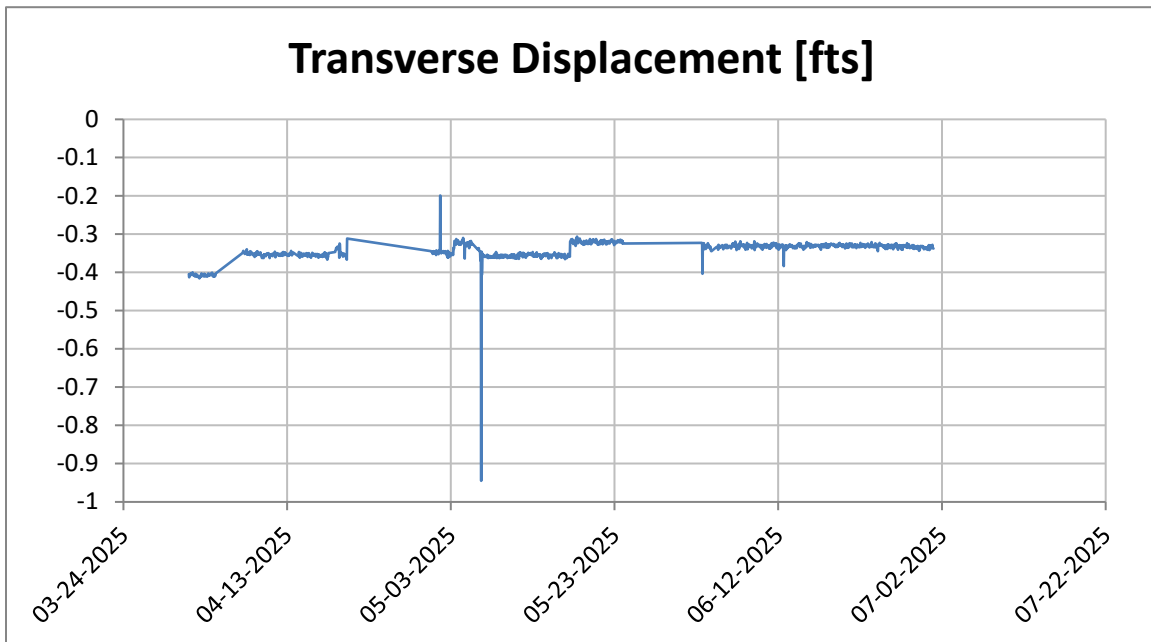
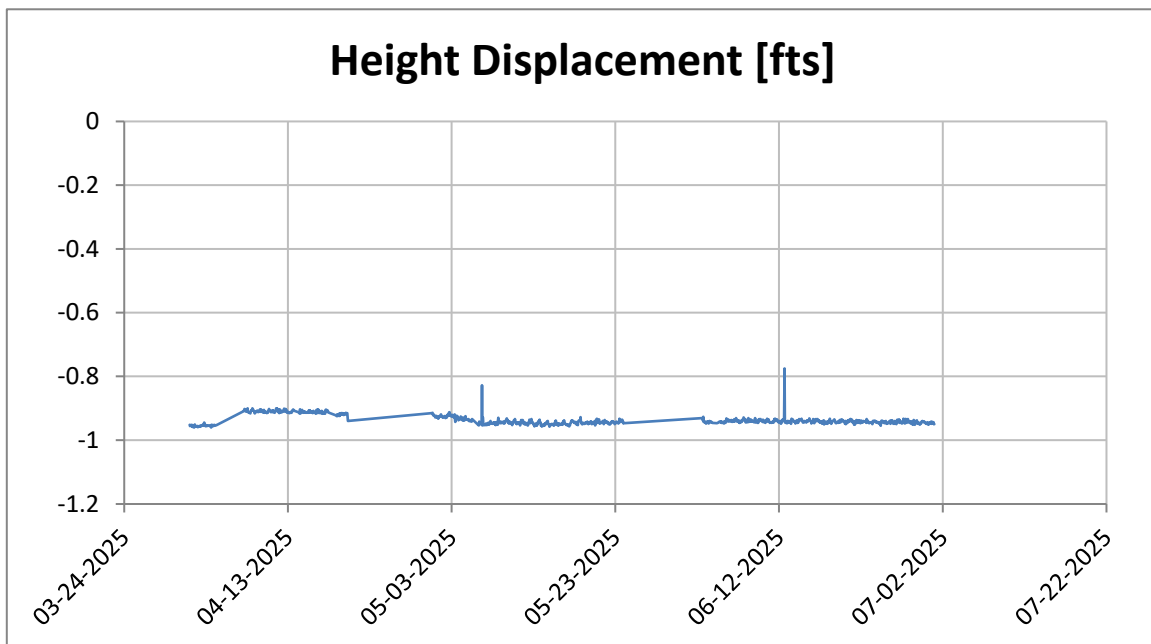
Prism B7400-1

1. Survey accuracy is +/-0.016 feet.
2. Alert threshold is +/-0.35 feet.
3. Transverse displacement is in the horizontal direction. Positive direction means closer to the robotic total station.
4. Height displacement is in the vertical direction. Positive direction means higher in elevation.
5. Data gaps April 4 to 7, April 20 to 30, and May 24 to June 4.

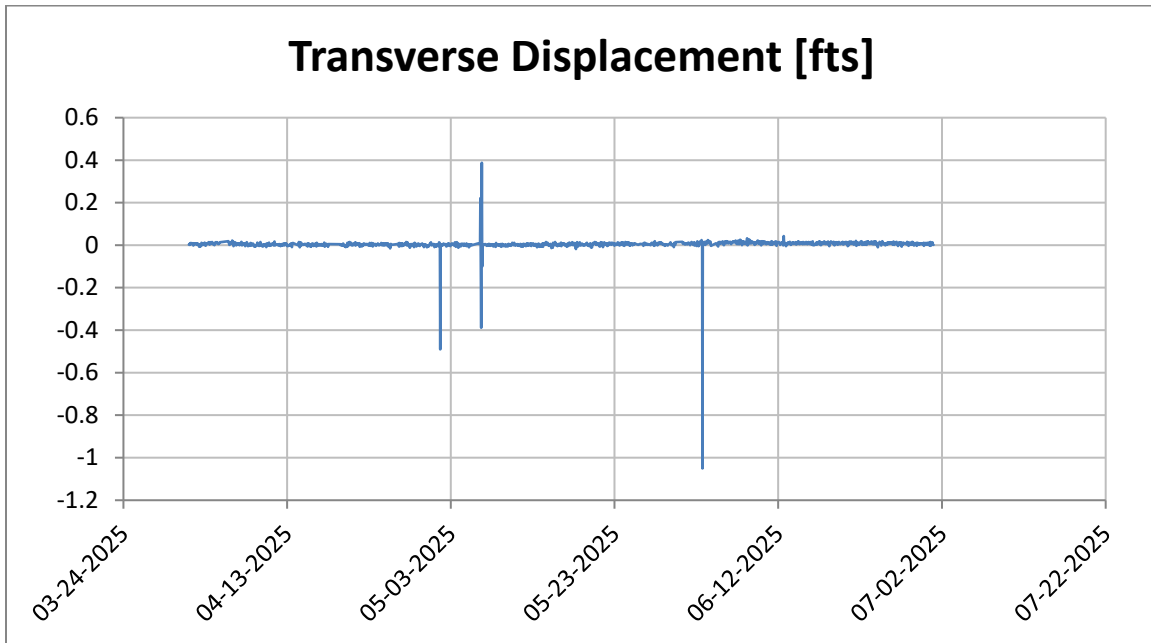
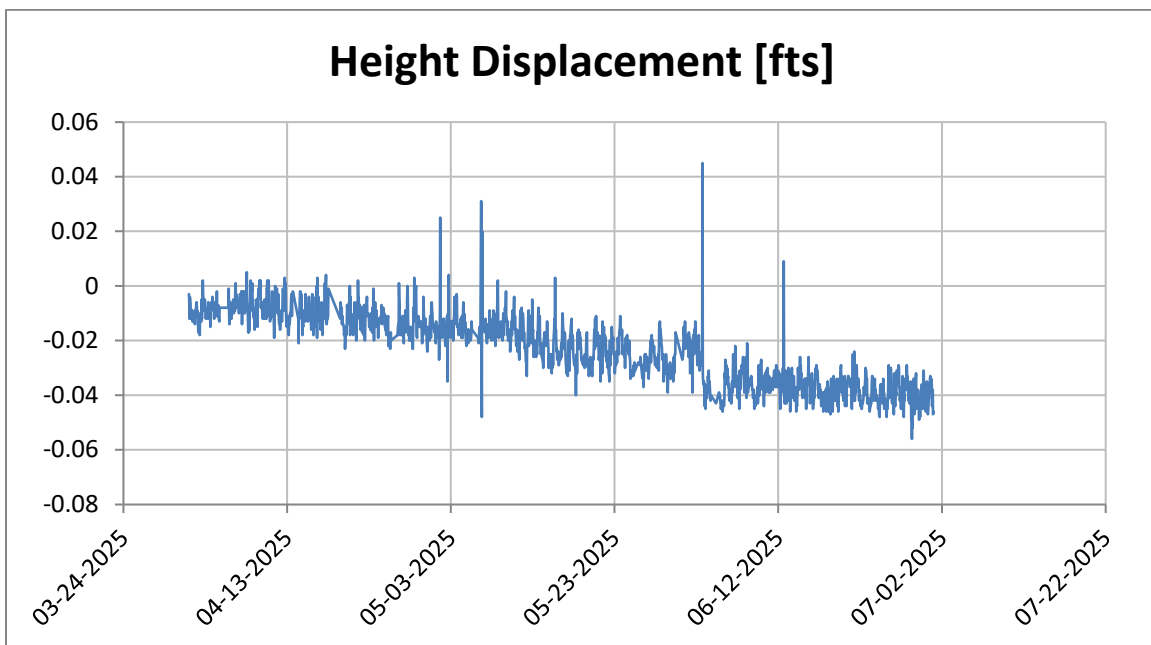
B7500-1R

1. Survey accuracy is ± 0.016 feet.
2. Alert threshold is ± 0.35 feet.
3. Transverse displacement is in the horizontal direction. Positive direction means closer to the robotic total station.
4. Height displacement is in the vertical direction. Positive direction means higher in elevation.
5. Prism was replaced on January 16, 2025, and renamed as P7500-1R. Displacement recorded that day is from the repairs and not attributed to slope movement.

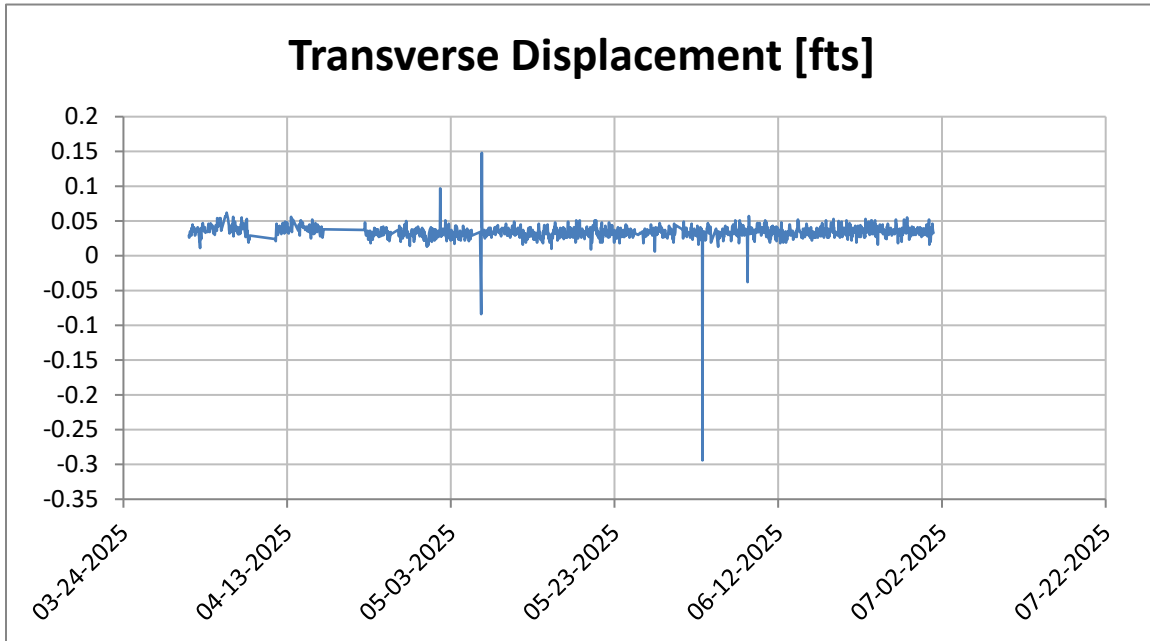
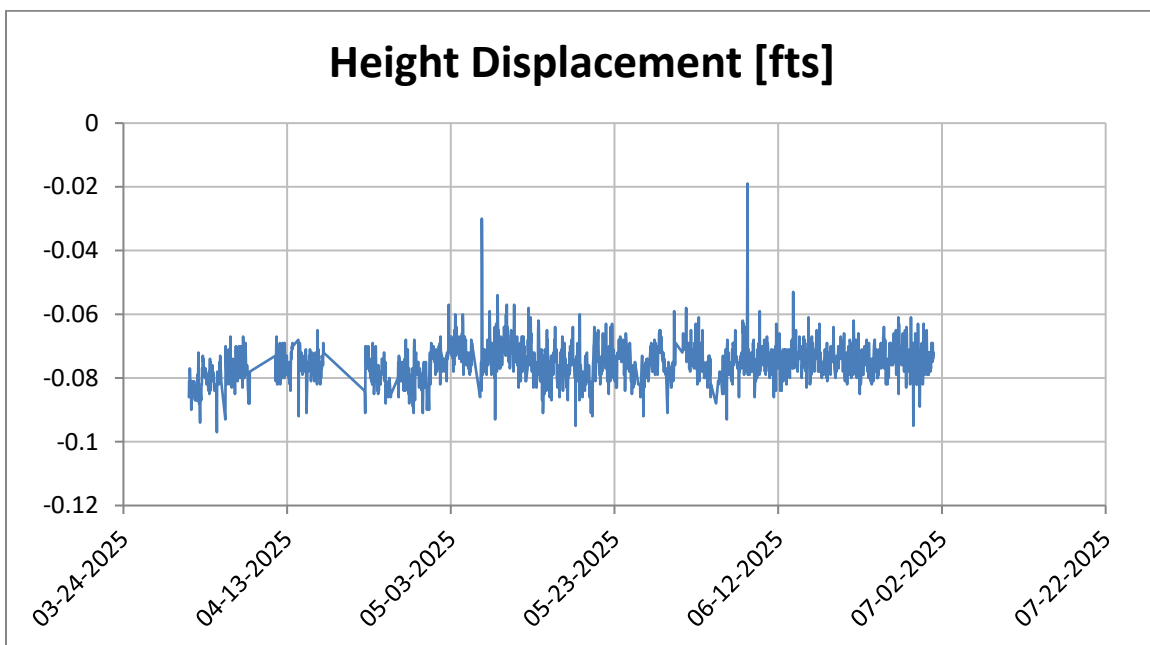
Prism NP4

1. Survey accuracy is ± 0.016 feet.
2. Alert threshold is ± 0.35 feet.
3. Transverse displacement is in the horizontal direction. Positive direction means closer to the robotic total station.
4. Height displacement is in the vertical direction. Positive direction means higher in elevation.
5. Data gaps from April 8 to 11 and April 17 to 22.

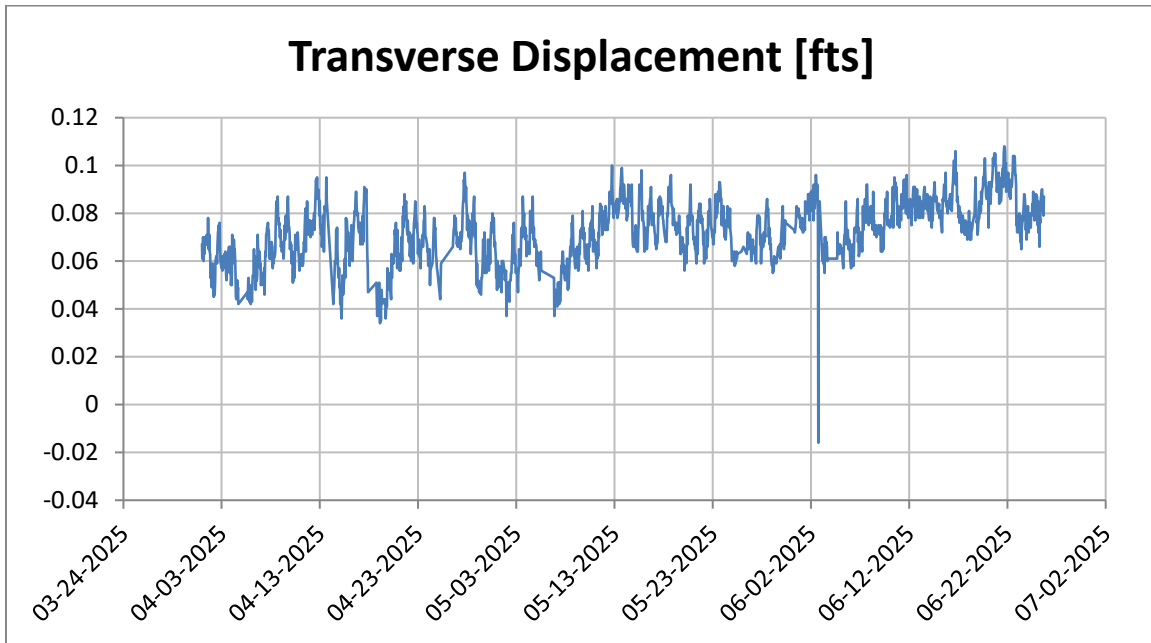
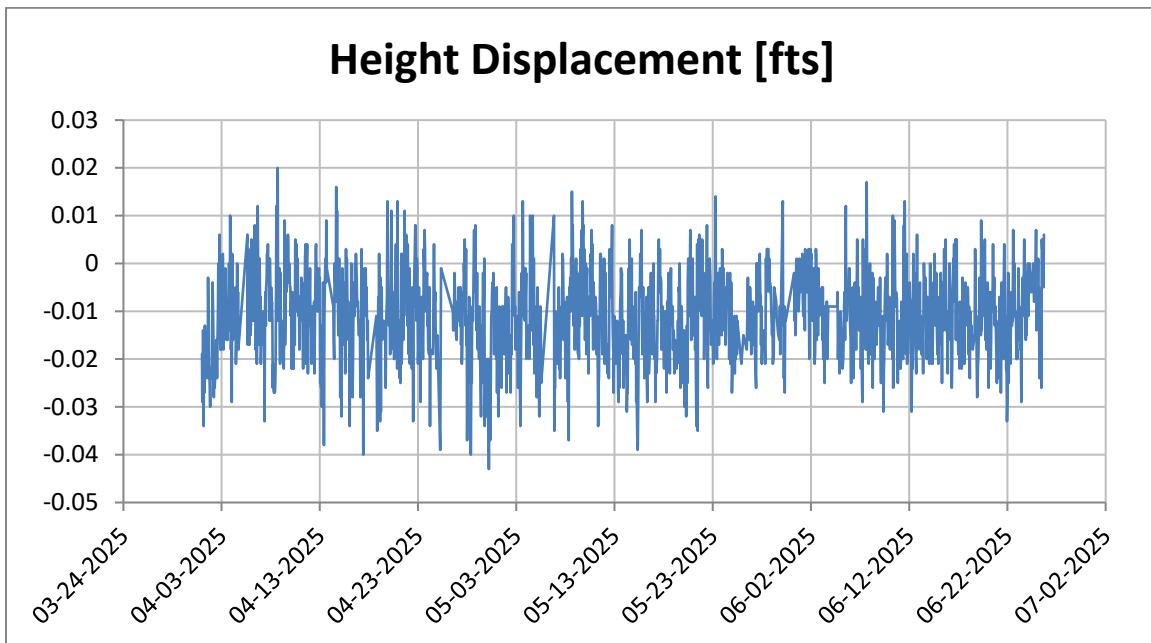
Prism P33

1. Survey accuracy is ± 0.016 feet.
2. Alert threshold is ± 0.35 feet.
3. Transverse displacement is in the horizontal direction. Positive direction means closer to the robotic total station.
4. Height displacement is in the vertical direction. Positive direction means higher in elevation.
5. No readings after June 25 due to prism vandalism.
