Job Number: 99-3983

Subject: Quarterly Observation Report,
Refuse Pile, Foidel Creek Mine, Routt
County, Colorado.

TCC Refuse Pile-Quarterly Inspection

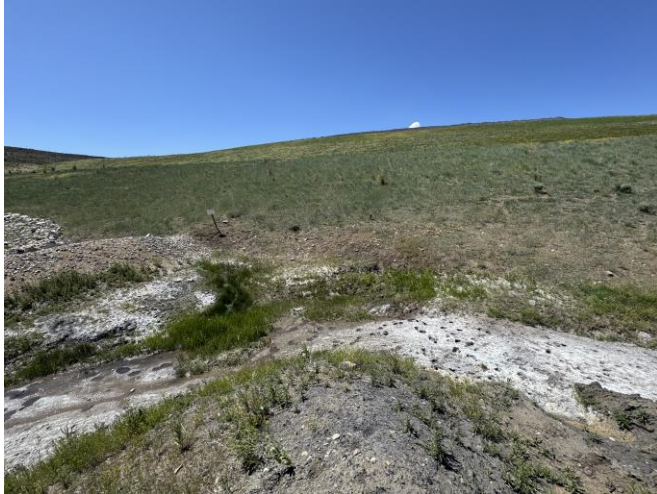
A seepage area at the toe of the northeast end of the refuse pile expansion area, approximately 30 feet northwest of the outlet of the underdrain, developed in fall 2014. At the time of our observations, the seepage was surfacing at the toe of the slope and flowing into the drainage from the undrain outlet then into the existing pond east of the Refuse Pile Expansion Area. The discharge was clear, with no evidence of sediment. No signs of washout, slumps or slope instability were observed at this time. The seepage area will be monitored during future inspections and noted in our inspection reports. Photographs of the seepage area taken at the time of our inspection on June 30, 2025 are attached.

June 30, 2025-Drain Outlet and Seepage Area

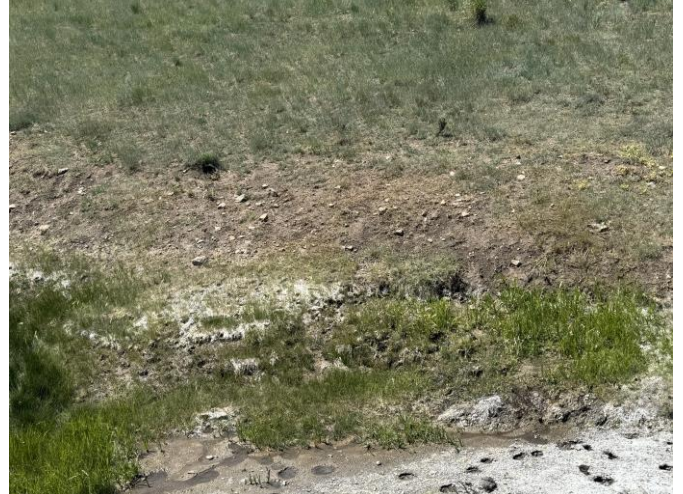
June 30, 2025-Seepage Area

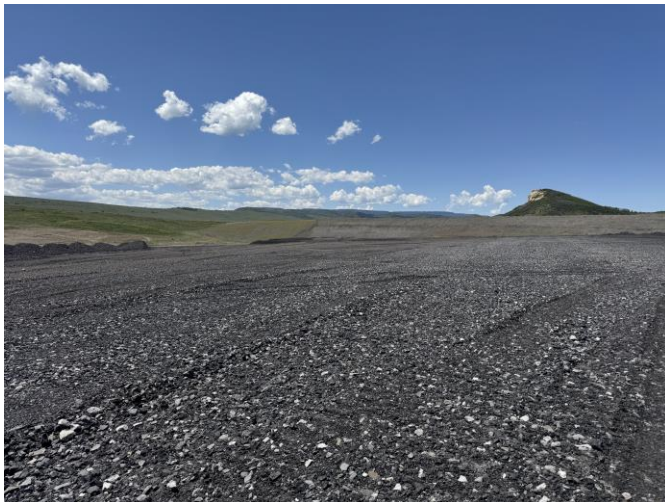
The internal roadways in the new expansion area of the pile are in good condition. The upper haul road to Areas 2, 3 and 4 of the refuse pile was not accessible.

June 30, 2025- Areas 2, 3 and 4 from Expansion Area

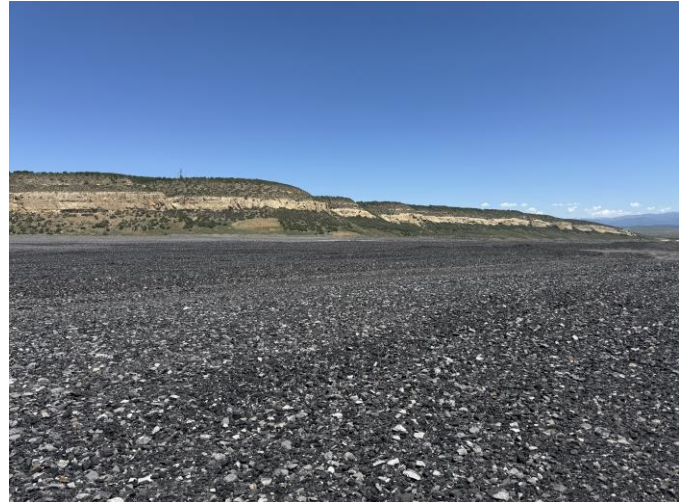
At the time of our site visit on June 30, 2025, NWCC completed a site inspection of the existing refuse pile. Based on our observations made during this visit, it appeared that the contractor was presently stockpiling, grading and compacting refuse coal in the new Expansion Area. At the time of our site visit, the refuse coal had been placed and compacted to an elevation above the third bench, near the fourth bench, situated along the east side of the stockpile.

June 30, 2025- Expansion Area

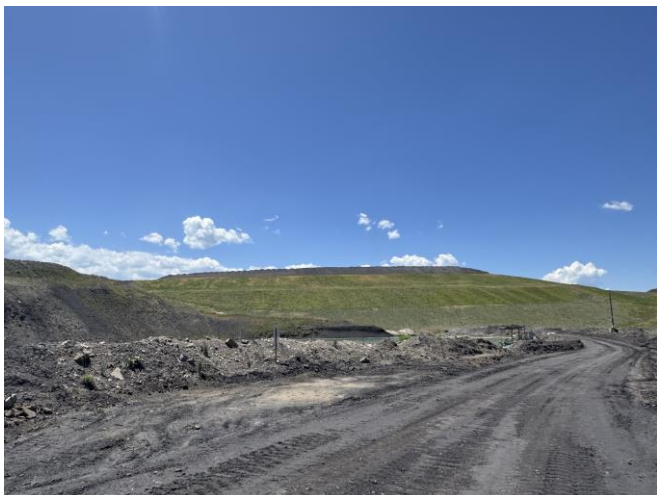
June 30, 2025- East End of Expansion Area

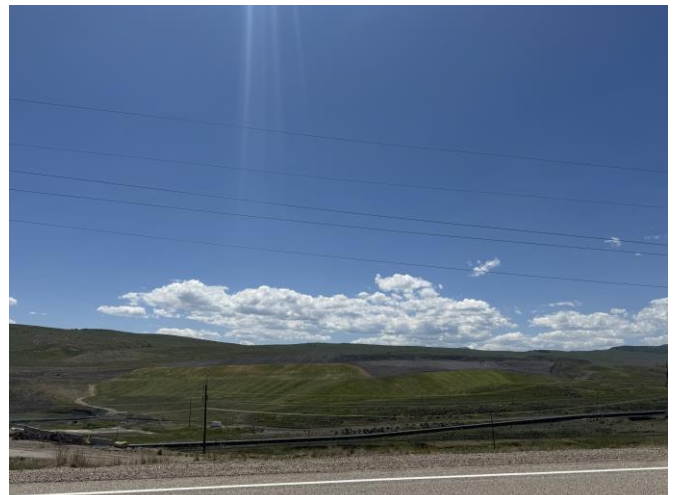
Based on our observations, the surface drainage conditions generally appeared to be adequate across the top and sides of the pile. Based on our observations, we did not observe any signs of instability, structural weakness or hazardous conditions at the refuse pile.

June 30, 2025- Refuse Pile
