MINERALS PROGRAM INSPECTION REPORT
PHONE: (303) 866-3567

MINE NAME: Whiting Pit	MINE/PROSPECTING ID#: M-2007-025	MINERAL: Gravel and sand	COUNTY: Delta
INSPECTION TYPE: Monitoring	WEATHER: Clear	INSP. DATE: July 23, 2025	INSP. TIME: 10:05
OPERATOR: Delta County	OPERATOR REPRESENTATIVE: Timothy Hunter, Anthony Hunter, Hunter Voss	TYPE OF OPERATION: 112c - Construction Regular Operation

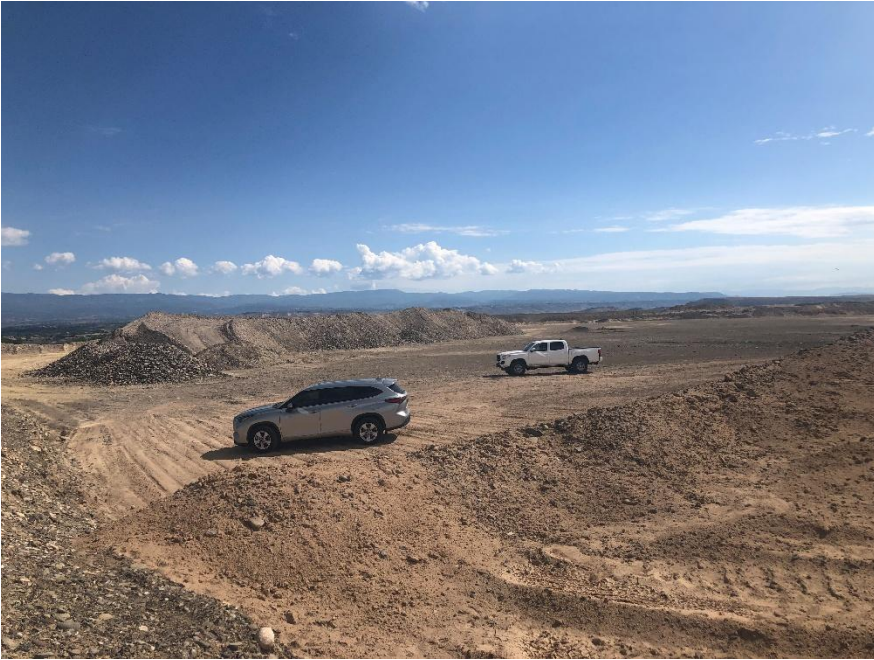
Pit area

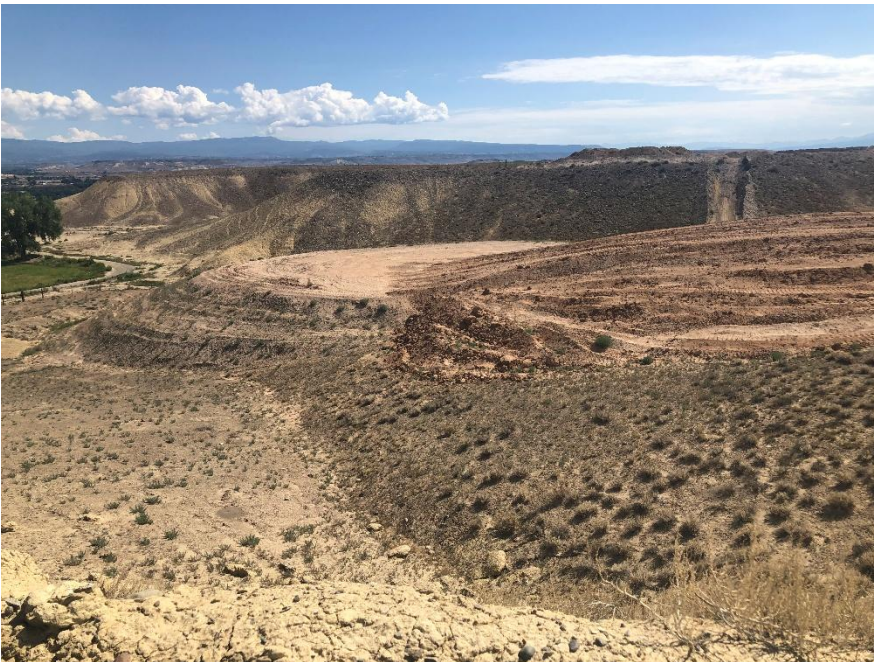
PROBLEM/POSSIBLE VIOLATION: Problem: The topsoil stockpile does not have established vegetation and is therefore susceptible to erosion. Rule 3.1.9(1) states if topsoil is not replaced into the backfill area within a time short enough to avoid deterioration of the topsoil, vegetative cover or other means shall be employed so that the topsoil is protected from erosion.

The topsoil needs to be protected with erosion control practices (e.g., a berm or wattles) and seeded.

Topsoil stockpile

CORRECTIVE ACTIONS: The operator shall seed the stockpile with the seed mix that was submitted as part of the approved Reclamation Plan. The Operator shall demonstrate compliance by submitting seed tags, a bill of sale or photographs of seeding activities. Alternatively, erosion best management practices should be employed. Ideally, both seeding and other erosion control shall be used.

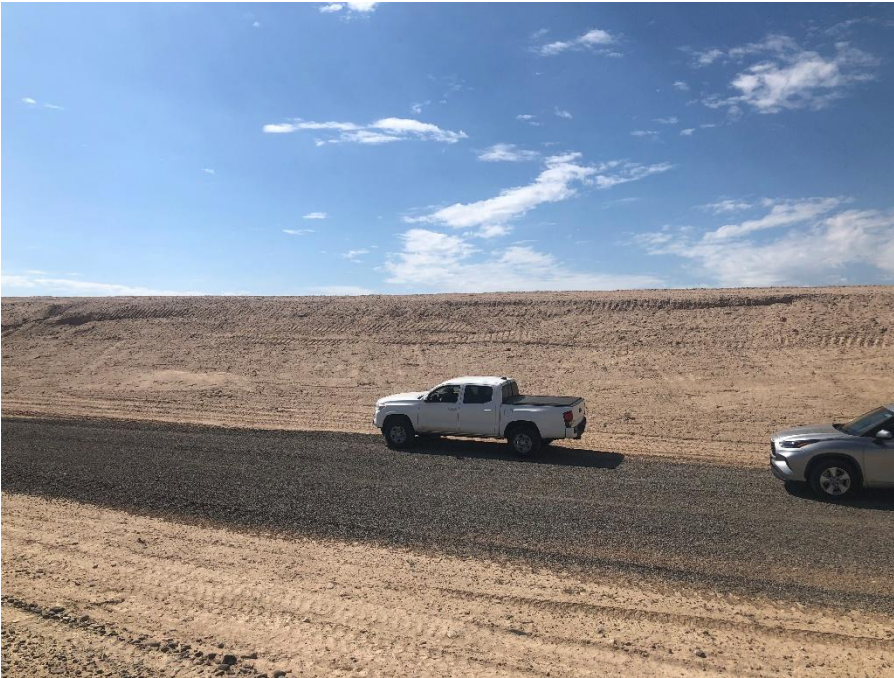
Large overburden pile along road

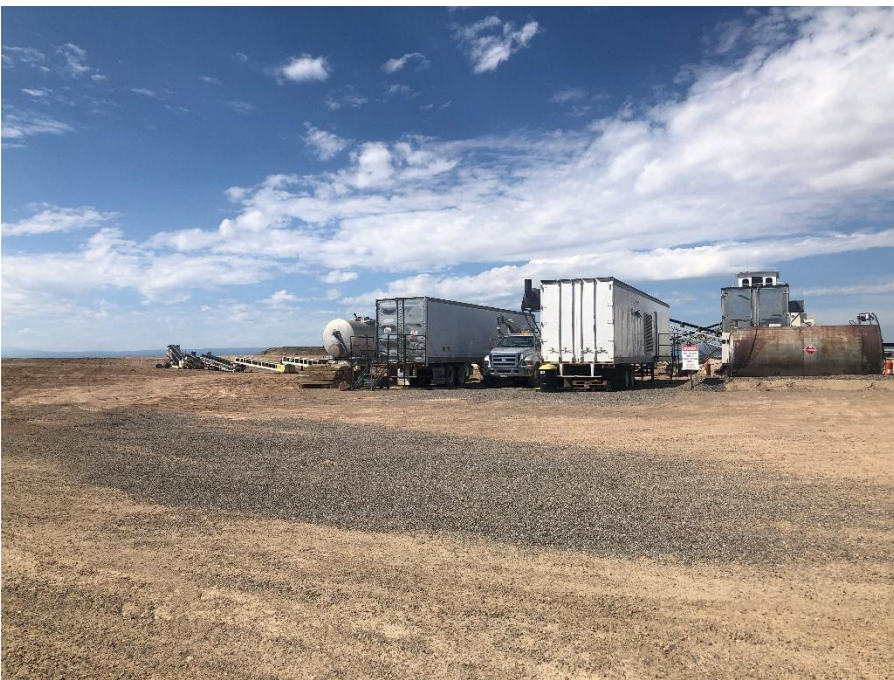
The site included a mining area near the west end (the County was not actively mining at the time of the inspection), product piles, a topsoil stockpile, an overburden pile, processing equipment (recently moved from Ellison Pit, not yet in operation at time of inspection), and a 16-foot long diesel tank, which is located within a containment structure.

Processing site, with equipment, trailers, and diesel tank

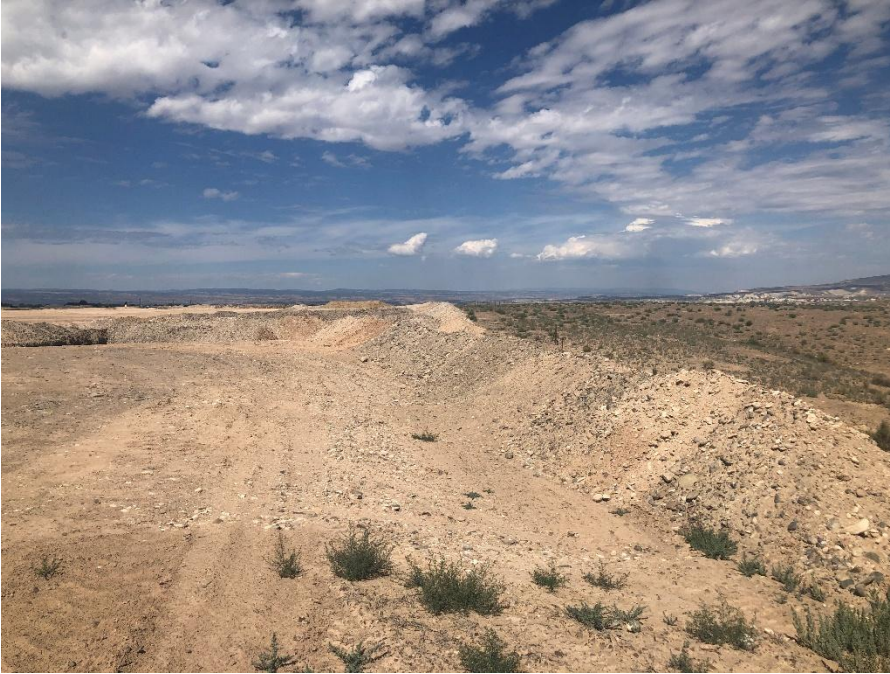
No ditches or other surface water control structures were seen. The grading of the site and berms are preventing runoff to surrounding areas. There is no indication that the site is causing offsite impacts to surface water hydrology.

Berm on north side of affected area

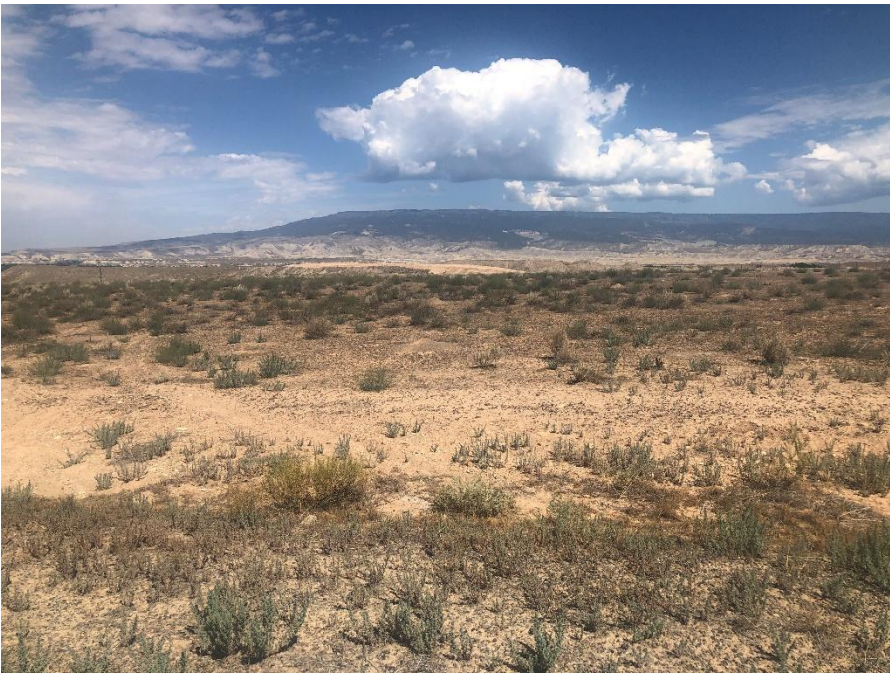
No mining activity at southwest portion of site
