MINERALS PROGRAM INSPECTION REPORT

MINE NAME: Wet Canyon Mine	MINE/PROSPECTING ID#: M-2003-072	MINERAL: Sand and gravel	COUNTY: Las Animas
INSPECTION TYPE: Monitoring	WEATHER: Cloudy	INSP. DATE: July 24, 2025	INSP. TIME: 08:48
OPERATOR: Michael Browning	OPERATOR REPRESENTATIVE: Michael Browning	TYPE OF OPERATION: 110c - Construction Limited Impact

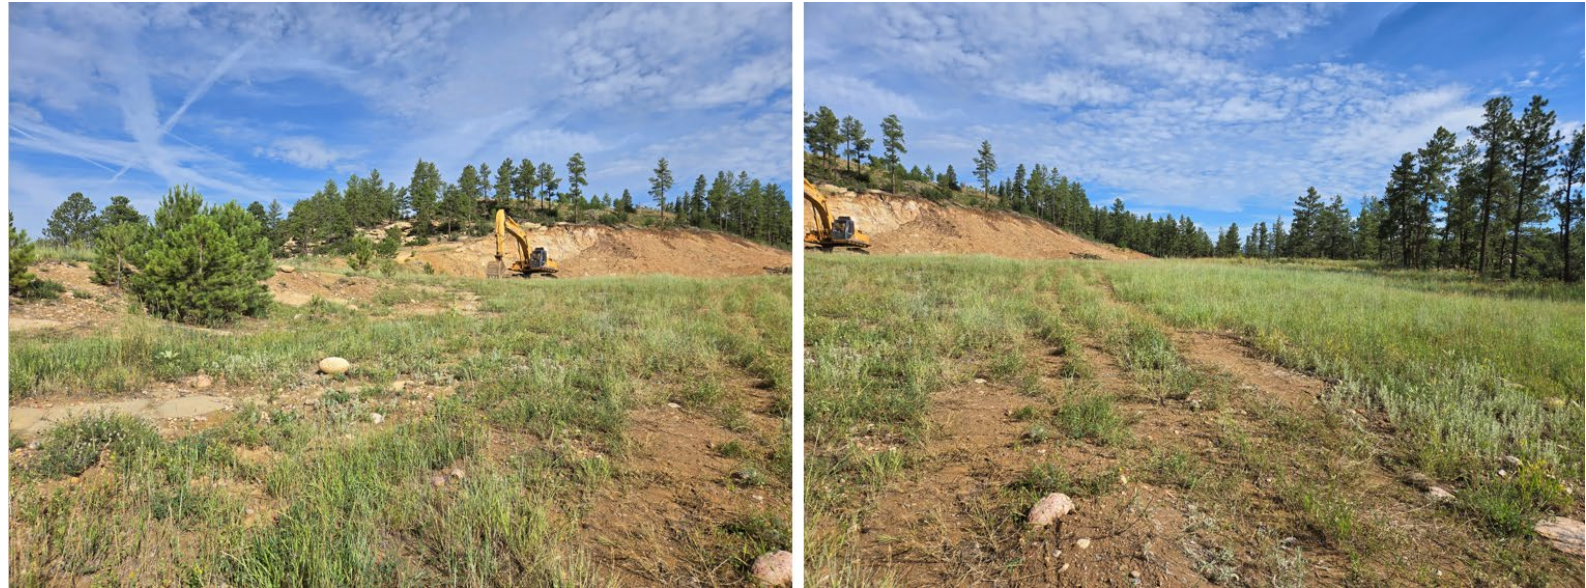
Photo 1: Looking northwest at the lower shelf area. The excavator highlights the recent backfilling and grading work done along the highwall separating the upper and lower shelves.

The last reported date of mining activity is August 15, 2013. This site has been in final reclamation for over a decade. Except for the highwall separating the upper and lower shelves of the operation, the slopes have been backfilled and graded to a 3H:1V slope or shallower. At the time of the inspection, the Division observed that the highwall appeared to recently have been backfilled and graded, except for a small vertical section in the center (See photos 1-4). The Operator stated that they had a contractor grade and backfill the highwall slopes a week prior to the inspection, and that they were expecting them to be onsite later that day to continue working. The small vertical section of highwall is all that remains of the slopes that need to be backfilled and graded around the site.

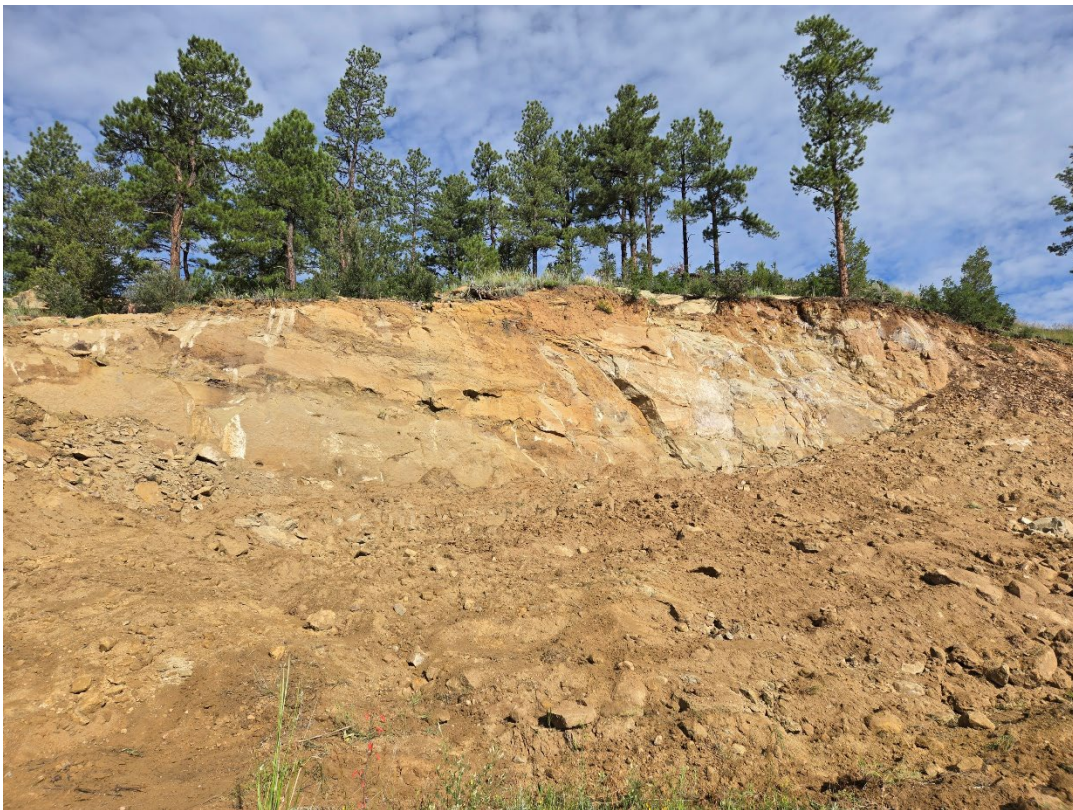
Photo 2: All that remains of the highwall that needs to be graded to a 3H:1V slope.

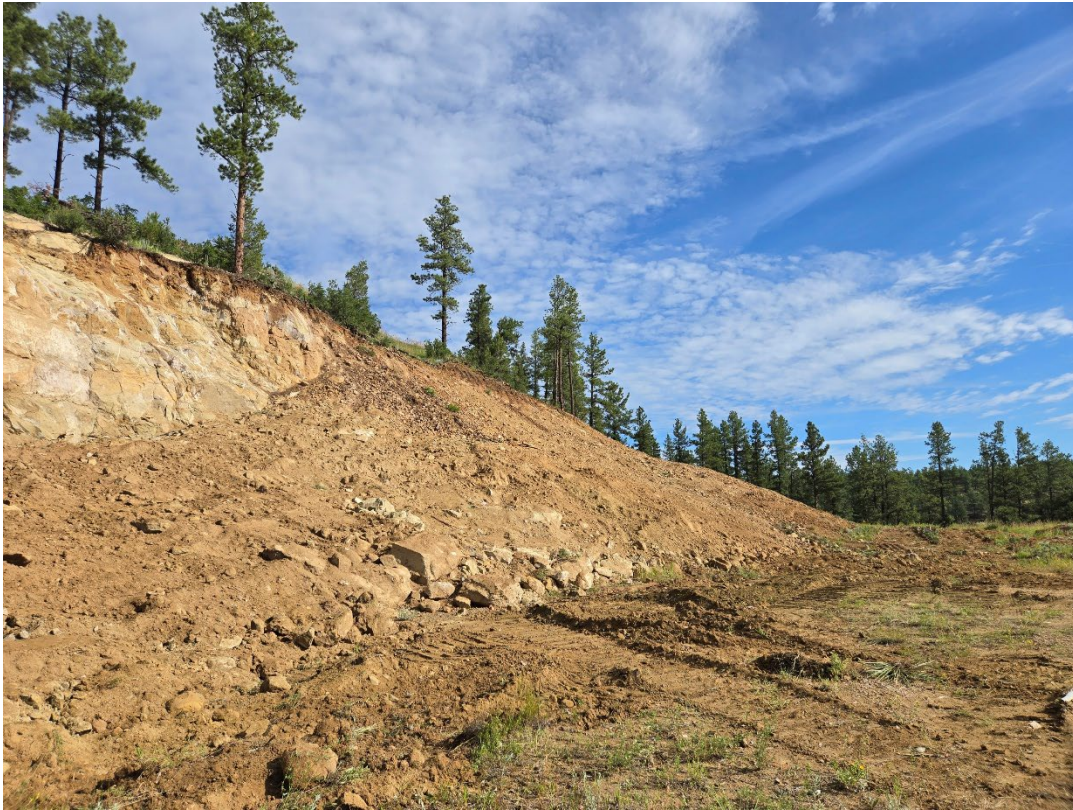
Photo 3: Looking north at a section of highwall that has been graded to a 3H:1V.

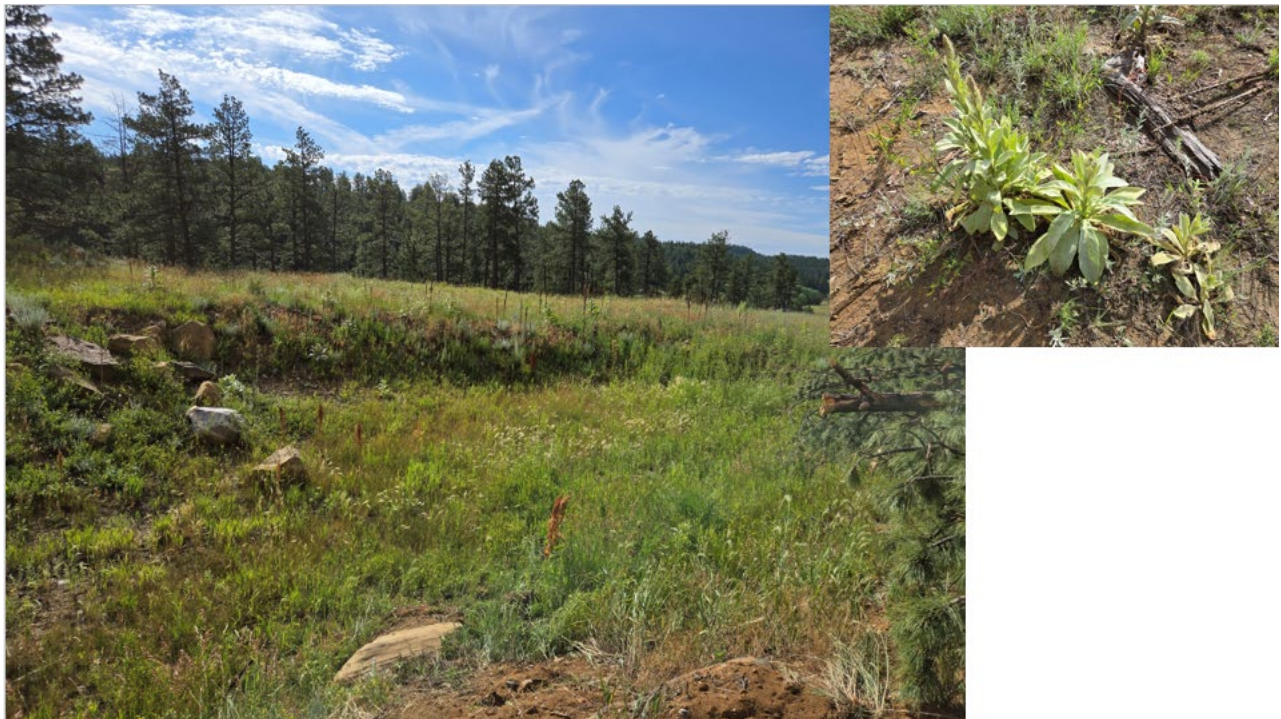
PROBLEM: There are state-listed noxious weeds present on site. This is a problem for failure to employ weed control methods for state listed noxious weed species within the permitted area, and to reduce the spread of weeds to nearby areas as required by Section 3.1.10 (6) of the rule.

Photo 4: Looking at the dense vegetation established onsite. The small photo, and the stalks within the photo on the right, indicate the presence of common mullein on site.

CORRECTIVE ACTIONS: Implement approved weed control plan and provide proof to the Division that this has been done. Proof that weed control measures have been conducted, via photos and/or weed treatment receipts, shall be submitted to the Division by the corrective action date.

Other than the freshly graded highwall, the site has been topsoiled and revegetated. Overall, the vegetation growing on the site is dense, diverse, and primarily composed of desirable species. There is a variety of grasses, shrubs, and even trees growing throughout the site (see Photos 4-7). On the upper shelf, there are some sparse areas that may require re-seeding. Unfortunately, there are patches throughout the site where noxious weeds have begun to establish (see Photos 4-5). Both the state listed noxious weeds Common Mullein (C-listed) and Canada Thistle (B-listed) were observed onsite. **This has been cited as a problem above.** The Operator shall treat and/or remove the noxious weeds, and submit photo evidence of having done so, by the corrective action date.

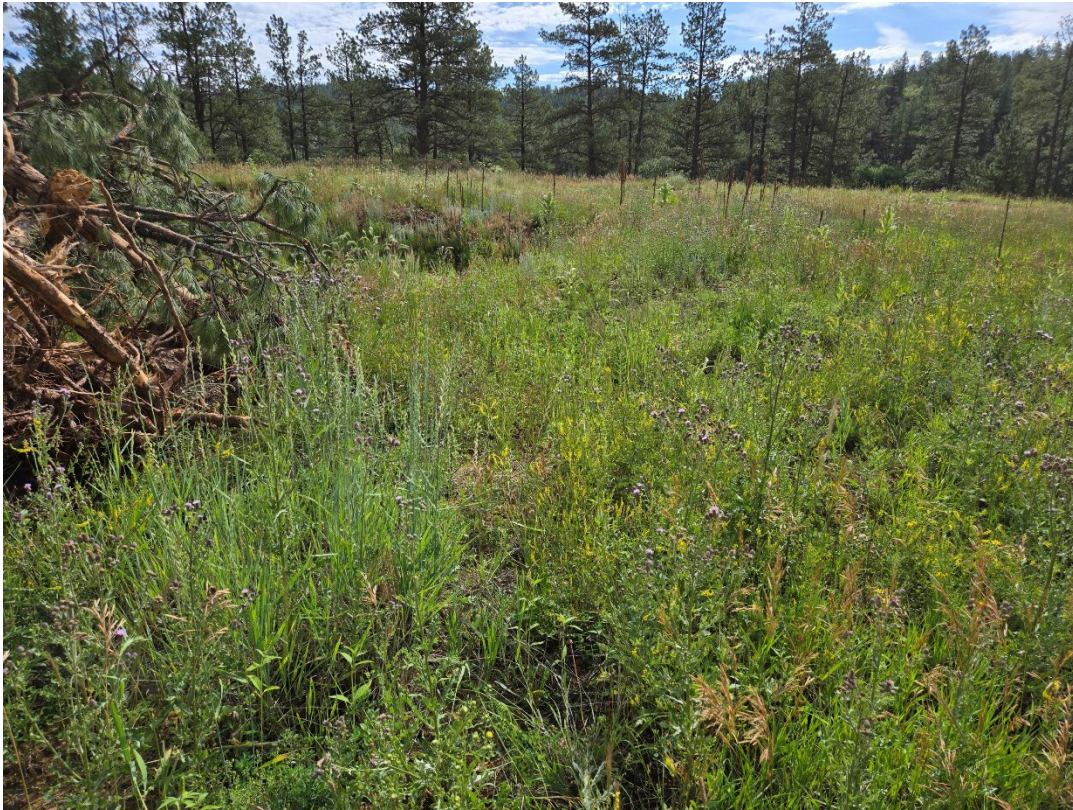
Photo 5: Canada thistle established in patches in small areas within the site.

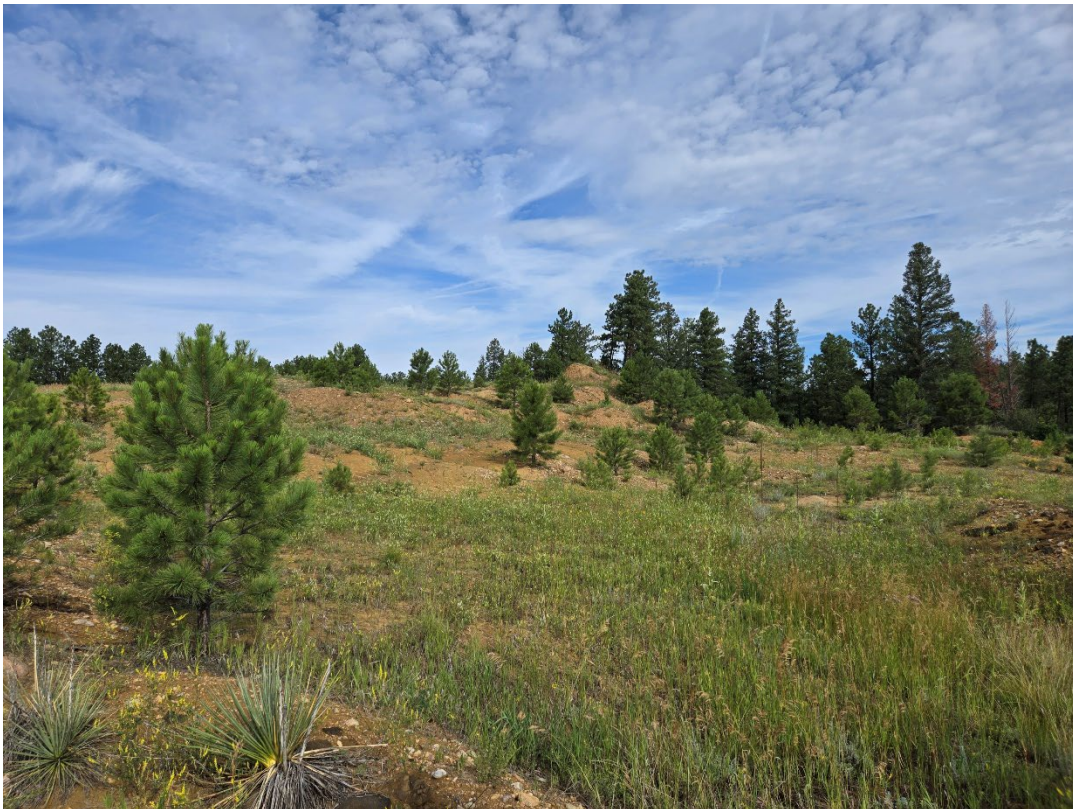
Photo 6: Looking north at the revegetation within the upper shelf area.

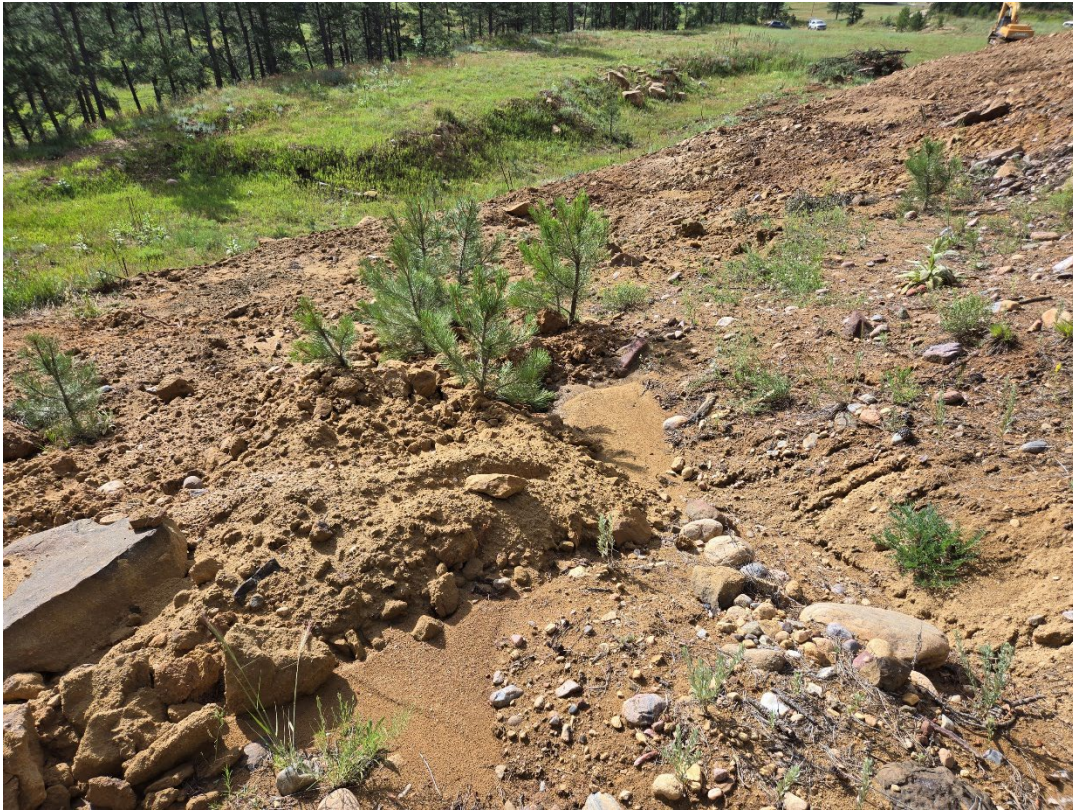
Photo 7: Trees beginning to grow along some of the sparsely vegetated areas.

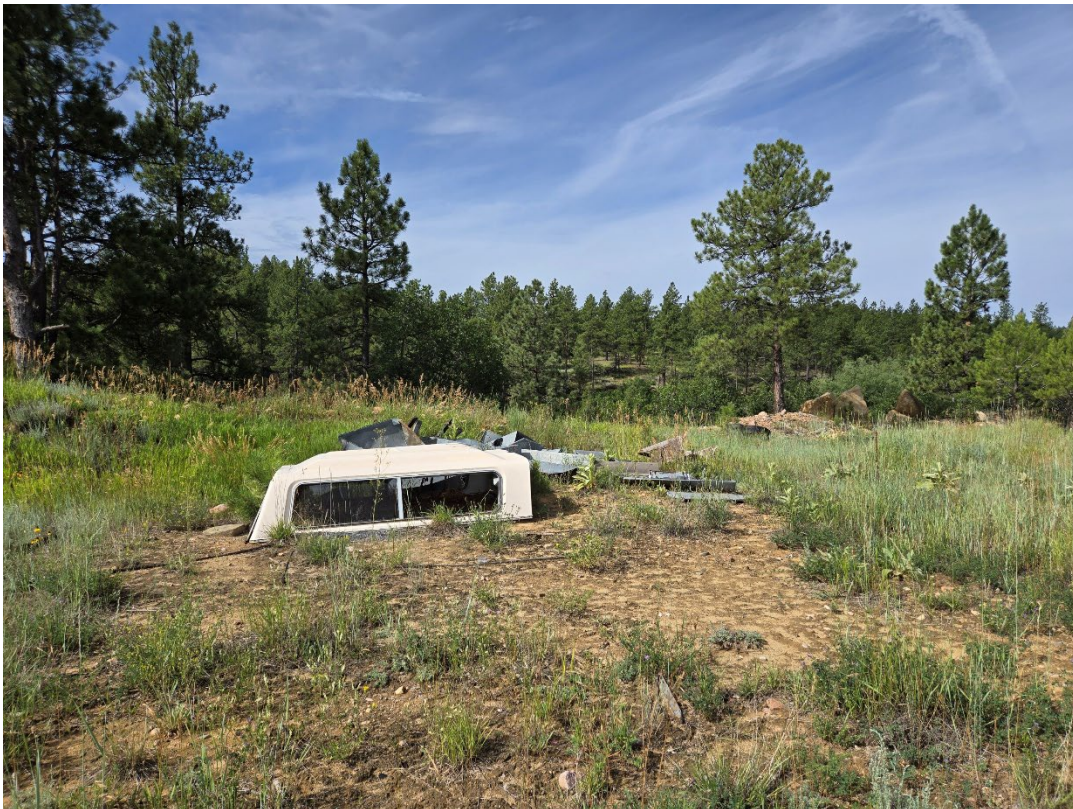
Photo 8: Debris from the destroyed camper, placed along the southside of the disturbed area.

The Division observed a small pile of debris near the south side of the disturbed area (Photo 8). The Operator stated that they had had a camper within the area that was flattened for a house, on the west side of the upper shelf (Photo 9). The camper had been destroyed by trespassers, and the remnants are temporarily being stored onsite. The Operator is aware that this material must be removed prior to the permit being eligible for final release.

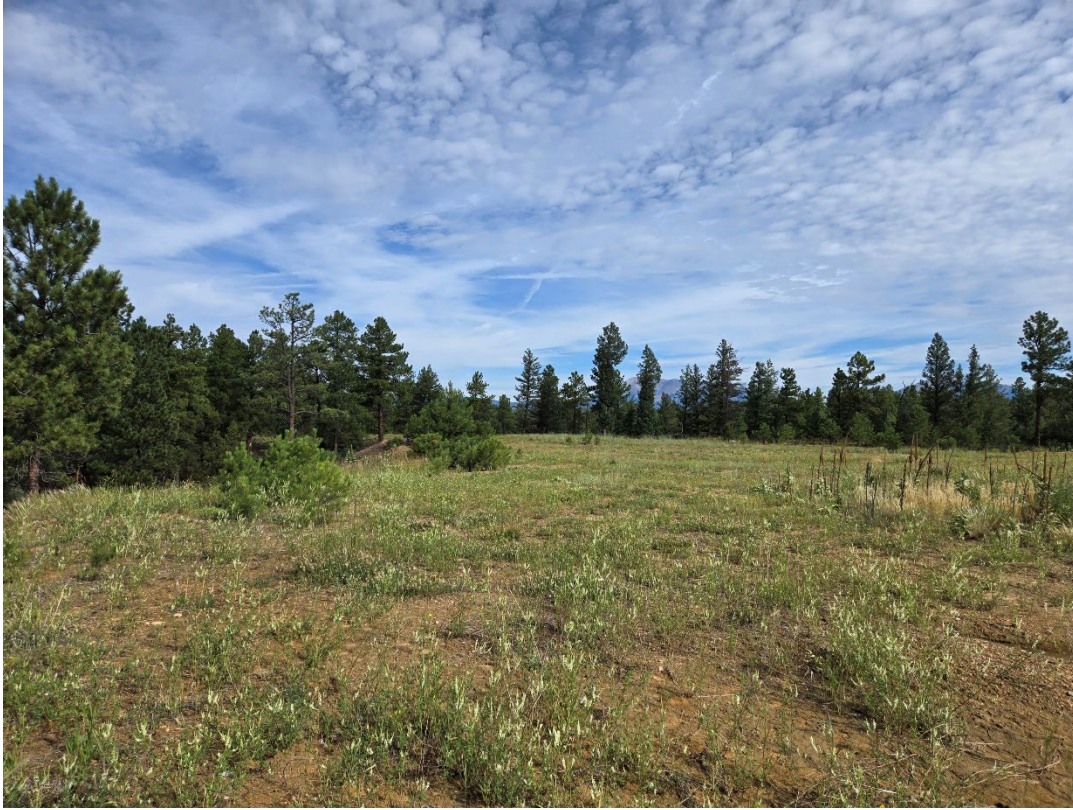
Photo 9: Looking northwest at the area that had been flattened for building a house, not associated with the mining operation. The Operator stated that they no longer intend to put a house within this area.

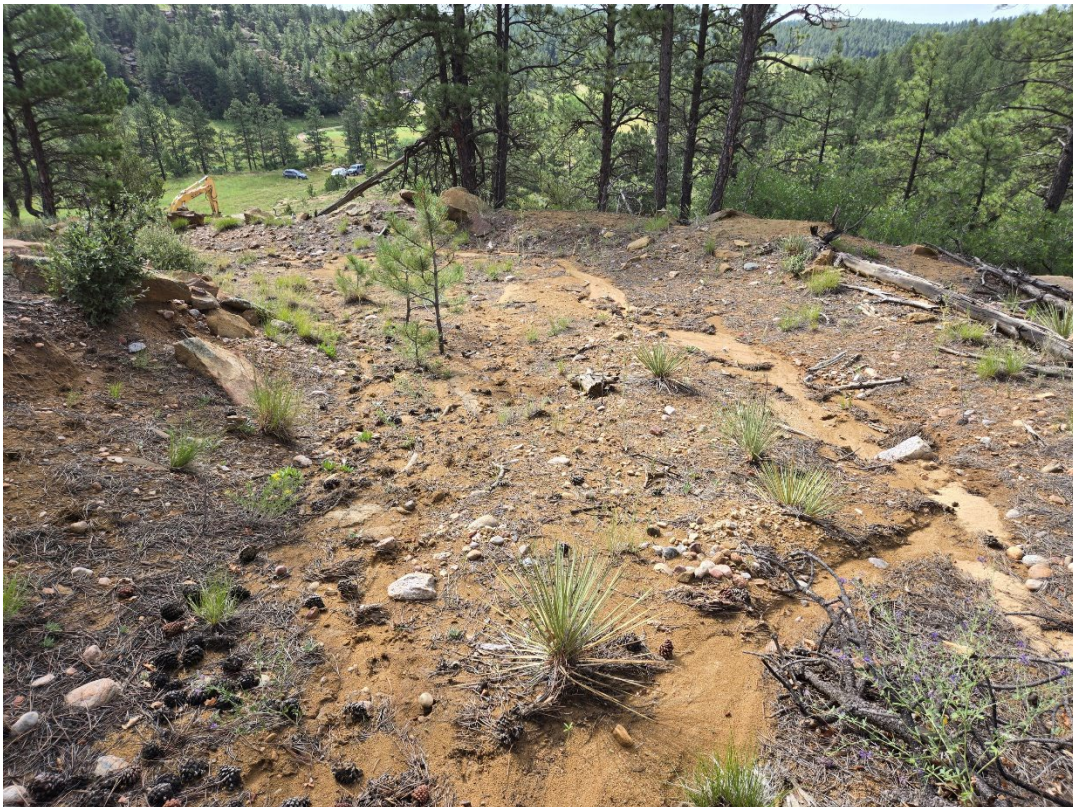
Erosion gullies were observed throughout areas within the upper shelf (see Photos 10-13). The sediment run-off generated from the erosion is contained on site. No signs of stormwater runoff or sediment deposition having left the site were observed during the inspection. No standing water was observed onsite at the time of the inspection.

Photo 10: Looking at where sediment accumulation from stormwater runoff is contained onsite through the use of perimeter berms.

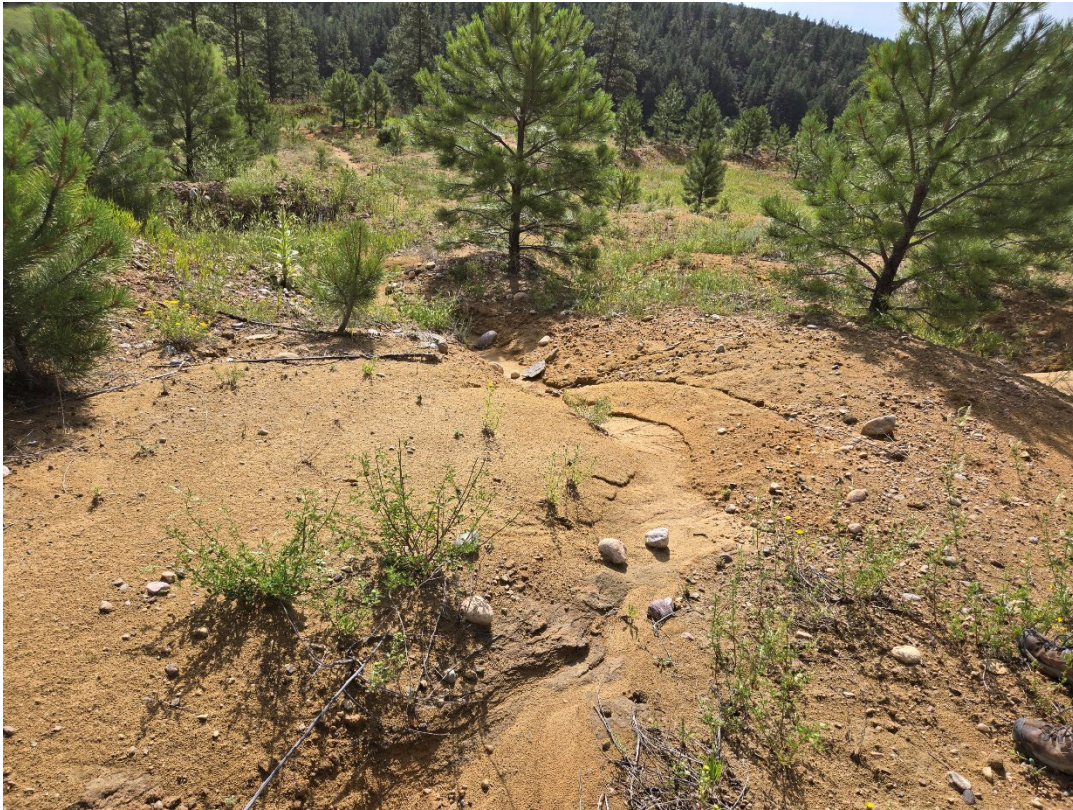
Photo 11: Looking at an area within the upper shelf where some erosion is occurring that needs to be re-stabilized and re-seeded.

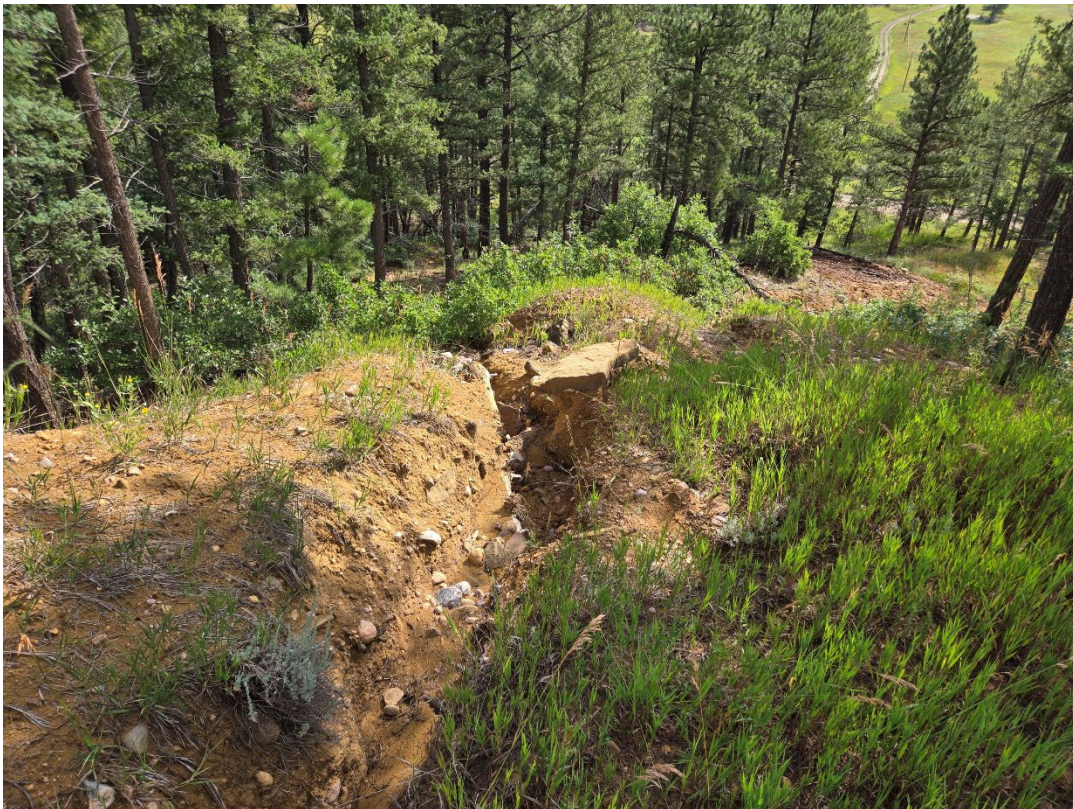
Photo 12: Looking east at the deep erosion gully that has formed between the upper and lower shelves, requiring re-grading and stabilizing.

The Operator was instructed to regrade and stabilize the area along the north side of the disturbance (where the upper and lower shelves connect), as a deep erosion gully has formed there (Photos 12-13). Small piles of material were observed within the upper shelf area that may be used to fill in any deep erosional cuts (see Photos 14-16).

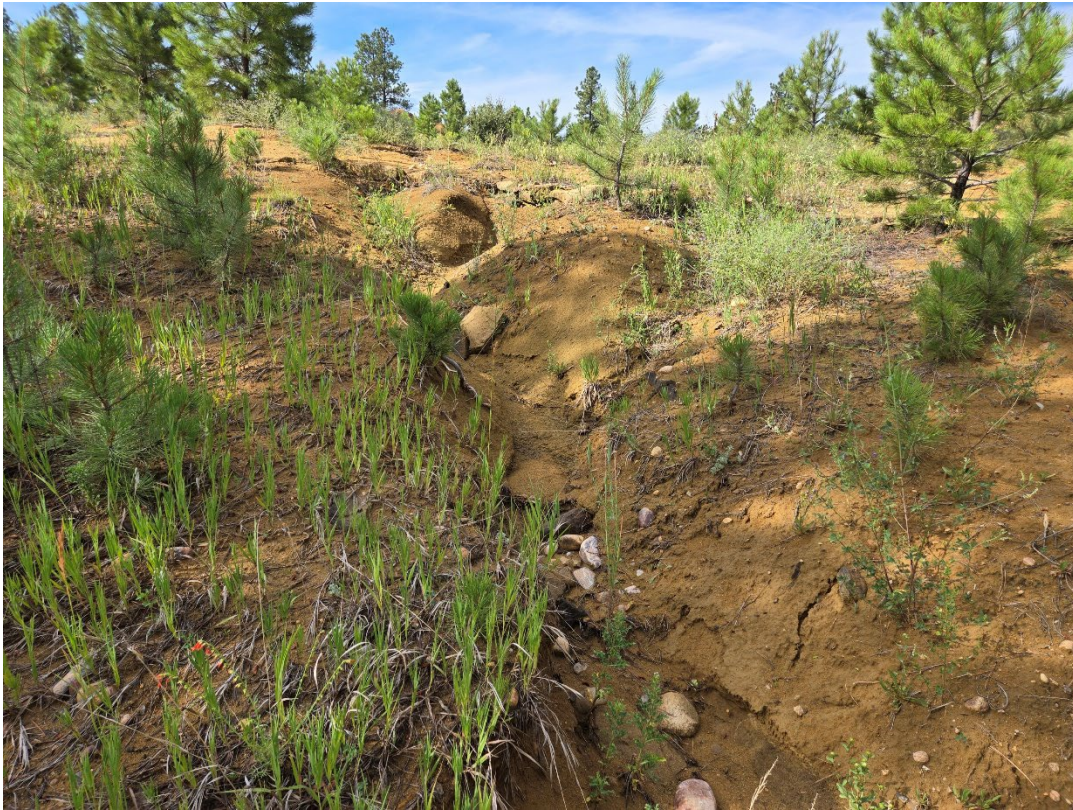
Photo 13: Looking west at the beginning of the deep erosion gully that has formed between the upper and lower shelves, requiring re-grading and stabilizing.

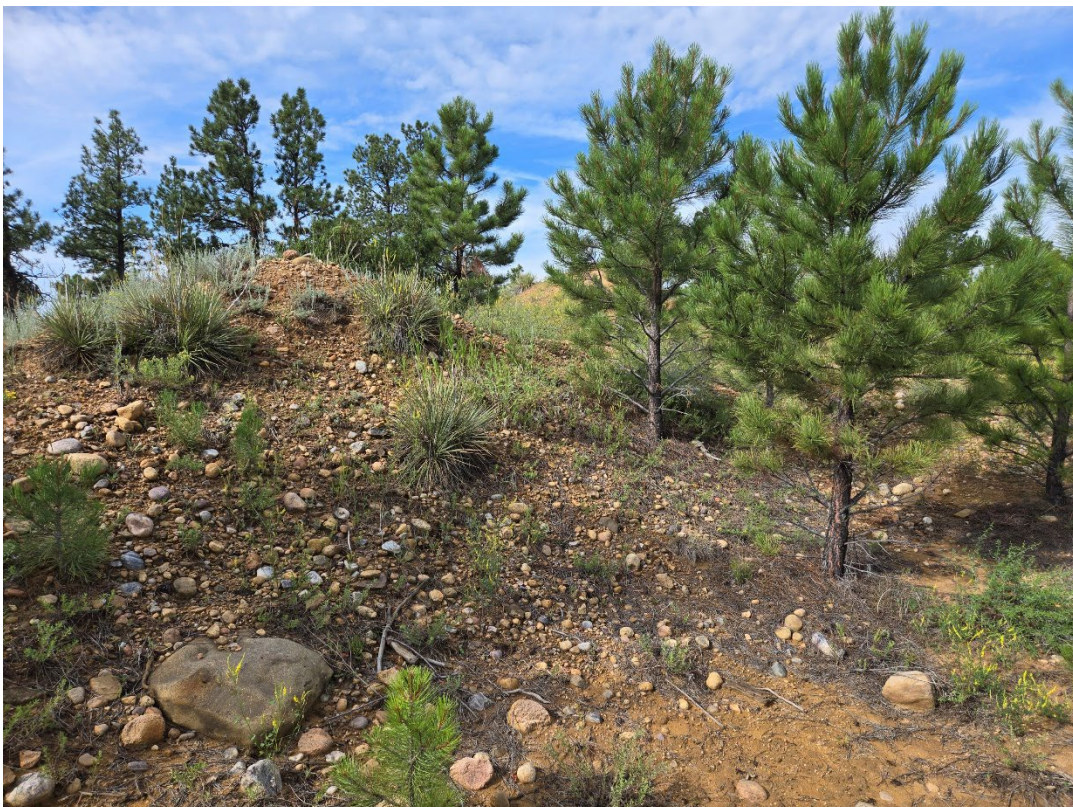
Photo 14: Material pile that may be used to fill erosional cuts.

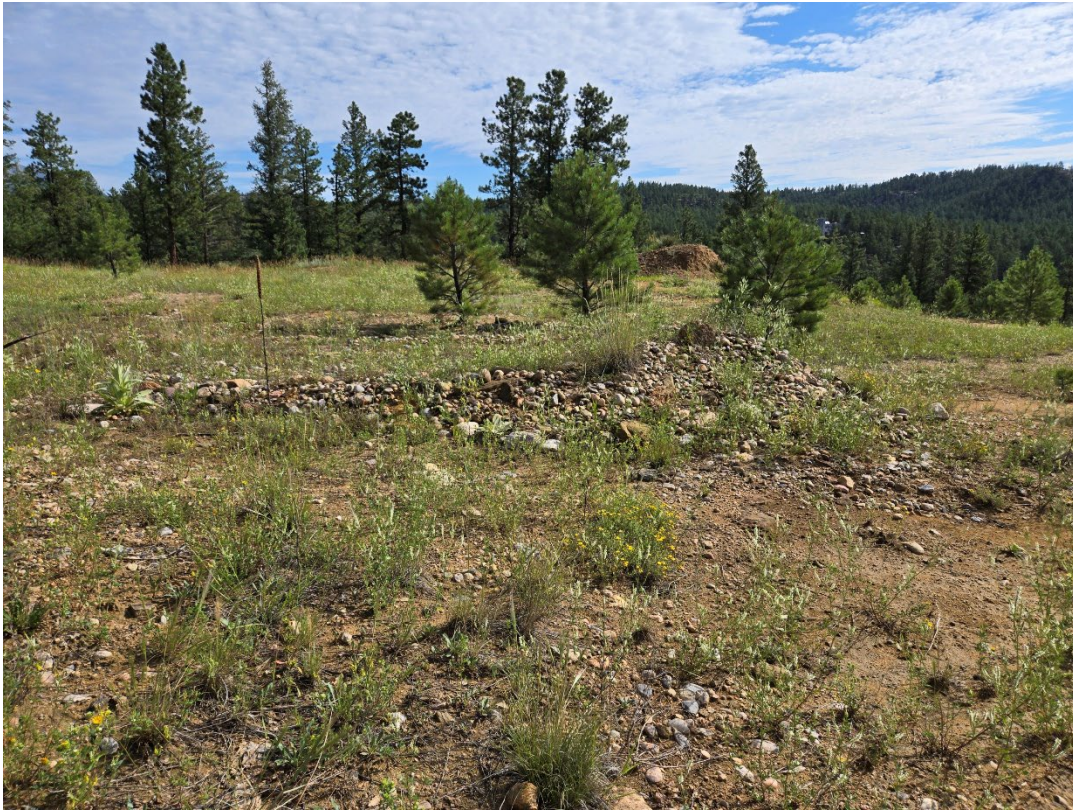
Photo 15: Material pile that may be used to fill erosional cuts.

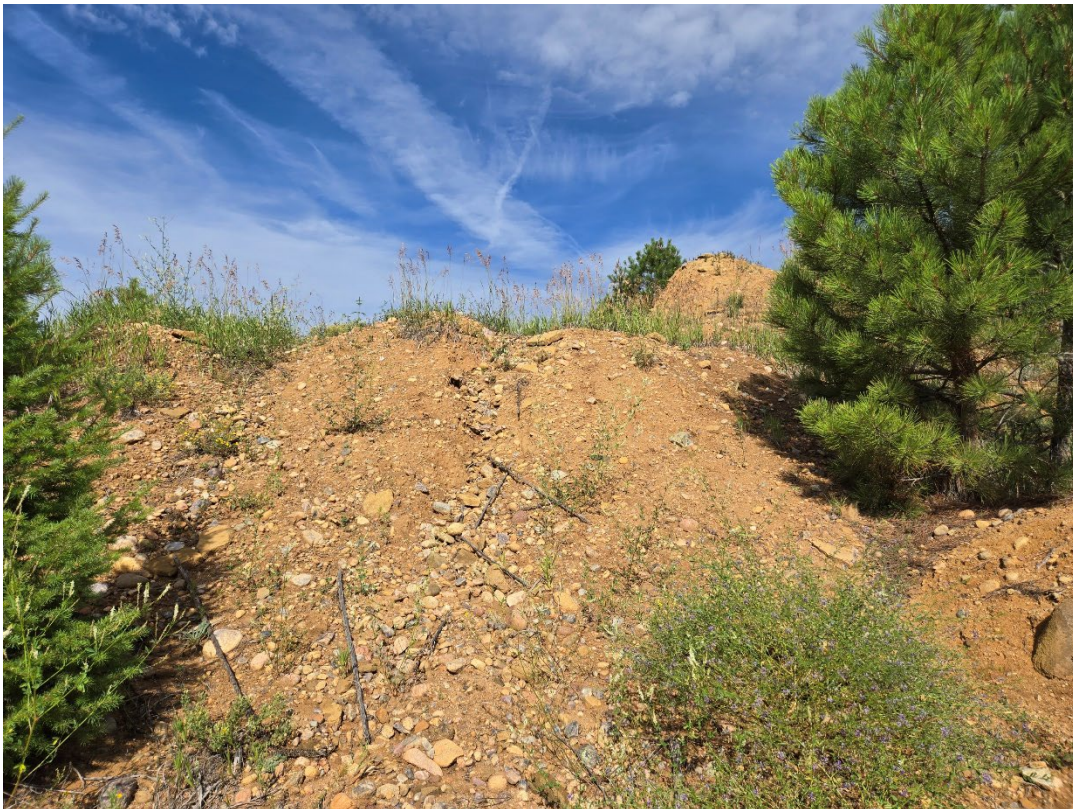
Photo 16: Material pile that may be used to fill erosional cuts.

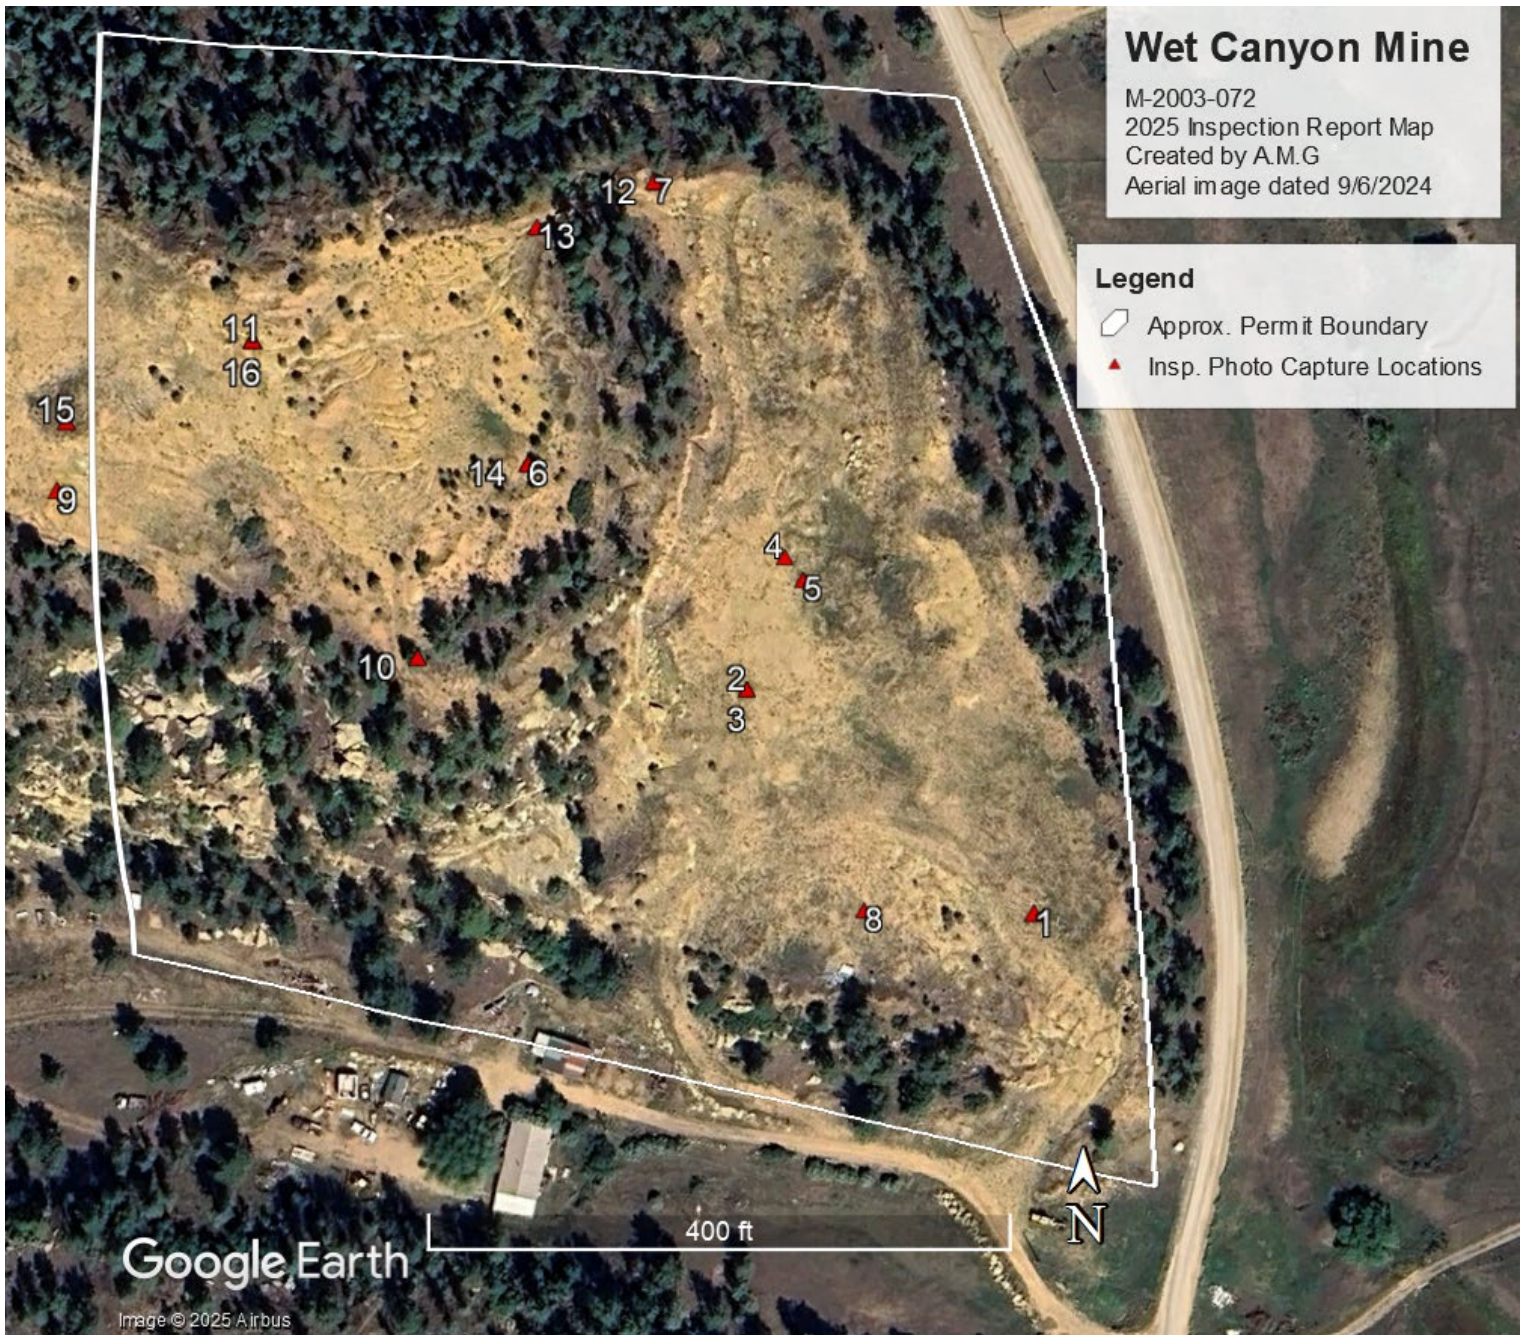
Map 1: Inspection Report Map generated using Google Earth Pro. The labels for the inspection photo capture locations correspond with the inspection photo captions within this report.
