Gold Hill Mill
Tailings Storage Facility Evaluation
August 2025

RE: Geophysical Letter Report | Project # 250174
Gold Hill Mill Tailings Pond Liner Integrity Investigation

Gold Hill Mill Tailings Pond Liner Integrity Investigation: ERT 2D Models <i>Gold Hill, CO</i>		
 COLLIER GEOPHYSICS	Colorado Milling Company, LLC	
	Project #: 250174	Figure A-1
Drafted by: D. Lipert Reviewed by: R. Bowling July 2025

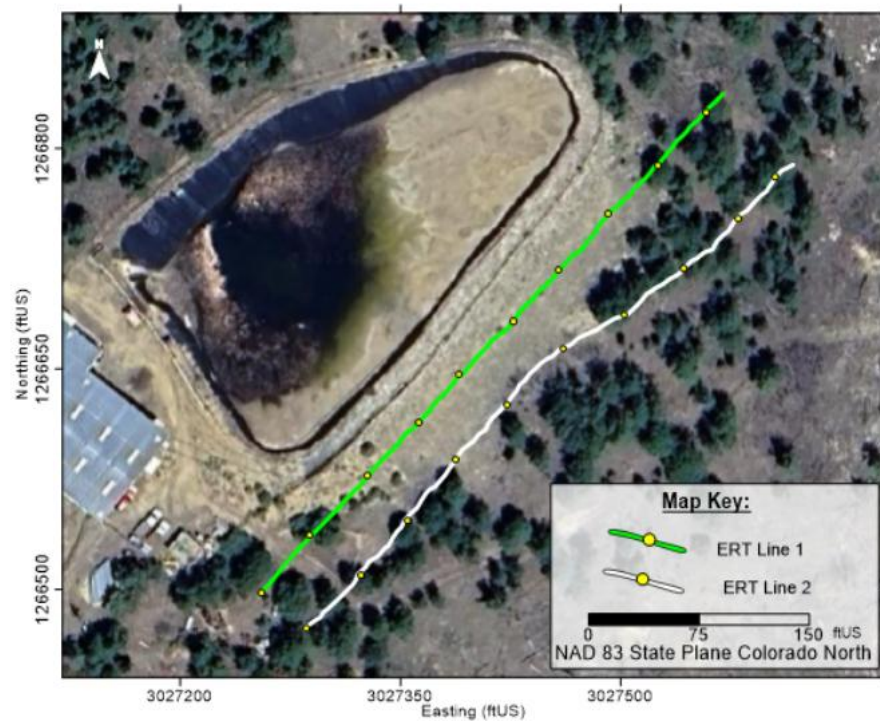
Figure 2. Shows the Tailings Pond at the Gold Hill Mill site with the locations of the two electrical resistivity lines collected on July 8th, 2025.

At the request of Colorado Milling Company, LLC, Collier Geophysics LLC (Collier) conducted an Electrical Resistivity Tomography (ERT) survey at a Tailings Storage Facility (TSF) at the Gold Hill Mill located approximately 7.5 miles west of Boulder, Colorado (**Figure 1**). The survey's objective is to conduct a geophysical investigation into the geosynthetic liner's integrity to identify any anomalous zones that may indicate subsurface water flow from a potential liner leak. There was no observed surface seepage reported before or during the time of data acquisition. On July 8th, 2025, Collier Geophysicist Kassidy Page collected two (2) 450-foot ERT survey lines on the downgradient side of the TSF (**Figure 2**).

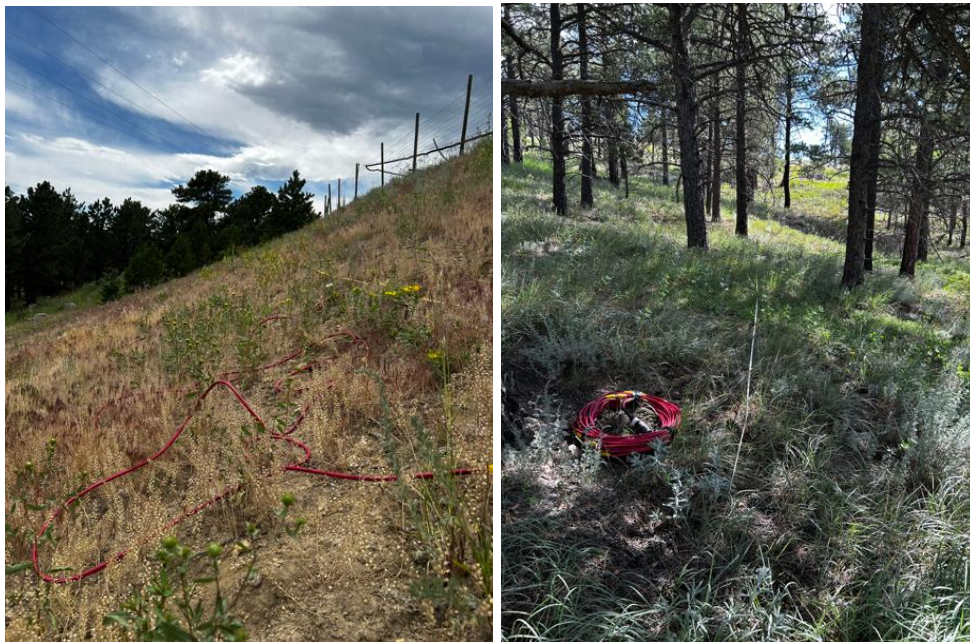
Figure 3. Image on the left shows the surface condition for ERT Line 1. Image on the right shows the conditions for ERT Line 2.

The geologic setting of TSF at the Gold Hill Mill is located on the Idaho Springs Formation schist and gneiss, as well as Boulder Creek Granite. The site featured a mix of forested areas and open, grass-covered embankments (**Figure 3**). During data collection weather was sunny and partly cloudy with temperatures around 80 degrees Fahrenheit, conducive to data collection.

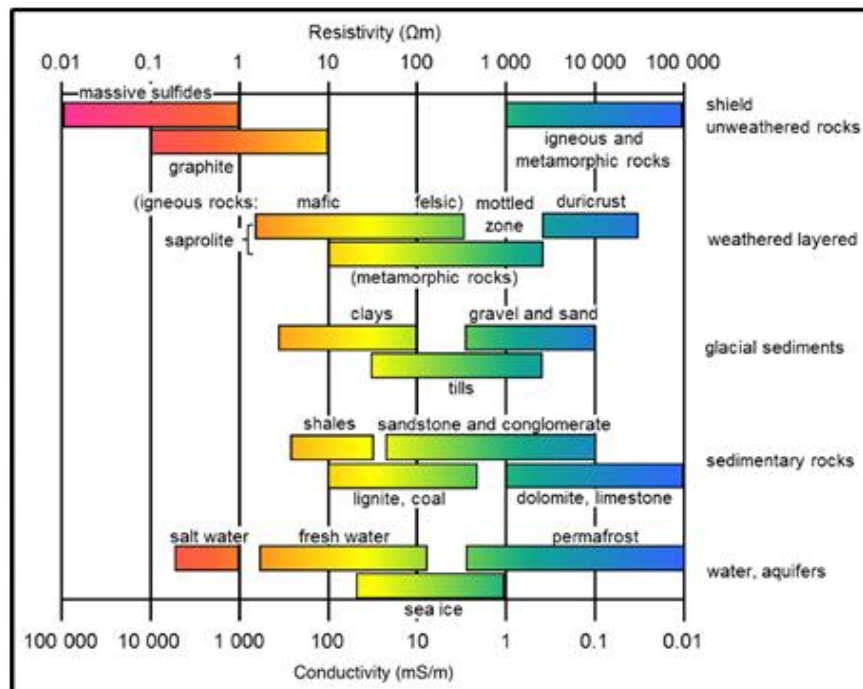
Figure 6. The range of possible resistivity values for various earth materials.

Electrical resistivity (the reciprocal of conductivity) is a physical property which is diagnostic of the type of geologic material present. Unsaturated soils have higher resistivity (lower conductivity) than saturated soils. Coarse-grained soils with minimal fines content have higher resistivities than soil with high fines content. Sandstone, limestone, and granite typically have higher resistivity values than shale and siltstone (**Figure 6**).
