### MINERALS PROGRAM INSPECTION REPORT

| <b>MINE NAME:</b><br>Brighton Mine | <b>MINE/PROSPECTING ID#:</b><br>M-1977-436 | <b>MINERAL:</b><br>Sand and gravel | <b>COUNTY:</b><br>Adams |
| <b>INSPECTION TYPE:</b><br>Surety-Related Inspection | <b>WEATHER:</b> Clear | <b>INSP. DATE:</b><br>September 2, 2025 | <b>INSP. TIME:</b><br>10:00 |
| <b>REASON FOR INSPECTION:</b><br>Partial Acreage Release AR2 | <b>BOND CALCULATION TYPE:</b><br>None | <b>BOND AMOUNT:</b><br>\$150,000.00 | |

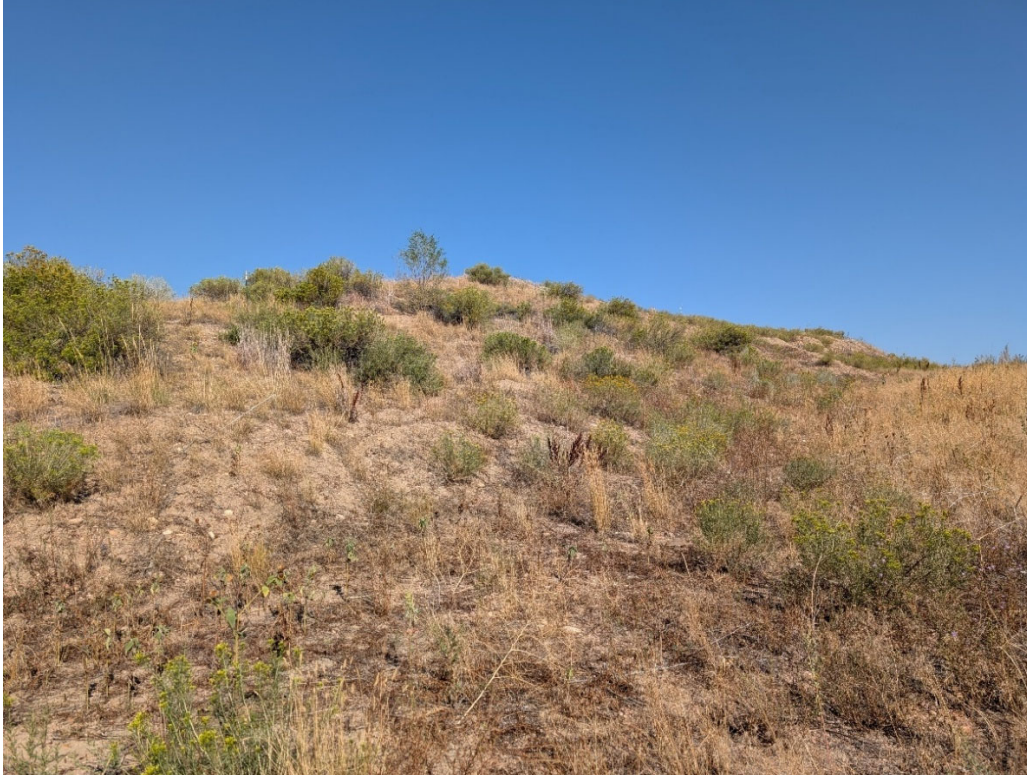
Photo 1: Looking at vegetation established on the southeast side of the large stockpile on the City of Thornton property.

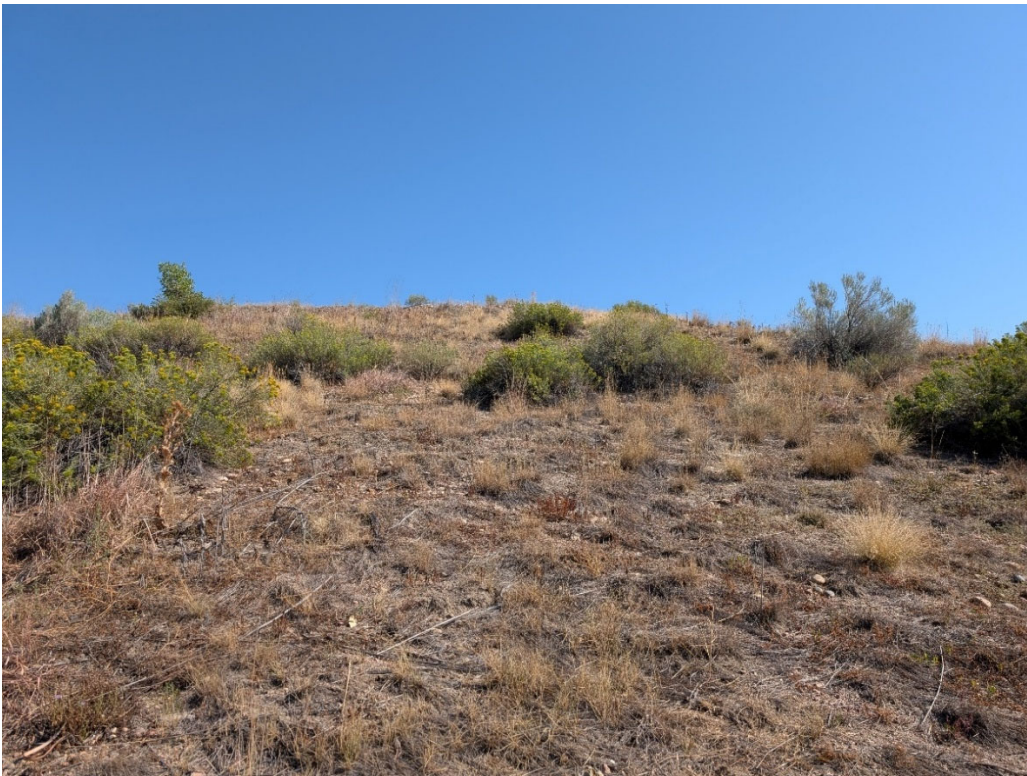
Photo 2: Looking at vegetation on the south side of the large stockpile on the City of Thornton property.

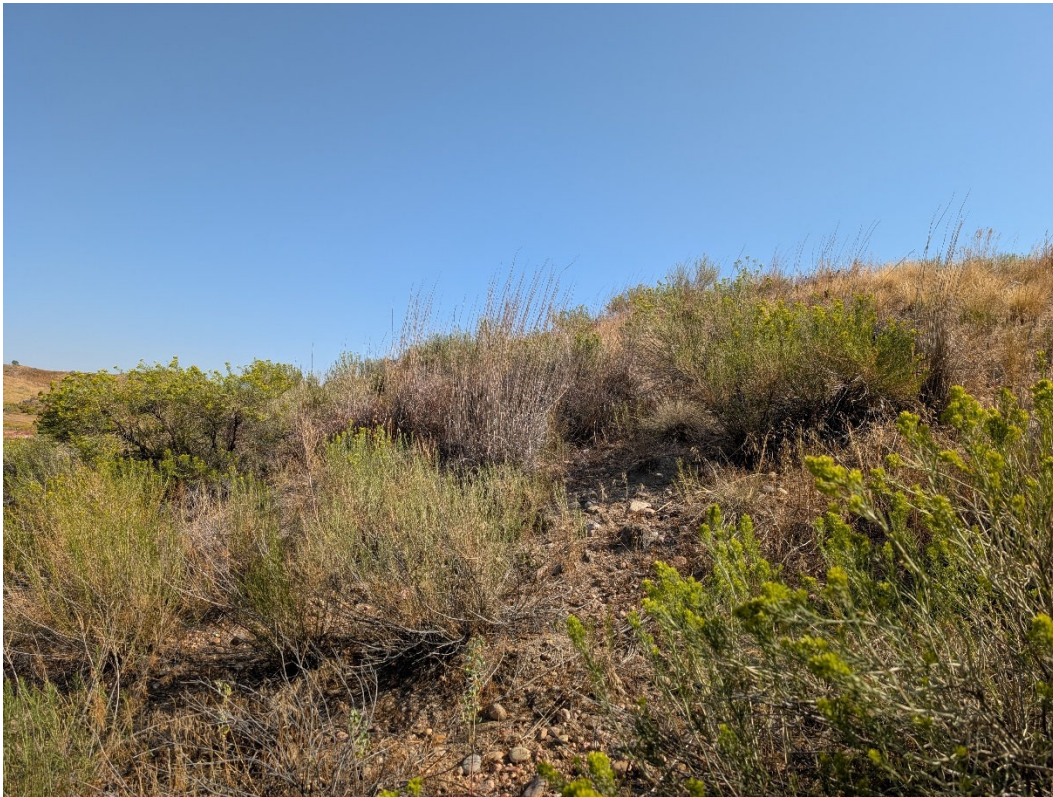
Photo 3: Shrubs observed growing on the west side of the large stockpile.

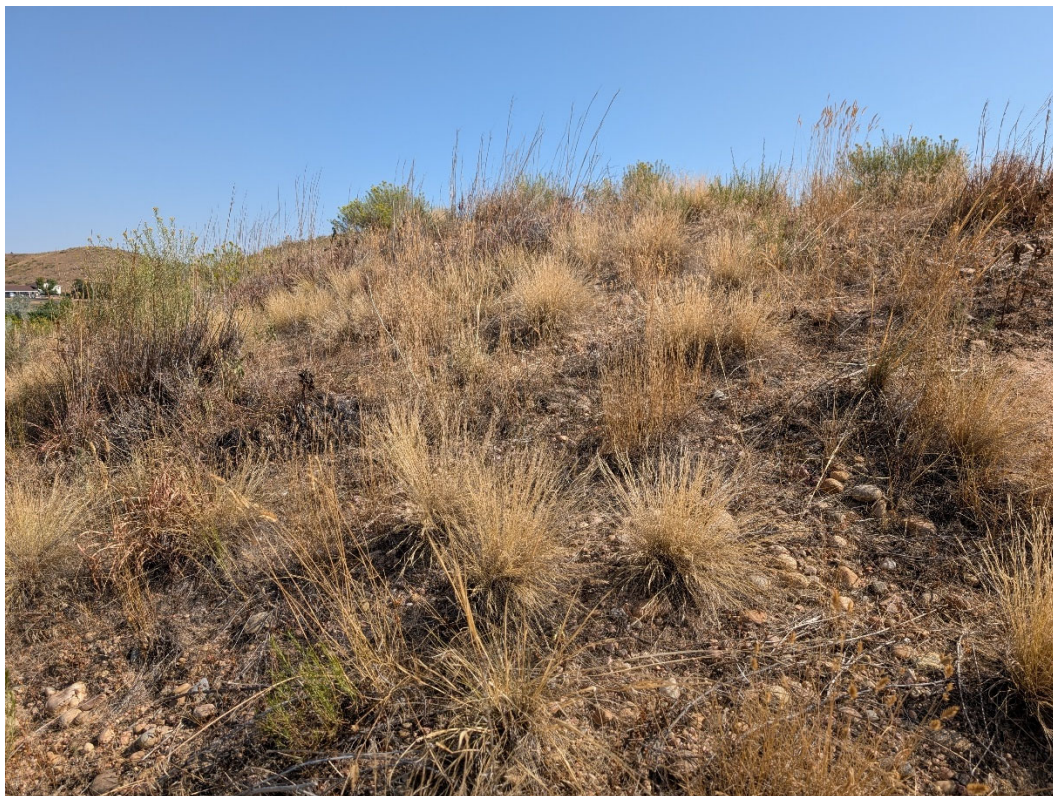
Photo 4: Closeup of bunch grasses established on the western slope of the stockpile.

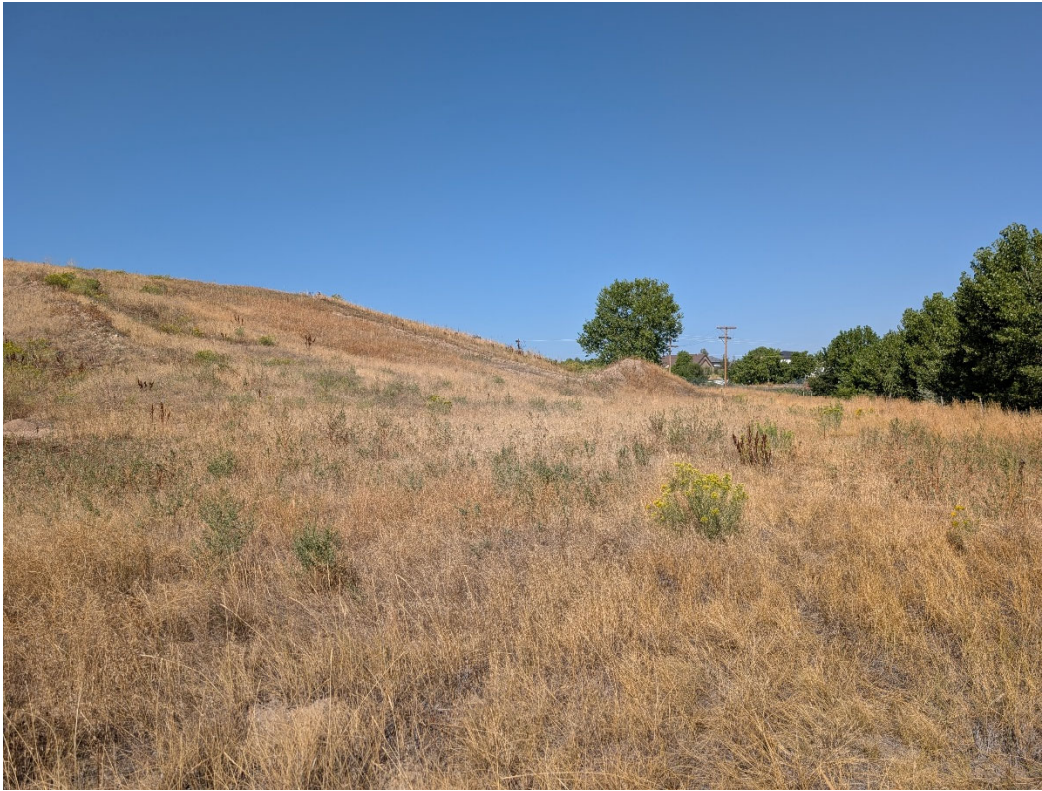
Photo 5: Looking at the northeast corner of the large stockpile adjacent to the south pond. Grasses and annual weeds observed on the slopes.

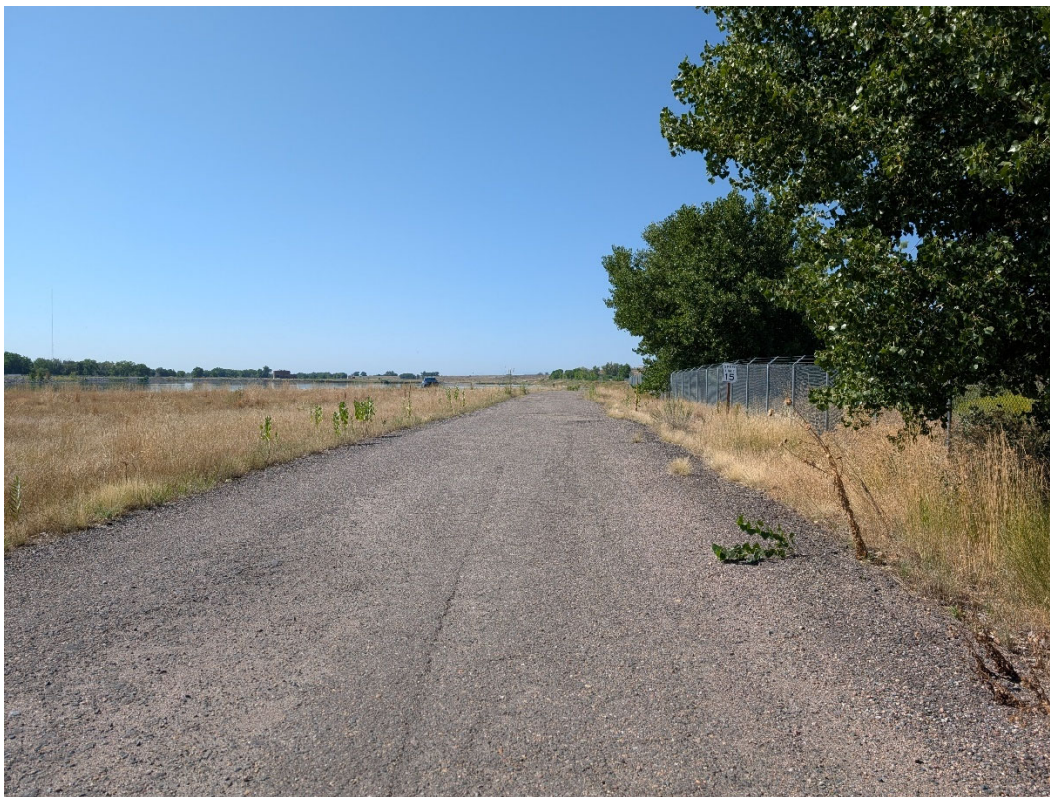
Photo 6: Looking south at the graveled access road adjacent to the central pond on the City of Thornton property.

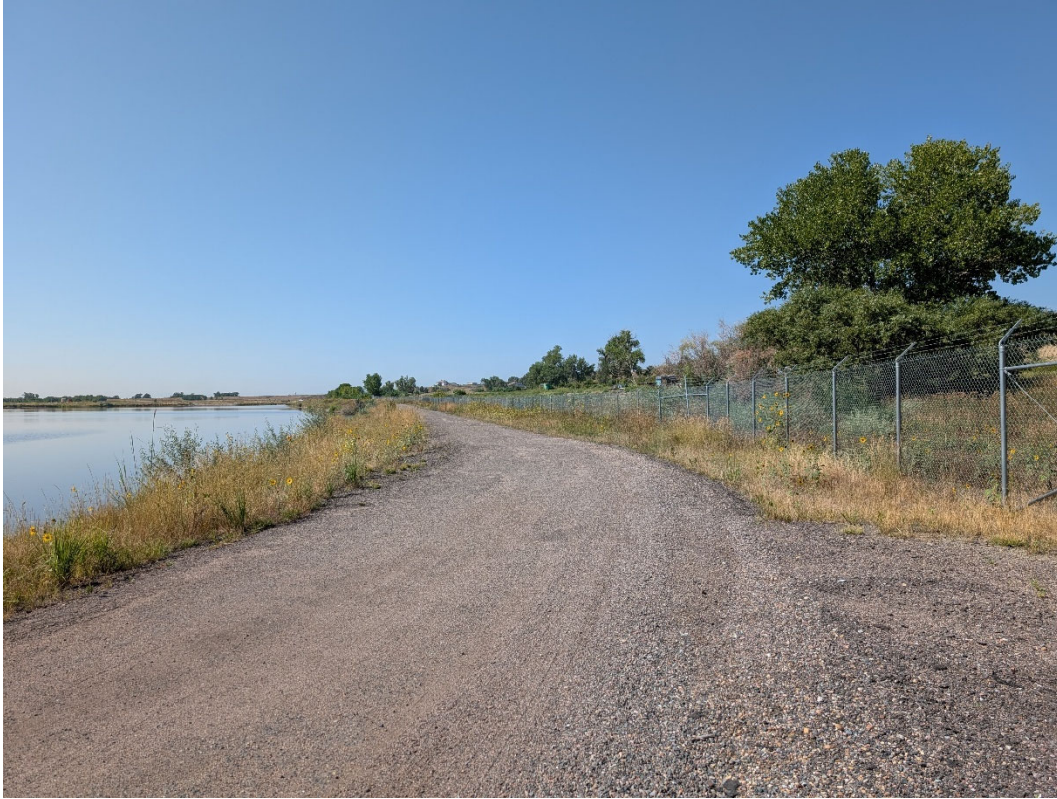
Photo 7: Looking south down the graveled access road adjacent to the south pond on the City of Thornton property.

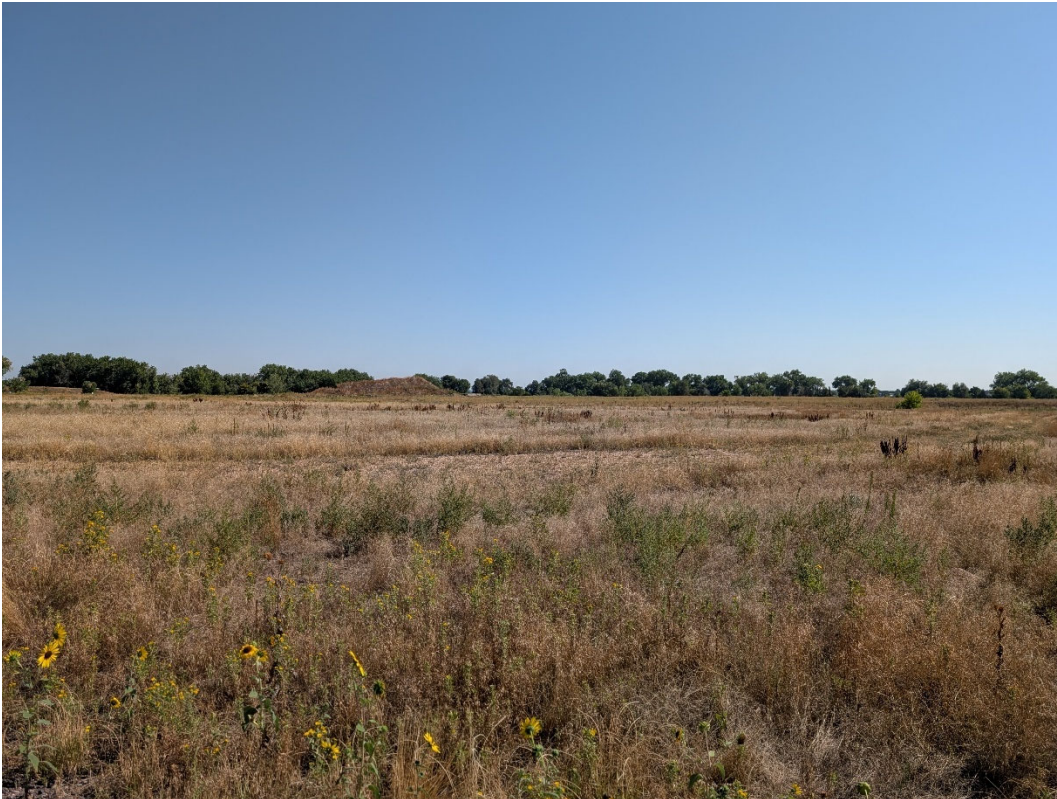
The Division observed dense grasses, forbs, sunflowers and annual weeds on the south and east sides of the northern parcel. In the backfilled pond area, annual weeds (russian thistle, yellow sweet clover) and sunflowers are the dominate species, interspersed with a few grass species. Bare ground was noted near the entrance to the site and along the interior haul road.

Photo 8: Looking northeast across the northern pond area from the southwest corner. Native grasses and annual weeds and sunflowers observed here.

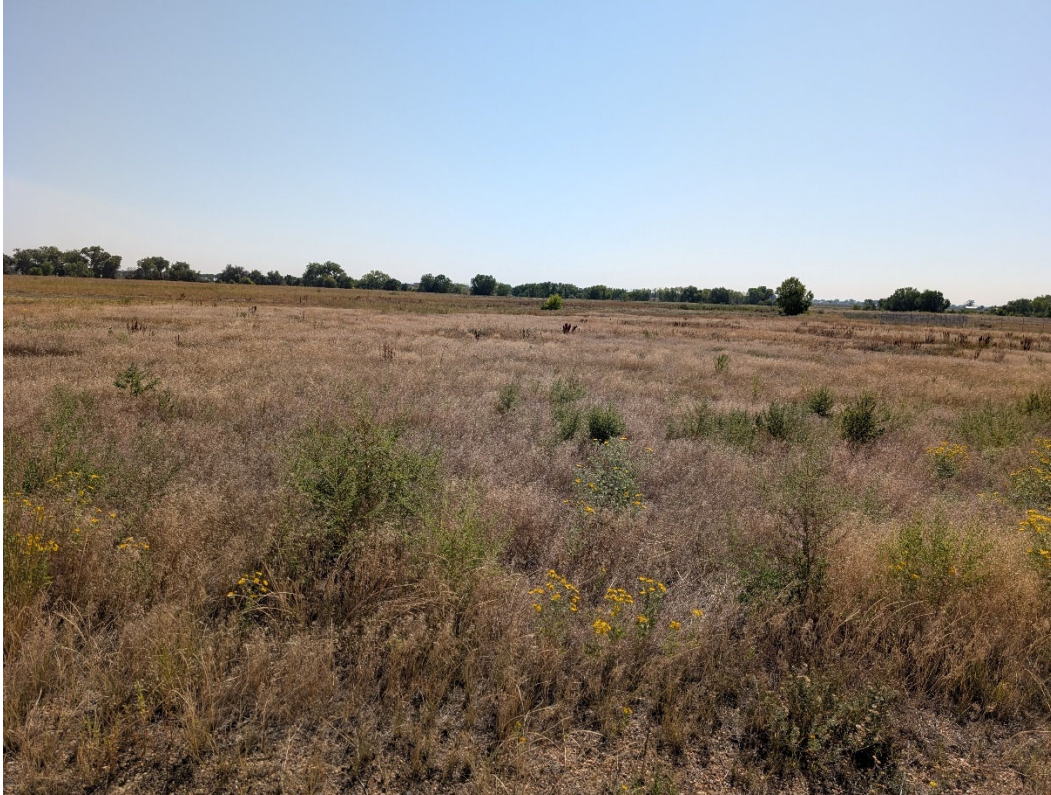
Photo 9: Looking east across the southern end of the north pond area. Native grasses, annual weeds and sunflowers observed.

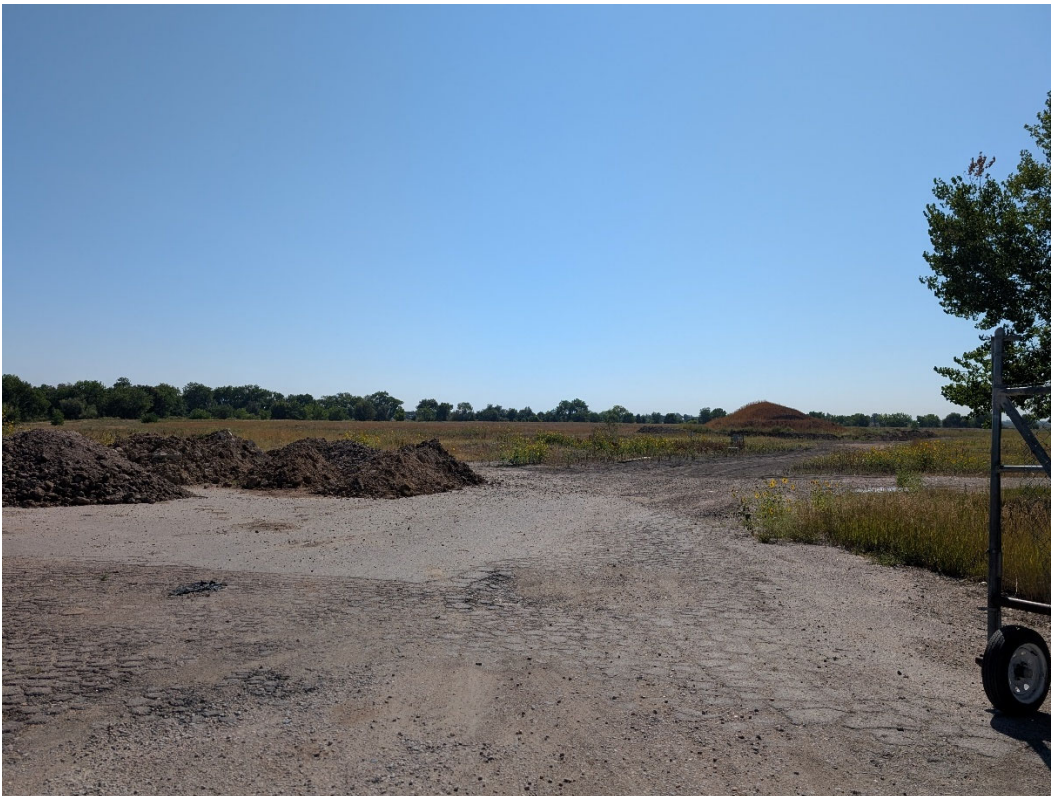
No mining or reclamation activity was occurring during this inspection. The north area has been backfilled and graded to relatively level. The operator stated that topsoil has been replaced on the graded areas. A large stockpile of mined material remains in the center of the north area. Concrete blocks from the truck scale are stored on east side of the stockpile. An excavator was observed next to some smaller stockpiles of material stored near the entrance to the mine. The smaller stockpiles are not vegetated, indicating the piles were placed there recently.

Photo 10: Small stockpiles of material stored at the entrance to the mine site.

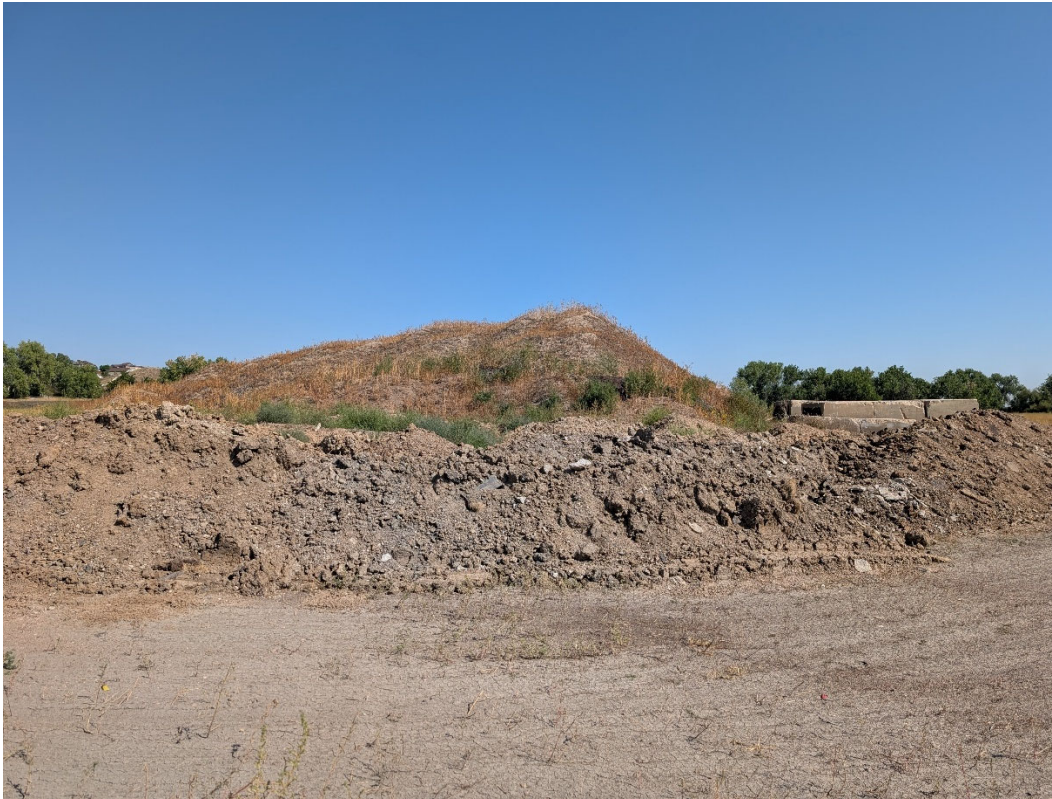
Based on the approved reclamation plan, the operator has not completed grading of the north reservoir area consistent with the contours in the approved reclamation plan. Additionally, it appears reclamation has stalled, and little has changed at the site since the last inspection in 2022. The current reclamation plan needs to be updated and clarified pursuant to C.R.S. 34-32.5-116 (1) and Rule 6.4.5 - Exhibit E. **As stated in Problem #1 above, by the corrective action date, the operator shall submit a Technical Revision, with the required \$216 revision fee, to update and clarify the current approved reclamation plan (Exhibit E) in accordance with Rule 6.4.5 to reflect existing and proposed activities. Additionally, per Rule 6.4.5(d), the updated plan shall include a schedule indicating how and when reclamation will be implemented.**

Photo 11: Large stockpile of material located in in the center of the mining area. Concrete blocks stored on the east side of the pile.

**CORRECTIVE ACTIONS:** The operator must follow the approved reclamation plan or provide sufficient information to describe or identify how the operator intends to conduct reclamation. The operator shall submit a Technical Revision, with the required \$216 revision fee, to update and clarify the current approved reclamation plan for the north pond area to reflect existing and proposed activities by the corrective action date and submit a schedule for completing the reclamation tasks, grading, topsoiling and seeding in the north pond area.

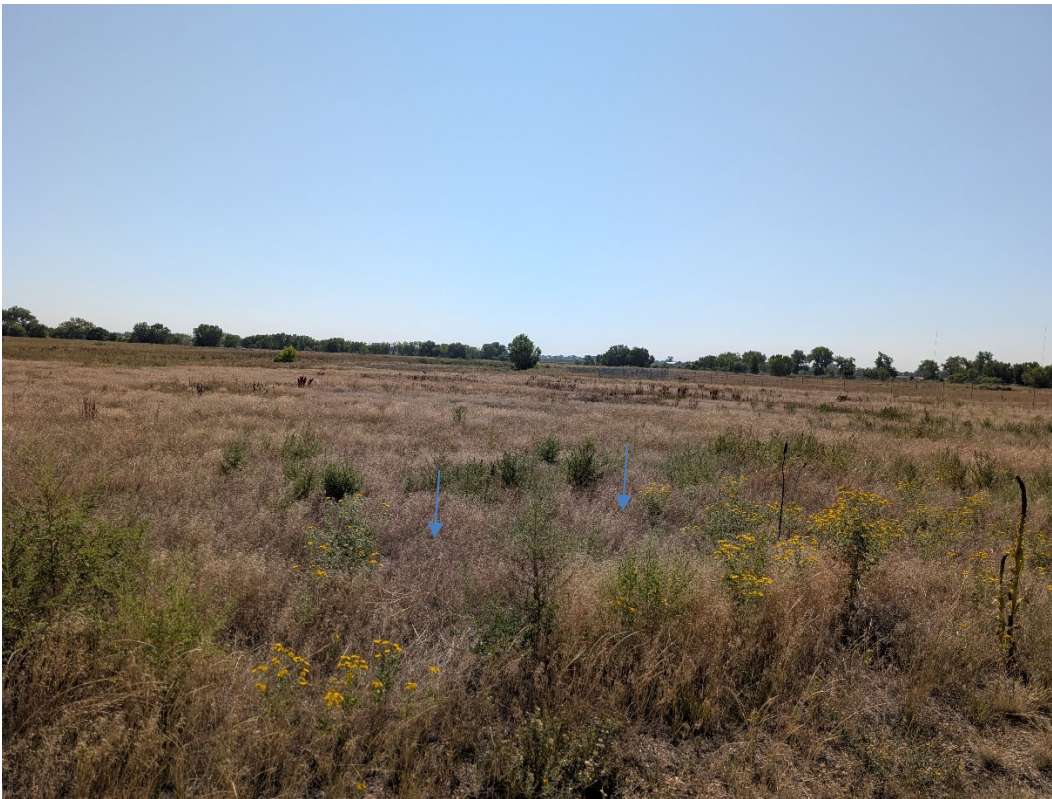
**PROBLEM 2:** The Division observed state-listed noxious weeds present on site. This is a problem for failure to employ weed control methods for state listed noxious weed species within the permitted area, and to reduce the spread of weeds to nearby areas as required by Section 3.1.10 (6) of the rule.

During the inspection, the Division observed patches of common mullein along the access road, and downy brome (cheat grass) and thistle plants interspersed with the grasses. **As stated in Problem #2 above, the operator should weed control in accordance with the approved weed plan and submit photo evidence to the Division that this has been completed**

Photo 12: Downy brome (blue arrows) and thistles (red arrows) observed in the north area.

**CORRECTIVE ACTIONS:** Implement approved weed control plan and provide proof to the Division by the corrective action date that this has been done. Evidence of completing weed control may be in the form of photographs showing dead plants after treatment or a receipt from a contractor for weed control.

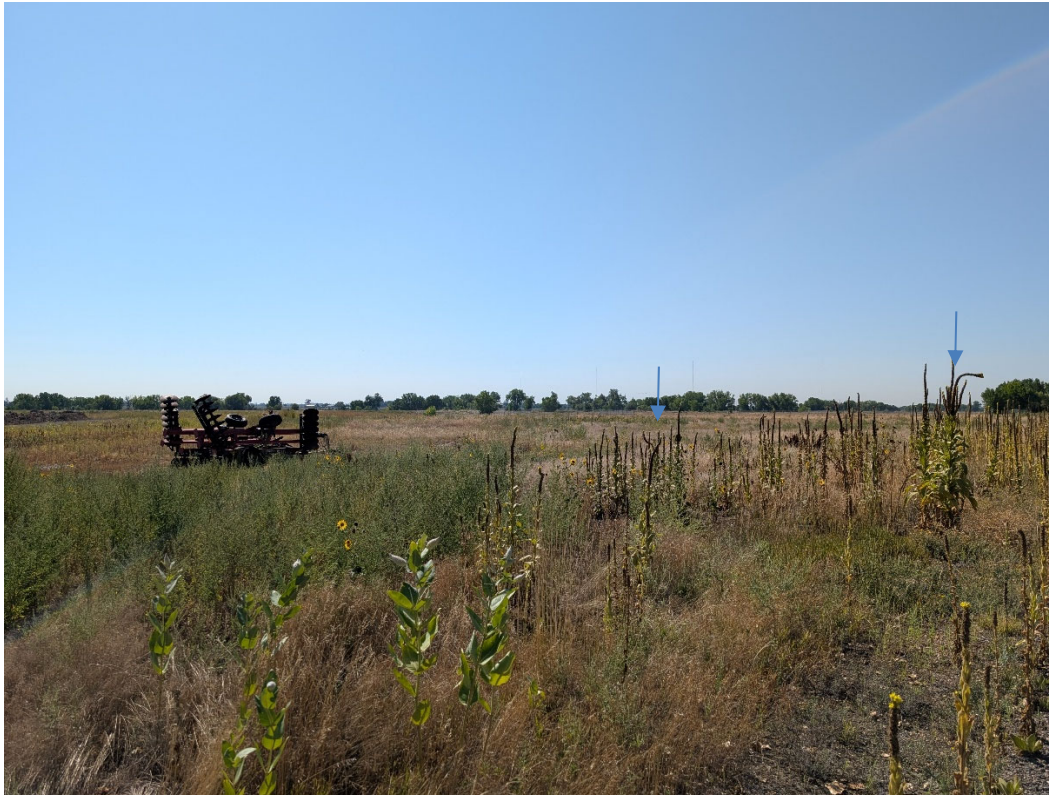
Photo 13: Common mullein observed in the north pond area, adjacent to the access road.

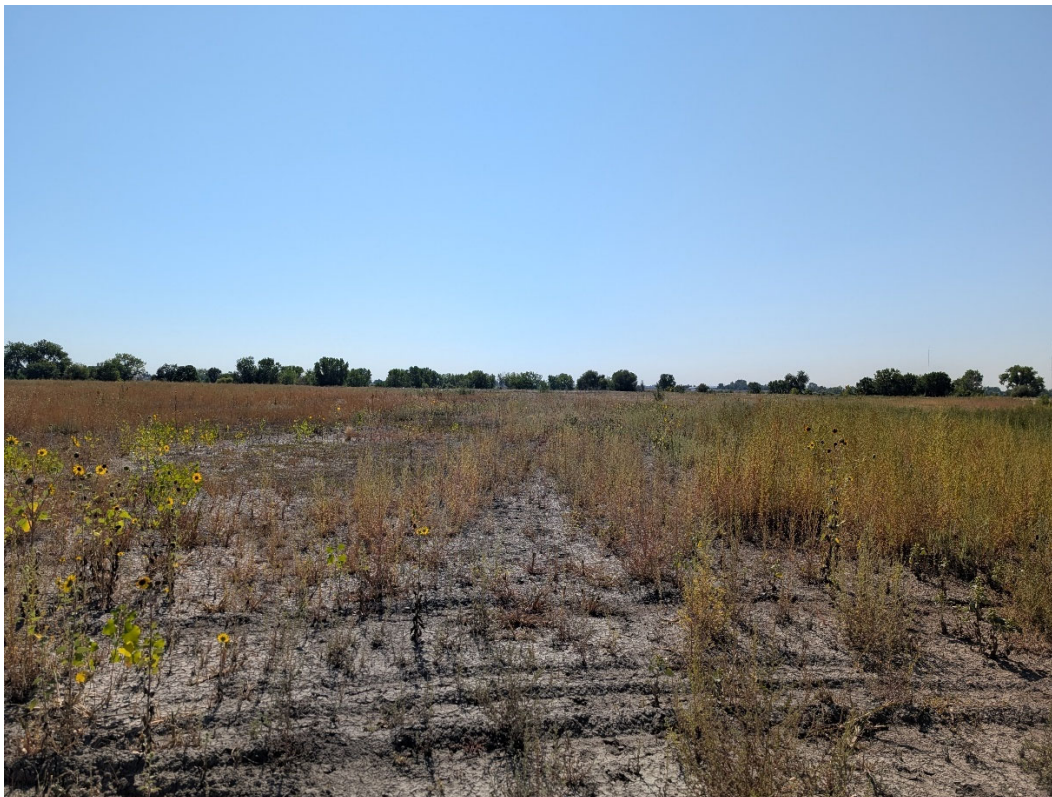
Photo 14: Annual weeds and sunflowers are the dominate vegetation in the backfilled portion of the north area.

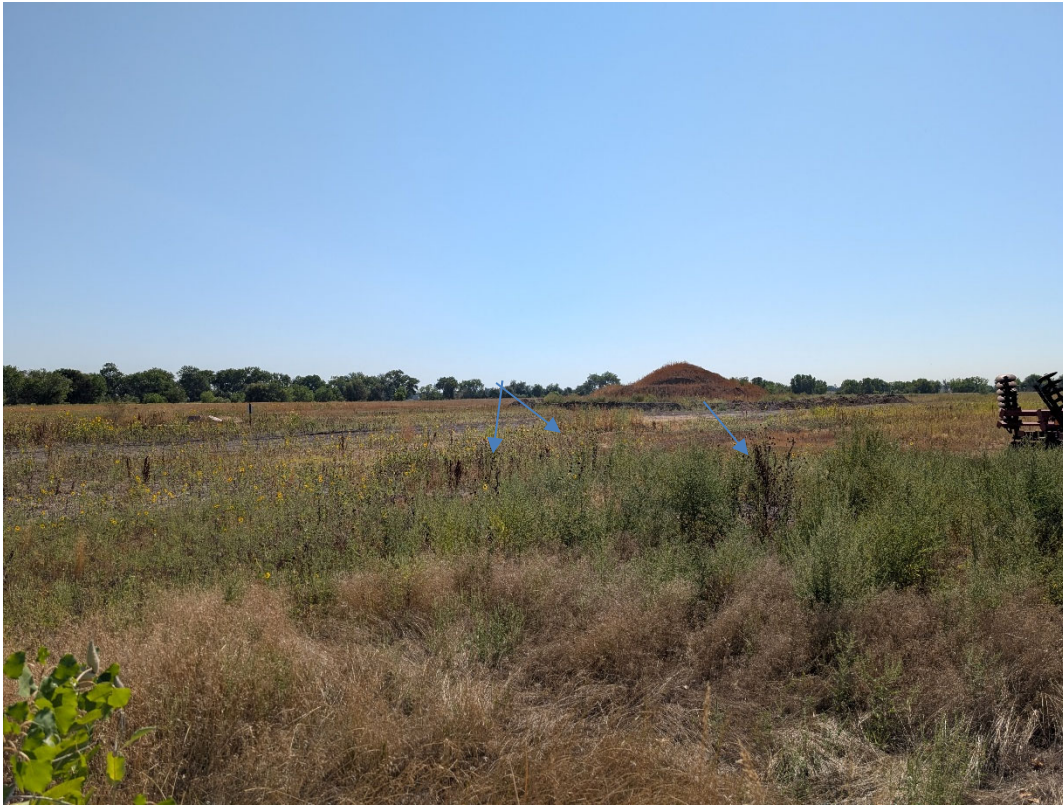
Photo 14: An area of thistle plants observed near the entrance.

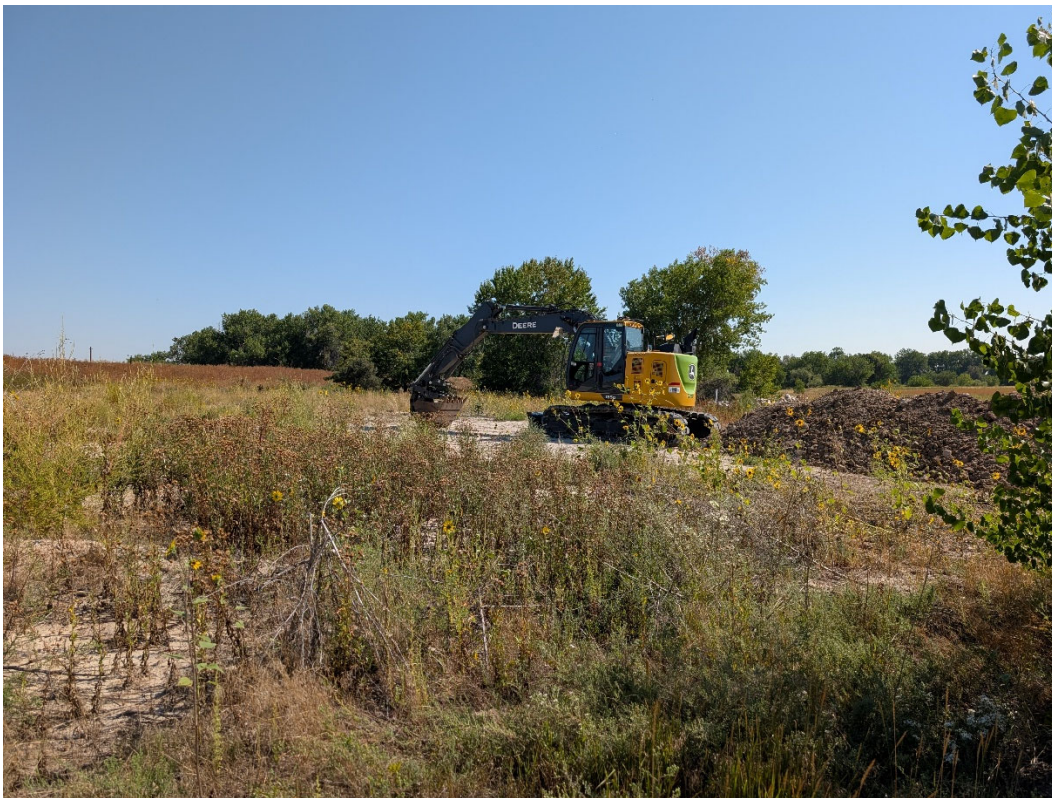
Photo 15: An excavator near the entrance next to some small stockpiles of material.

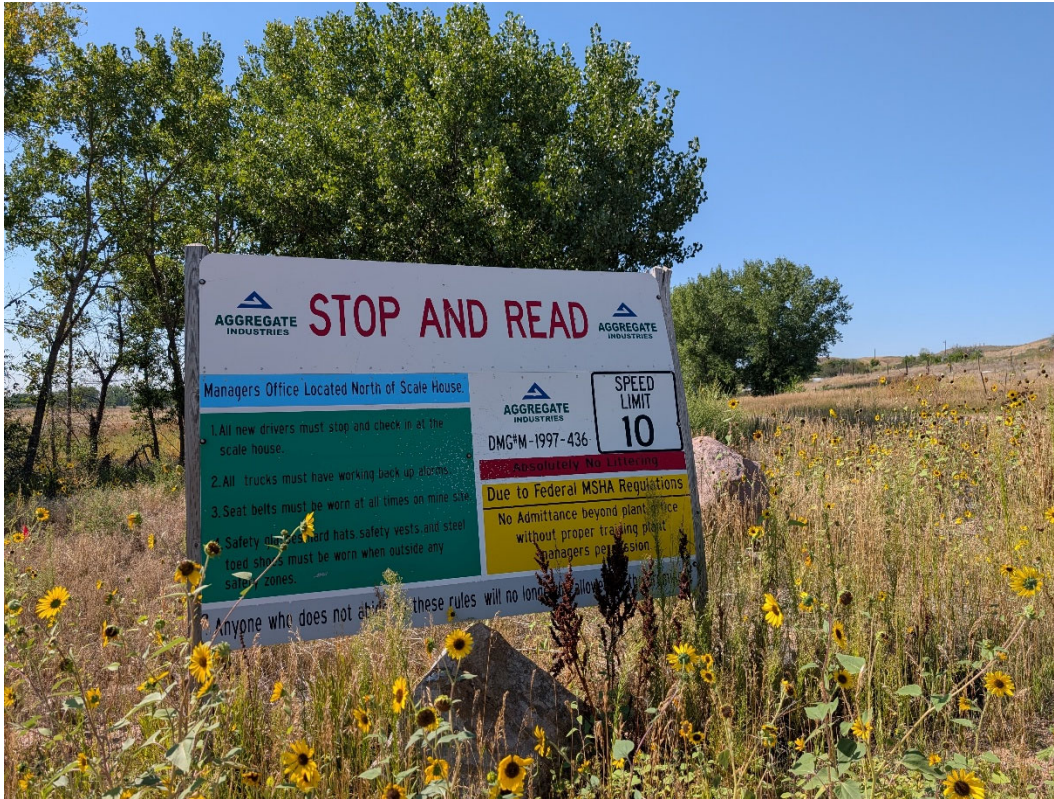
**PROBLEM 3:** The permit sign was posted at the entrance to the site as required by Rule 3.1.12(1). The sign has the permit number and the name of the former operator. Pursuant to Rule 3.1.12(1)(a) and (b) the sign should list the current operator and include a statement that a reclamation permit for the operation has been issued by the Colorado Mined Land Reclamation Board.

The permit sign was posted at the entrance to the site as required by Rule 3.1.12(1). The sign has the permit number and name of the previous operator. Per Rule 3.1.12(1)(a)(b) the sign should list the current operator and include the statement that "a reclamation permit for the operation has been issued by the Colorado Mined Land Reclamation Board." **As stated in Problem #3 above, the operator will need to install a new sign that meets all the requirements of the rule and submit evidence to the Division of the sign in place.**

Photo 15: Mine sign posted at the entrance to the site listing the former operator. The sign should list the current operator and include a statement that a reclamation permit for the operation has been issued by the Colorado Mined Land Reclamation Board.

**CORRECTIVE ACTIONS:** The operator will need to install a new mine sign at the entrance to the site that meets the requirements of Rule 3.1.12(1) and submit evidence of the sign in place to the Division.

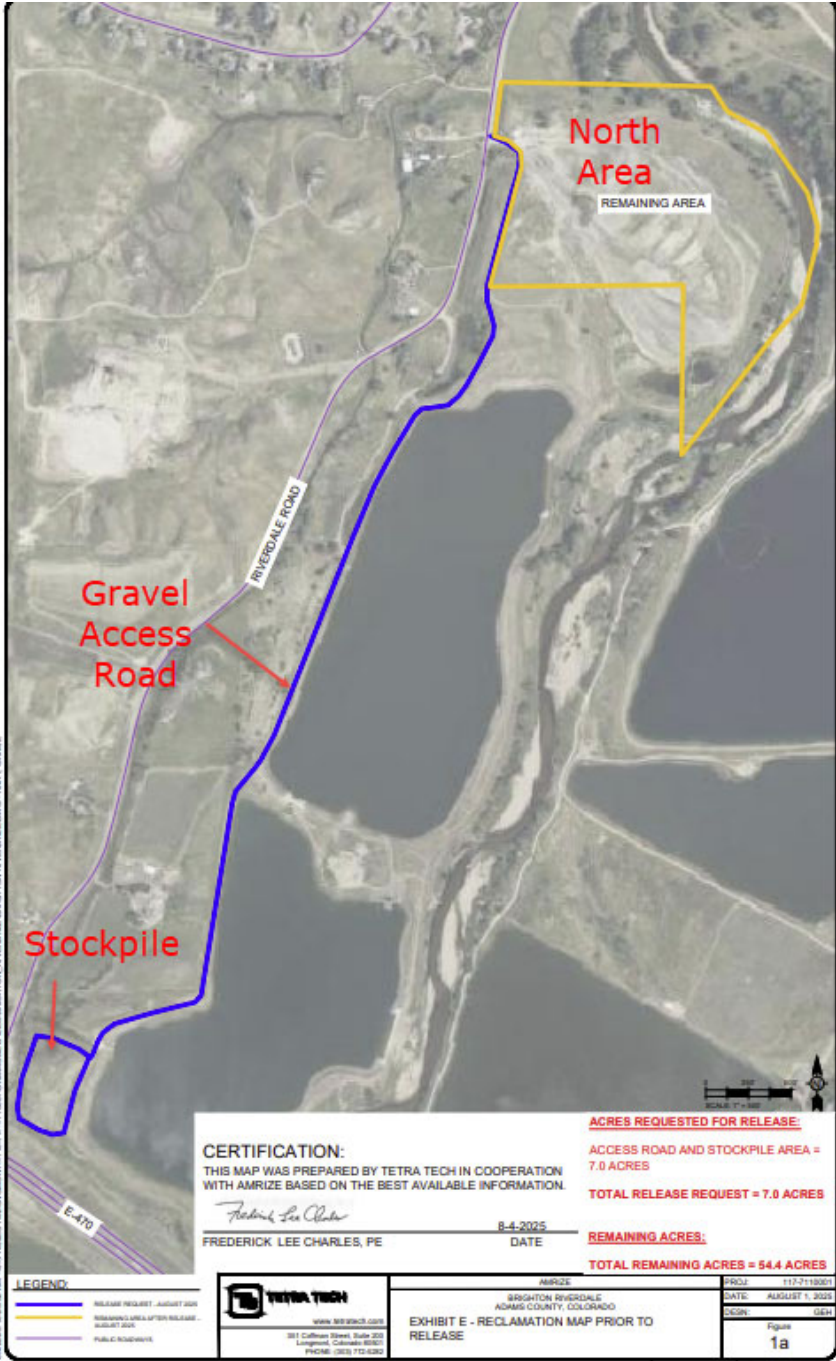
The operator submitted an acreage release for 7.0 acres which includes the access road and large stockpile adjacent to the South reservoir. The access road and the stockpile are on land owned by the City of Thornton. On July 17, 2025, the City sent a letter to the Division (enclosed), indicating that they do not object to the operator leaving the stockpile in the place for Thornton's future use. During this inspection the Division observed the stockpile in the southwest corner of the permit area. The stockpile is stable and no erosion rills or gullies were observed. Shrubs, primarily rabbitbrush and sage, were observed on the south and west sides along with native grasses. Annual weeds interspersed with grasses cover the east and north sides. Vegetation on the slopes is sufficient to control erosion and meets the requirements of Rule 3.1.6(3).

Figure 1: Map of the 7.0 acre stockpile and access road to be released, and the north area remaining in the permit.
