**MINERALS PROGRAM INSPECTION REPORT**  
**PHONE: (303) 866-3567**

<b>MINE NAME:</b> Rowe Gravel	<b>MINE/PROSPECTING ID#:</b> M-1999-038	<b>MINERAL:</b> Sand and gravel	<b>COUNTY:</b> La Plata
<b>INSPECTION TYPE:</b> Monitoring	<b>WEATHER:</b> Clear	<b>INSP. DATE:</b> September 3, 2025	<b>INSP. TIME:</b> 10:50
<b>OPERATOR:</b> Rowe Gravel	<b>OPERATOR REPRESENTATIVE:</b> Brad Rowe	<b>TYPE OF OPERATION:</b> 110c - Construction Limited Impact	
<b>REASON FOR INSPECTION:</b> Normal I&E Program	<b>BOND CALCULATION TYPE:</b> Complete Bond	<b>BOND AMOUNT:</b> \$6,686.00	
<b>DATE OF COMPLAINT:</b> NA	<b>POST INSP. CONTACTS:</b> None	<b>JOINT INSP. AGENCY:</b> None	
<b>INSPECTOR(S):</b> Dustin Czapla	<b>INSPECTOR'S SIGNATURE:</b>

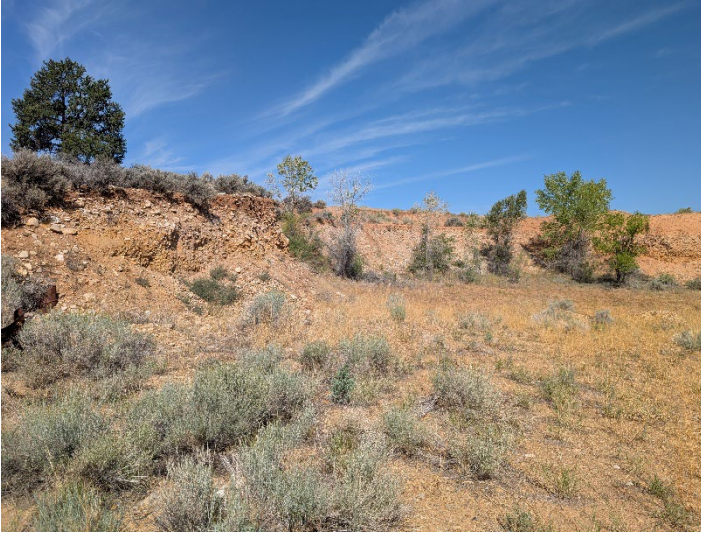
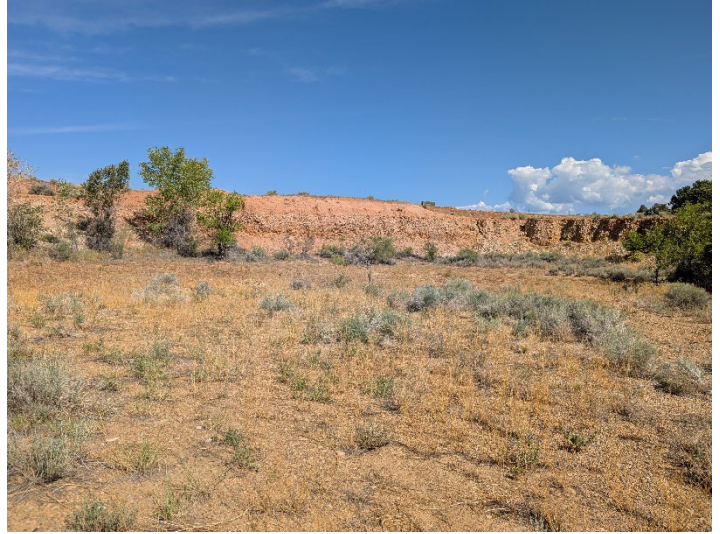
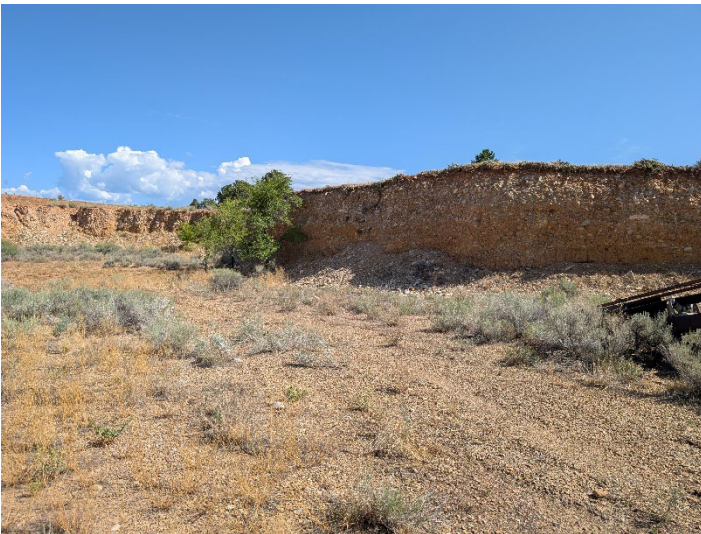
The disturbed mining area includes approximately 1.25 acres. A pit has been excavated to a depth of approximately 25 feet. The pit daylights on the south side. The highwall is near vertical around most of the pit, with sloughed material at the base of the highwall in spots. Vegetation is well established on the pit floor. Several pieces of old mining equipment are stored within the pit. No stockpiles of materials were observed within the pit.

No stability or erosional concerns were noted.
