**MINERALS PROGRAM INSPECTION REPORT**  
**PHONE: (303) 866-3567**

| <b>MINE NAME:</b><br>Pig Mesa Pit | <b>MINE/PROSPECTING ID#:</b><br>M-1978-168 | <b>MINERAL:</b><br>Sand and gravel | <b>COUNTY:</b><br>Delta |
| <b>INSPECTION TYPE:</b><br>Monitoring | <b>WEATHER:</b> Clear | <b>INSP. DATE:</b><br>September 3, 2025 | <b>INSP. TIME:</b><br>08:30 |

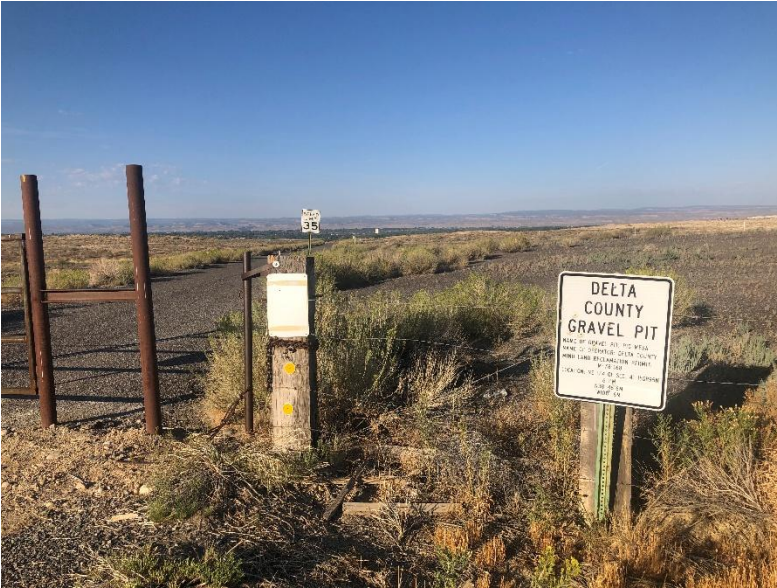
The entrance sign was clearly visible at the entrance to the west pit. It was large enough and contained the necessary information, per Rule 3.1.12(1). However, this sign should be moved to the entrance for the entire site. The affected boundary was not well marked with posts or other markers (as required by Rule 3.1.12(2)) in some areas, including most of the west side of the site.

Sign at gate securing west pit area

**CORRECTIVE ACTIONS:** The operator shall move the sign at the gate to the west pit area to the entrance of the mine site. It must be clearly visible from the access road. The County shall submit photo documentation that the sign has been posted at the proper location by the corrective action date.

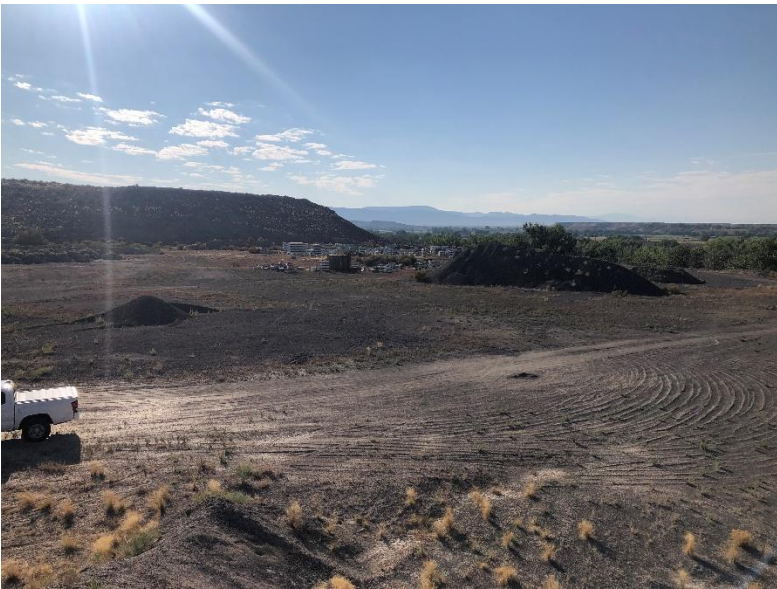
West pit area, with small pile of 3/4" chips on left and plant mix soil on right  
(taken from large sand pile, Pile #10 on map)

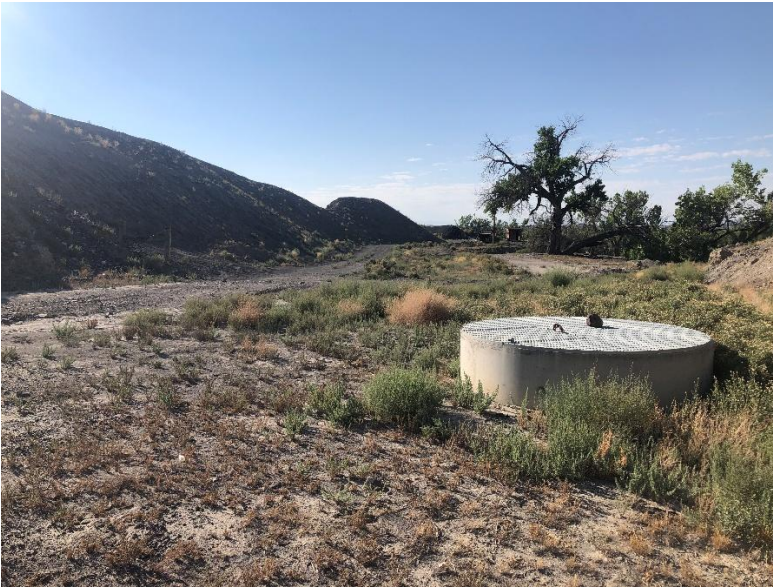
**West side of affected area, with road on left, and irrigation structure for the North Delta Canal**

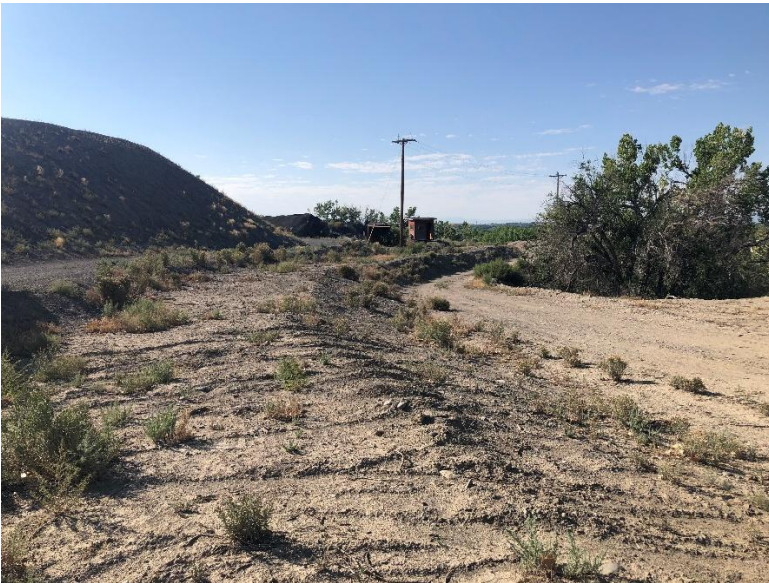
No ditches or ponds were seen. Berms generally prevent runoff to surrounding areas, but improvements are required in three locations: along the west side of the disturbed area, at the southwest corner of the western pit area, and on the south side of the west pit area (where there are Jersey barriers). A CDPS discharge point was seen at the south end of the eastern pit area. There is no indication that the site is causing offsite impacts to surface water hydrology, including Tongue Creek and the North Delta Canal (the receiving waters that are adjacent to the site). On the south side of the site, there is significant disturbance that could impact these waters, but it does not appear to be mining related; it is likely related to construction of the pipeline that carries the canal water around the south side of the site as well as the road adjacent to the pipeline.

**West side of affected area where a berm is needed**

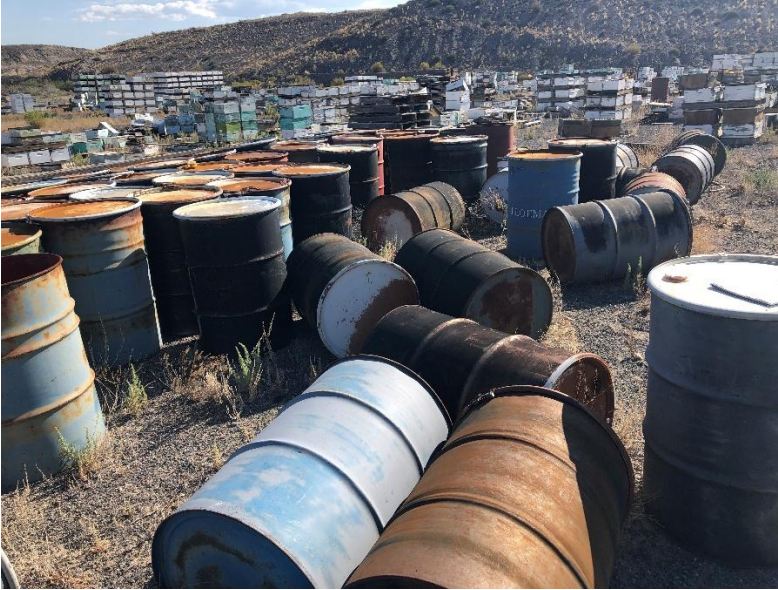
**PROBLEM/POSSIBLE VIOLATION #2:** Trash and refuse was noticed on the site. This is a problem at this time for failure to dispose of refuse in a manner that controls unsightliness or deleterious effects of such refuse pursuant to C.R.S. 34-32.5-116(4)(e).

Many 55-gallon drums, bee boxes, and other materials (some appearing to be trash) were seen on the site, and they appear to be unrelated to mining. No stained soil was seen, and the drums appeared to be empty, but it is necessary that the County perform one of the following: remove the drums and other material from the site (and cease the practice of storing drums and other materials at this site) or include a discussion of the materials to be stored in the mining plan, via a Technical Revision (TR). If the County chooses the latter option, the following must be clearly identified in the mining plan and mining plan map: the storage areas, the types of materials that will be temporarily stored there, and how those areas will be reclaimed.

**55-gallon drums, bee boxes, and other material unrelated to mining operations**

**CORRECTIVE ACTIONS:** The 55-gallon drums and other materials that are stored on the site, and are not related to mining, need to be removed, and the County shall submit a written notice to the Division, with photo documentation, that the trash has been removed from the site by the corrective action date. Alternatively, a TR must be submitted to add a detailed discussion of these materials in the mining plan and mining plan map. The reclamation plan may also need to be revised to address the removal of these materials for reclamation and how the storage area will be reclaimed. This information could be submitted in the same TR required for other problems noted in this report.

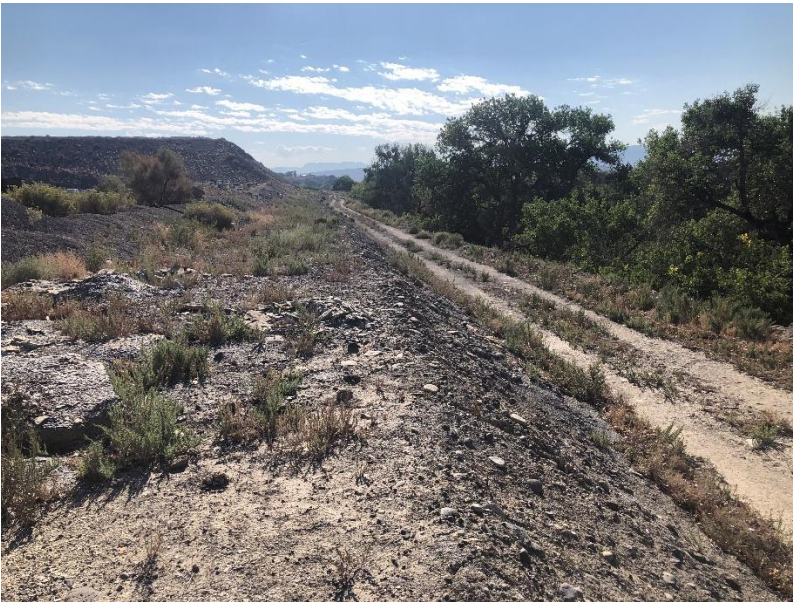
**South end of site near west pit area – North Delta Canal is piped and adjacent to road (looking east)**

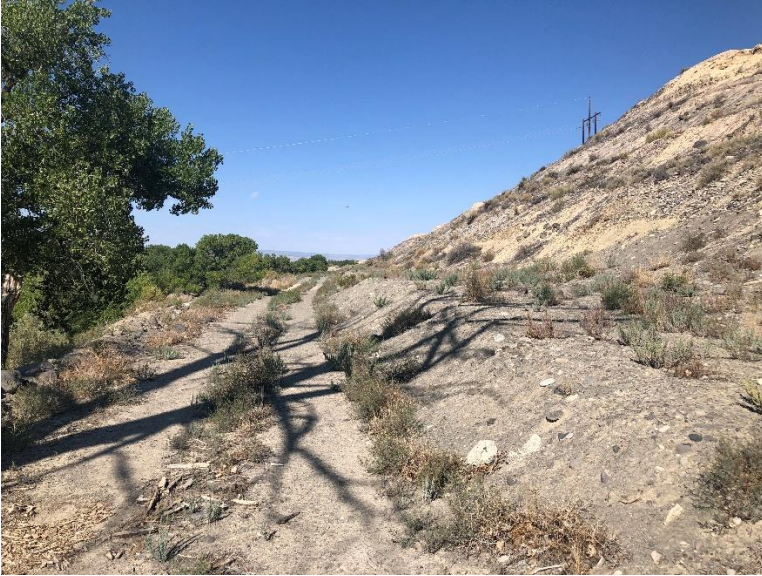
**South end of site near southeast corner – underground pipe is adjacent to road (looking west)**

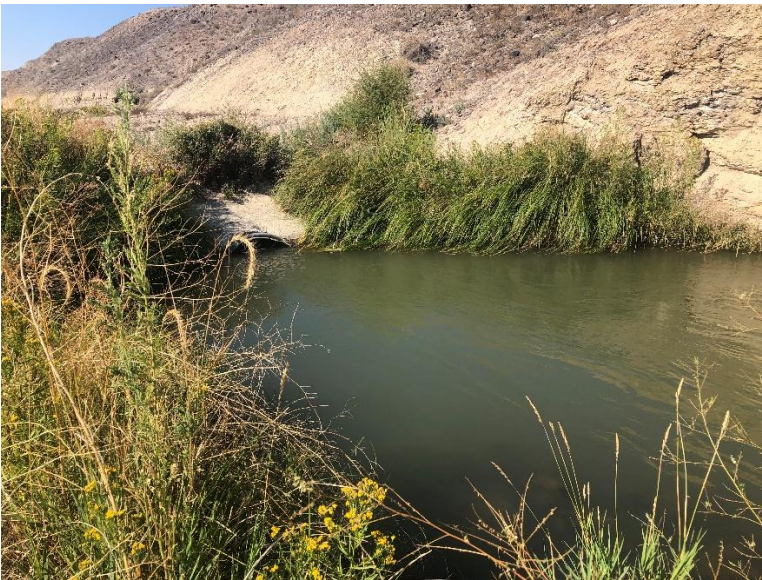
**North Delta Canal on east side at transition from open channel to pipe**

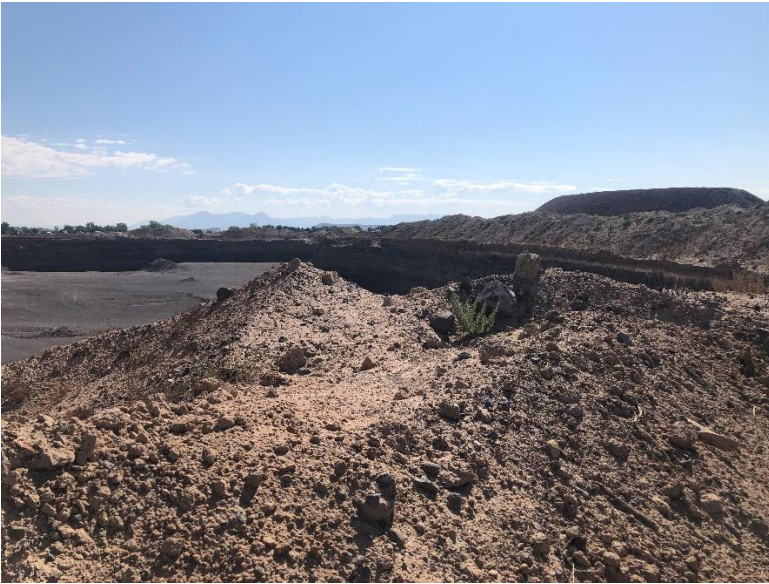
The site includes two mining areas: one near the southwest corner and one near the east end of the site. The depths of the pits are approximately 50 feet (southwest pit) and 30 feet (east pit). North of the east pit, there is a larger pit that is operated by Benson Brothers (Benson Brothers Pig Mesa Pit, M-2004-084). A portion of the Benson Brothers pit has extended into the permit area for the Pig Mesa Pit operated by the County. According to aerial imagery available in Google Earth, this encroachment started sometime between August 2019 and April 2023. This issue will need to be resolved with the other operator. However, if the affected lands are eventually included in another permit, Delta County would need to submit an Acreage Reduction request to remove them from the County's Pig Mesa Pit permit.

**Looking east at Benson Brothers Pit, with County's permit on right**

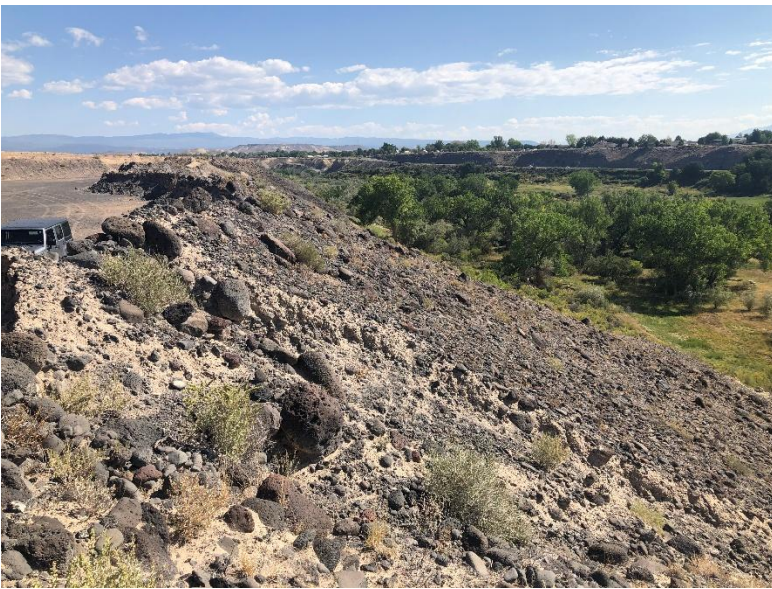
**Berm and slope below the east pit area**

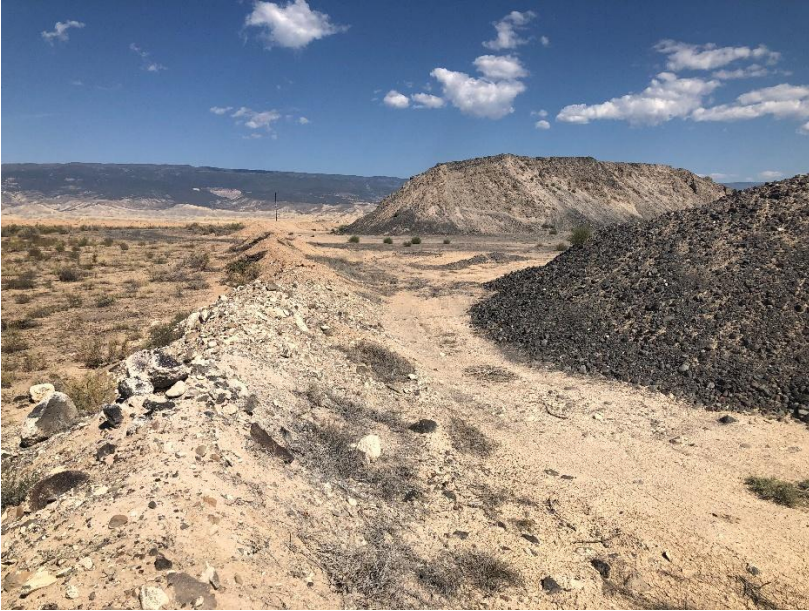
**Area west of east pit, with road base piles (#2 in foreground, #8 in background)**

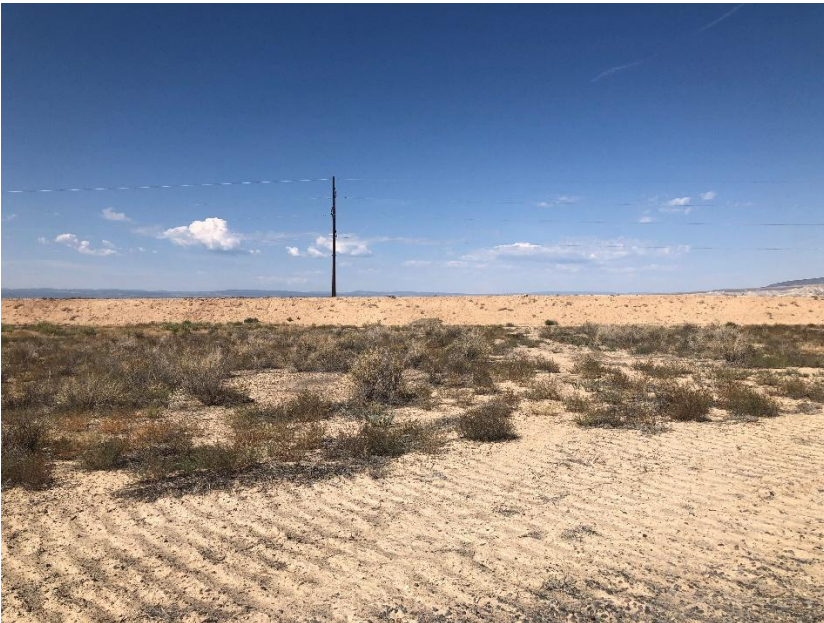
The County needs to ensure that the topsoil is protected from erosion, including seeding it and using erosion control BMPs around the sides of the pile.

**Topsoil pile (#11 on map), looking west**

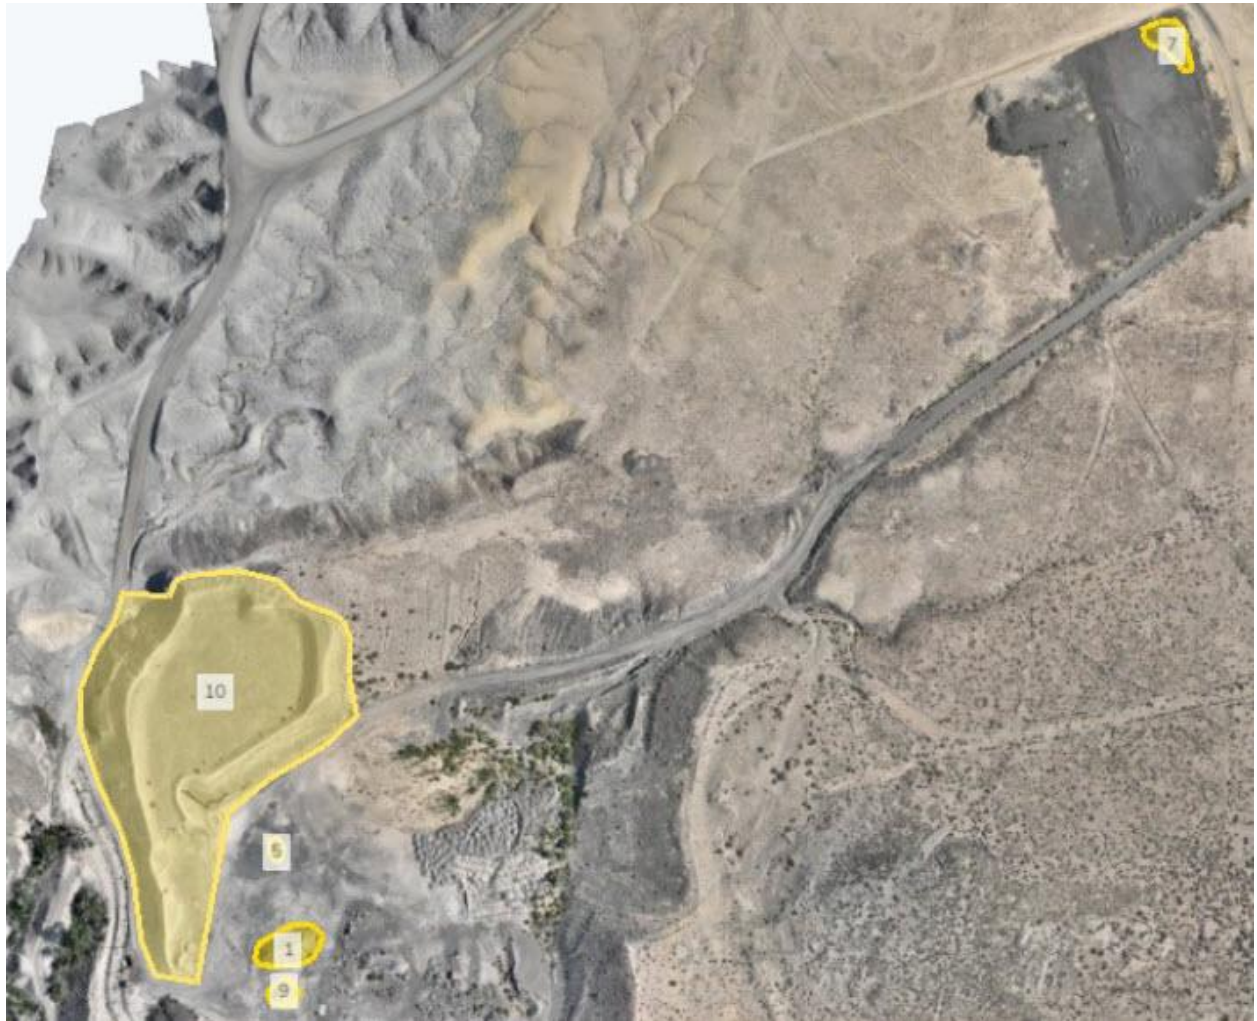
**Map from Delta County Drone Inventory of Piles, West Side of Pig Mesa Pit Permit**

1. Plant mix (5/16" minus)
2. 3" road base
3. 1 1/2" road base
4. 1 1/2" road base
5. 3/4" chips
6. 3" road base
7. 1/2" chips
8. 3" road base
9. Waste
10. Sand
11. Topsoil
