**MINERALS PROGRAM INSPECTION REPORT**  
**PHONE: (303) 866-3567**

| <b>MINE NAME:</b><br>Arnold Pit | <b>MINE/PROSPECTING ID#:</b><br>M-2018-019 | <b>MINERAL:</b><br>Sand and gravel | <b>COUNTY:</b><br>Las Animas |
| <b>INSPECTION TYPE:</b><br>Monitoring | <b>WEATHER:</b><br>Clear | <b>INSP. DATE:</b><br>September 12, 2025 | <b>INSP. TIME:</b><br>10:50 |
| <b>OPERATOR:</b><br>Las Animas County | <b>OPERATOR REPRESENTATIVE:</b><br>Brian Heguy | <b>TYPE OF OPERATION:</b><br>112c - Construction Regular Operation | |

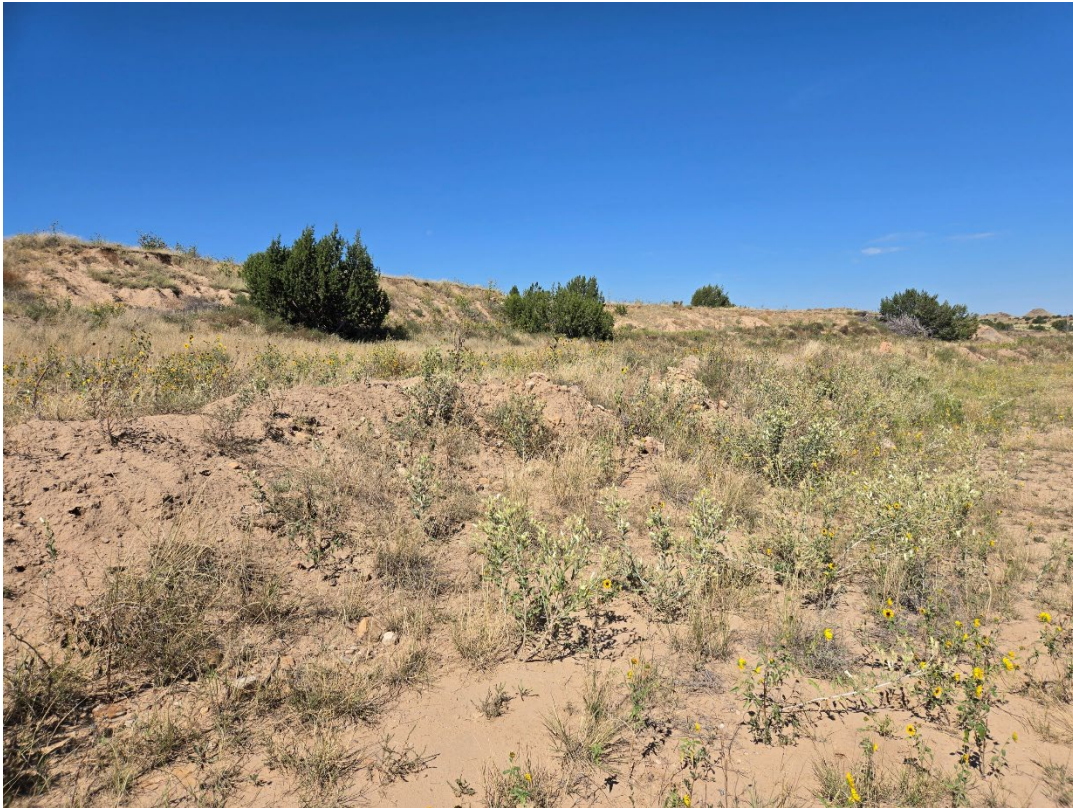
**Photo 1:** Looking west at a topsoil berm lining the southern disturbed area.

Topsoil is located in a shallow earthen berm along the southwest side of the disturbed area. The berm had volunteer vegetation on it and appeared stable at the time of the inspection.

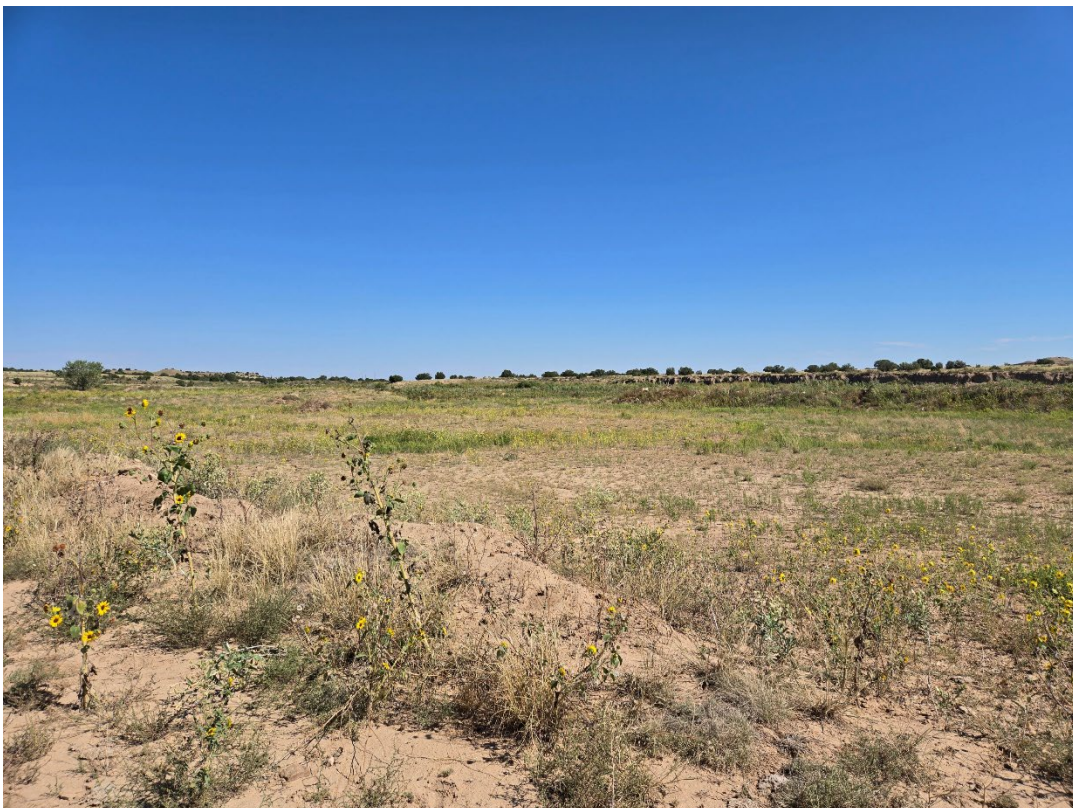
**Photo 2:** Looking east at the western berm lining the southern disturbed area.

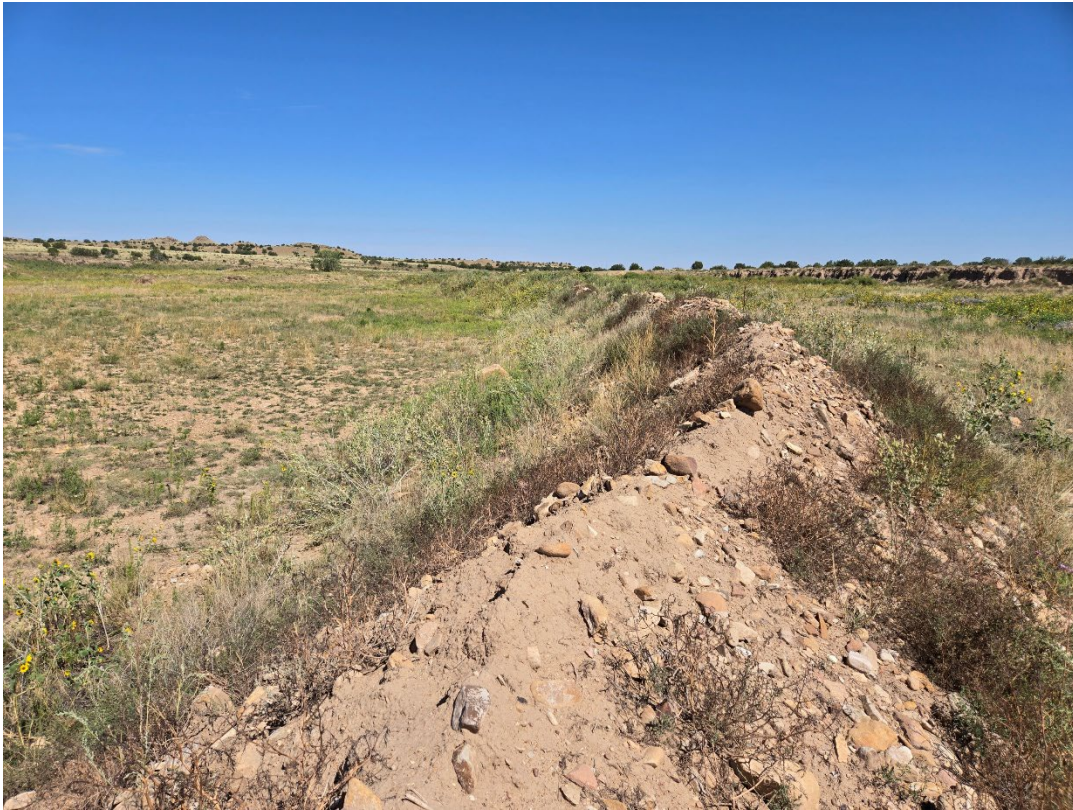
**Photo 3:** Looking at a berm lining the west side of the southern disturbed area.

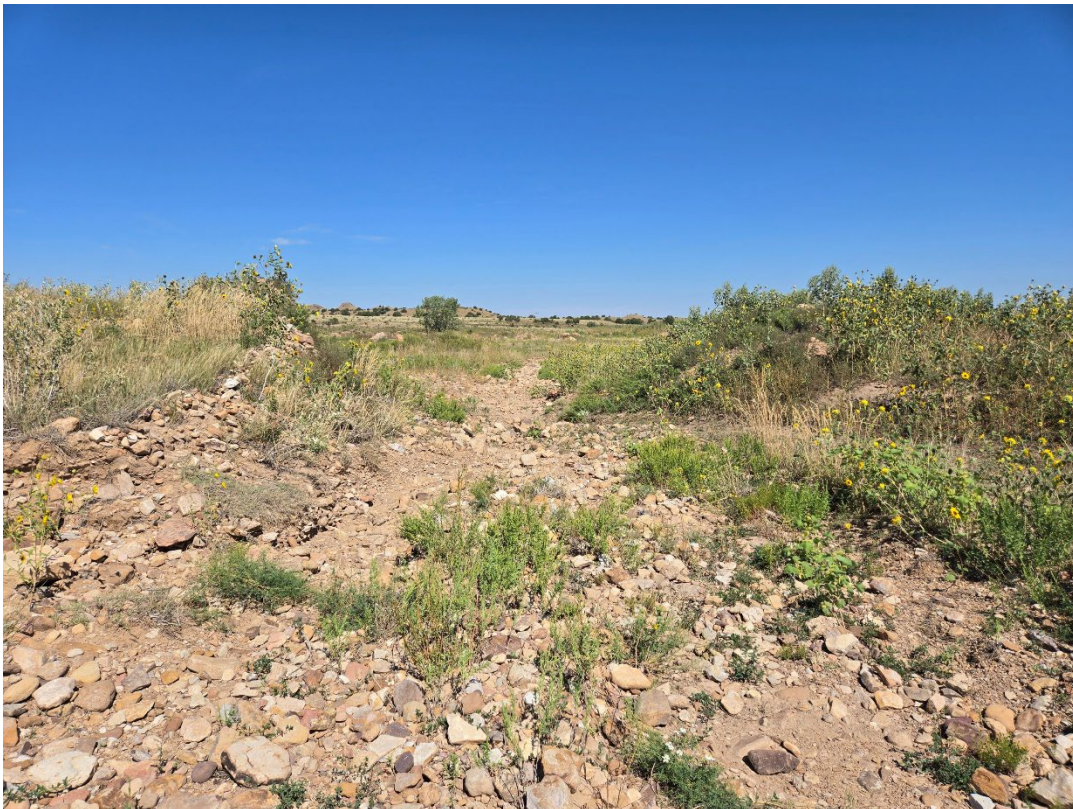
**Photo 4:** Looking north from within the southern disturbed area, at the path cut between the two areas.

Reclamation activities have not yet commenced at this site. There appeared to be two areas where material had been removed, which are separated by a central berm with a path cut between. Within both areas, small piles of overburden and product were observed. The only slope to be reclaimed would be where the two areas meet, along the cut. Otherwise, reclamation would consist of grading out the earthen berms, spreading topsoil, seeding, and weed control.

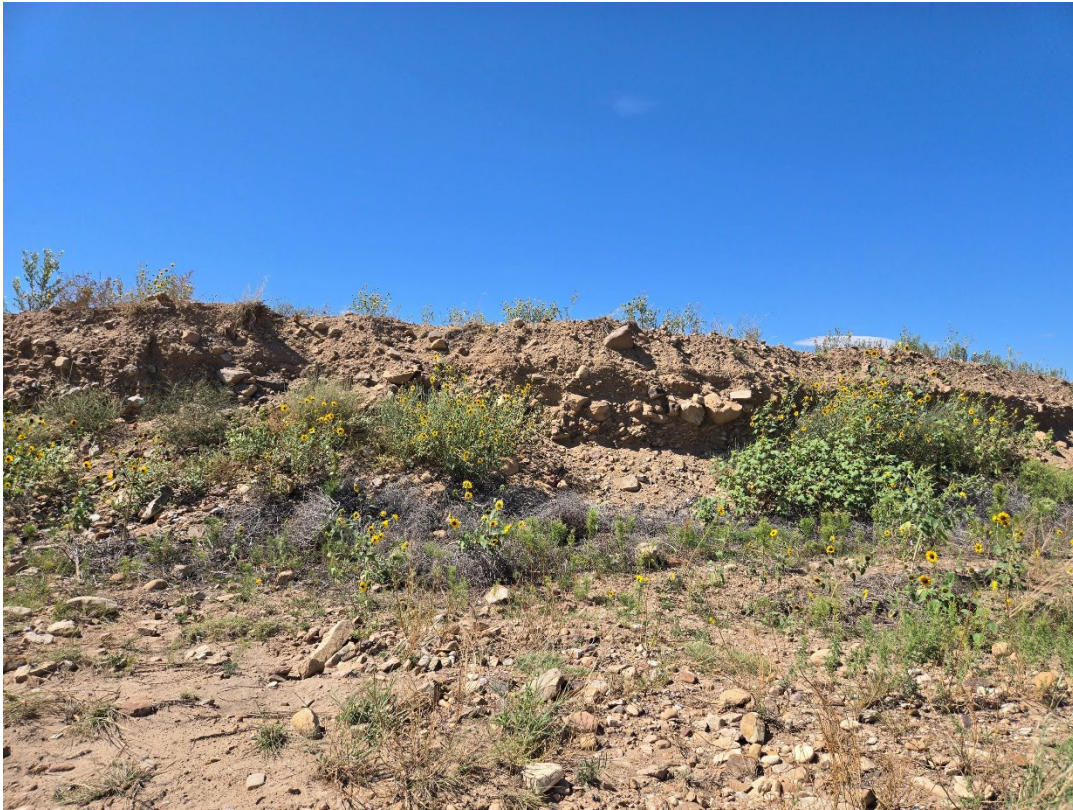
**Photo 5:** Looking west within the path cut between the north and south disturbed areas at the small highwall containing gravel material.

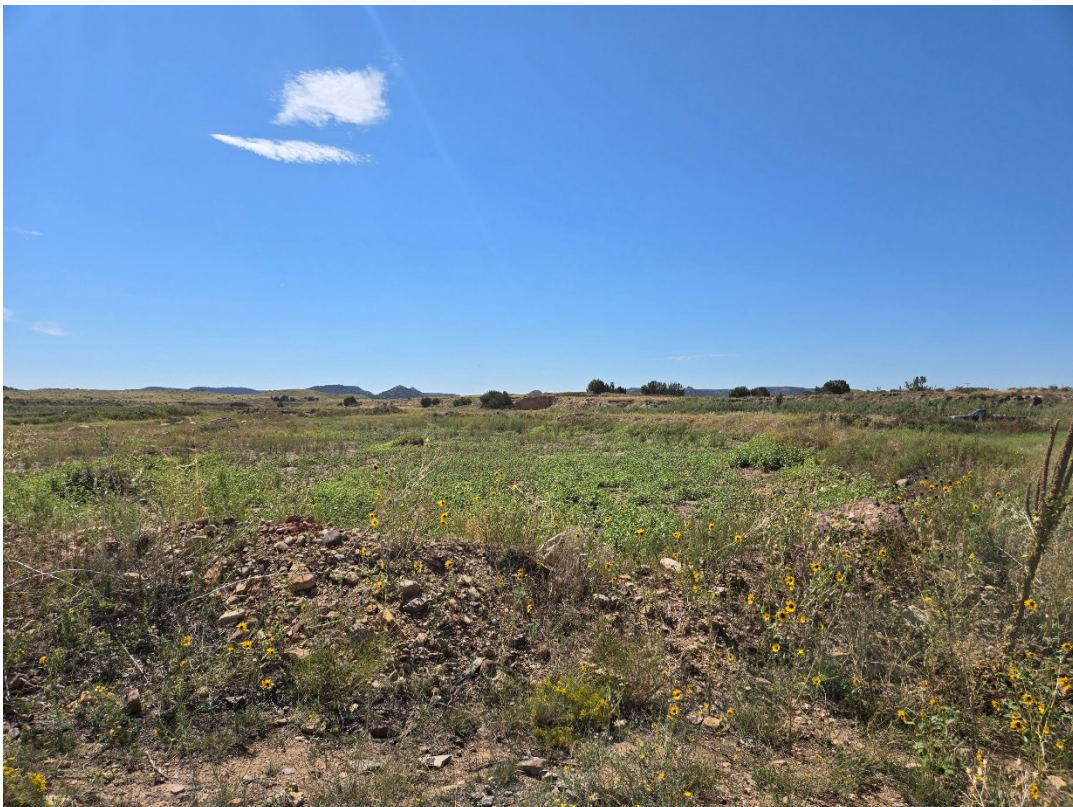
**Photo 6:** Looking south from the northernmost point of disturbance within the permit boundary.

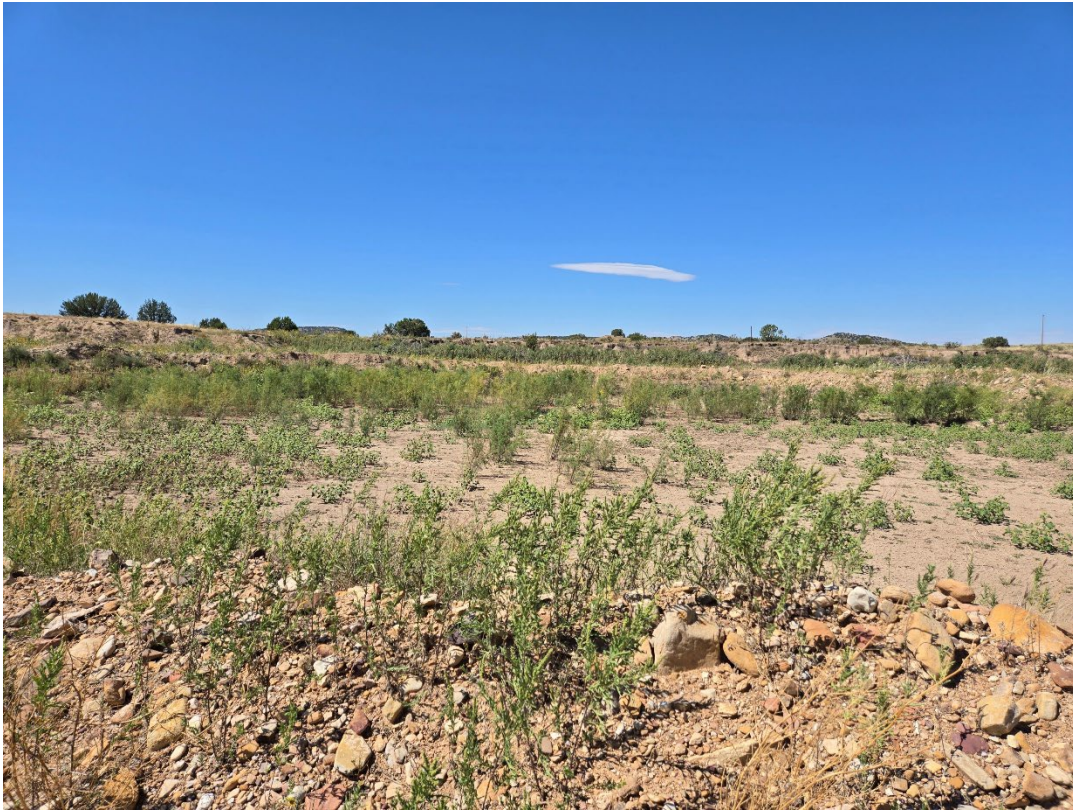
**PROBLEM:** There are state-listed noxious weeds present on site. This is a problem for failure to employ weed control methods for state listed noxious weed species within the permitted area, and to reduce the spread of weeds to nearby areas as required by Section 3.1.10 (6) of the Rule.

Evidence of standing water having been within the disturbed area was evident by a thin layer of sediment exhibiting mud cracks, as well as the establishment of annual weeds and the B-listed State Noxious weed Tamarisk (a.k.a. Salt Cedar). Tamarisk is well established within the intermittent stream, and has begun to spread into the areas where topsoil and gravel have been removed (see Photo 7). **This has been cited as a problem above.** The Operator shall remove the smaller, newly established Tamarisk trees as soon as possible. The Operator had stated that it may be early next year before they can work on removal. As Tamarisk is established within stream bed within the permit area, the Operator is advised to work on removing and treating the Tamarisk to the best of their abilities, and work to prevent further spread of the trees throughout the permit area. In addition to the Tamarisk, the C-listed State Noxious weed, Mullein was also observed. Fact sheets that provide advice for treatment of both the above-stated noxious weeds are enclosed with this report. The Operator shall include in the above required Technical Revision, a weed control plan to address weed management at the site.

**Photo 7:** Looking west across the northern disturbed area where many small Tamarisk trees have begun to establish.

**CORRECTIVE ACTIONS:** Implement approved weed control plan and provide proof to the Division that this has been done. If a weed control plan is not already in place, the Operator shall develop a weed control and management plan in accordance with Section 3.1.10 (6) of the Rule. This plan should be developed in consultation with the county extension agency, or weed control district office and should include specific control measures to be applied, a schedule for when control measures will be applied and a post-treatment monitoring plan. This weed control plan shall be submitted to the Division as a Technical Revision to the approved plan with the appropriate Technical Revision fee of \$216.00 by the corrective action date.

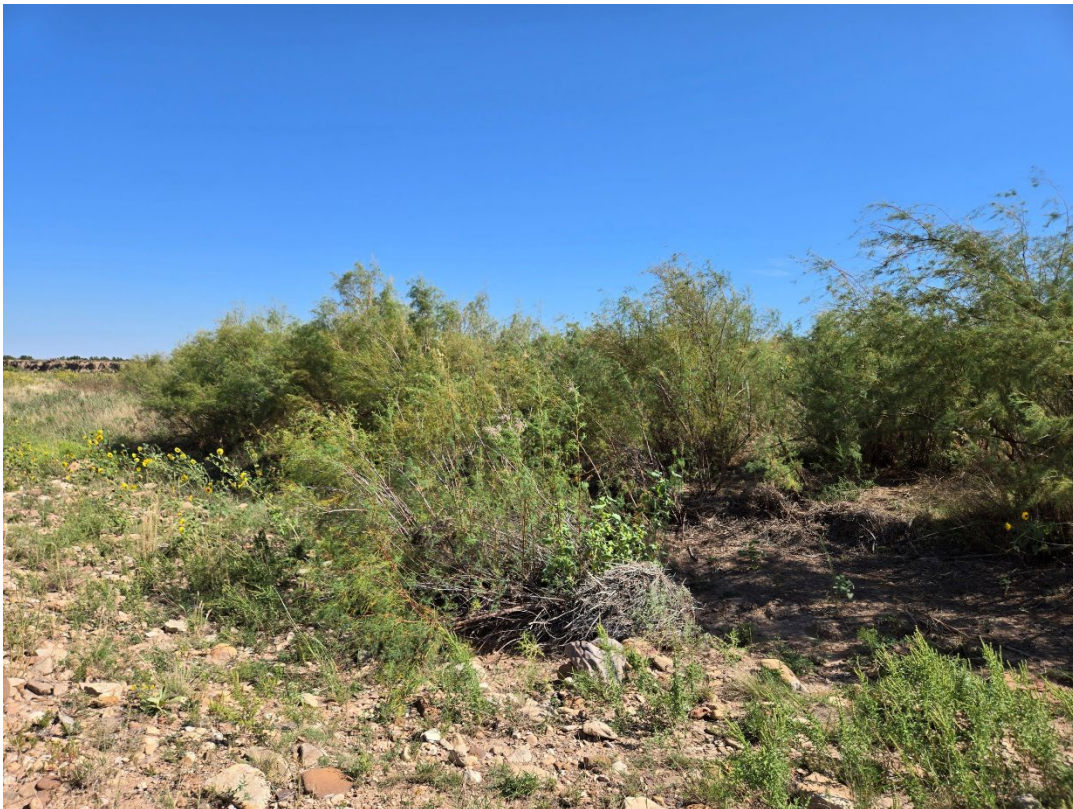
**Photo 8:** Looking north within a section of the intermittent stream that lies within the permit boundary where Tamarisk is established.

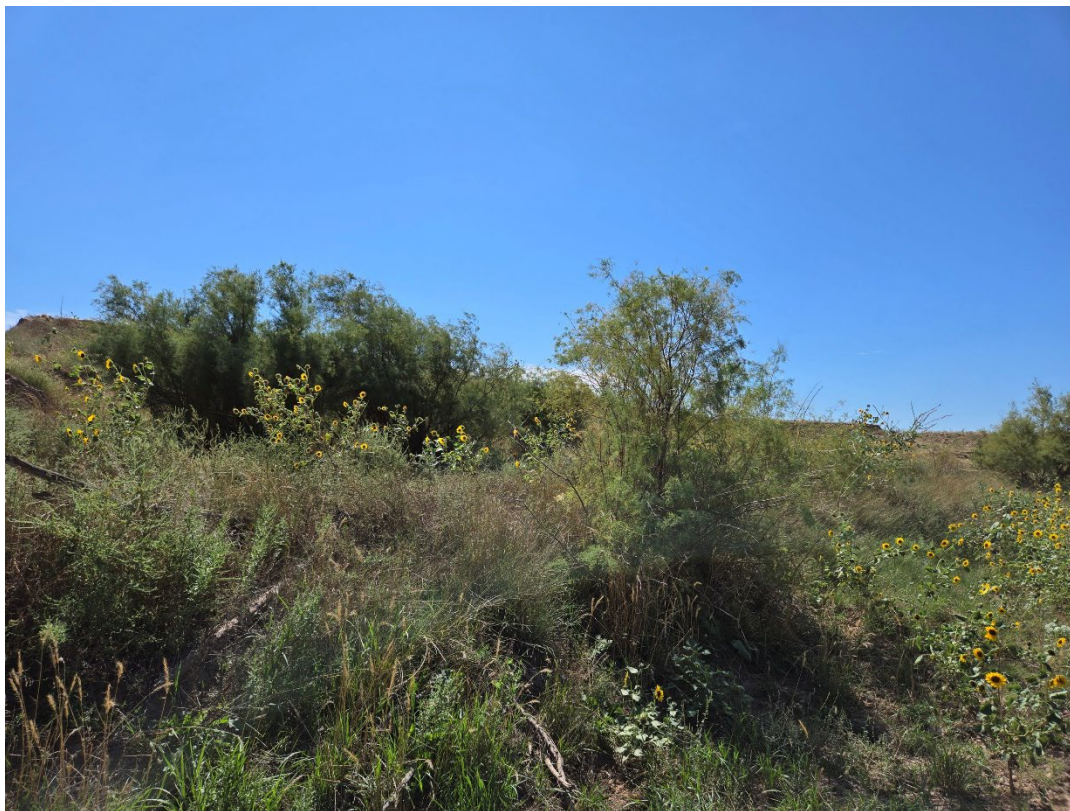
**Photo 9:** Looking south beyond the permit boundary at Tamarisk established within the intermittent stream bed.

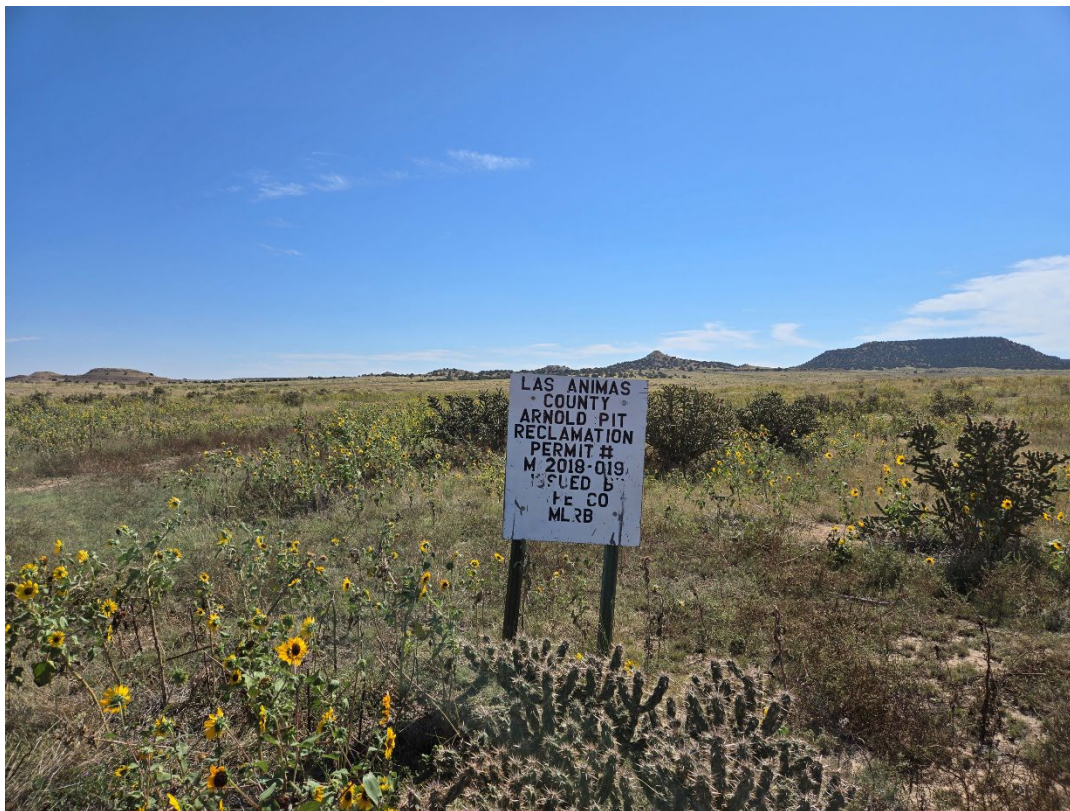
A mine sign was posted at the entrance to the southern access road. If the Operator submits a technical revision to update the access roads locations, the Operator shall ensure that a mine sign is posted at both entrances in compliance with Rule 3.1.12(1). T-posts were observed around the site, marking the affected boundary/permit area. The northern-most t-post was unable to be located at the time of the inspection, but was temporarily marked with a rock. The Operator stated that they would ensure there is a visible marker in place prior to re-

**Photo 11:** Mine sign posted at the southern access road entrance (see Figure 1 and Map 1 below).

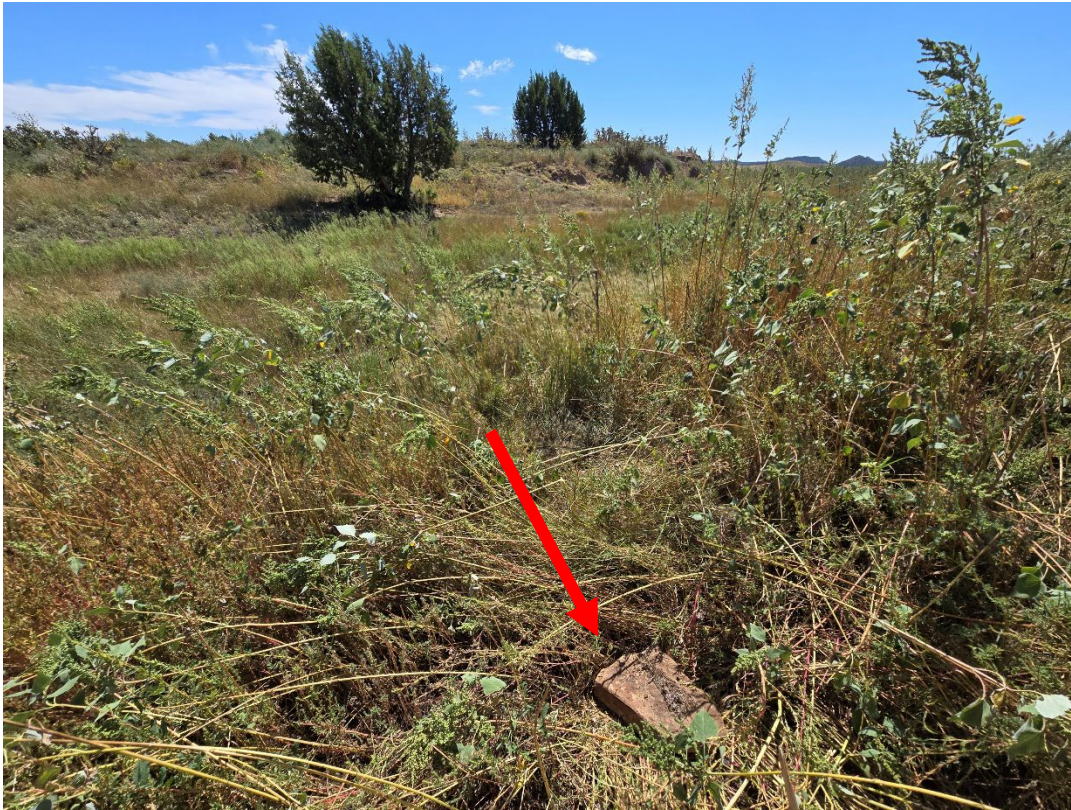
**Photo 13:** Looking southeast from the northern-most point on the permit boundary. The rock in the photo acts as a temporary permit boundary marker.

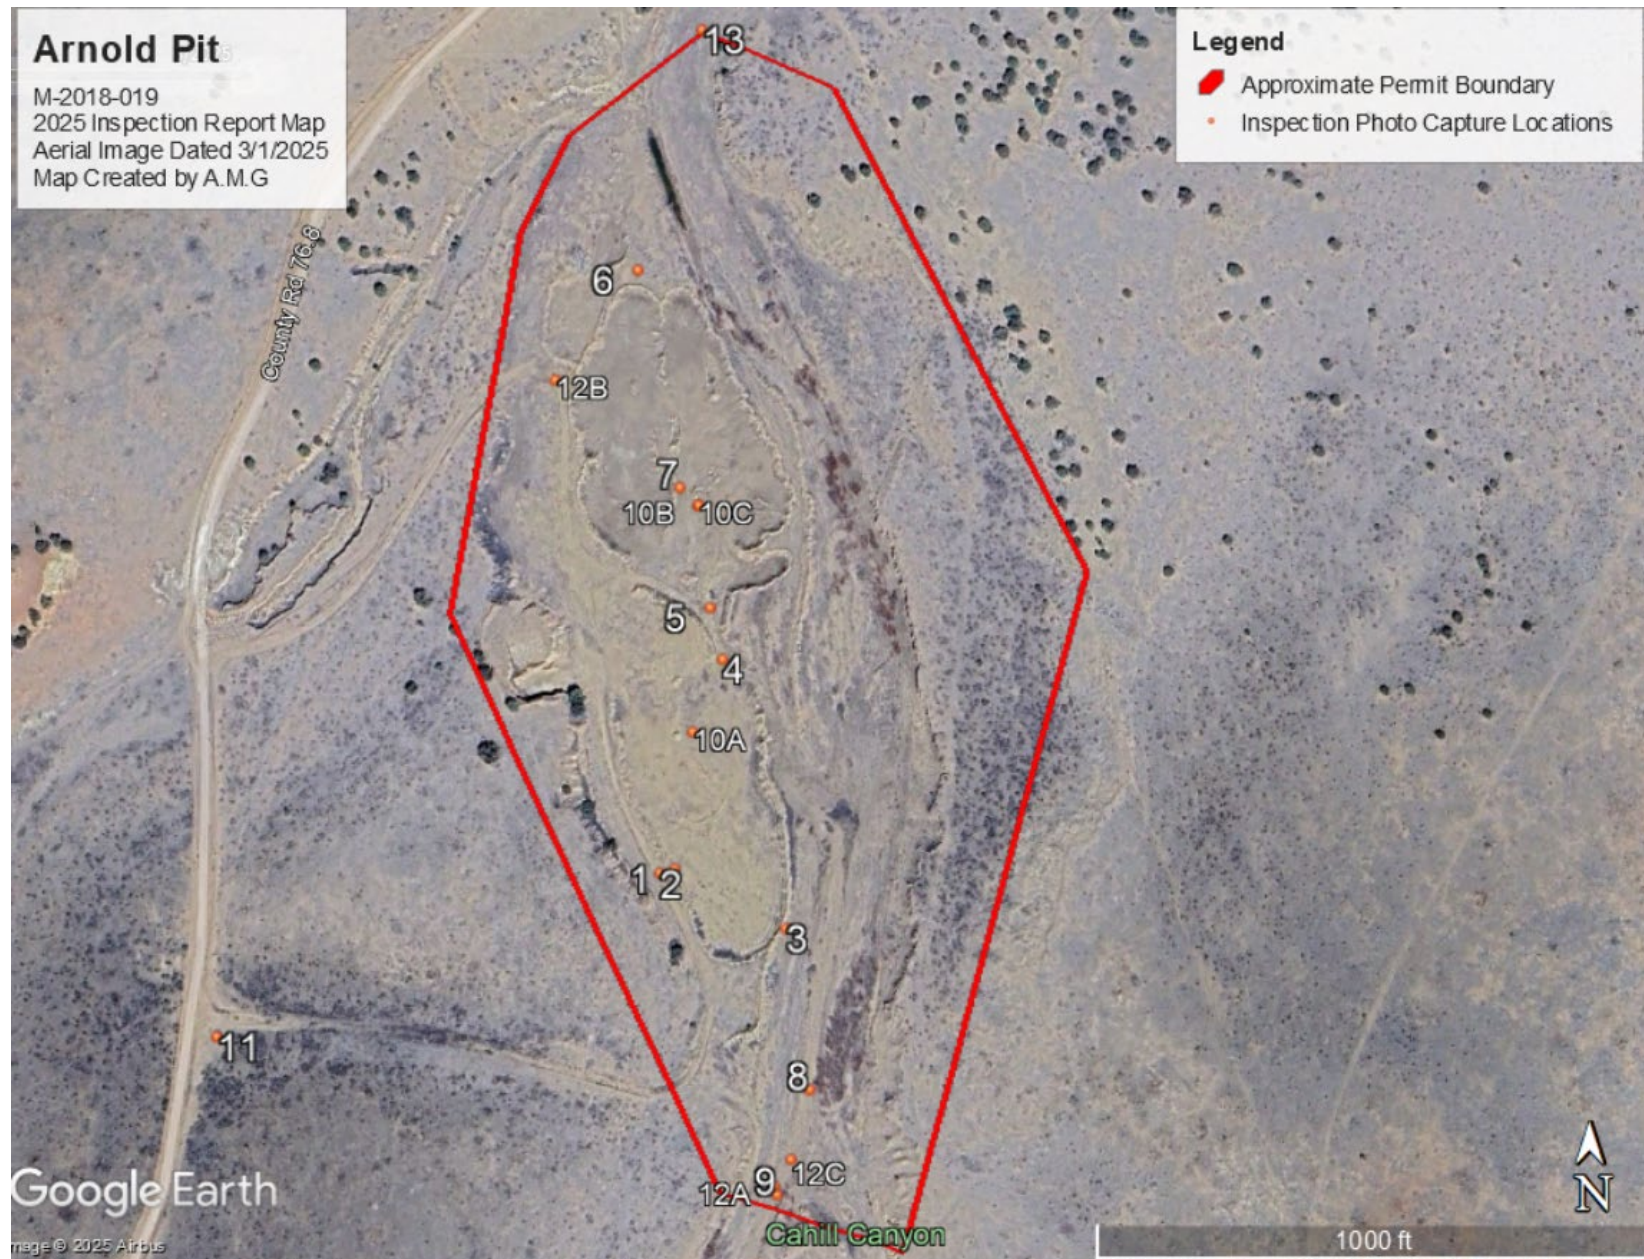
**Map 1:** Inspection Report Map created in Google Earth Pro. The numbers associated with the inspection photo capture locations indicated by the red dots on the map correspond with the inspection photo captions within this report.
