**MINERALS PROGRAM INSPECTION REPORT**  
**PHONE: (303) 866-3567**

| <b>MINE NAME:</b><br>Gunnison River Gravel Pits | <b>MINE/PROSPECTING ID#:</b><br>M-2009-048 | <b>MINERAL:</b><br>Sand and gravel | <b>COUNTY:</b><br>Mesa |
| <b>OPERATOR:</b><br>CW Construction, LLC | <b>OPERATOR REPRESENTATIVE:</b><br>Tim Loncarich | <b>TYPE OF OPERATION:</b><br>112c - Construction Regular Operation | |

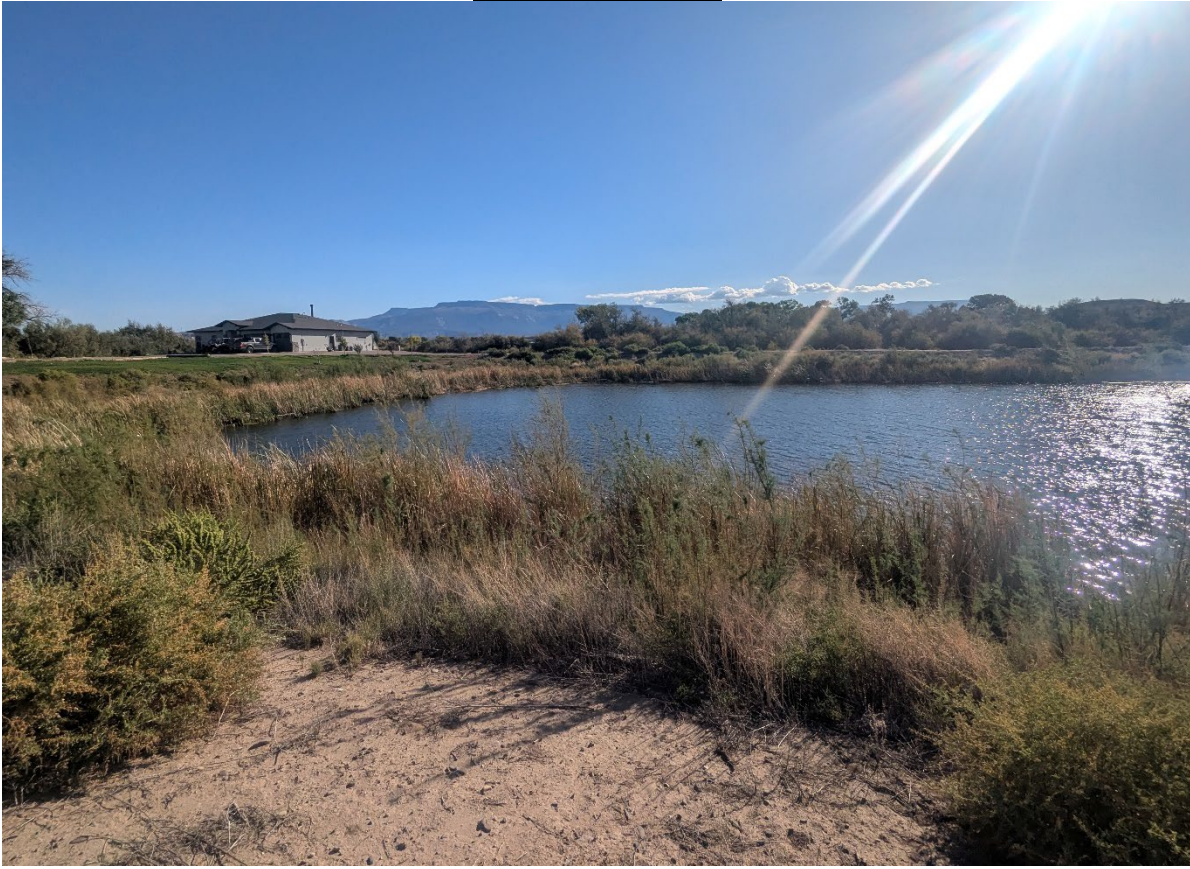
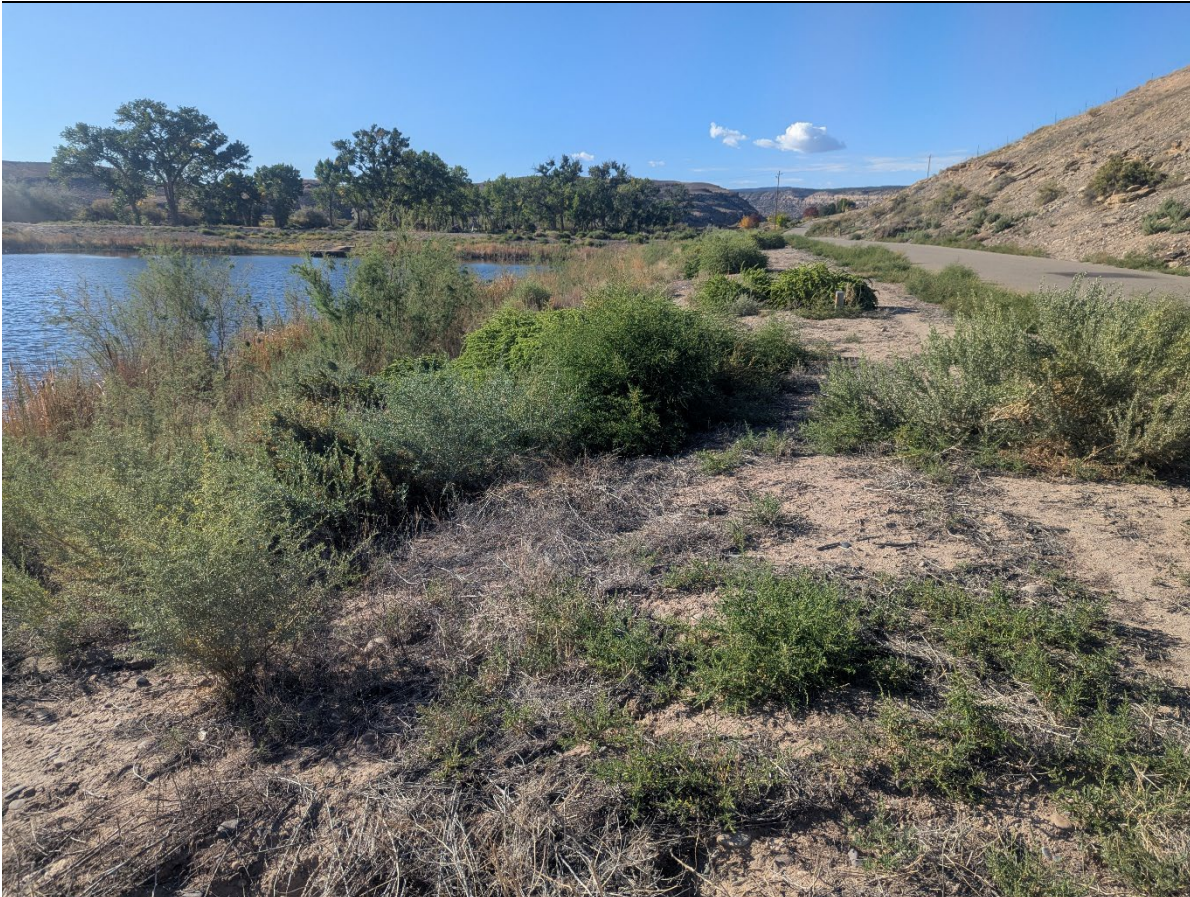
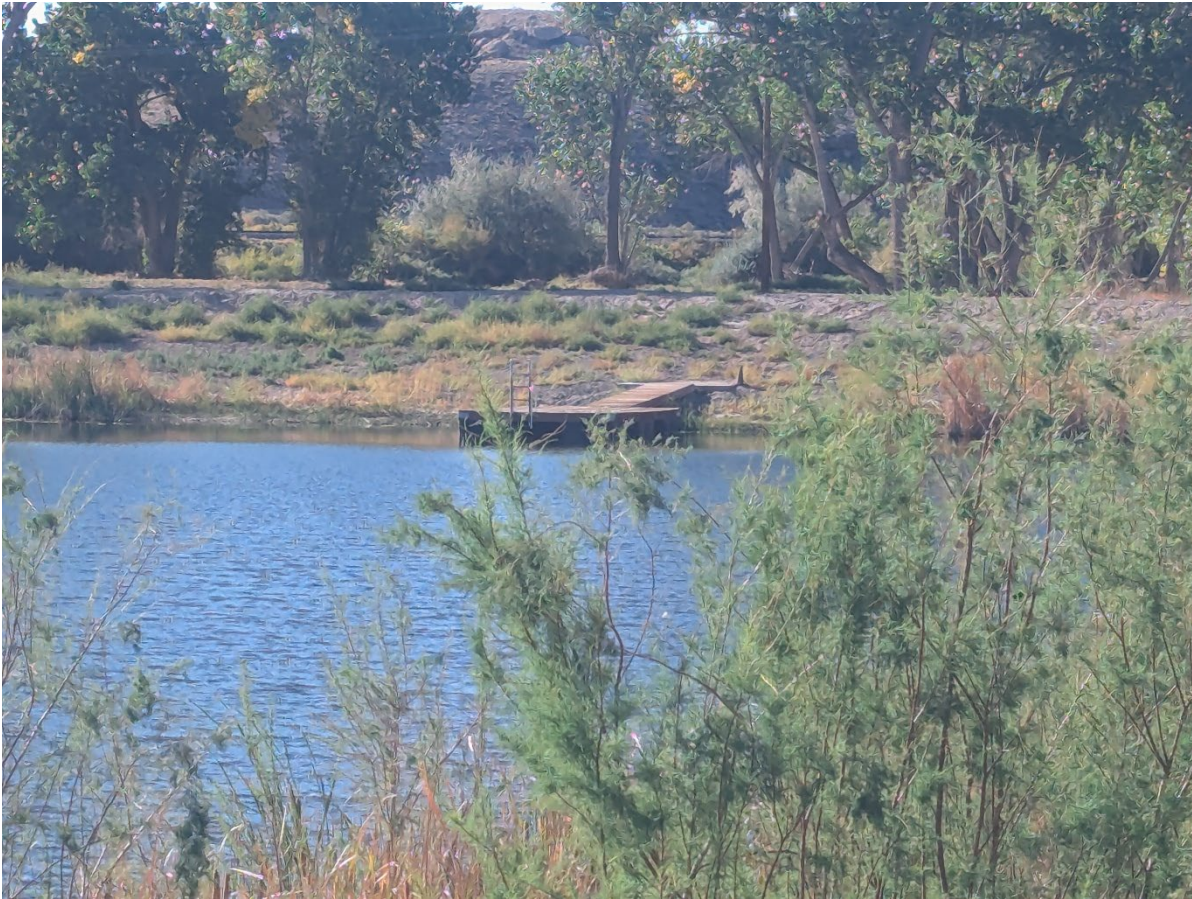
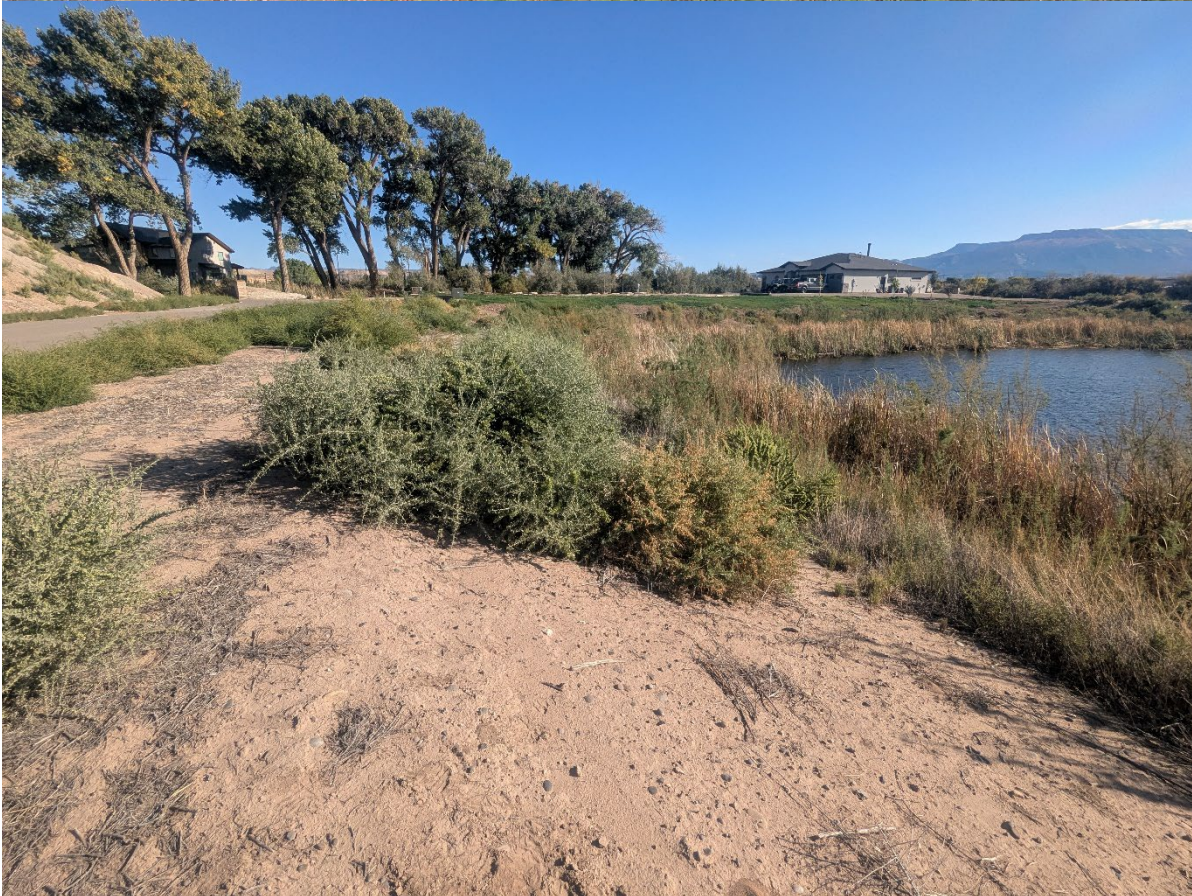
**PHOTOGRAPHS**

All backfilling and grading at Pit 1 was completed a number of years ago under a different operator. All slopes appear to be graded to a 3H:1V or less.

Improvements and development have occurred to the areas adjacent to the affected lands and in some cases have occurred within the permit boundary. These improvements include but are not installation of boat dock, and graveled path/road. Please note that prior to releasing the approved Reclamation Plan Maps must match current site conditions. The operator and landowner are encouraged to work together throughout this process.

Pit 1 was revegetated a number of years ago with limited success. Areas adjacent to the water have established riparian species. Above the water line minimal desirable vegetation was observed. Little to no additional desirable vegetation germinated over the growing season. Upland species consist of primarily salt brush and Kochia (weed). Additional follow-up seeding of the dryland areas will be required given the lack of progress over the years. Prior to seeding the operator is encouraged to remove all non-desirable species to avoid mixing into the seed bed or preventing seed to soil contact during hydro seeding.

Additionally, a fair amount of Tamarisk was observed. This site is the sink not the source. However, the Operator must make a reasonable effort to control noxious weeds on the affected lands. Please remove all Tamarisk from the affected lands and treat with an herbicide to prevent recurrence. Treatment of other undesirable species should also occur to help improve reclamation spices.

Vegetation is to be dry rangeland. Irrigation was not considered during the permitting process and use of such is discouraged. If water is applied, the Division will still have to wait 2 growing seasons after irrigation ceases to ensure vegetation can survive without ongoing maintenance. Given the aridity of this area, establishment of desirable species will take a number of years to reach adequate density and diversity. The Division will not consider reclamation until after a minimum of 2 growing seasons, however 5 or more years depending on progress is also not uncommon in this area.
