## Baseline Resource M1997058- AR and SR Inspection Report

Attached to this email is a pdf of the Division's inspection report for the inspection conducted on August 21, 2025 at the Baseline Resource permit, file no. M-1997-058.

### MINERALS PROGRAM INSPECTION REPORT

| <b>MINE NAME:</b><br>Baseline Resource | <b>MINE/PROSPECTING ID#:</b><br>M-1997-058 | <b>MINERAL:</b><br>Sand and gravel | <b>COUNTY:</b><br>Weld |

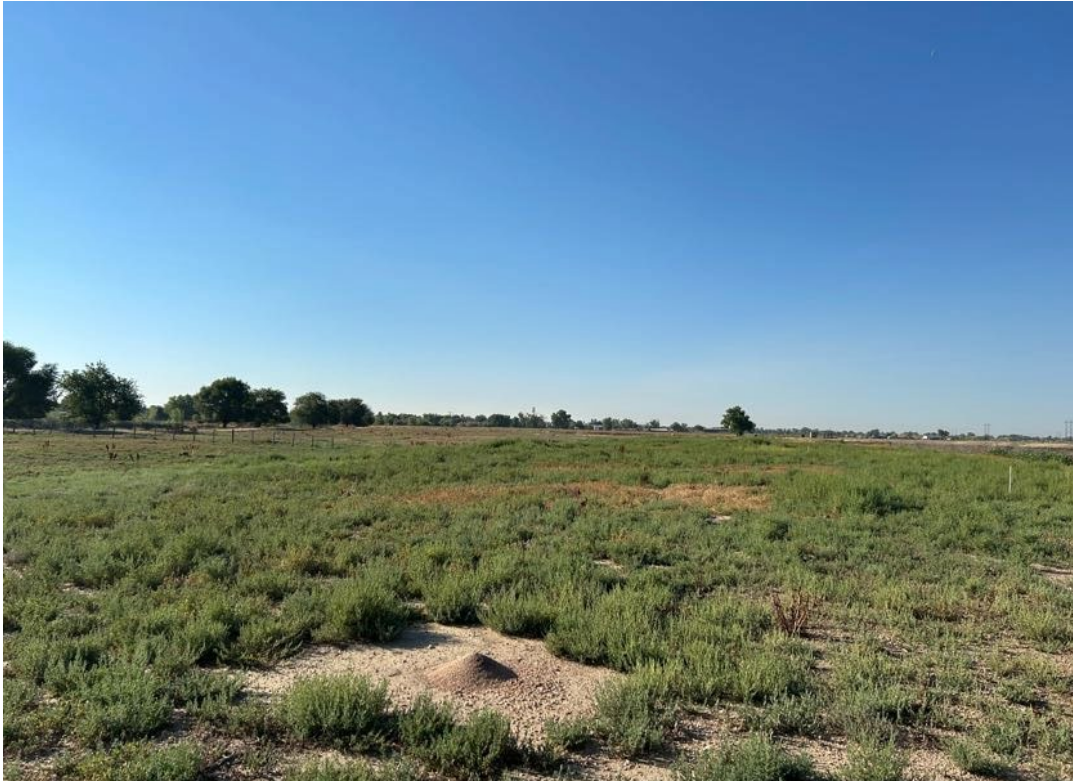
The small area east of the Walker North Lot C area that has been requested for release is flat with thick, vegetative cover. The Operator stated the area was drill seeded in 2021 and 2023. Straw was also used as a soil amendment after seeding. However, the vegetation is dominated by a cover of annual weeds, namely Kochia, Cheatgrass, and Curled dock (see Photos 1-2). The reclamation seed mix consists of predominantly Western wheatgrass, Green needlegrass, Indian ricegrass, and a few Bluestem species. A few spots were barren and did not contain any annual weeds or reclamation grasses. If the reclamation seed mix species are growing under the cover of the annual weeds, it was not observable during this inspection. The Division noted that mowing would be beneficial in this area, and potentially an alternate seed mix.

Photo 1: View of the 9.904-acre release request area dominated by weed cover, facing south.

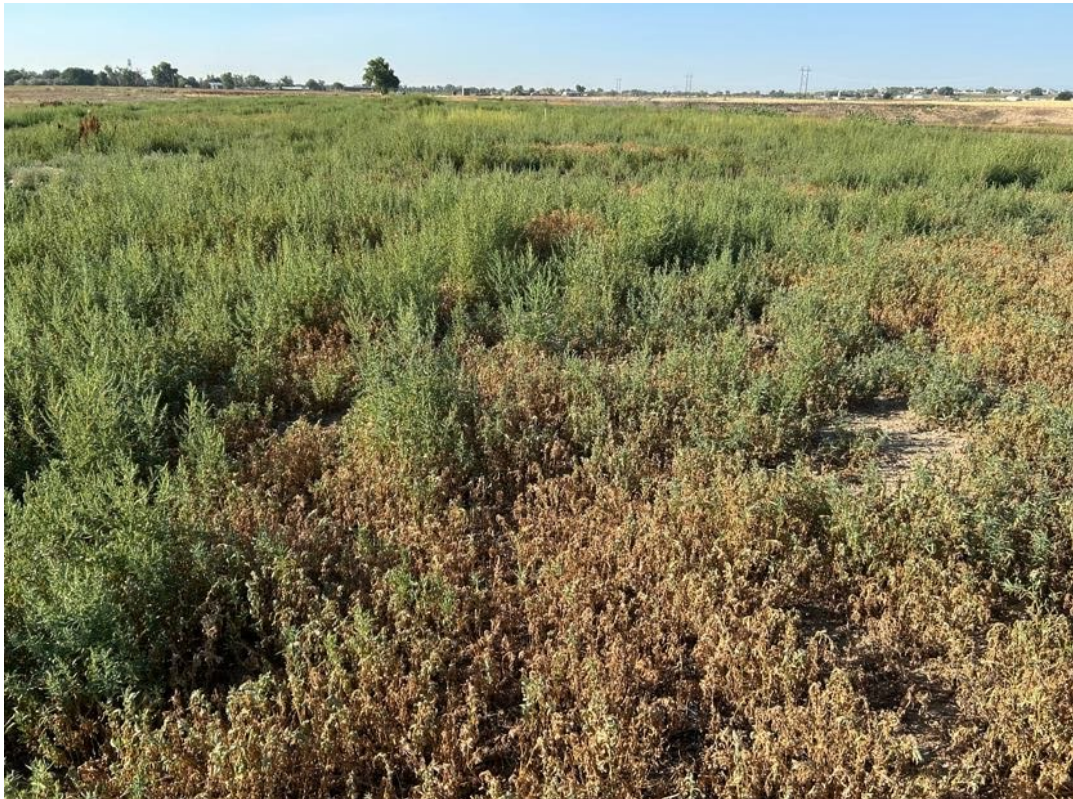
Photo 2: Alternate view of the 9.904-acre release request area with significant amount of Kochia, facing southwest.

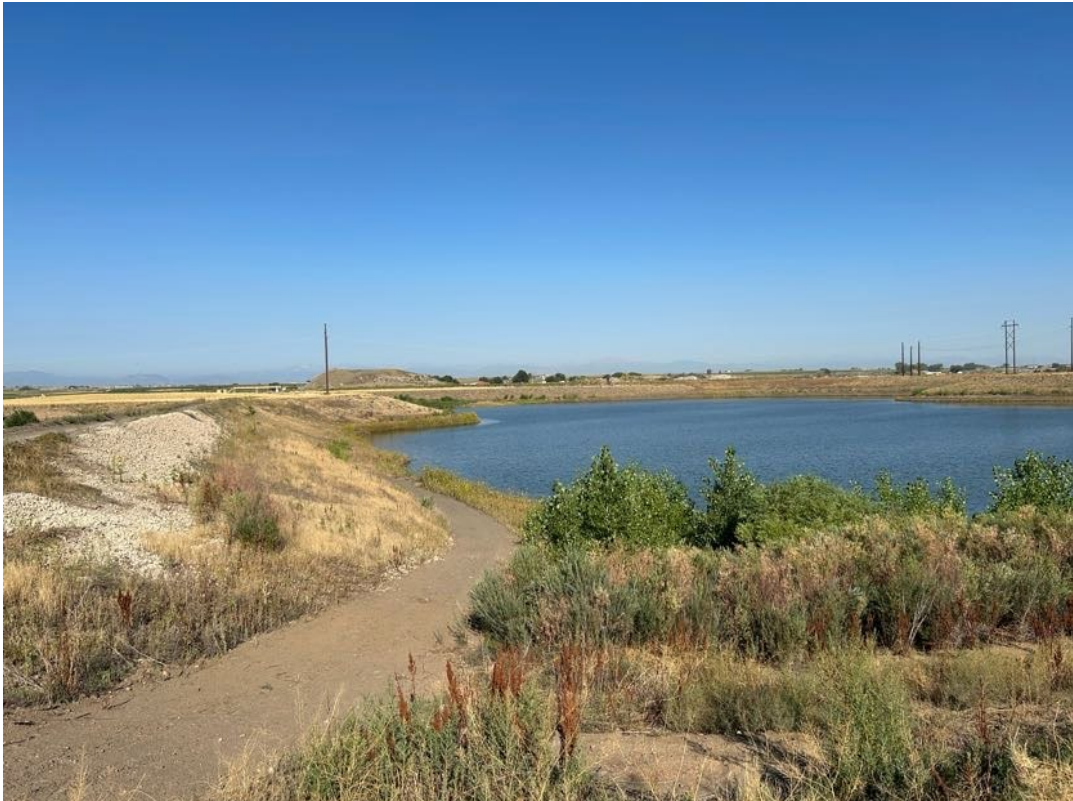
On July 29, 2025, the Operator submitted an Acreage Reduction (AR-3) for partial release of the permit area in accordance with Rule 4.17.1. The Operator also submitted a Surety Reduction (SR-6) application for a reduction in the reclamation bond held by the Division in accordance with Rule 4.14.1. The Division conducted this inspection in accordance with Rule 4.17.2(2). The requested acreage reduction (release area) is 37.804 acres. This area consists of the entirety of Area A, which is 27.90 acres of a lake and surrounding shoreline areas, and 9.904 acres of land east of the Walker North Lot C reservoir. The Walker North Lot C reservoir was in stable condition, with the side slopes having been graded to a 3:1 horizontal to vertical configuration. The slopes were covered in vegetation, including some woody species, grasses, and annual weeds (see Photos 3-4).

Photo 3: View of the Walker North Lot C lined reservoir, facing west.

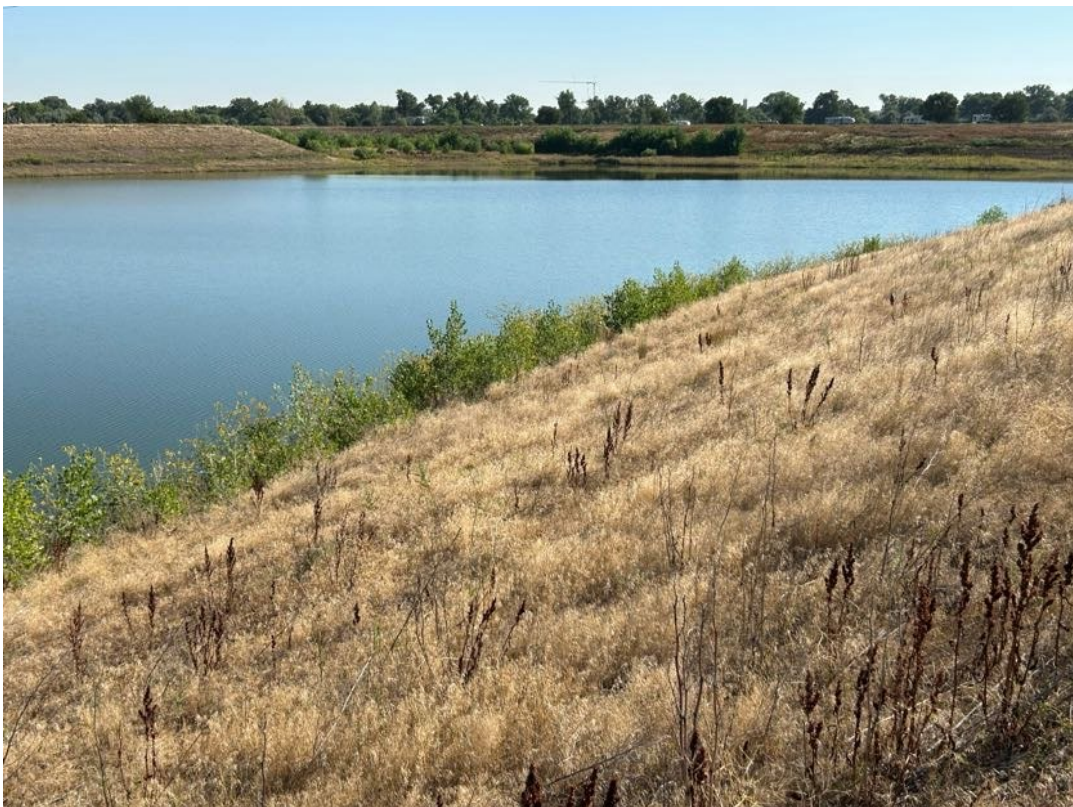
Photo 4: Alternate view of the southern reservoir slope and vegetation within the Walker North Lot C area, facing northeast.

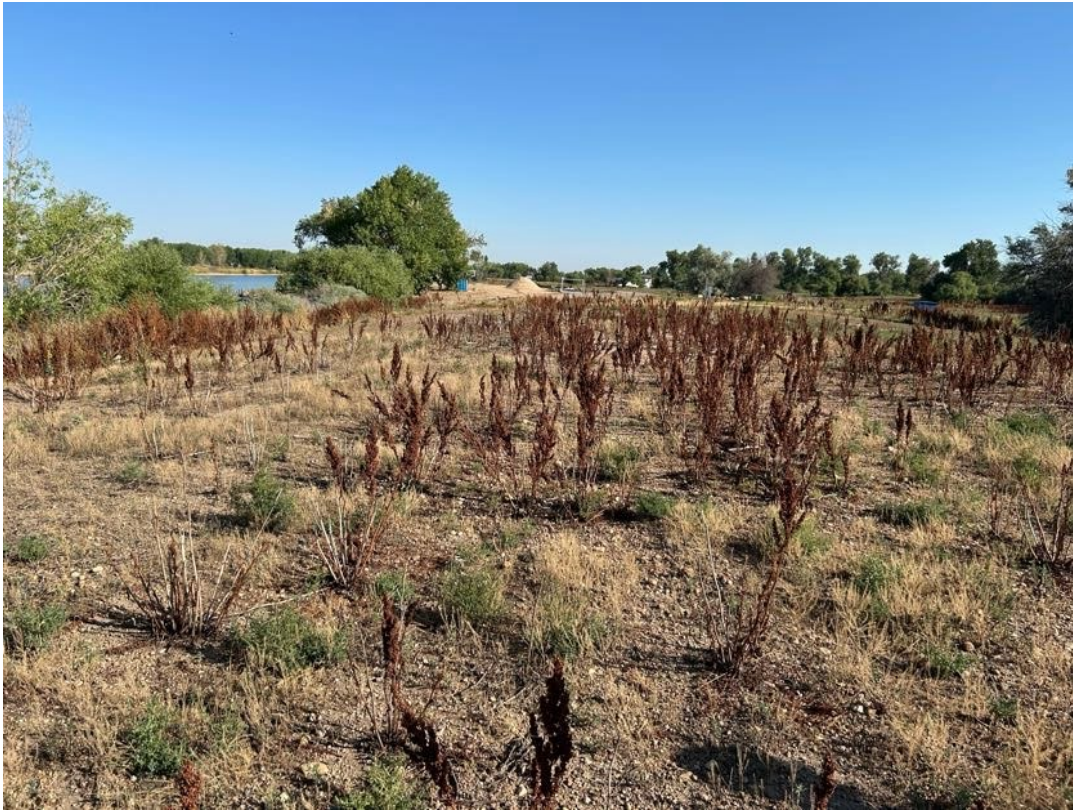
The 27.90-acre area designated as Area A that also has been requested for release contains a lake with flat shorelines (see Photo 8-11). This area also contains a permanent access road on the southern side. PVP pipes marked the eastern permit boundary in this area. Much of the shoreline is dominated by Narrowleaf willow and other wetland species. 1.8 acres are reserved as a recreation area for RVs and boats (see Photo 9). The Division notes that the reseeding in this area is moderately established in some patches but still will require additional seeding before release for some areas (see Photos 5-8). Seeding conducted on adjacent to the

Photo 5: View of the southeastern corner of the Area A pond, facing north.

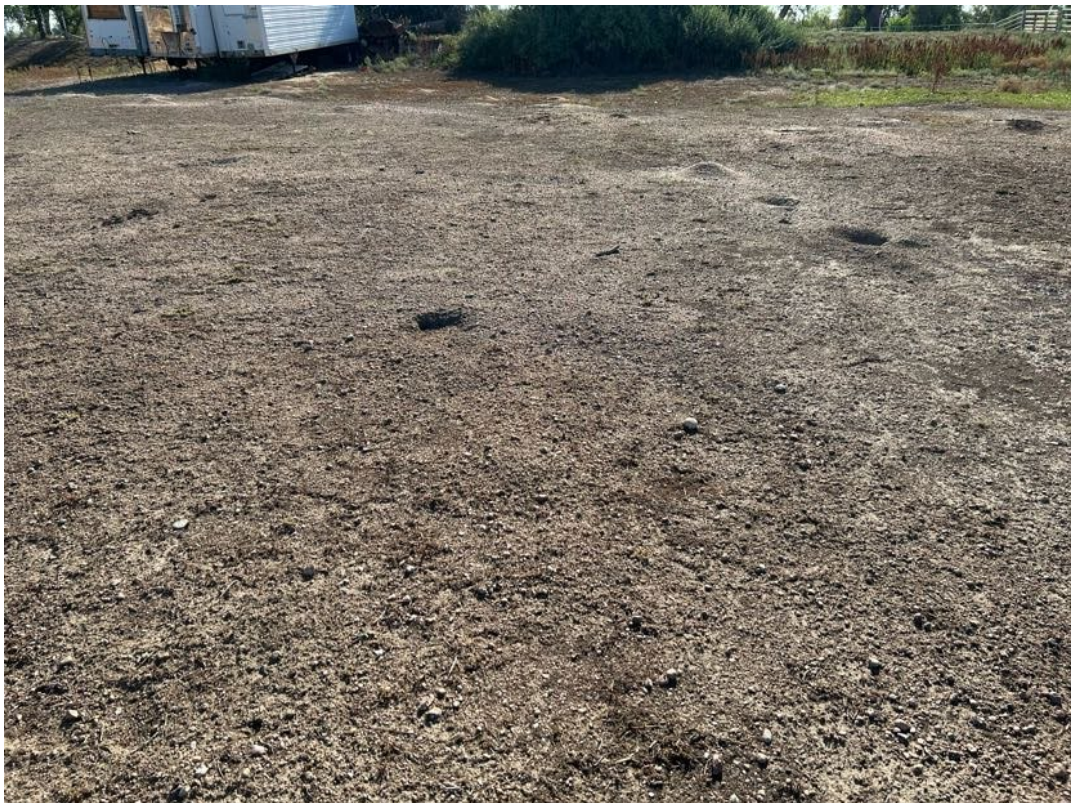
north and south of the access road yielded little to no establishment of the reclamation seed mix (see Photos 6-8). North of the recreation area, the lake shoreline exhibited good coverage of grasses (see Photos 11-12) and will not require additional seeding events.

Photo 6: View of the unsuccessful seeded area south of the access road within Area A, facing south.

AR-3 and SR-6 Release Decision: After conducting this inspection, the Division determined the requested 37.804-acre release area has not been reclaimed according to the approved reclamation plan. AR-3 and SR-6 will be denied in accordance with Rule 4.17.2(4). The Division notes that consultation with Weld County and/or the CSU Extension Service may be warranted to determine if an alternative seed mix or soil amendment(s) would facilitate better revegetation success.

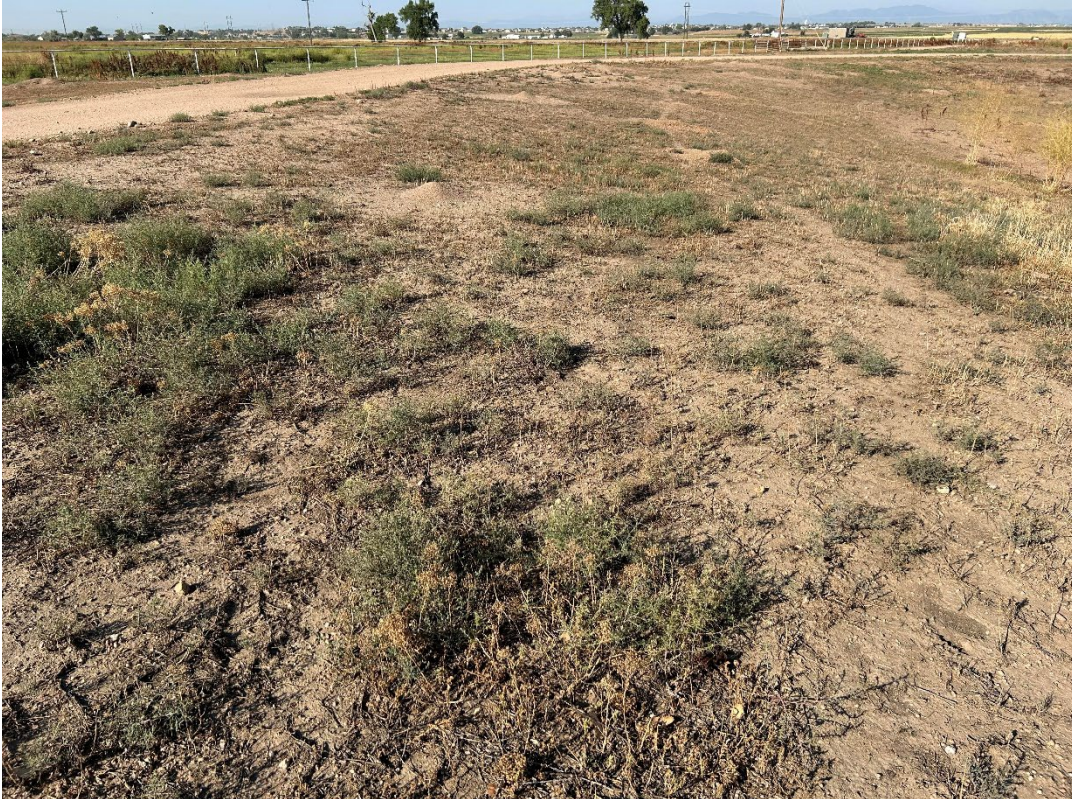
Photo 7: Mostly unsuccessful vegetation effort along the southern pond shoreline within Area A, facing west.

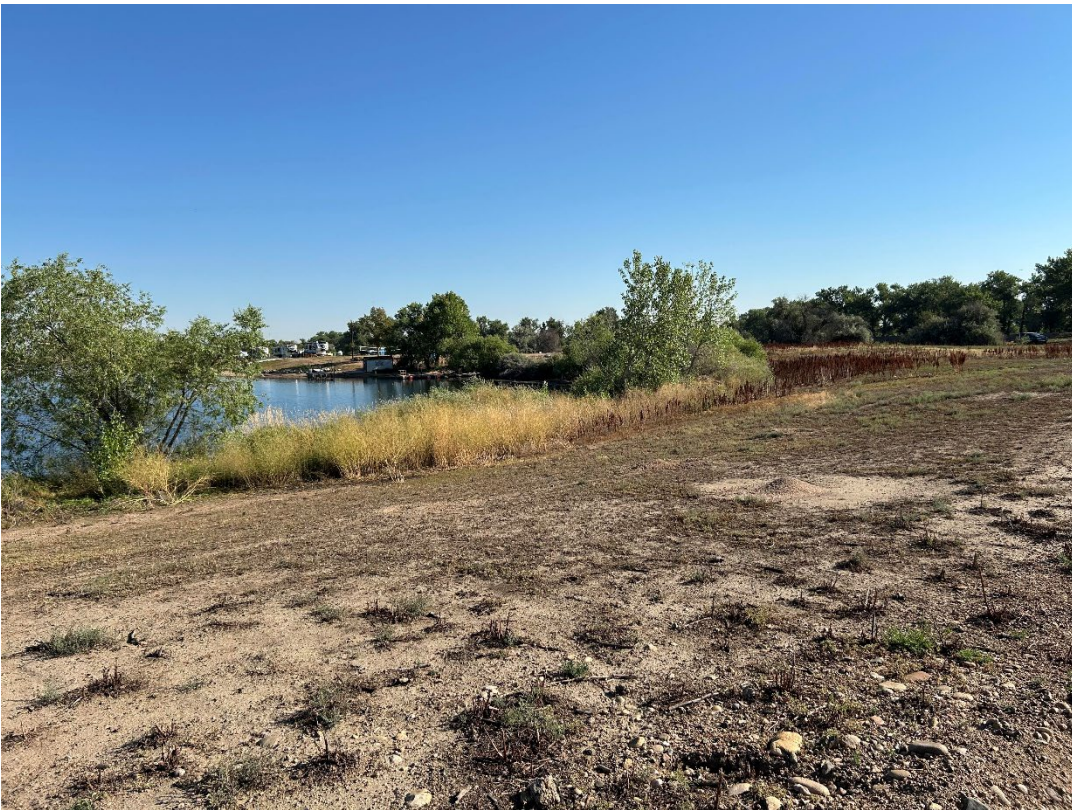
Photo 8: Mostly unsuccessful vegetation effort south of pond within Area A, facing north.

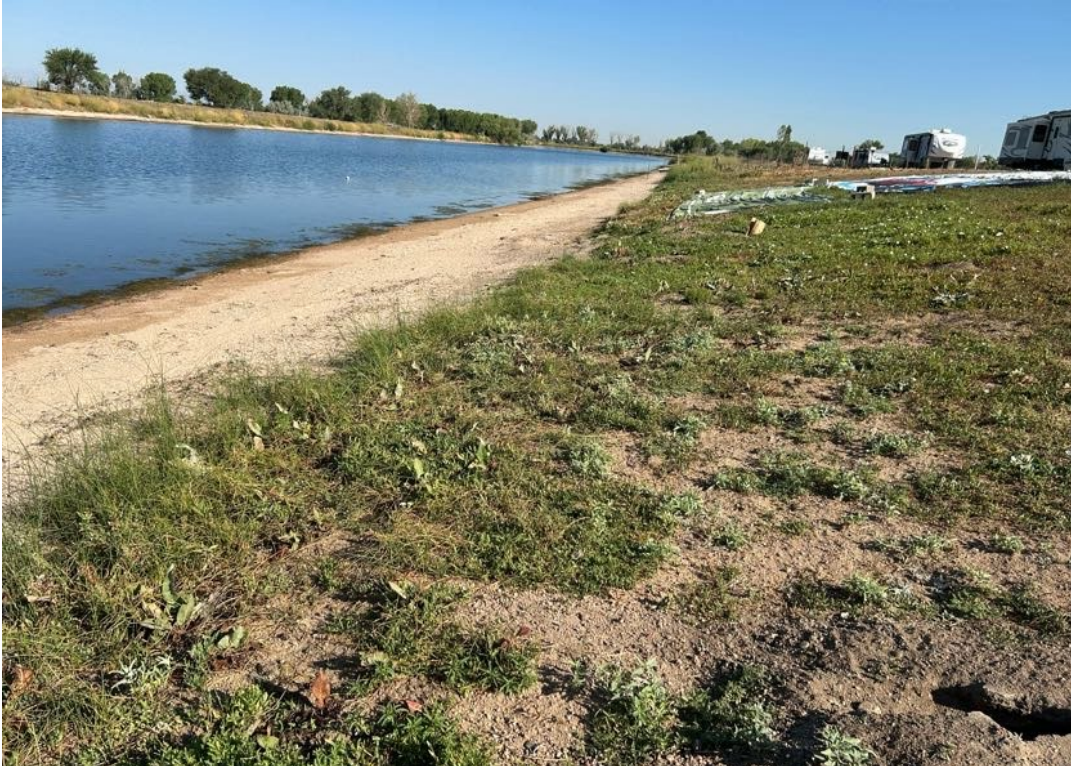
Photo 9: View of the recreation area and seeded area along the eastern pond shoreline of Area A, facing north.

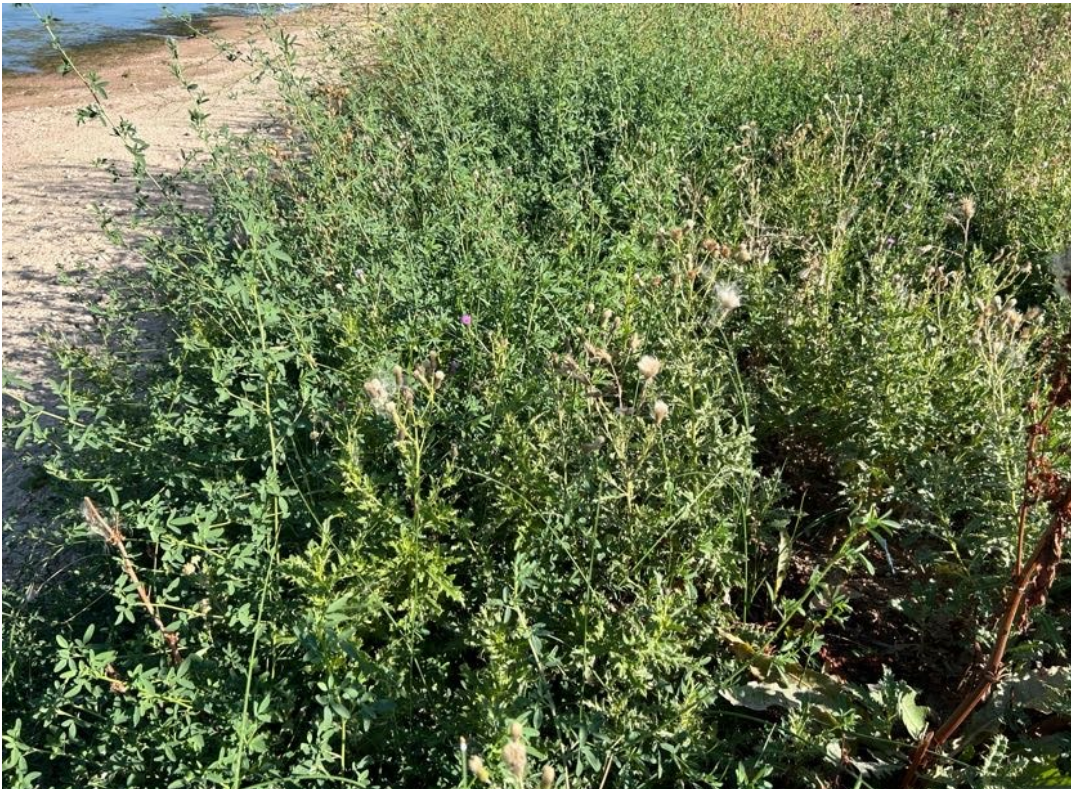
**PROBLEM:** Russian olive trees and Russian knapweed are present within or have volunteered into the permit area and are becoming established. This is a problem for failure to employ weed control methods for a state listed noxious weed species within the permitted area, and to reduce the spread of weeds to nearby areas as required by Section 3.1.10 (6) of the rule.

A minor amount of Kochia and Curled dock was observed within Area A. A few Russian olive trees were observed along the northern lake shoreline, to which the landowner committed to removing (see Photo 11). Russian thistle and Russian knapweed were observed along the eastern shoreline as well (see Photo 10). This is cited as a problem at the beginning of this report. Russian knapweed and Russian olive are List B Noxious weeds and need to be eradicated immediately through the application of an herbicide as approved in Technical Revision #3 in 2021.

Photo 10: View Russian knapweed and annual weeds along the pond shoreline within Area A, facing north.

**CORRECTIVE ACTIONS:** The operator shall implement the existing weed control measures approved in Technical Revision #3 by use of an herbicide and mechanical measures in accordance with Section 3.1.10 (6) of the Rule.

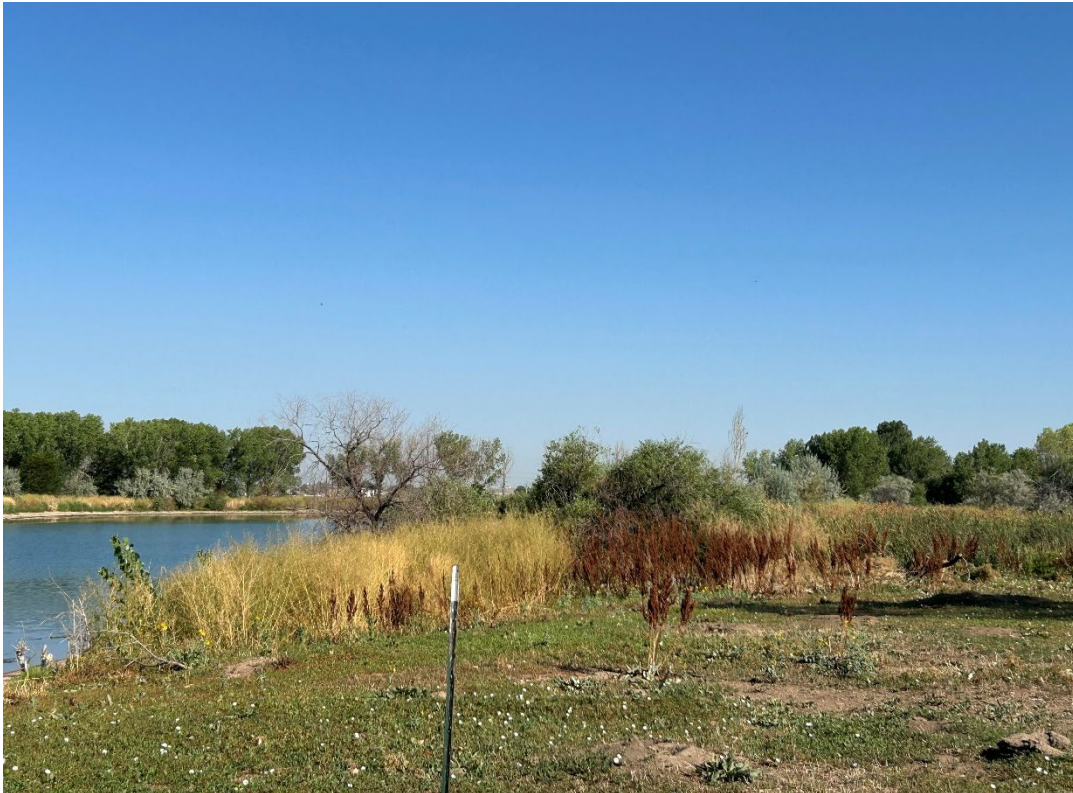
Photo 11: View of vegetation, including grasses, annual weeds, woody vegetation, and Russian olives trees along the lake shoreline area, facing north.

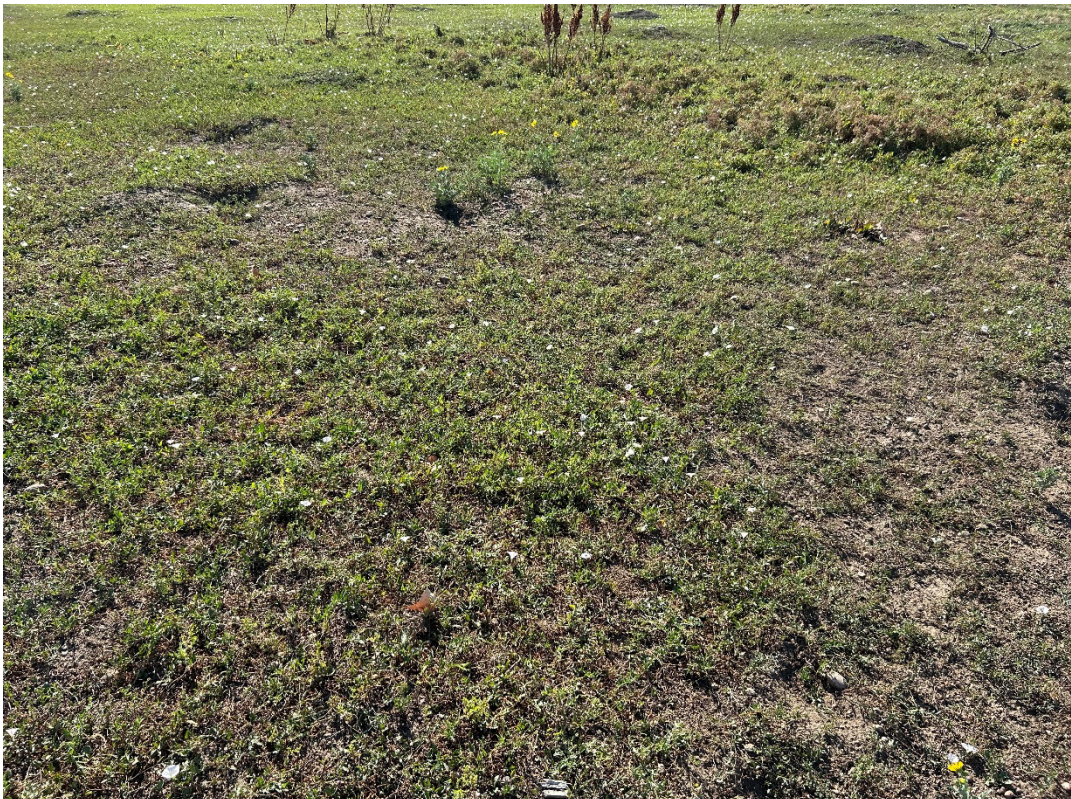
Photo 12: View of well-established grasses along the northeast lake shoreline.
