## Inspection report for Keenesburg Strip Mine

### PERMIT INFORMATION

<b>Permit Number:</b> C-1981-028 <b>Mine Name:</b> Keenesburg Strip Mine <b>Operator:</b> Coors Energy Company <b>Operator Address:</b> Mr. Ben Moline P.O. Box 4030 Golden, CO 80402	<b>County:</b> Weld <b>Operation Type:</b> Surface <b>Permit Status:</b> Permanent Cessation <b>Ownership:</b> Private
	<b>Operator Representative Present:</b> None
<b>Operator Representative Signature: (Field Issuance Only)</b>

<b>Inspection Start Date:</b> October 28, 2025 <b>Inspection Start Time:</b> 09:45 <b>Inspection End Date:</b> October 28, 2025 <b>Inspection End Time:</b> 11:15	<b>Inspection Type:</b> Coal Complete Inspection <b>Inspection Reason:</b> Normal I&E Program <b>Weather:</b> Clear
<b>Joint Inspection Agency:</b> None	<b>Joint Inspection Contacts:</b>
<b>Post Inspection Agency:</b> None	<b>Post Inspection Contacts:</b>
<b>Inspector(s):</b> Robert Zuber, P.E.	<b>Inspector's Signature:</b>

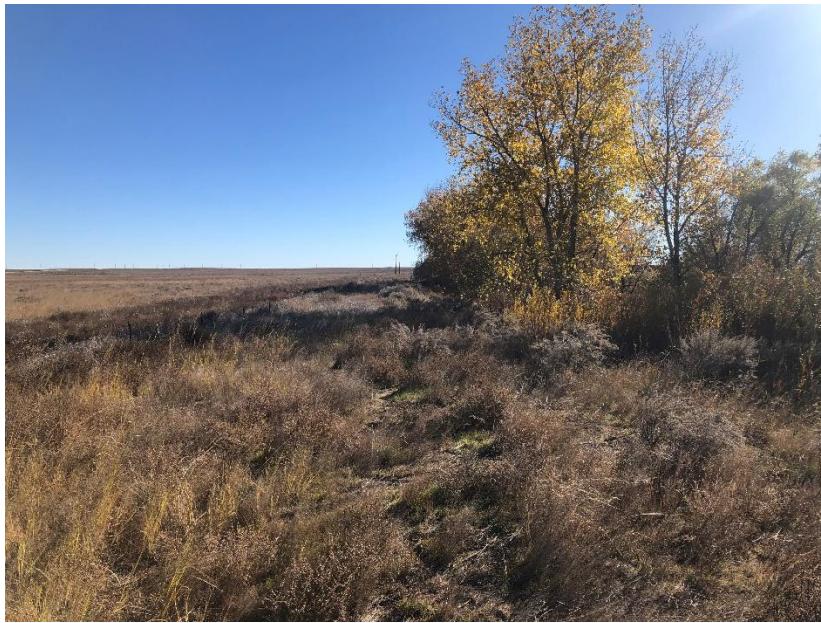
Sediment Pond 2 and the Dugout Pond contained no visible water; both ponds have large amounts of vegetation on their bottoms. Neither was discharging during the inspection, and there were no signs that the ponds had discharged recently. No problems were observed.

**Area below Sediment Pond 2**

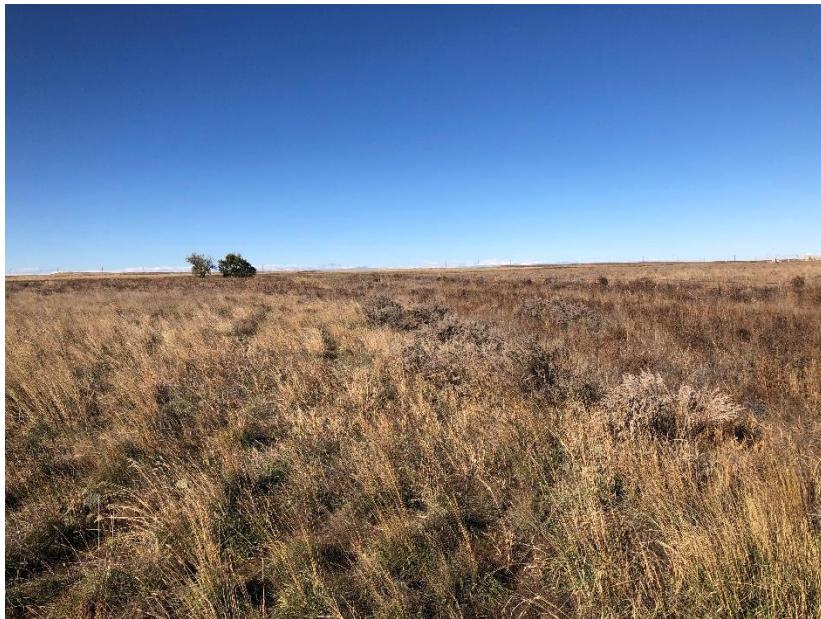
The ditch along the north boundary, which directs runoff to Sediment Pond 2, appears to be functioning well.

**North side of permit area, with ditch (looking west)**

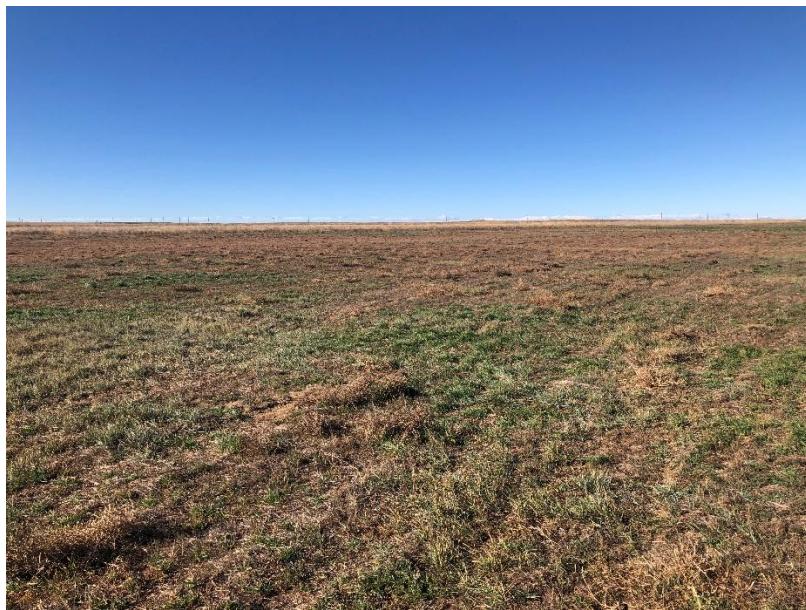
No Coors Energy Company (CEC) representative was present at the inspection, but Ben Moline of CEC was called via telephone at the end of the inspection. Mr. Moline indicated that the mowing that was performed at the site in the spring and summer of 2025 was done to address the large amount of cheat grass on the site.

As noted above, large areas of the permit have been mowed to address cheat grass. These include Areas 25, 34, 37, and 42. Area 42 includes reclaimed roads and adjacent areas.

**Mowed vegetation in Area 42 (west of Area 26)**

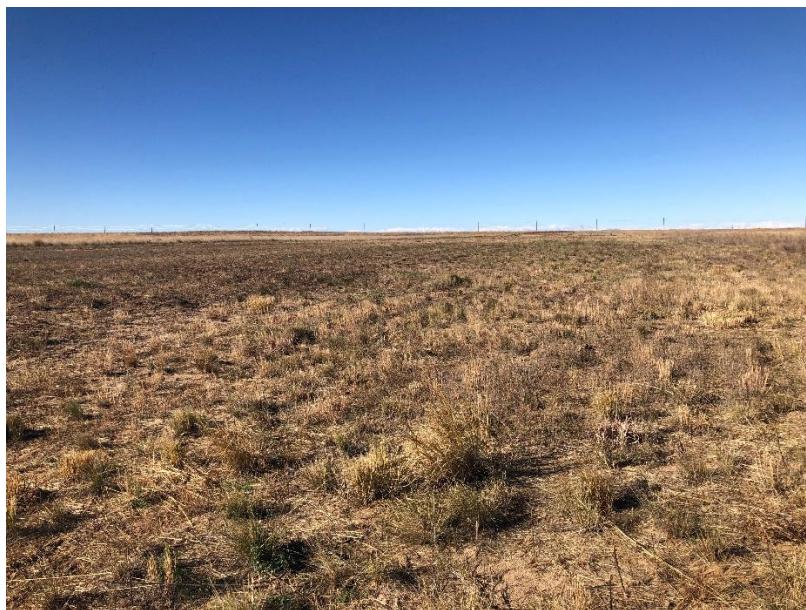
**Mowed vegetation in Area 37 (north central portion of site)**

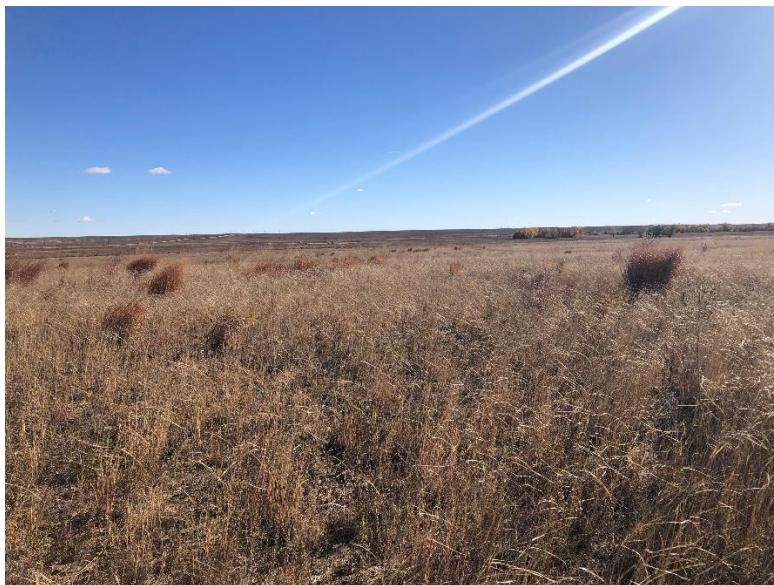
Across the site, vegetation cover was generally very good in areas that have not been mowed.

**Good vegetation cover in Area 43**

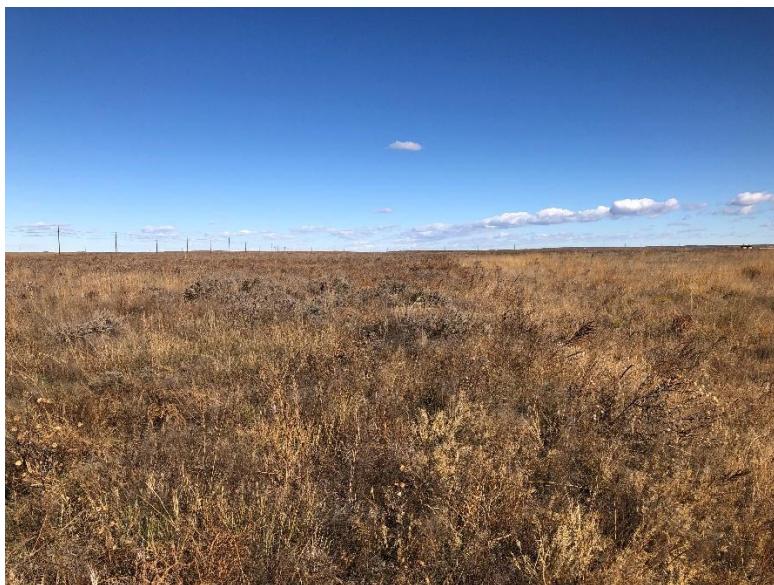
The entrance sign was in place and contained the necessary information. Boundary markers were observed on all sides of the site.

**Good cover at west side of site, looking north with reclaimed area on right  
(note white permit boundary markers)**

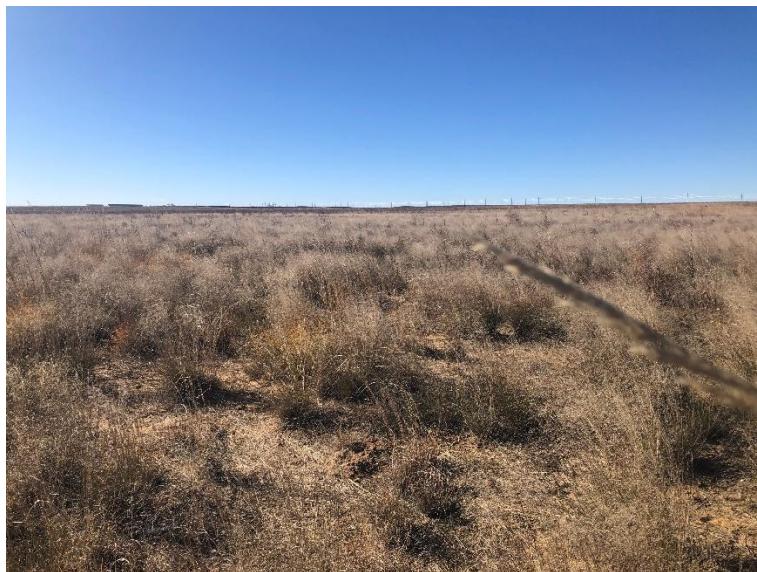
Looking south at good cover in Area 36 (reclaimed Long Term Spoil Area)

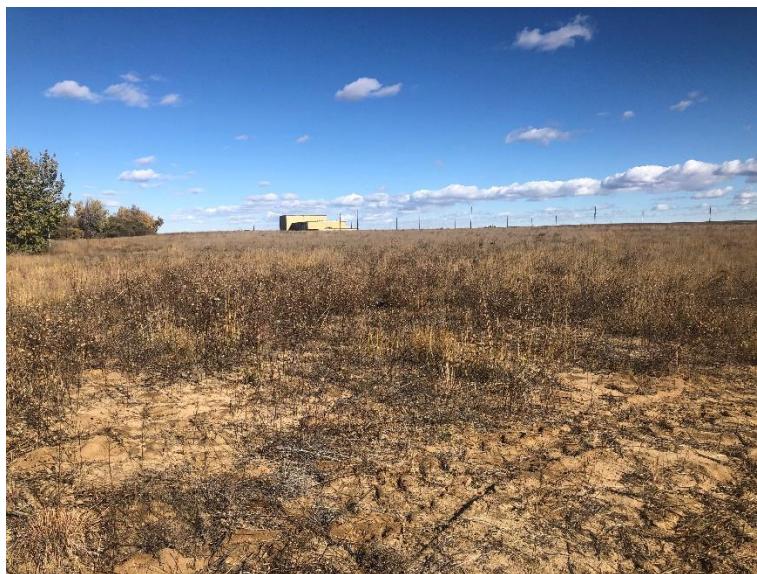
Looking north at good cover in Area 38 (south of facilities area)
