COLORADO DIVISION OF RECLAMATION, MINING AND SAFETY
MINERALS PROGRAM INSPECTION REPORT
PHONE: (303) 866-3567

MINE NAME: Fedinec Pit	MINE/PROSPECTING ID#: M-1977-057	MINERAL: Crushed stone mater	COUNTY: Moffat
INSPECTION TYPE: Monitoring	INSPECTOR(S): Dustin M. Czapl	INSP. DATE: March 27, 2012	INSP. TIME: 14:45
OPERATOR: Pioneer Sand Company Inc	OPERATOR REPRESENTATIVE: Shane Ridenour	TYPE OF OPERATION: 110c - Construction Limited Impact	
REASON FOR INSPECTION: Normal I&E Program	BOND CALCULATION TYPE: Complete Bond	BOND AMOUNT: \$15,500.00	
DATE OF COMPLAINT: NA	POST INSP. CONTACTS: None	JOINT INSP. AGENCY: None	
WEATHER: Clear	INSPECTOR'S SIGNATURE:

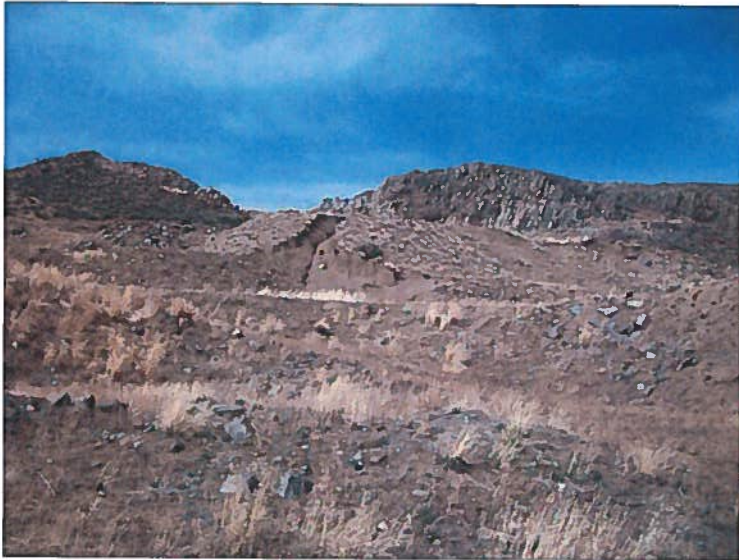
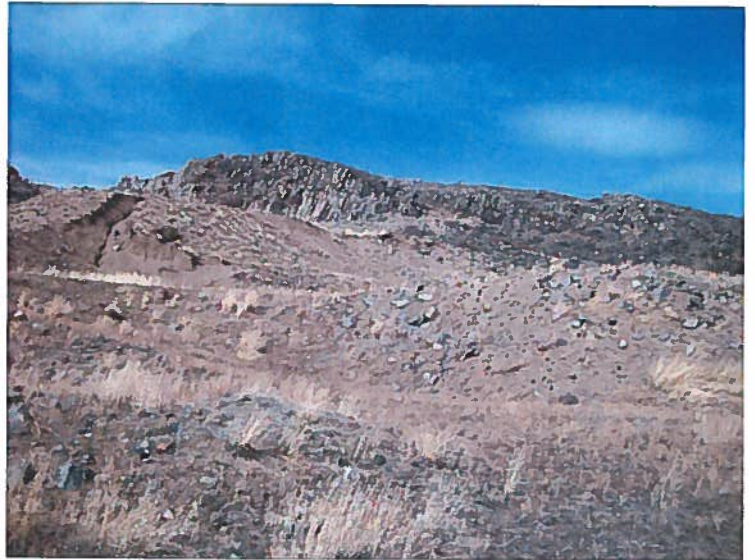
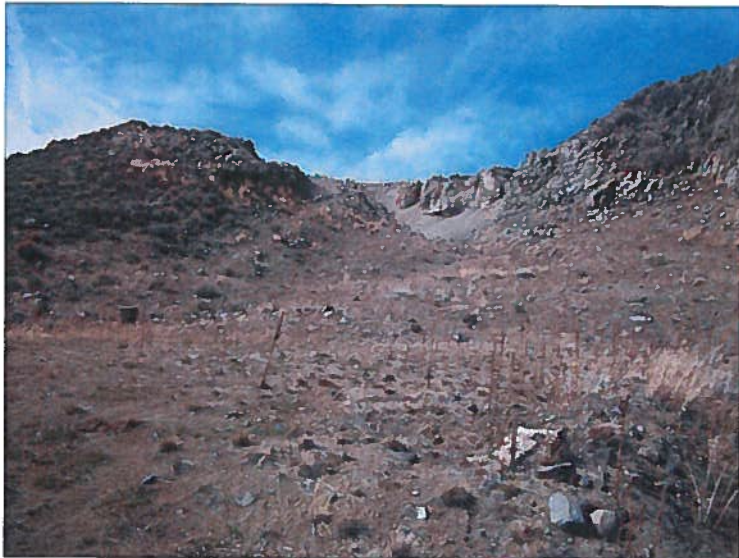
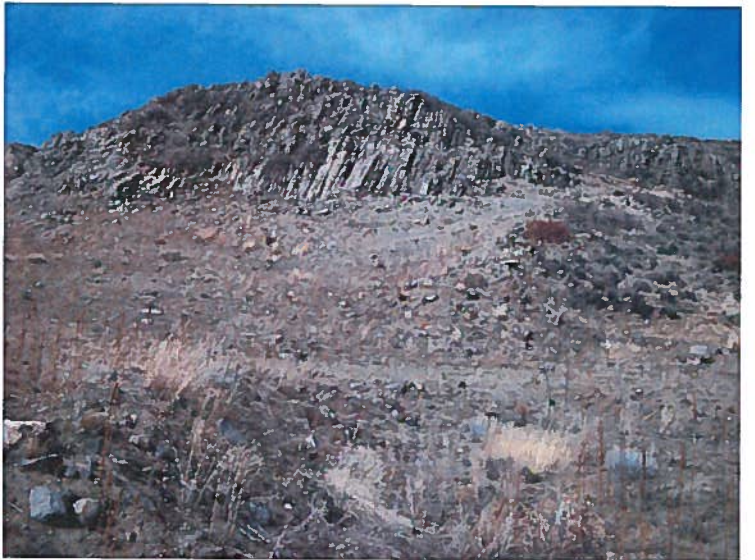
PHOTOGRAPHS

Little mining activity occurs at this site and reclamation of the site has not commenced. As described in past inspection reports, two benches have been created at the site with outcrops of approximately 2H:1V. Upon final reclamation the slopes will need to be reduced to 3H:1V.
