**COLORADO DIVISION OF RECLAMATION, MINING AND SAFETY
MINERALS PROGRAM INSPECTION REPORT
PHONE: (303) 866-3567**

MINE NAME: Reynolds Pit	MINE/PROSPECTING ID#: M-2006-028	MINERAL: Sand and gravel	COUNTY: Delta
INSPECTION TYPE: Monitoring	INSPECTOR(S): Travis H. Marshall	INSP. DATE: March 7, 2012	INSP. TIME: 13:00
OPERATOR: Eldon & Cornelia Reynolds	OPERATOR REPRESENTATIVE: Eldon Reynolds	TYPE OF OPERATION: 112c - Construction Regular Operation

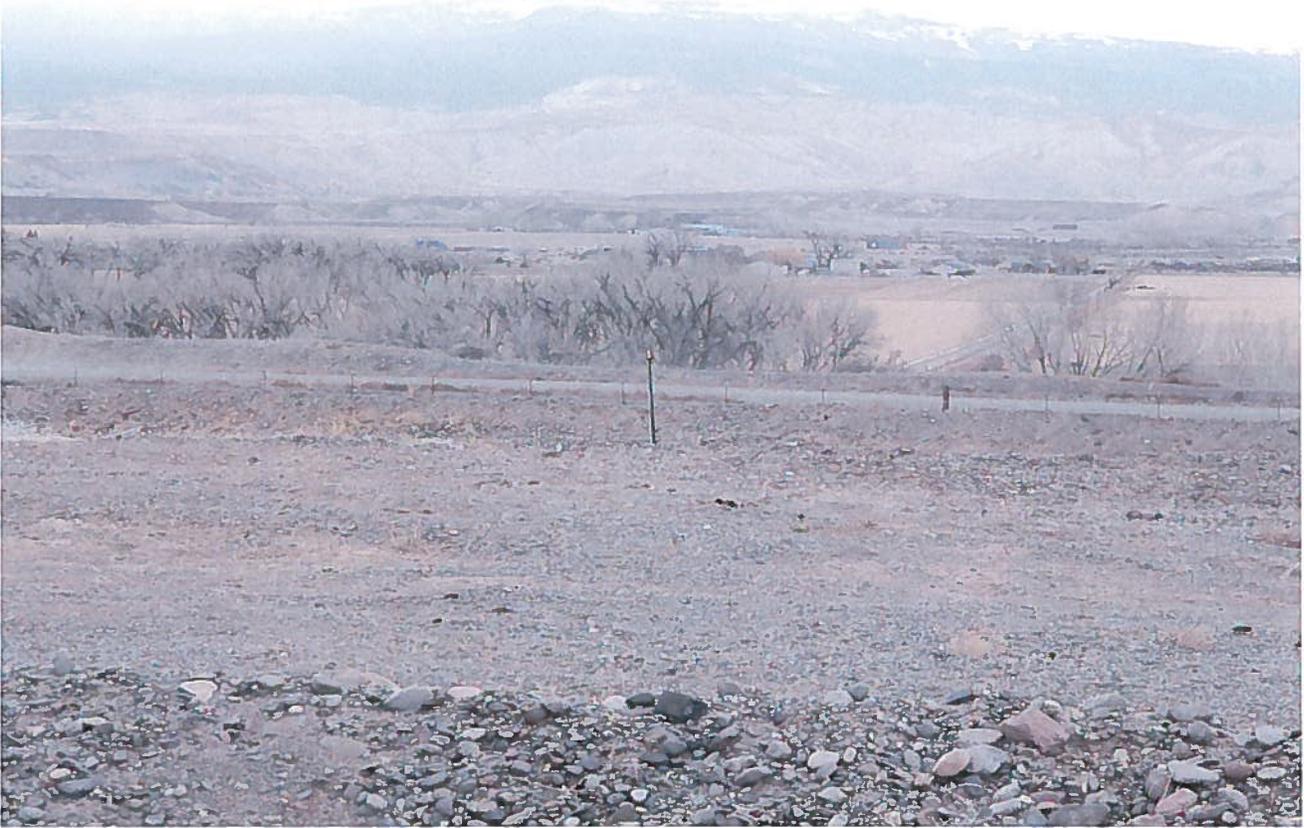
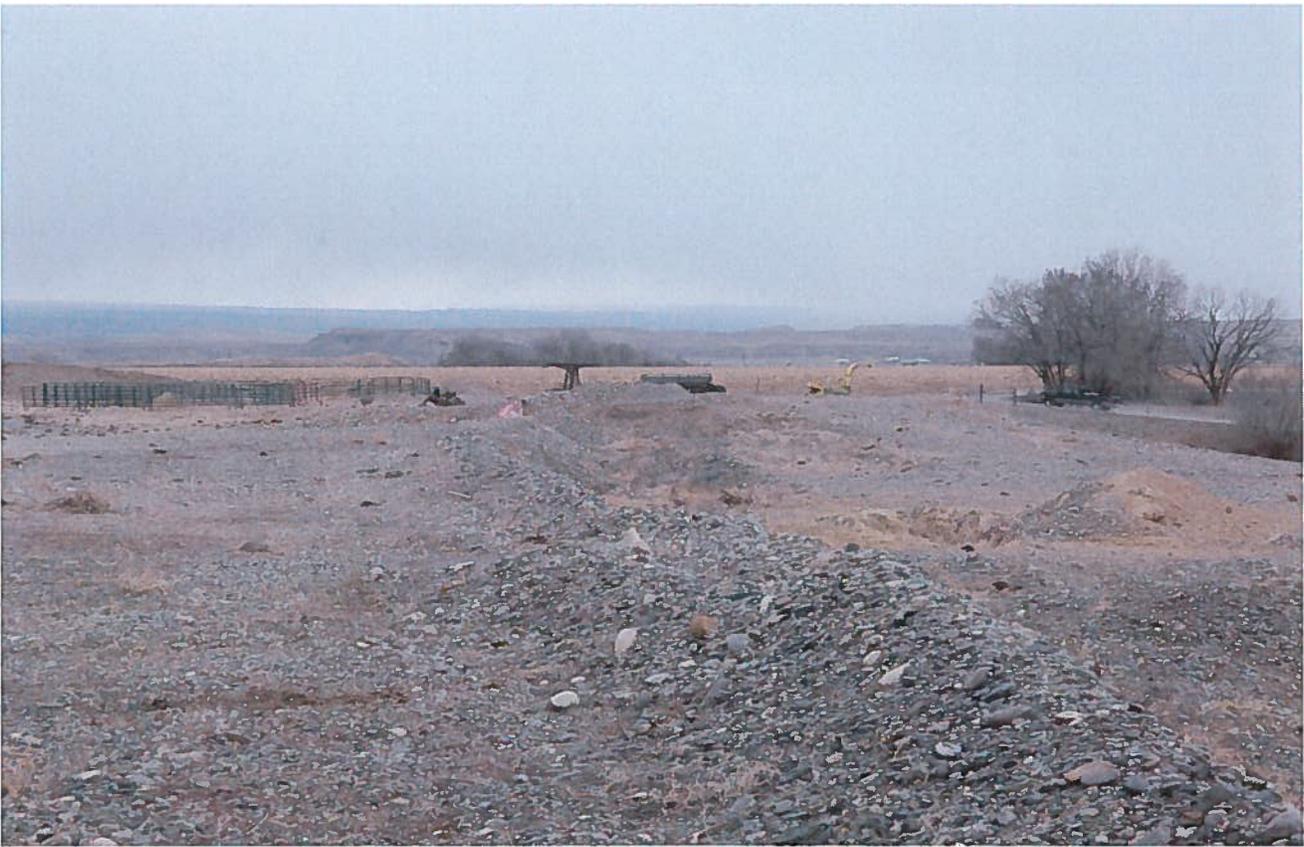
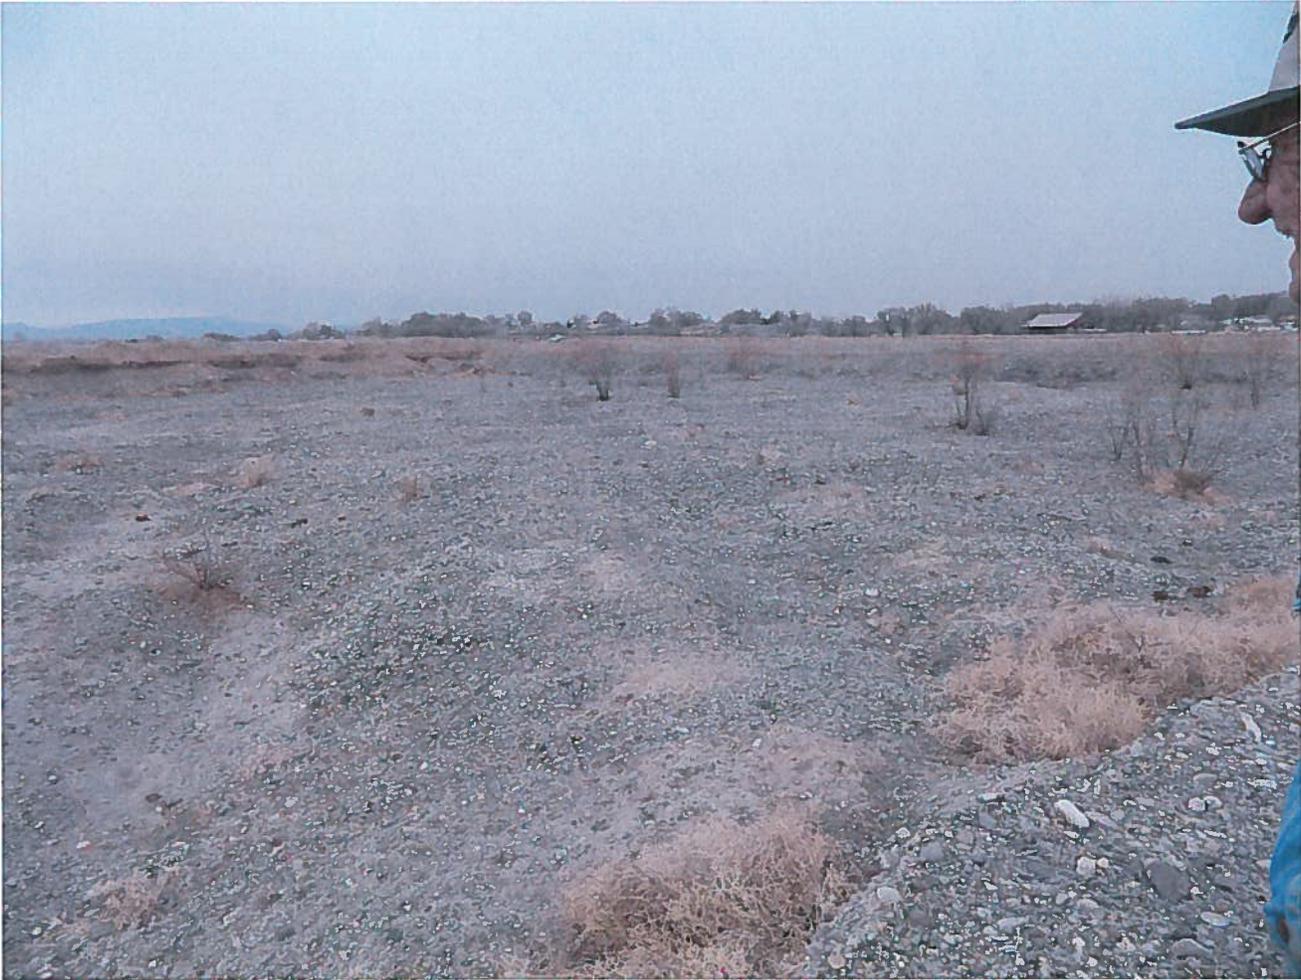
PHOTOGRAPHS

The mine was inactive during the inspection. Evidence of mining was observed in the northern portion of the permit area. The depth of excavation during the inspection was approximately 4-5 feet in depth and the area of disturbance was significantly less than the approved maximum disturbance limit of 18 acres.

A tamarisk infestation was observed within the affected area. The infestation, if not controlled, will most likely hinder and/or delay successful reclamation of this site and contribute to off-site spreading and establishment of tamarisk. The approved weed control plan is either not being implemented or is not effective in its current application. Please indicate what measures will be taken to improve weed control and, if appropriate, submit a technical revision to incorporate these measures into the permit no later than May 4, 2012. Weed infestation is not noted as a problem at this time due to the operator verbally committing to immediately initiating weed control during the inspection. However, if significant progress toward control of on-site weeds is not demonstrated, enforcement action will be initiated.
