COLORADO DIVISION OF RECLAMATION, MINING AND SAFETY
MINERALS PROGRAM INSPECTION REPORT
PHONE: (303) 866-3567

MINE NAME: Breeze Basin Sand & Gravel Pit	MINE/PROSPECTING ID#: M-2008-022	MINERAL: Sand and gravel	COUNTY: Moffat
INSPECTION TYPE: Monitoring	INSPECTOR(S): Dustin M. Czapl	INSP. DATE: March 28, 2012	INSP. TIME: 08:00
OPERATOR: 4B Land & Livestock LLC	OPERATOR REPRESENTATIVE: Gayle Lyman	TYPE OF OPERATION: 112c - Construction Regular Operation

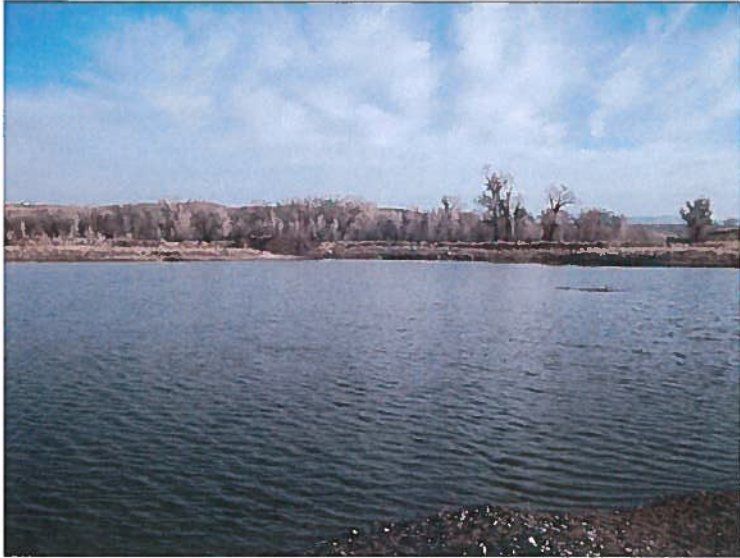
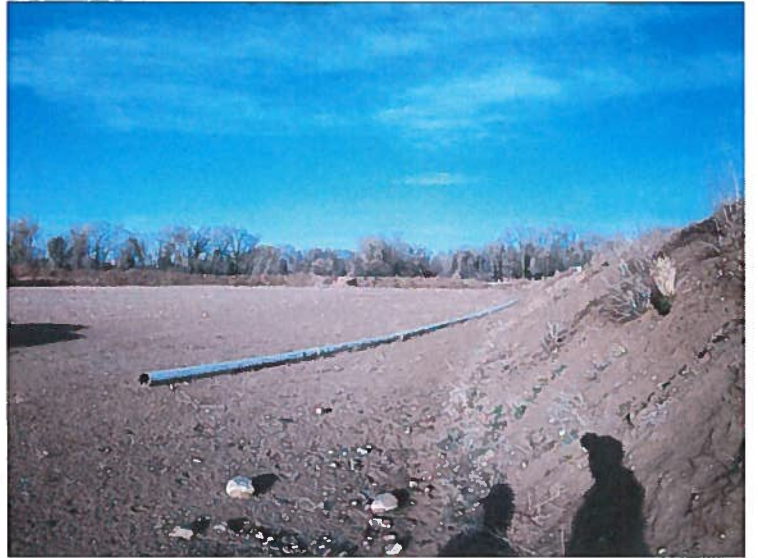
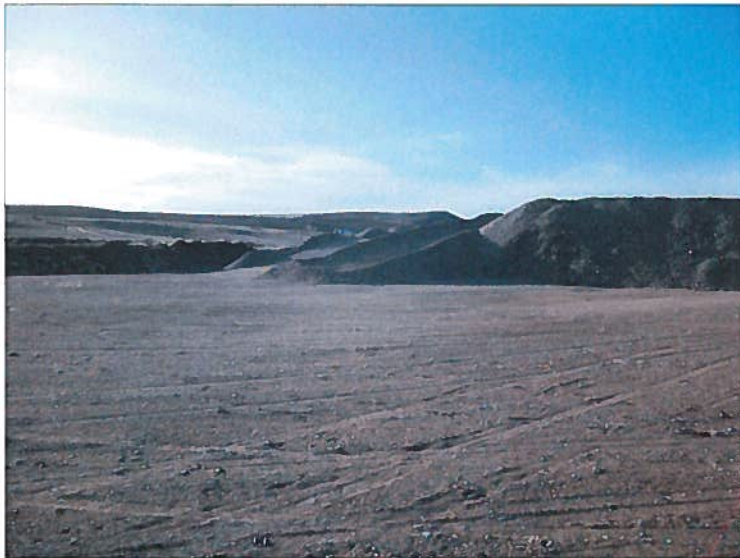
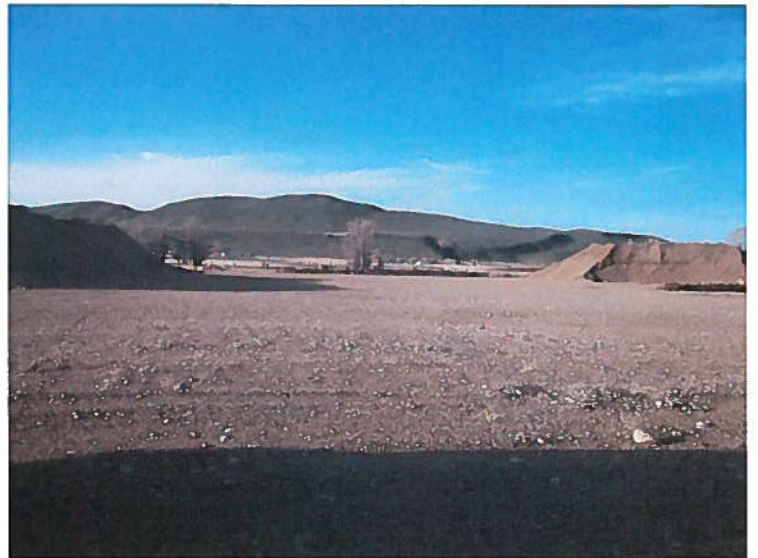
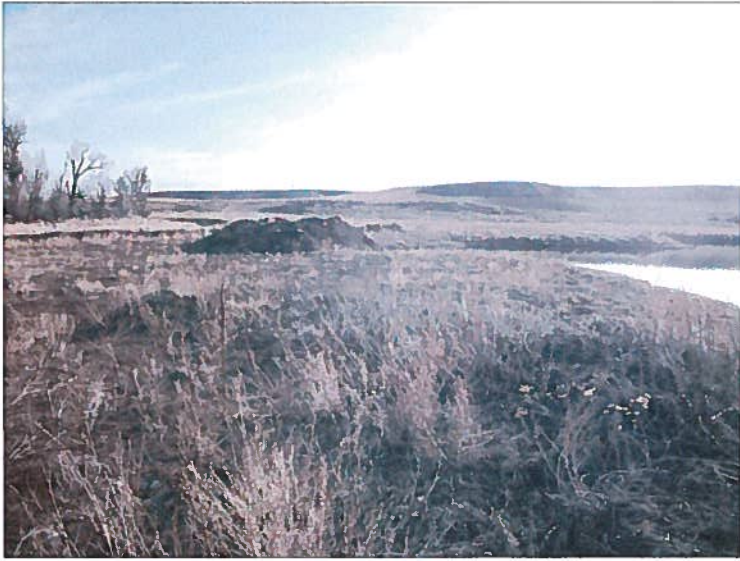
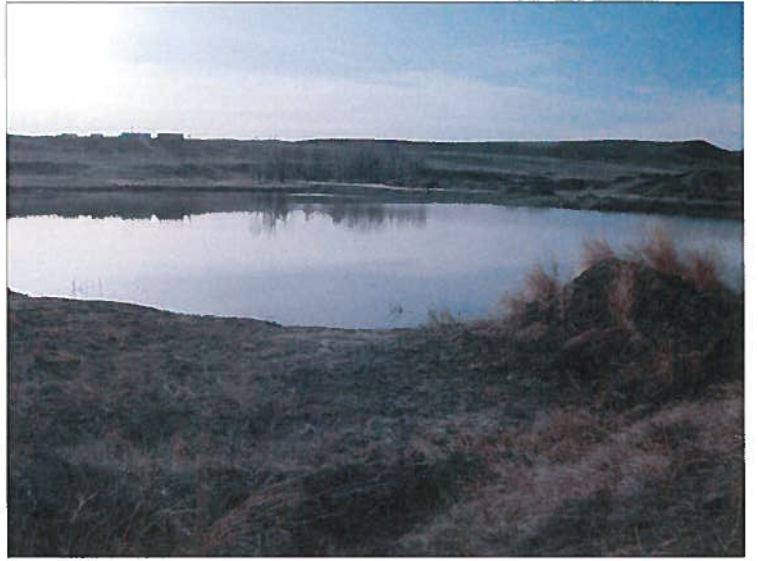
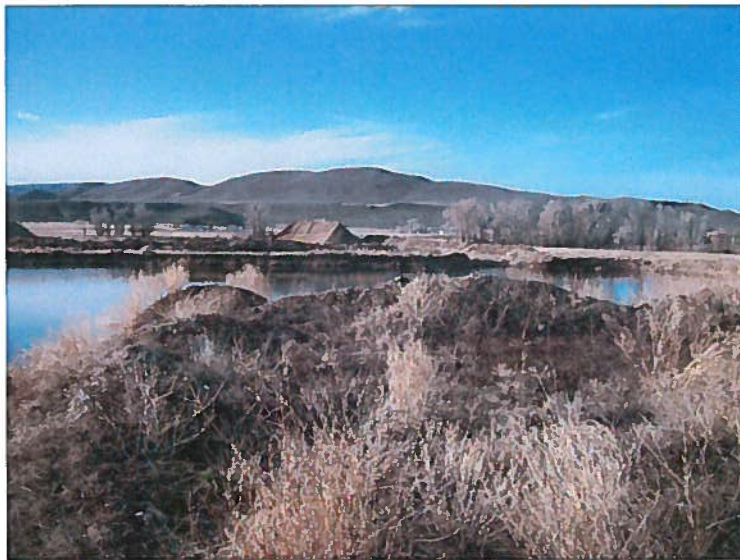
PHOTOGRAPHS

Adequate mine identification signage was noted at the entrance to the site.

The affected area was marked by fencing and t-posts that were clearly visible and adequate to delineate the affected area boundary.

Mining at the site is progressing from north to south. All but the southern pit slope had been graded to approximately 3H:1V or less steep. The south pit slope had been mined at approximately 2H:1V. The pond area included approximately 6-7 acres during this inspection.

The stockpile/processing area located south of the pit included approximately 6-7 acres. Stable topsoil stockpiles were located around this area.
