GRAND JUNCTION

The Division of Reclamation, Mining and Safety has conducted an inspection of the mining operation noted below. This report documents observations concerning compliance with the terms of the permit and applicable rules and regulations of the Mined Land Reclamation Board.

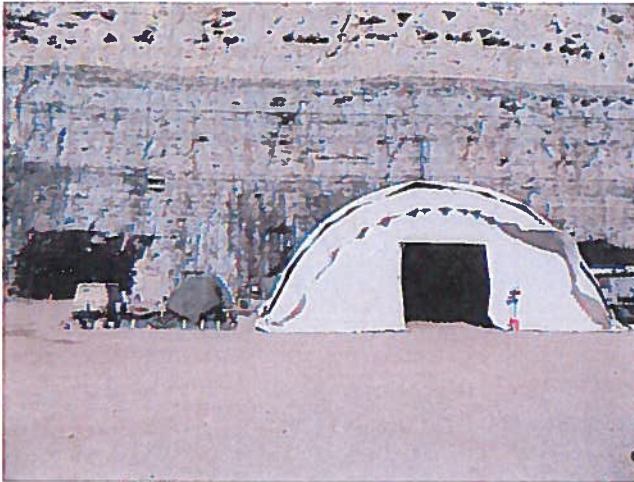
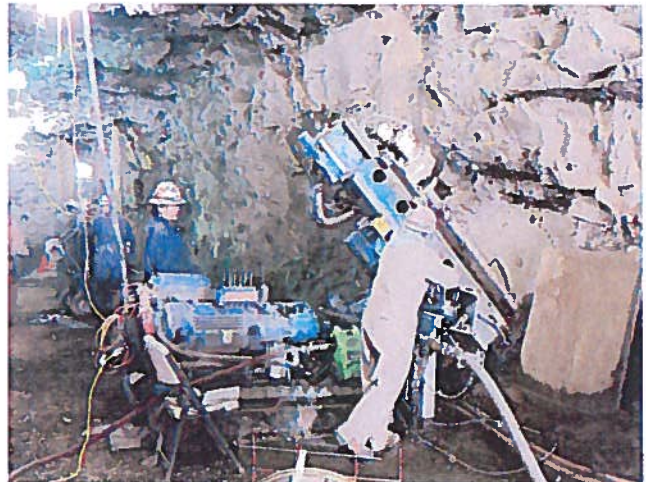
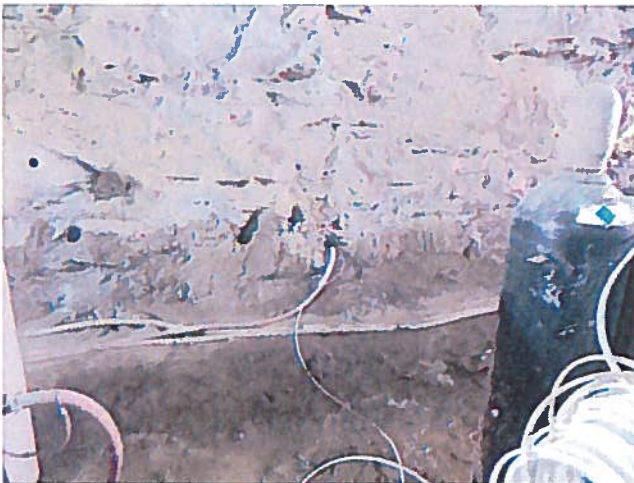
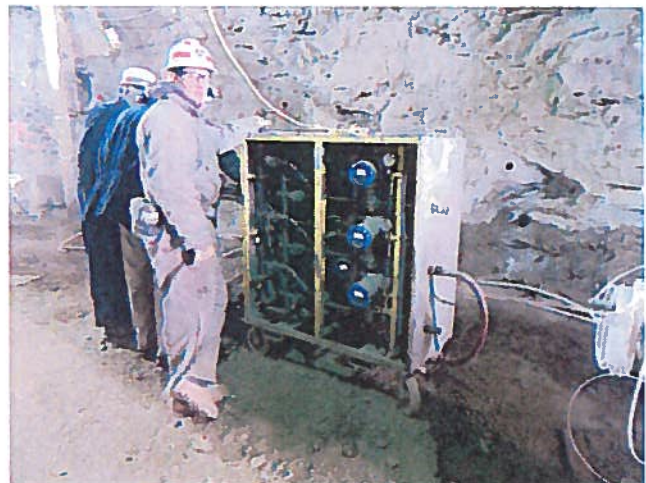
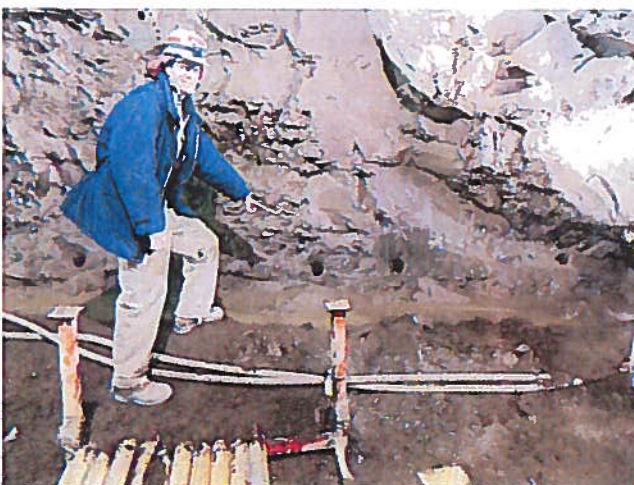
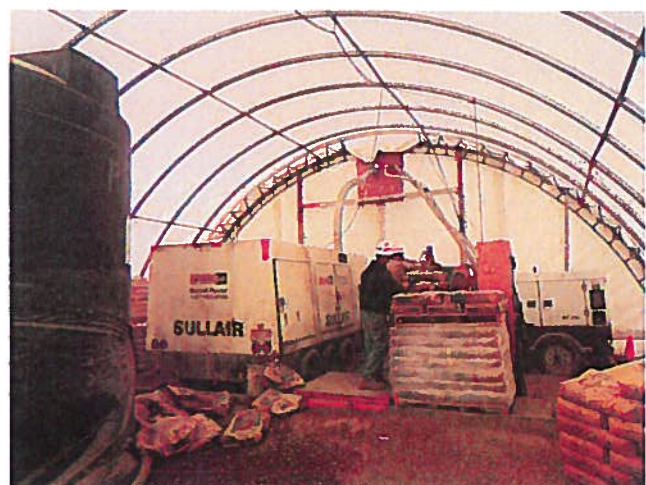
PHOTOGRAPHS

The drilling and grouting was being conducted from inside of the mine in the south drift. The purpose of the drilling and grouting was for the installation of the "grout curtain" that was approved in TR-15. The purpose of the grout feature is to isolate the A-Groove and B-Groove aquifers. The technicians performing the grouting stated that the grout was installed in 20 foot intervals and the pressure of grouting was approximately 60psi. Also, rock bolting of the north drift was being conducted during the inspection.
