COLORADO DIVISION OF RECLAMATION, MINING AND SAFETY
MINERALS PROGRAM INSPECTION REPORT
PHONE: (303) 866-3567

MINE NAME: Mooney Hills Permit	MINE/PROSPECTING ID#: M-2007-007	MINERAL: Aggregate	COUNTY: Las Animas
INSPECTION TYPE: Monitoring	INSPECTOR(S): T C. Wait	INSP. DATE: June 19, 2012	INSP. TIME: 15:15
OPERATOR: Mullett Excavating, L.L.C.	OPERATOR REPRESENTATIVE: Phil Crum	TYPE OF OPERATION: 110c - Construction Limited Impact	
REASON FOR INSPECTION: Normal I&E Program	BOND CALCULATION TYPE: None	BOND AMOUNT: \$15,000.00	
DATE OF COMPLAINT: NA	POST INSP. CONTACTS: None	JOINT INSP. AGENCY: None	
WEATHER: Clear, hot, dry	INSPECTOR'S SIGNATURE:

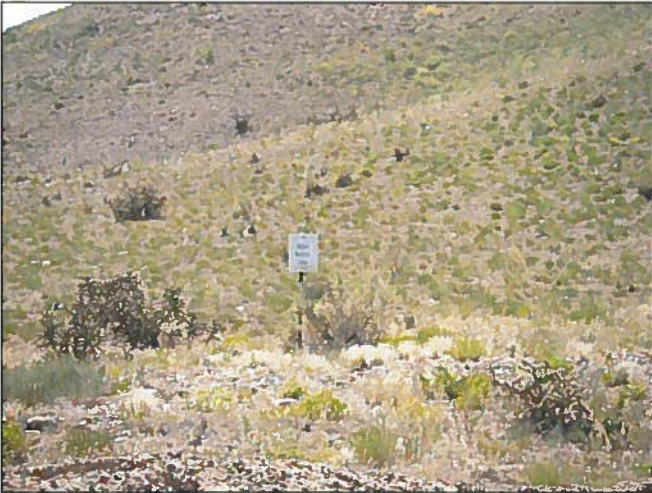
The site was not marked with a permit sign. The operator was advised to place permit signs (for both permitted mines) at the entrance. Visible permit boundary markers were in place.

Photo 1. Permit boundary marker

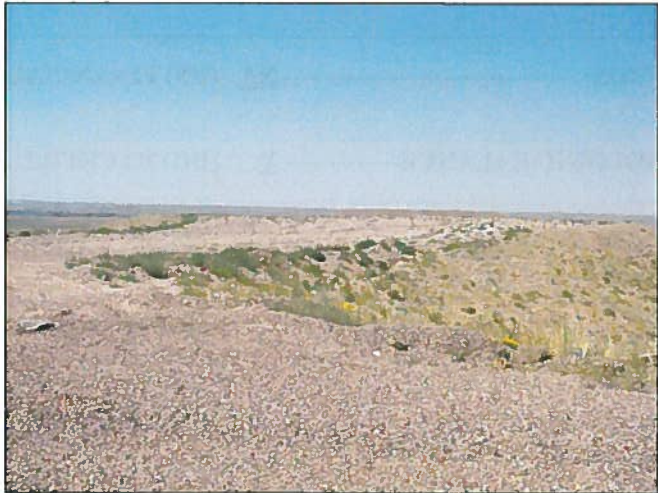
Photo 2. Looking north at mined area.

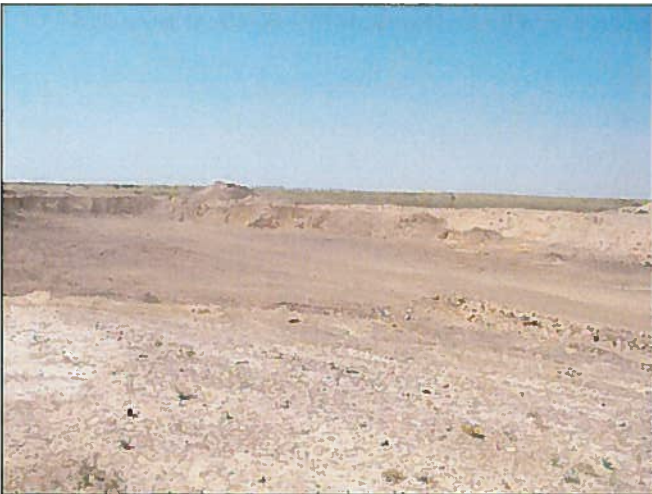
At the time of the inspection, the ground was dry. The site is actively being mined and no reclamation efforts have been conducted. Mr. Crum indicated that the average mining depth is about 8 feet. Mr. Crum estimates approximately 60k tons of material are stockpiled onsite.

Photo 3. Area of active mining, approx. 8 ft deep.

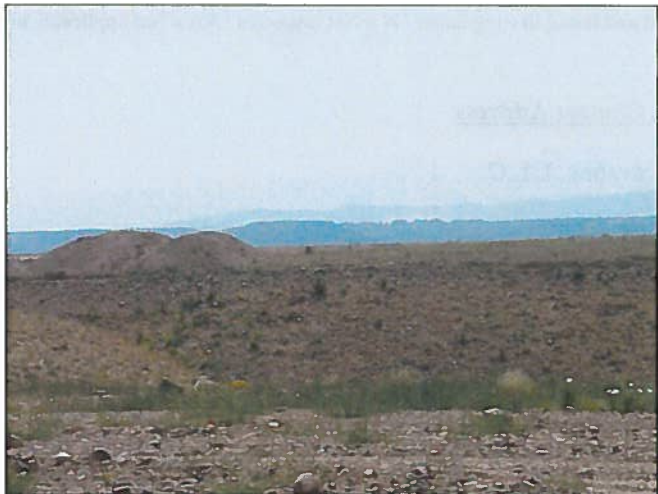
The permit area is approximately 9.9 acres and was accessed by vehicle. The site is adjacent to the Mooney 5804 Altura Pit (M-2010-012) also operated by Mullet Excavating. Currently the majority of mine operations are on the Mooney Hills permit area, with some in the eastern section of the Altura area. There is no delineation between the two permit areas. The total area for both pits is approximately 125 acres.

Photo 4. Mooney Hills area looking east from the Altura permit area.
