COLORADO DIVISION OF RECLAMATION, MINING AND SAFETY
MINERALS PROGRAM INSPECTION REPORT
PHONE: (303) 866-3567

MINE NAME: 120th Estates Partners	MINE/PROSPECTING ID#: M-2001-085	MINERAL: Sand and gravel	COUNTY: Adams
INSPECTION TYPE: Monitoring	INSPECTOR(S): Berhan M. Keffelew	INSP. DATE: August 30, 2012	INSP. TIME: 1330
OPERATOR: GSL/Brush LLC	OPERATOR REPRESENTATIVE: Eric Fensterlaw and Dan Schulejann	TYPE OF OPERATION: 112c - Construction Regular Operation

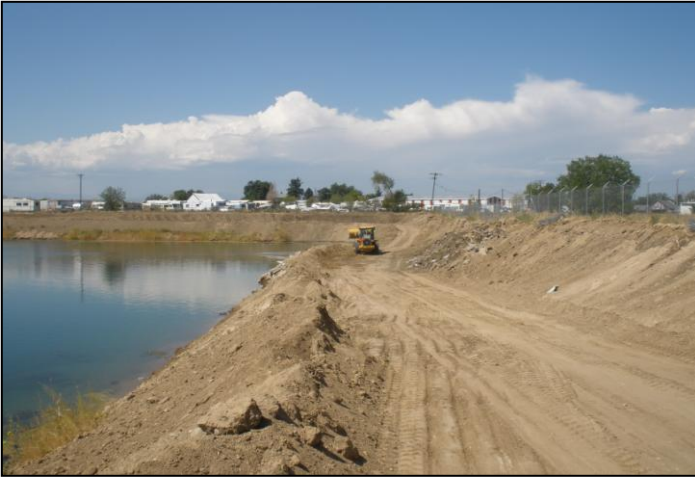
Figure 1 Looking west at the repaired embankment

- 1) The Division conducted a compliance inspection of the site on August 30, 2012. During the complaint inspection conducted on May 5, 2012, the Division had identified a possible problem for failure to protect areas from slides. The embankment along the north side of the pond was observed with a failure surface at the time of the May inspection. The Division did not want the failure surface to encroach on to an adjacent road, outside of the permit area and requested the repair work to be completed by August 30, 2012. This inspection was conducted to verify the proper completion of the repair work.

- 2) As requested, the operator has completed all the repair work and armored the embankment so it will remain stable.
- 3) The operator is expected to submit an amendment to the permit by September 30, 2012. The amendment will purpose to change the post mining land use from the current water storage to a backfilled dry pit.

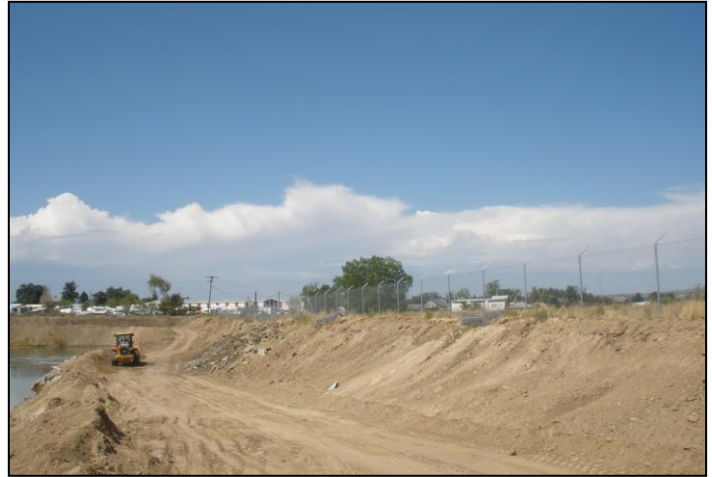
Figure 2 A close up look of the repaired embankment
