COLORADO DIVISION OF RECLAMATION, MINING AND SAFETY
MINERALS PROGRAM INSPECTION REPORT
PHONE: (303) 866-3567

MINE NAME: Toltec No 2	MINE/PROSPECTING ID#: M-1984-039	MINERAL: Silver, gold, copper,	COUNTY: San Juan
INSPECTION TYPE: Monitoring	INSPECTOR(S): Wallace H. Erickson	INSP. DATE: September 25, 2012	INSP. TIME: 09:30
OPERATOR: Wilbur F Benham	OPERATOR REPRESENTATIVE: Jim Lokey	TYPE OF OPERATION: 110(2) - Hard Rock Limited Impact

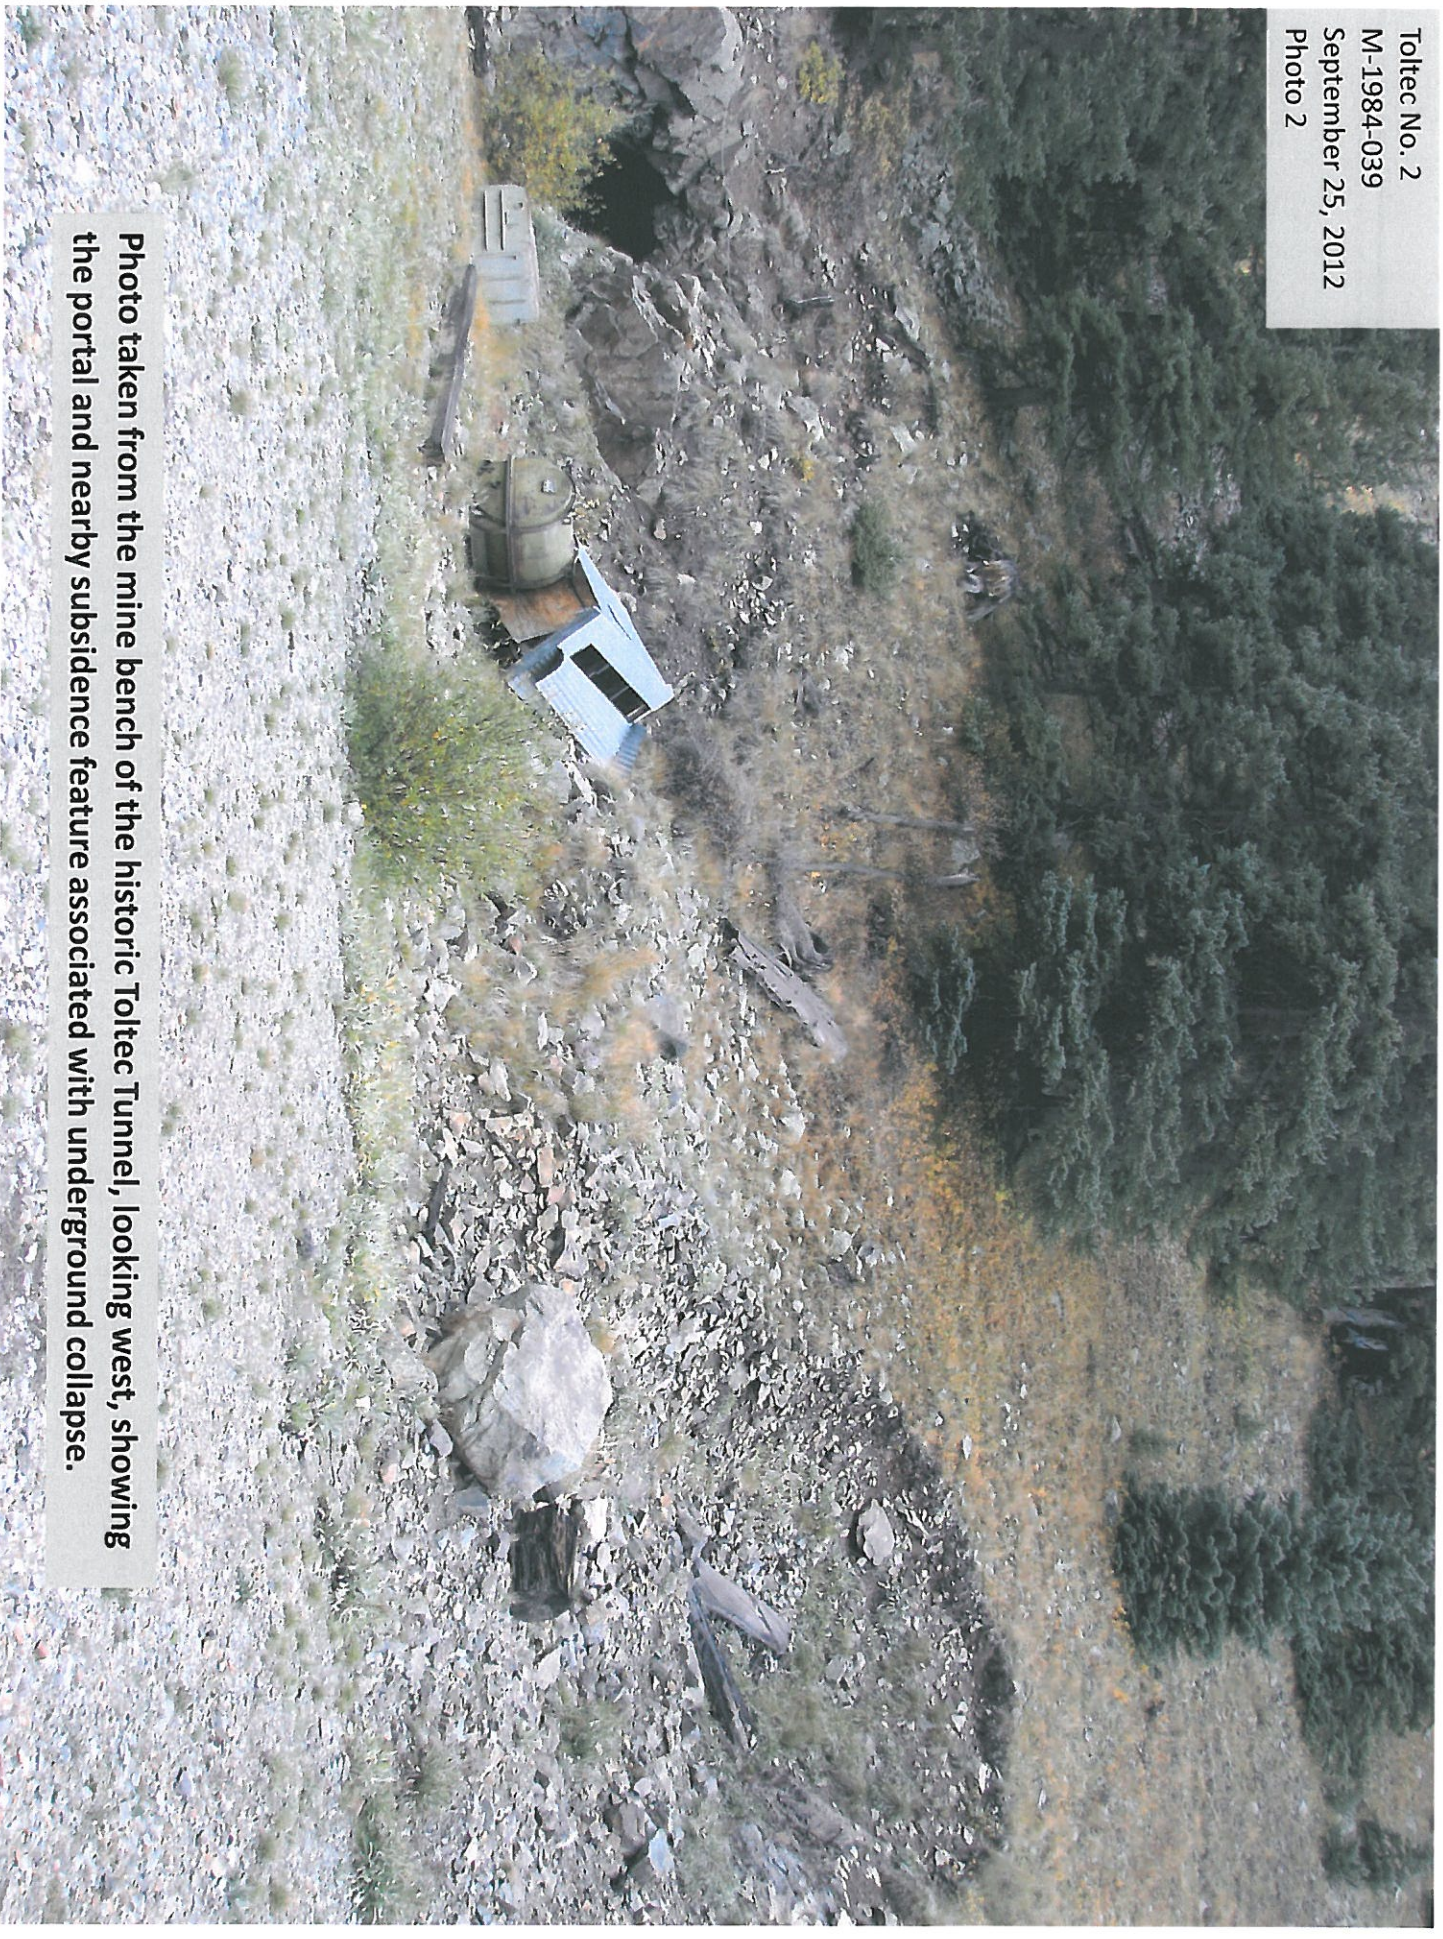
Toltec No. 2
M-1984-039
September 25, 2012
Photo 2

Photo taken from the mine bench of the historic Toltec Tunnel, looking west, showing the portal and nearby subsidence feature associated with underground collapse.

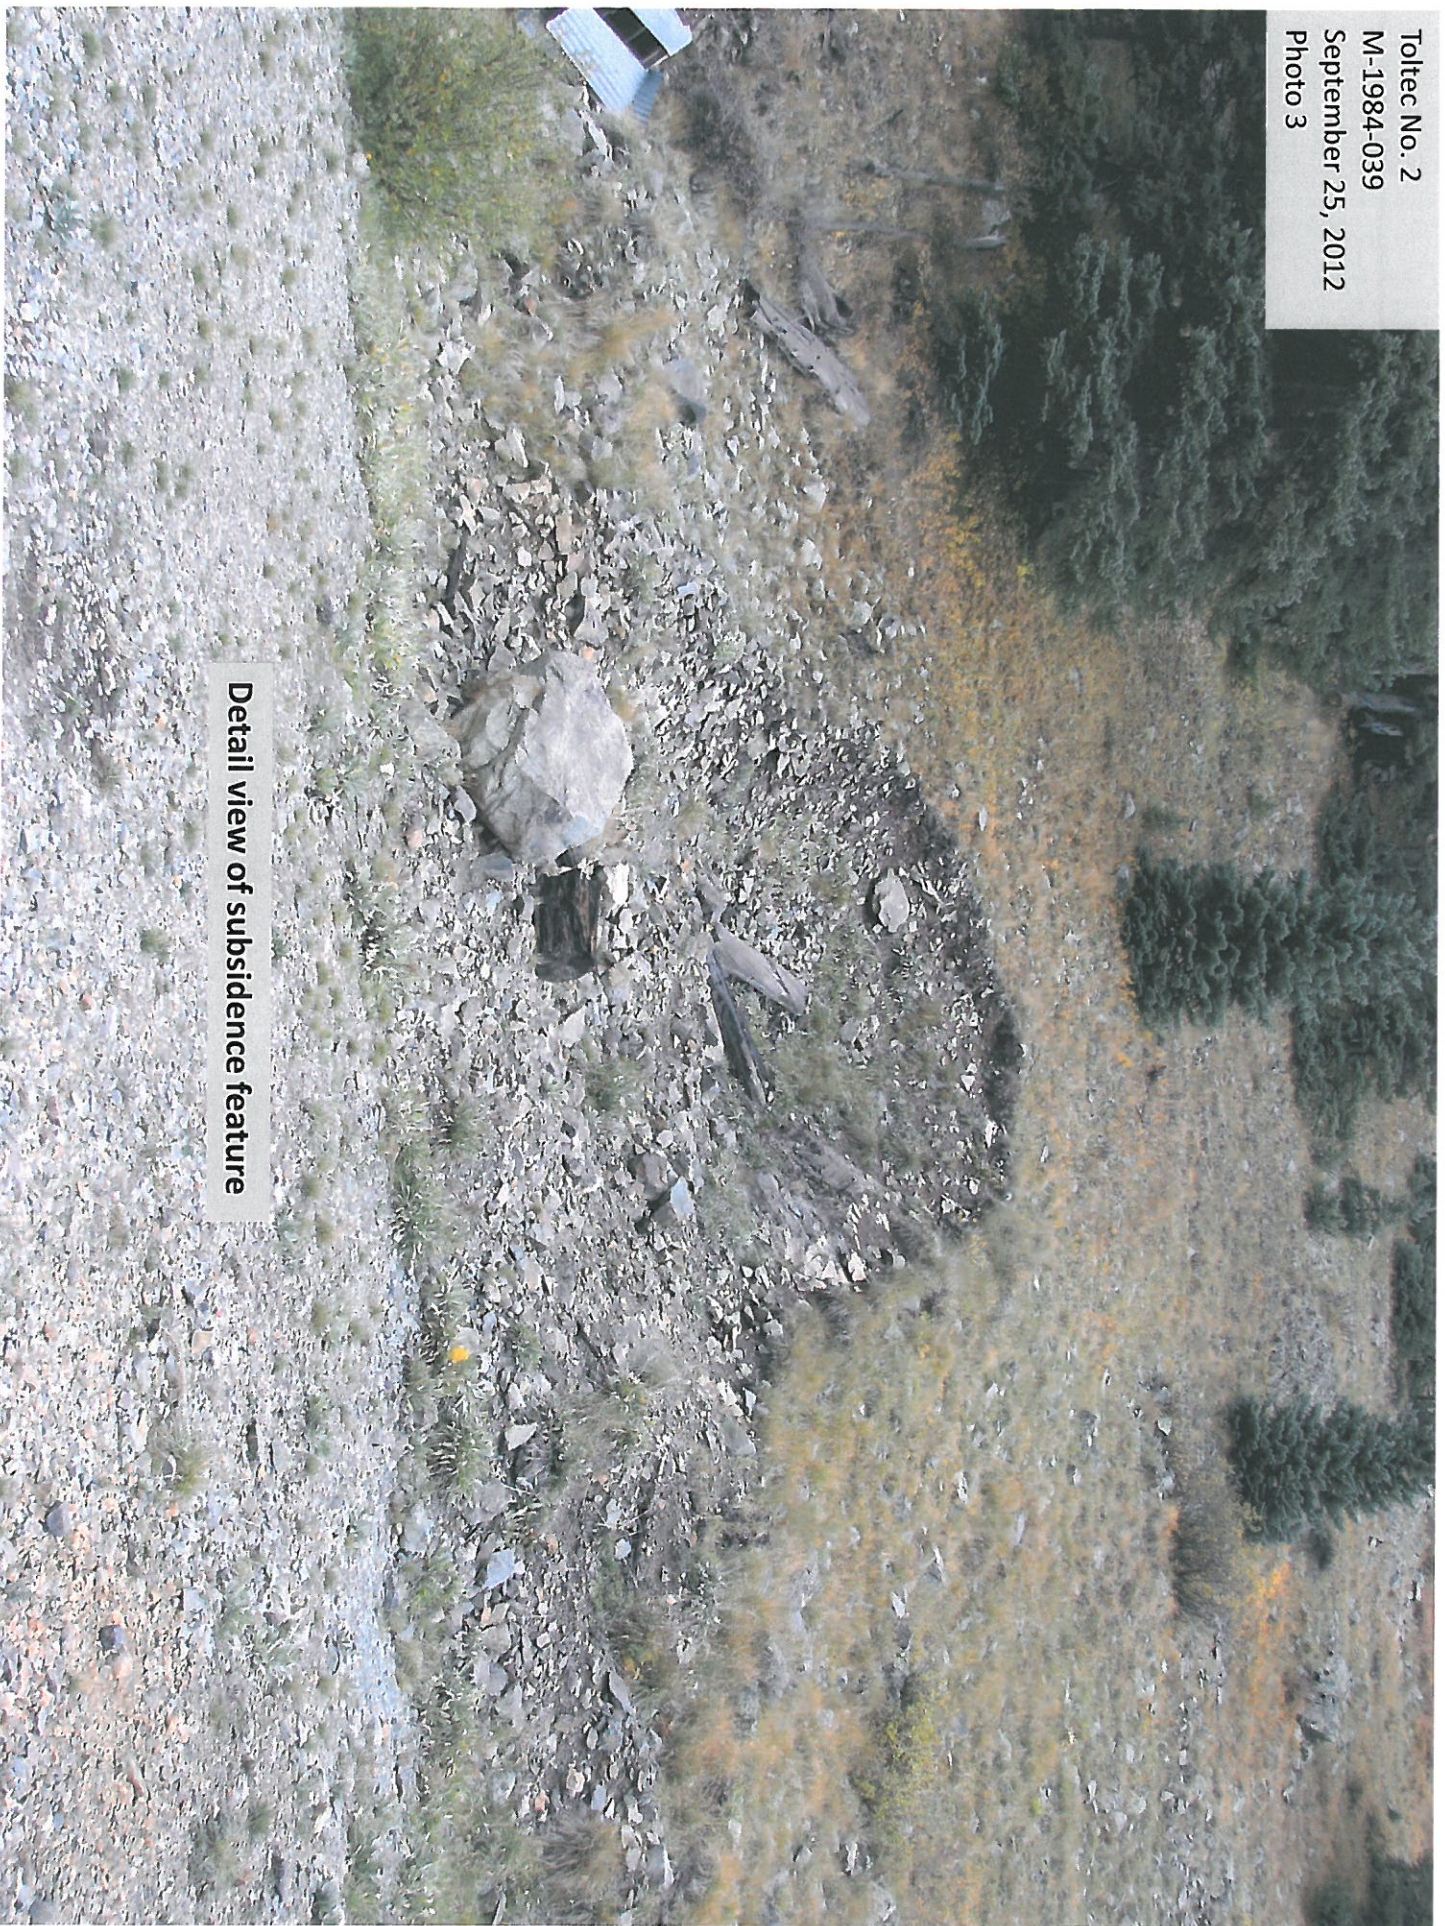
Toltec No. 2
M-1984-039
September 25, 2012
Photo 3

Detail view of subsidence feature

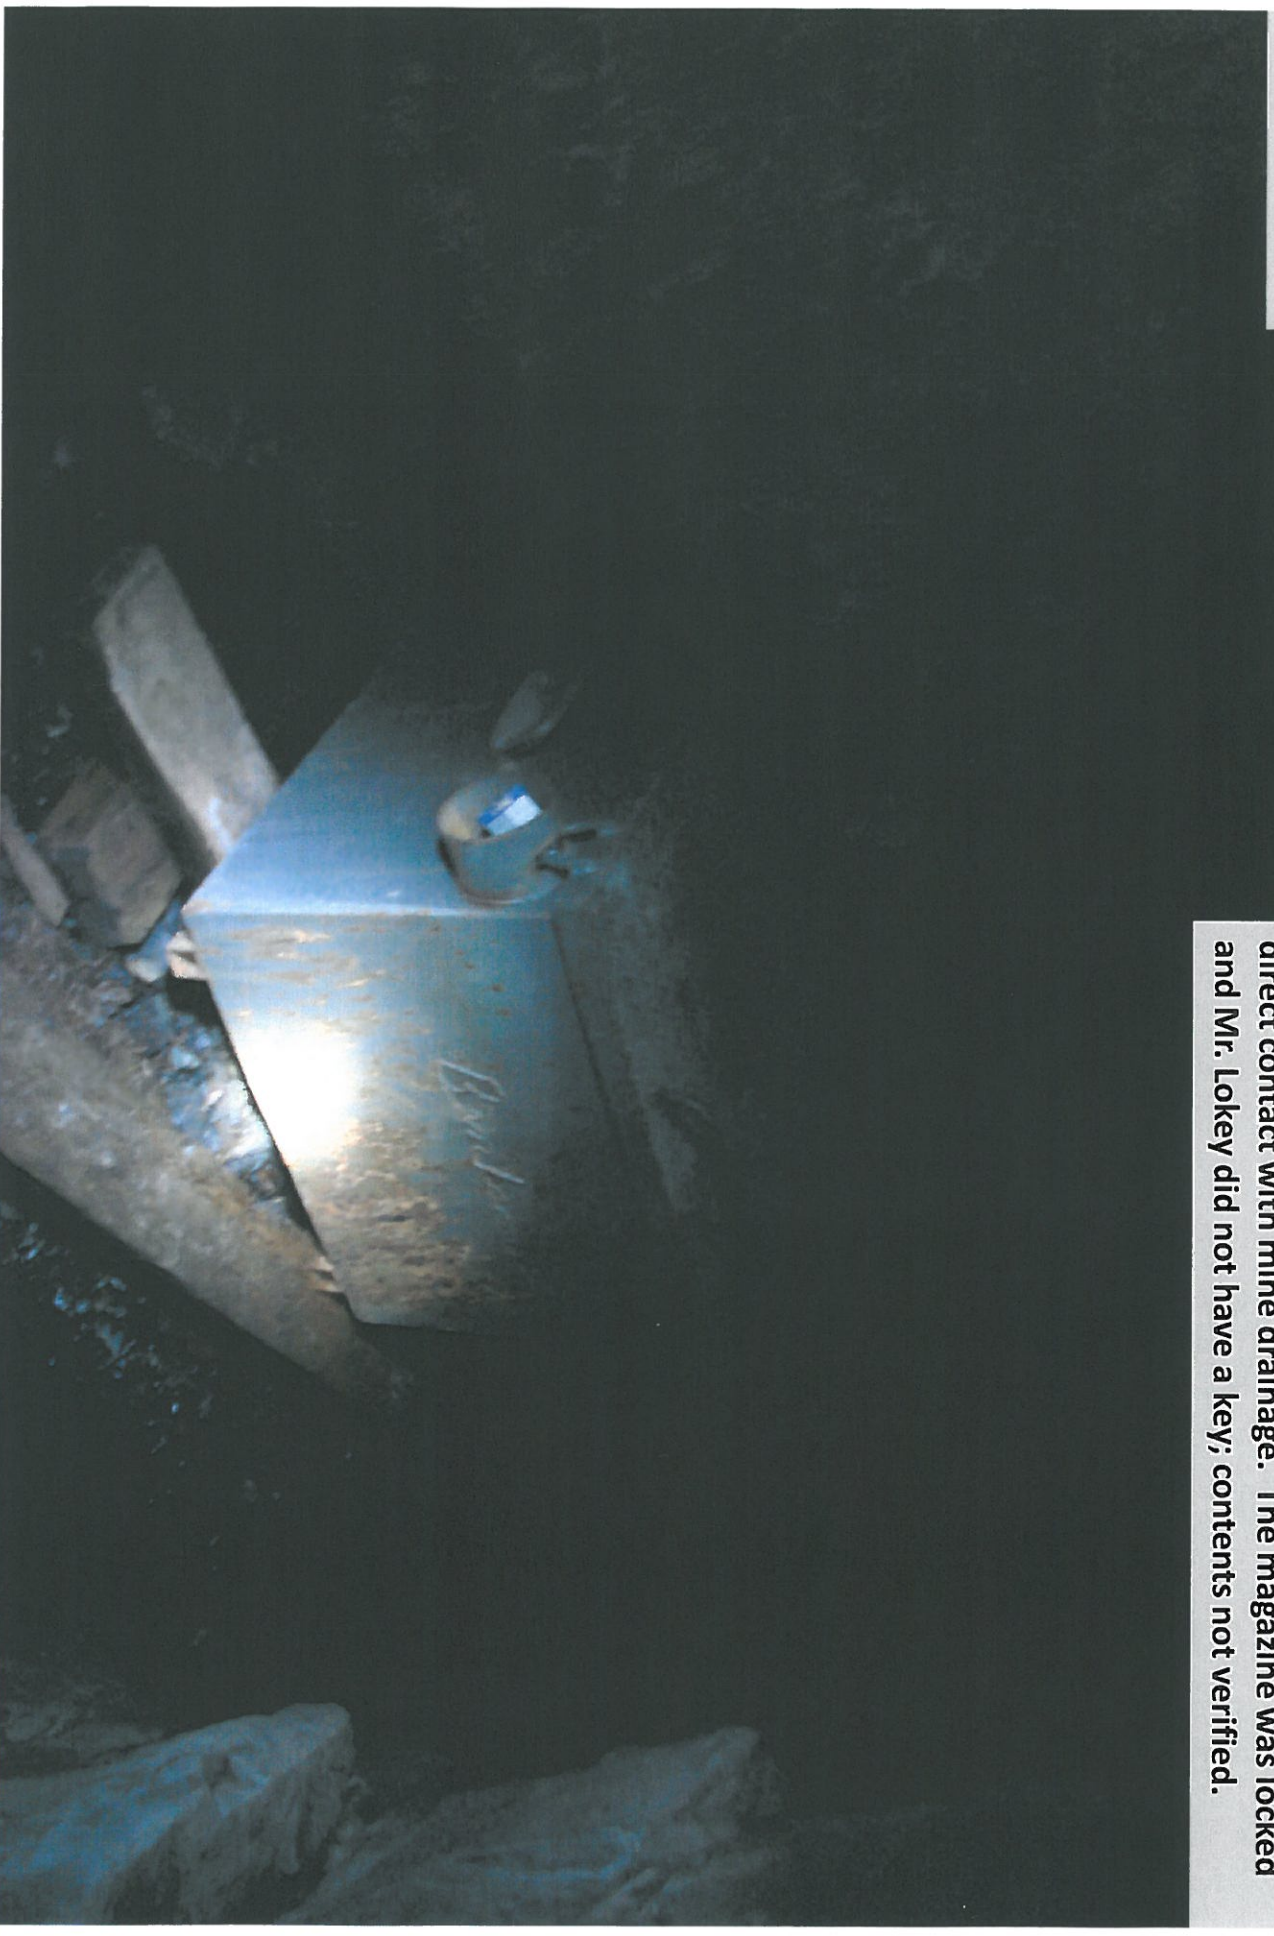
Toltec No. 2
M-1984-039
September 25, 2012
Photo 7

A second magazine was located approximately 30 feet in from the portal, at a T-intersection in the underground workings. The second magazine was set on mine timbers and not in direct contact with mine drainage. The magazine was locked and Mr. Lokey did not have a key; contents not verified.
