COLORADO DIVISION OF RECLAMATION, MINING AND SAFETY
MINERALS PROGRAM INSPECTION REPORT
PHONE: (303) 866-3567

MINE NAME: Mineral Joe Claims	MINE/PROSPECTING ID#: M-1977-284	MINERAL: Uranium and vanadium	COUNTY: Montrose
INSPECTION TYPE: Monitoring	INSPECTOR(S): Dustin Czapla, Russ Means	INSP. DATE: October 2, 2012	INSP. TIME: 13:10
OPERATOR: Cotter Corporation	OPERATOR REPRESENTATIVE: Glen Williams	TYPE OF OPERATION: 110d - Designated Limited Impact

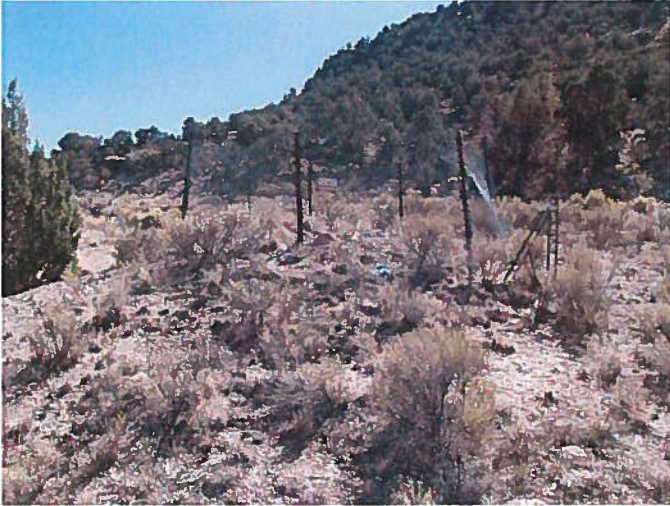
The shaft in this area was fenced off. Vegetation in this area was well established. No problems or violations were noted.

Figure 1: Mineral Joe 12 shaft.

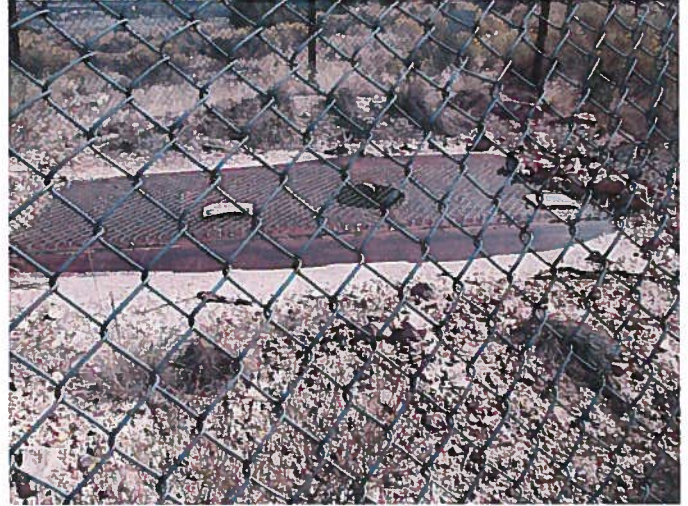
Figure 2: Mineral Joe 12 shaft.

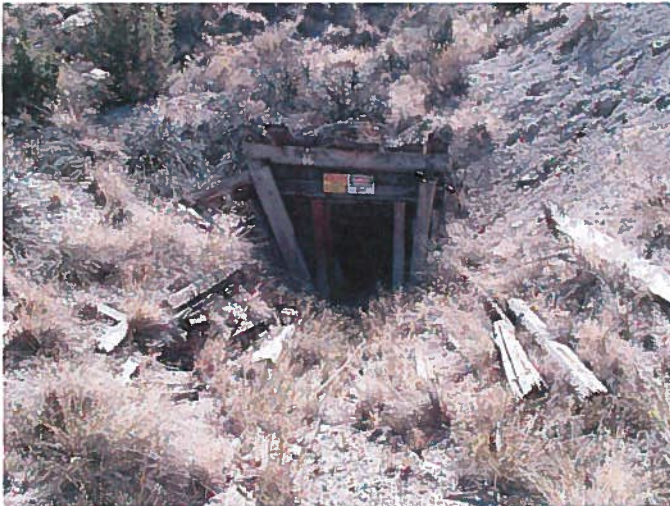
The escapeway remained caved-in. Final grading of the waste dump area has been completed. The area appeared stable. Adequate vegetation has not yet been established.

Figure 3: Mineral Joe 2 portal.

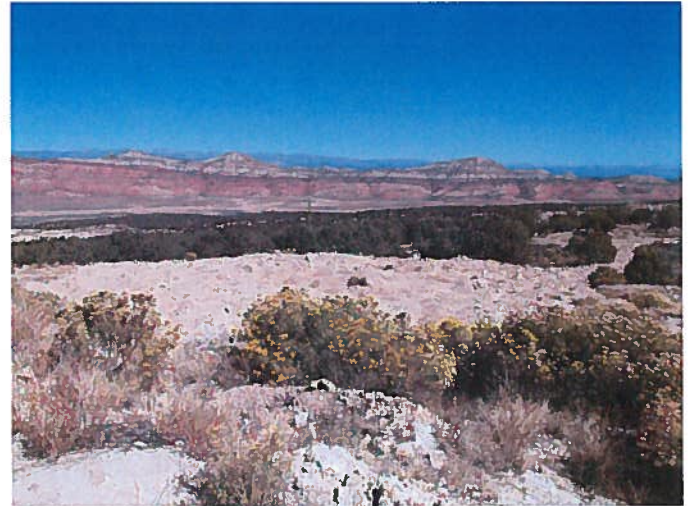
Figure 4: Mineral Joe 2 waste dump area.
