## **Executive Summary**

**Purpose:** Evaluate the cement bond in the well HW-8105.

**General:** The well HW-8105 is a heater well and has a 7-5/8", 26.4# casing from surface to 2128ft. CBL-VDL and Isolation Scanner Logs were run from 2128ft to surface. A combined CBL-VDL and Isolation Scanner presentation is in this report.

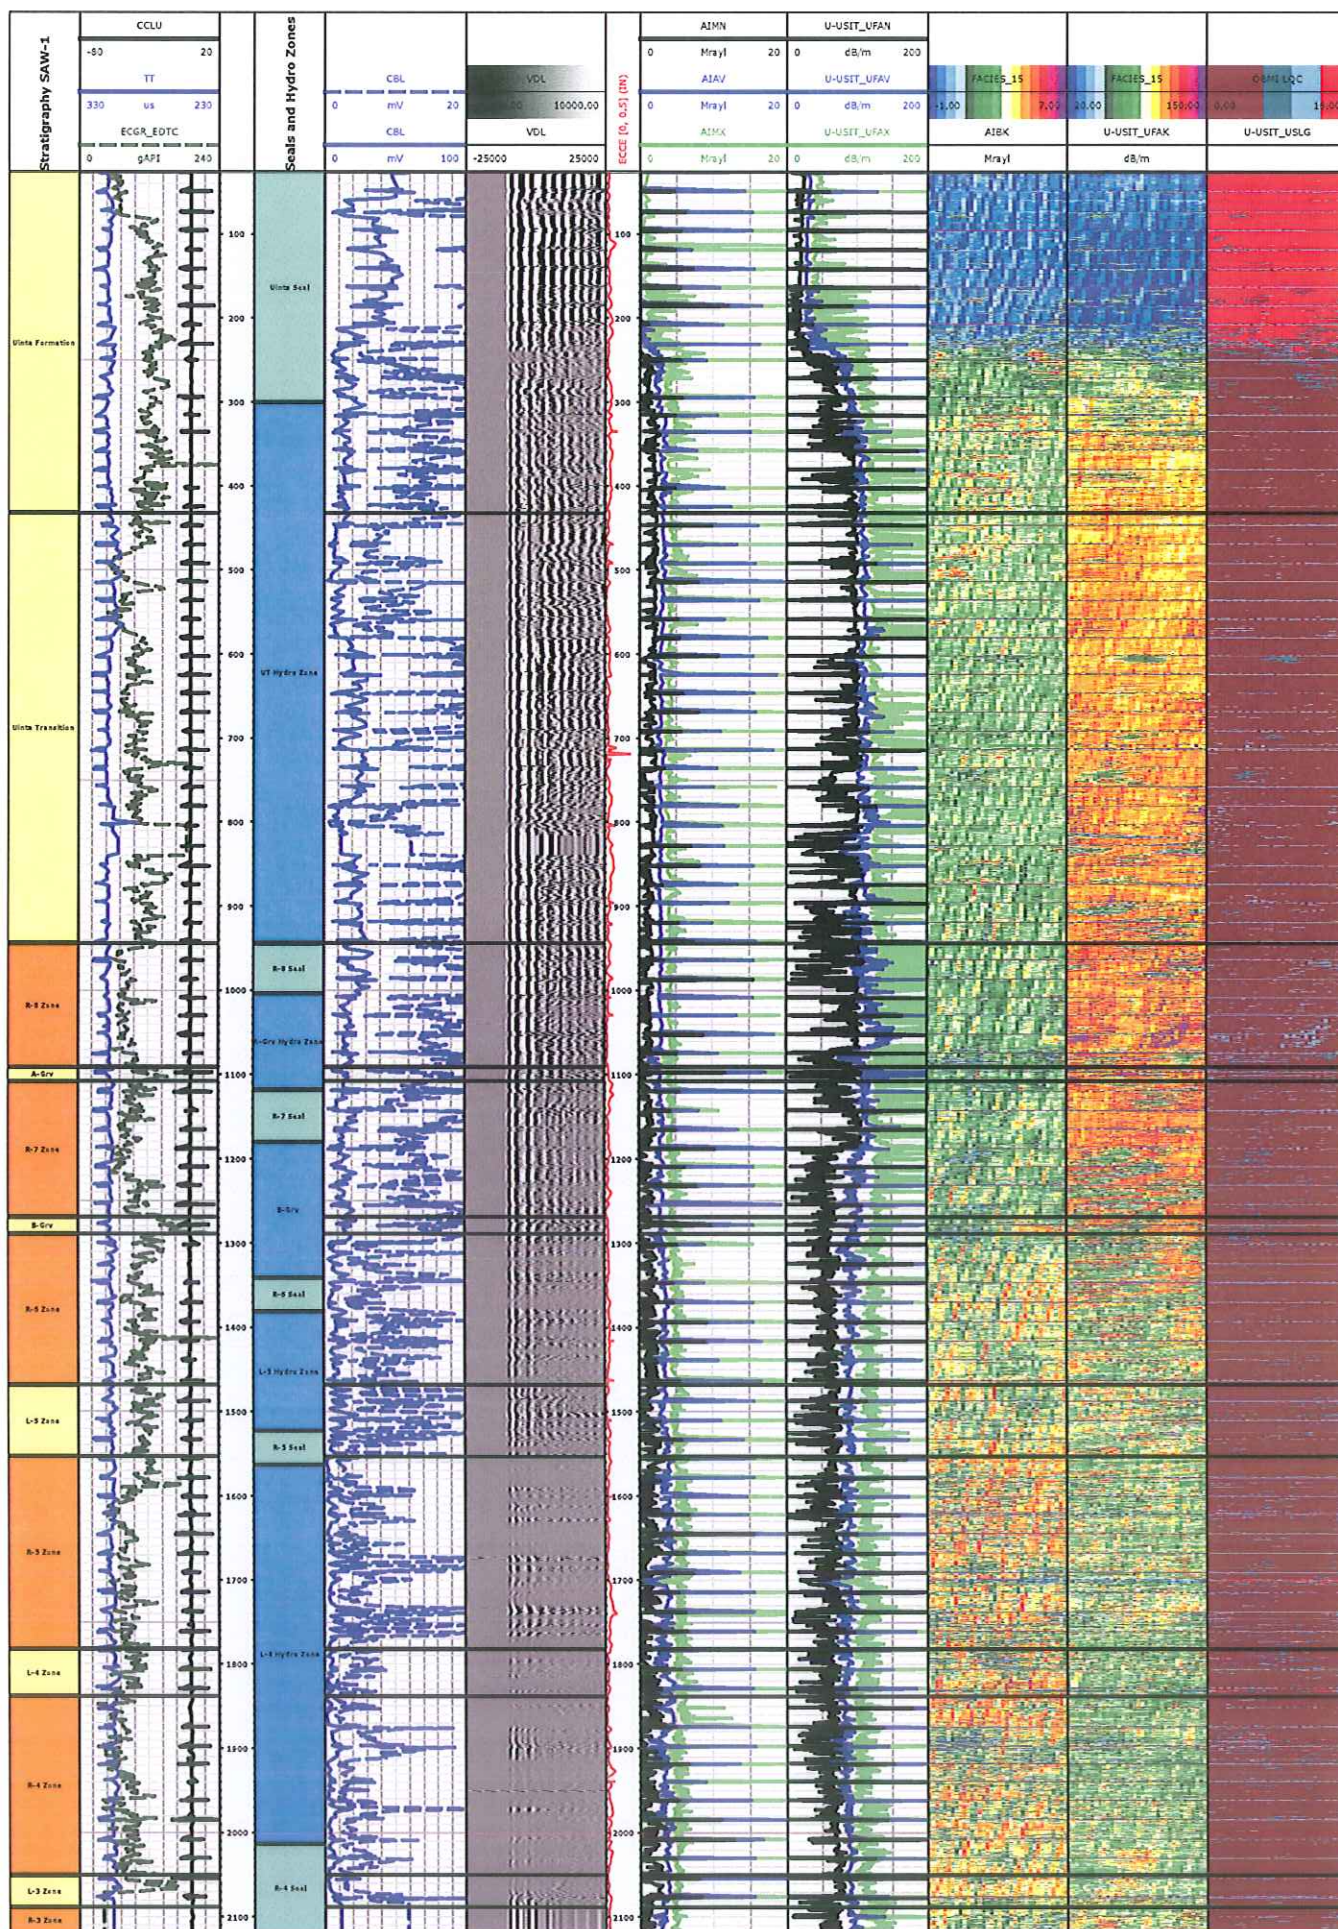
**Summary of Findings:** The Isolation Scanner Log from the raw curve measurements and all the images indicate Top of Cement (TOC) at 237ft.

Zone 1 - 1550ft – 2128ft: The flexural image map indicates cement is present in the annulus behind the casing and that casing is bonded. Adequate isolation exists. This is the tail cement at 15.5ppg. Top of tail cement is also supported by the VDL formation signal.

Zone 2 - : 237ft – 1550ft: The flexural image map indicates that adequate cement for isolation exists. There are some local channels with microdebonding cement in certain intervals as seen on the image map. Overall the cement condition is fair to good bonding.

Zone 3 - : Surface – 237ft: The flexural image indicates the Top of Cement (TOC) at 237ft and presence of air in the annulus preventing quantitative cement analysis. Spotty cement is visible on the image map. These indicate presence of cement fall-back during the curing process.

**Conclusions:** The Isolation Scanner Cement Bond Analysis indicates that cement bond is present in the annulus behind the casing. Adequate bonding exists to isolate the production zone and the saline water interval from the overlying water bearing intervals. The Top of Cement (TOC) is at 237ft.
