Reference: Cripple Creek & Victor Gold Mining Company,
Cresson Project Mill Site Construction

Subject: Weekly Construction Quality Assurance (“CQA”) Report:
AMEC Mill Site Earthworks Field Monitoring Summary: Week ending 11/10/2012.

MILL SITE EARTHWORKS FIELD MONITORING SUMMARY (WEEKLY REPORT)

Project Title: Mill Site Earthworks

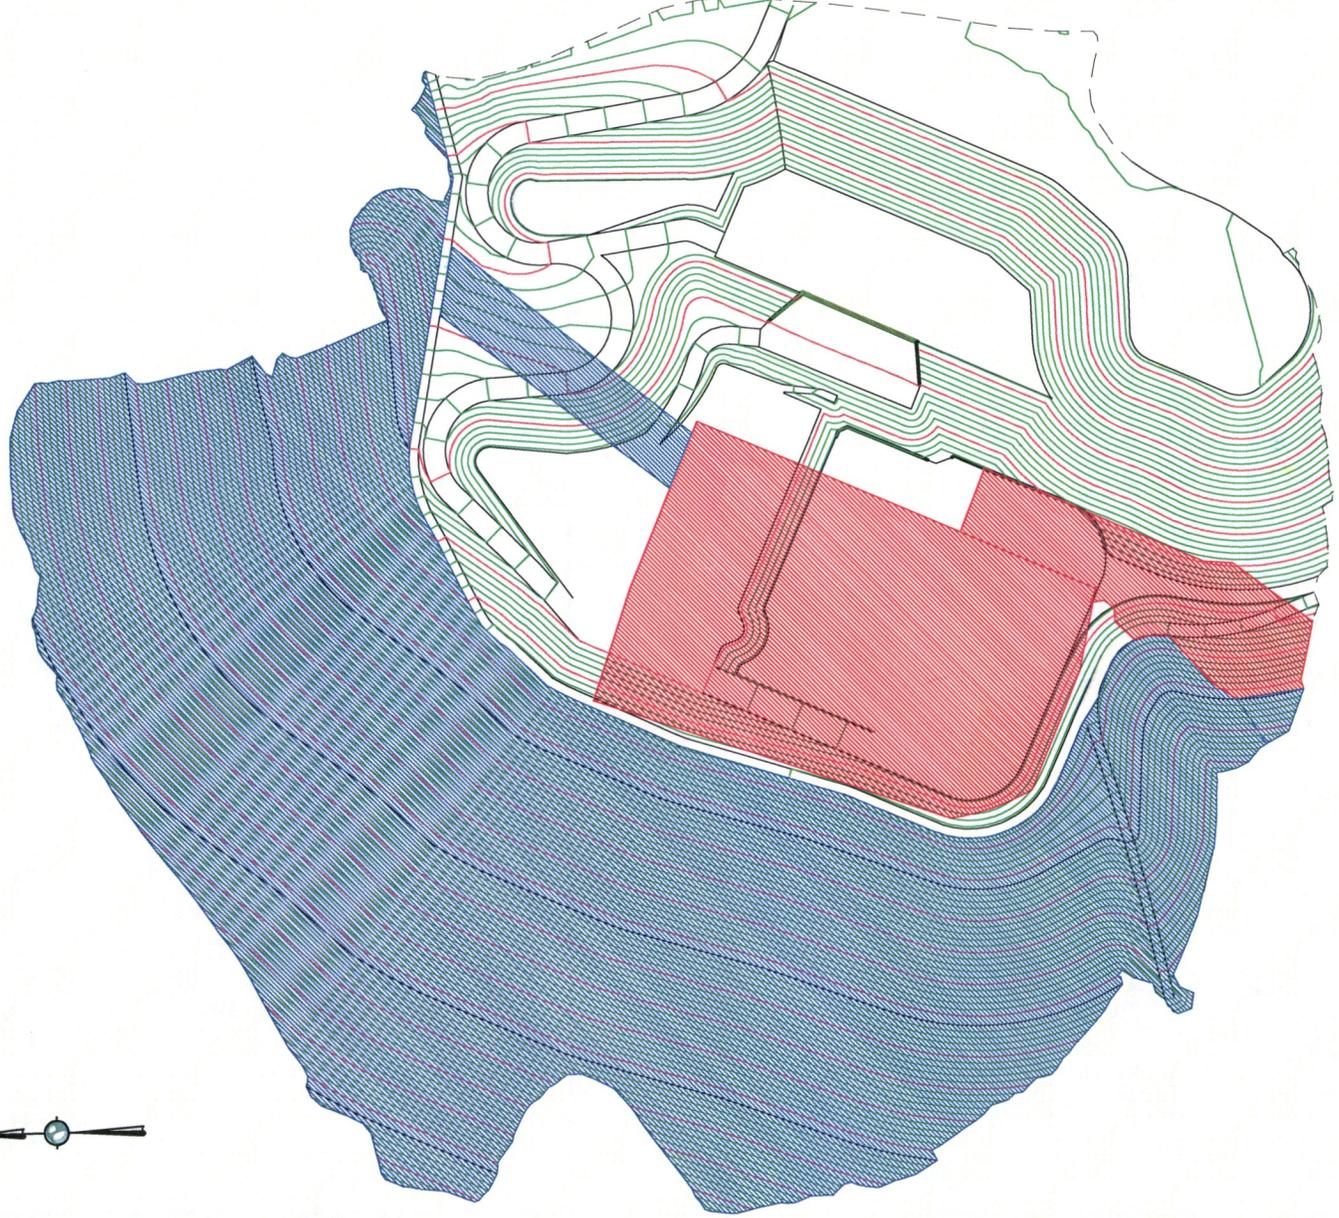
DESIGNED BY	JDH	CHECKED BY	JDH	DATE
DRAWN BY	JDH	APPROVED BY	JDH	11/10/12
CADD FILENAME				FIGURE No.
-				1
				REV
				-

Overburden fill was placed in the areas shown on Figure 1. DCF depth was checked by survey and the area was approved prior to fill placement above DCF. Overburden fill was placed in 36" to 40" lifts using various CAT dozers. Each lift was moisture conditioned using a tandem axle water truck (when necessary) and compacted using a 10-ton vibratory smooth drum compactor, passing over the entire fill surface at least 4 times (method compaction technique was applicable).

Subgrade temperatures were monitored by an AMEC field representative prior to fill placement when ambient temperatures were below 32°F. Fill material was not placed until the entire fill area was at or above 32°F. Fill temperatures averaged between 49°F and 53°F.

TITLE
OVERBURDEN FILL
PLACEMENT

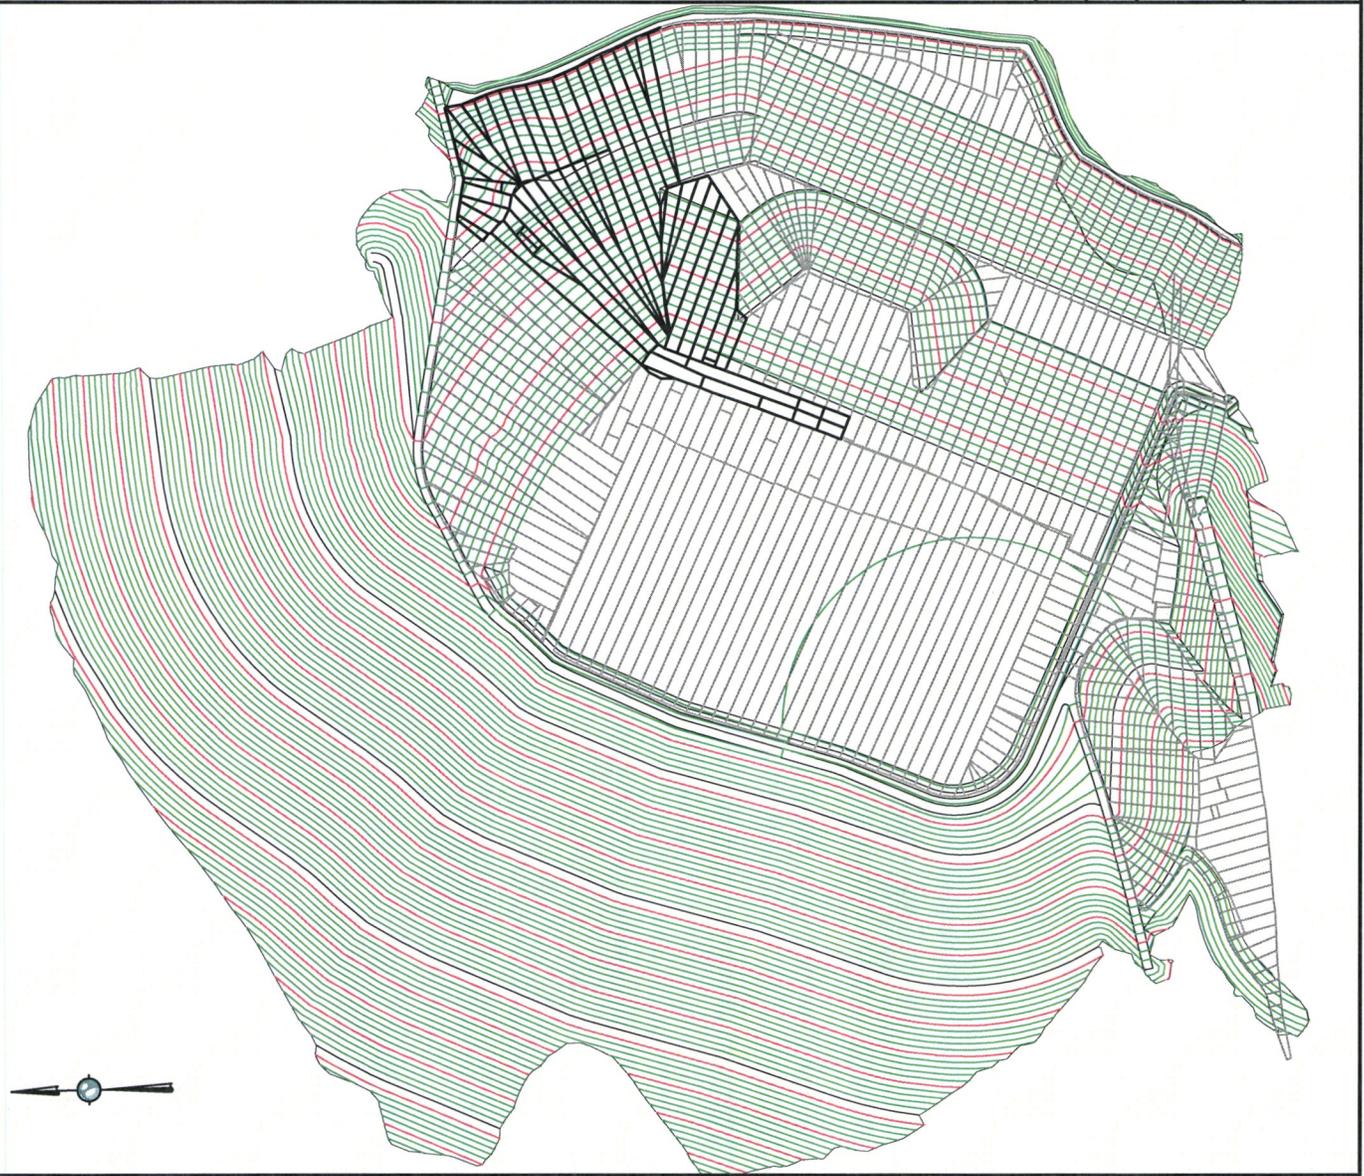
DESIGNED BY	JDH	CHECKED BY	JDH	DATE	11/10/12
DRAWN BY	JDH	APPROVED BY	JDH	FIGURE No.	3
CADD FILENAME				REV	—

Geomembrane installation continued in the area shown on Figure 3 performing deployment, seaming, and repair/QC activities. Approximately 192,894 square feet of 80mil LLDPE was deployed using a John Deere 544 front-end loader with spreader-bar attachments and a John Deere 200 excavator. Subgrade was inspected and approved by AMEC and Lonestar representatives prior to geomembrane deployment. Approximately 11,599 linear feet of seam was fusion welded using five fusion welding machine/welding technician combinations. Twenty-eight destructive test samples were marked during fusion seaming. All destructive tests performed were within project specifications. Non-destructive testing was performed for fusion welded seams. Repairs were performed using the extrusion welding method for all marked defects. Vacuum testing was performed for all extrusion welded seams and repairs.

1. APPROXIMATELY 192,894 SQUARE FEET OF PRIMARY 80 MIL GEOMEMBRANE WAS DEPLOYED DURING THE WEEK ENDING 11/10/2012.
2. TOTAL GEOMEMBRANE DEPLOYED FOR THE MILL SITE EARTHWORKS PROJECT = 1,511,144 SQUARE FEET.

CLIENT Cripple Creek & Victor Gold Mining Company
PROJECT MILL SITE EARTHWORKS
TITLE GEOMEMBRANE INSTALLATION

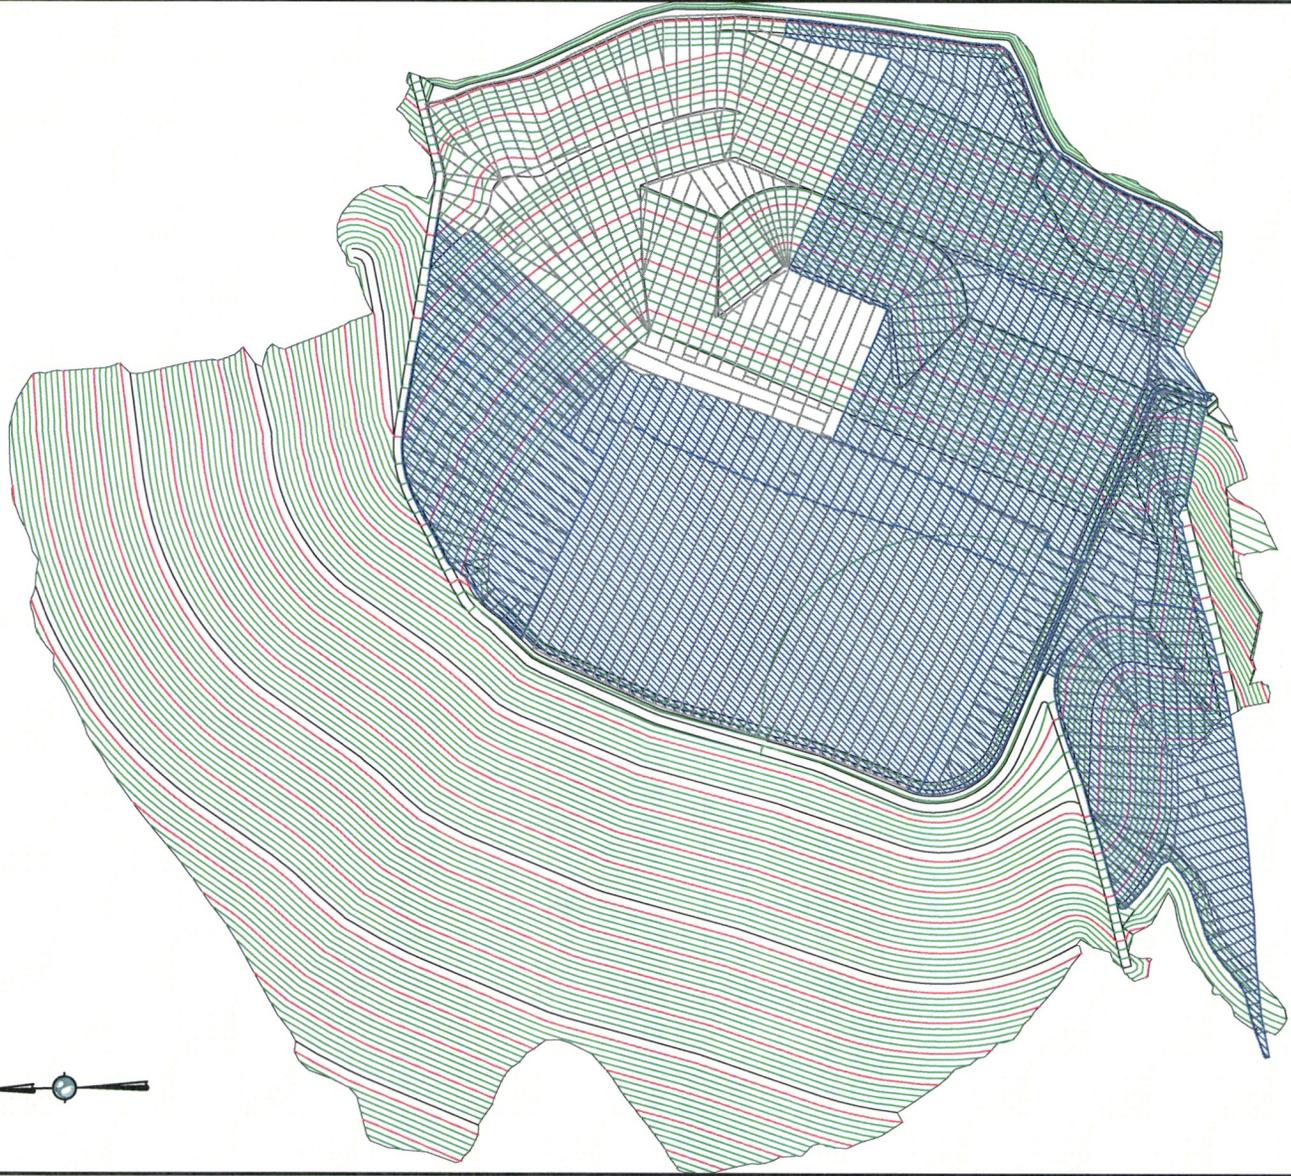
DESIGNED BY	JDH	CHECKED BY	JDH	DATE	
DRAWN BY	JDH	APPROVED BY	JDH	11/10/12	
CADD FILENAME				FIGURE No.	4
				REV	—

Primary 80mil geomembrane shown on Figure 4 (P381-P410) was inspected by AMEC and Lonestar representatives and found to be installed within project specifications and acceptable for continued construction activities.

TITLE
GEOMEMBRANE ACCEPTANCE

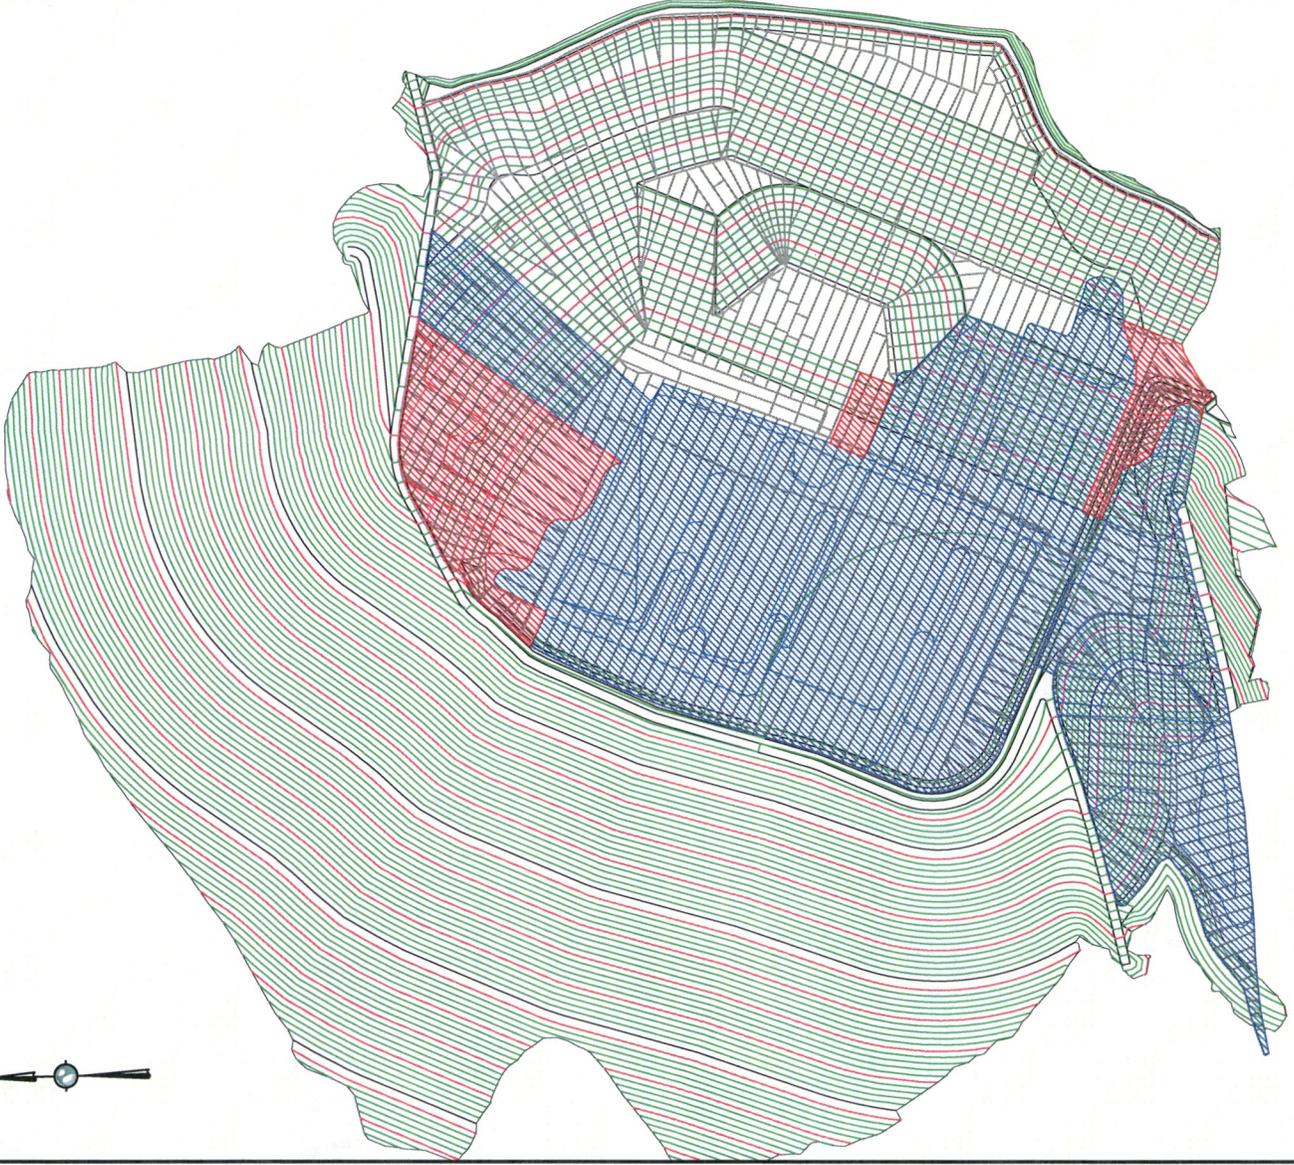
DESIGNED BY	JDH	CHECKED BY	JDH	DATE	
DRAWN BY	JDH	APPROVED BY	JDH	11/10/12	
CADD FILENAME			FIGURE No.	5	REV
					—

Drain cover fill (DCF) placement performed in the area shown on Figure 5. The DCF was hauled from the processing area to the placement area using 40-ton articulating haul trucks loaded by a CAT 988 front-end loader. The DCF was placed in a 2-foot lift using various CAT dozers except where haul routes were established. Haul routes consisted of four-foot lifts to be spread into 2-foot lifts later. Laborers were present at all times during placement removing debris/sandbags and assisting the dozer operator with lift thickness. All DCF was placed on previously approved primary geomembrane. Ambient temperatures remained above 32°F during all shifts. AMEC field representatives monitored the DCF placement constantly.

1. APPROXIMATELY 127,569 SQUARE FEET OF DRAIN COVER FILL WAS PLACED DURING THE WEEK ENDING 11/10/2012.
2. TOTAL DRAIN COVER FILL PLACED TO DATE FOR THE MILL SITE EARTHWORKS PROJECT = 970,635 SQUARE FEET.

CLIENT **CRIPPLE CREEK & VICTOR GOLD MINING COMPANY**
 PROJECT **MILL SITE EARTHWORKS**
 TITLE **DRAIN COVER FILL PLACEMENT**

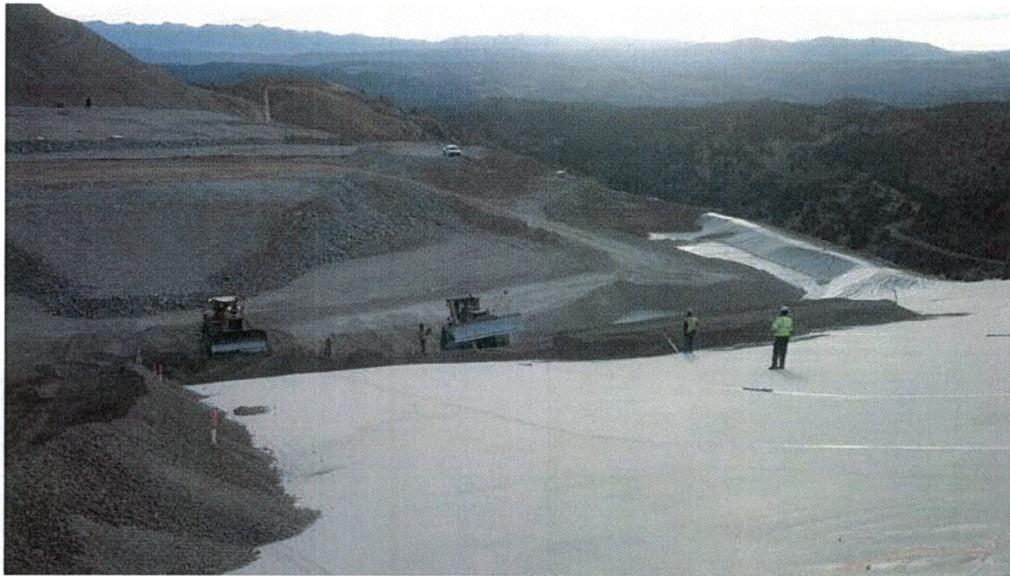
Photo #1; November 5, 2012; TMC; DCF placement

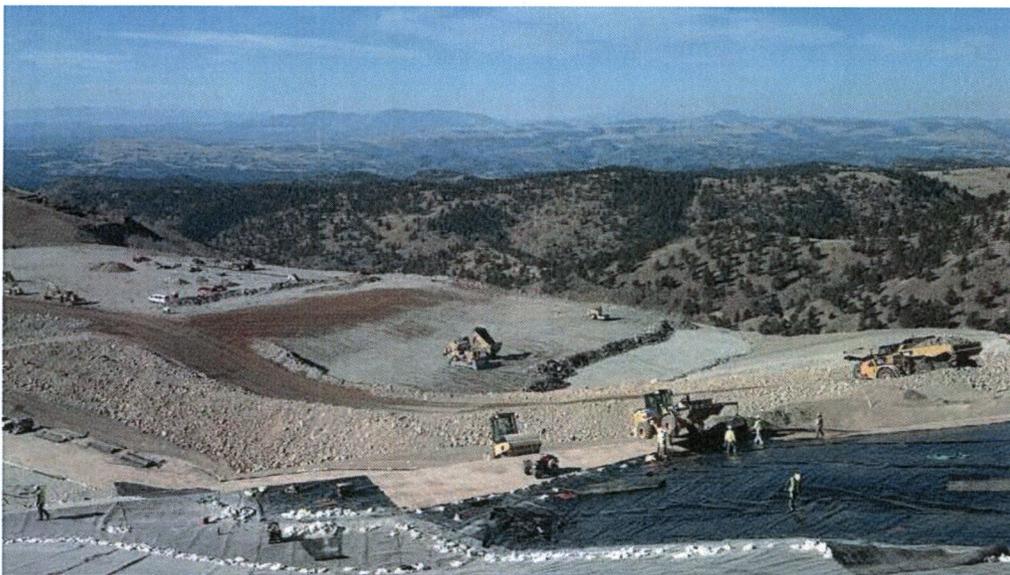
Photo #2; November 8, 2012; TMC; SF placement and Geomembrane Deployment

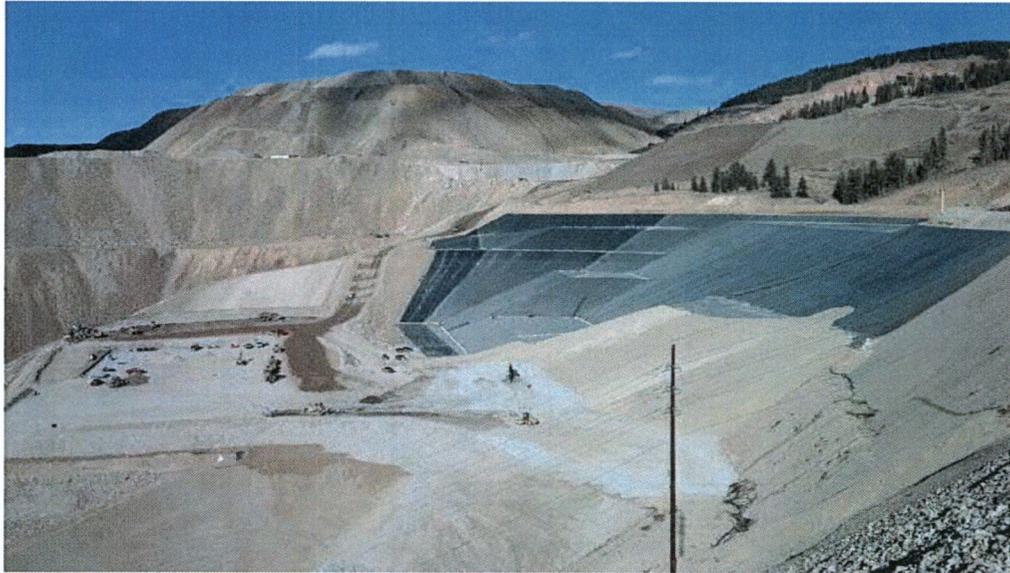
Photo #3; November 9, 2012; TMC; Overall site activities

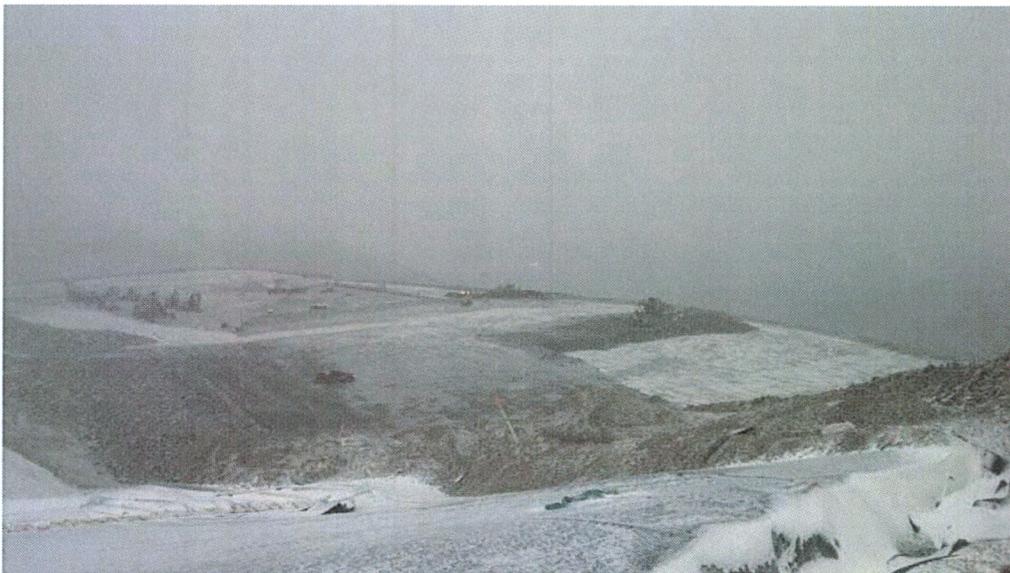
Photo #4; November 10, 2012; TMC; Overall site activities prior to shutdown due to weather
