COLORADO DIVISION OF RECLAMATION, MINING AND SAFETY COAL PROGRAM INSPECTION REPORT

Permit Number: C-1991-078 Mine Name: Hamilton Mine Operator: Honeywood Coal Company Operator Address: Mr. Johnny Rich 2120 Crestmoor Road Suite 3020 Nashville, TN 37215	County: Montrose Operation Type: Surface Permit Status: Permanent Cessation Ownership: Private
	Operator Representative Present: None
Operator Representative Signature: (Field Issuance Only) This report was issued electronically from the Division's Durango Field Office.

Inspection Start Date: January 30, 2013 Inspection Start Time: 10:55 Inspection End Date: January 30, 2013 Inspection End Time: 13:05		Inspection Type: Coal Complete Inspection Inspection Reason: Normal I&E Program Weather: Cloudy	
Joint Inspection Agency: None		Joint Inspection Contacts:	
Post Inspection Agency: None		Post Inspection Contacts:	
Inspector(s): Marcia L. Talvitie, P.E.	Inspector's Signature:

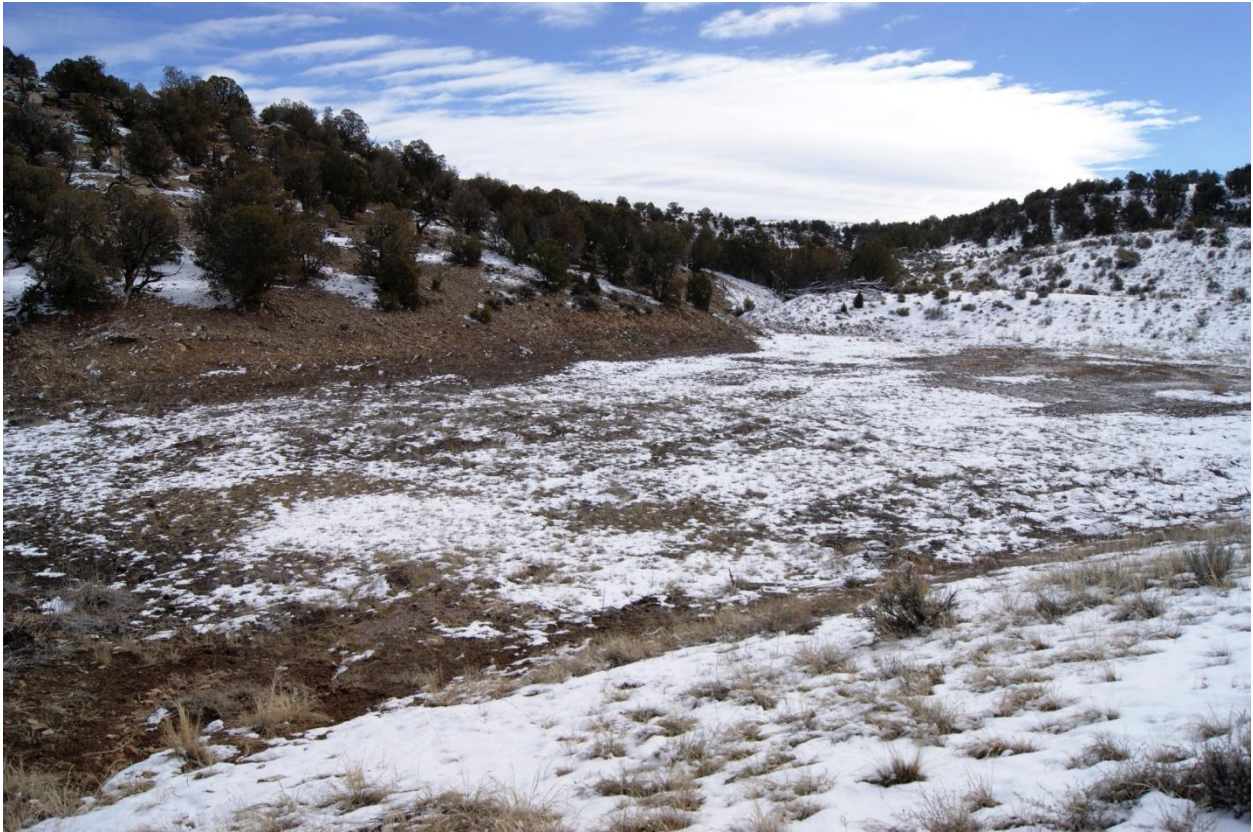
Photo 1 – Sediment Pond B, looking SE

- Sediment Pond B, which has been approved for retention as a permanent feature, did not hold any standing water, but the pond bottom was muddy with a light covering of snow (Photo 1).
- The Pond B impoundment and spillways were inspected and appeared to be stable and capable of functioning as designed (Photo 2).

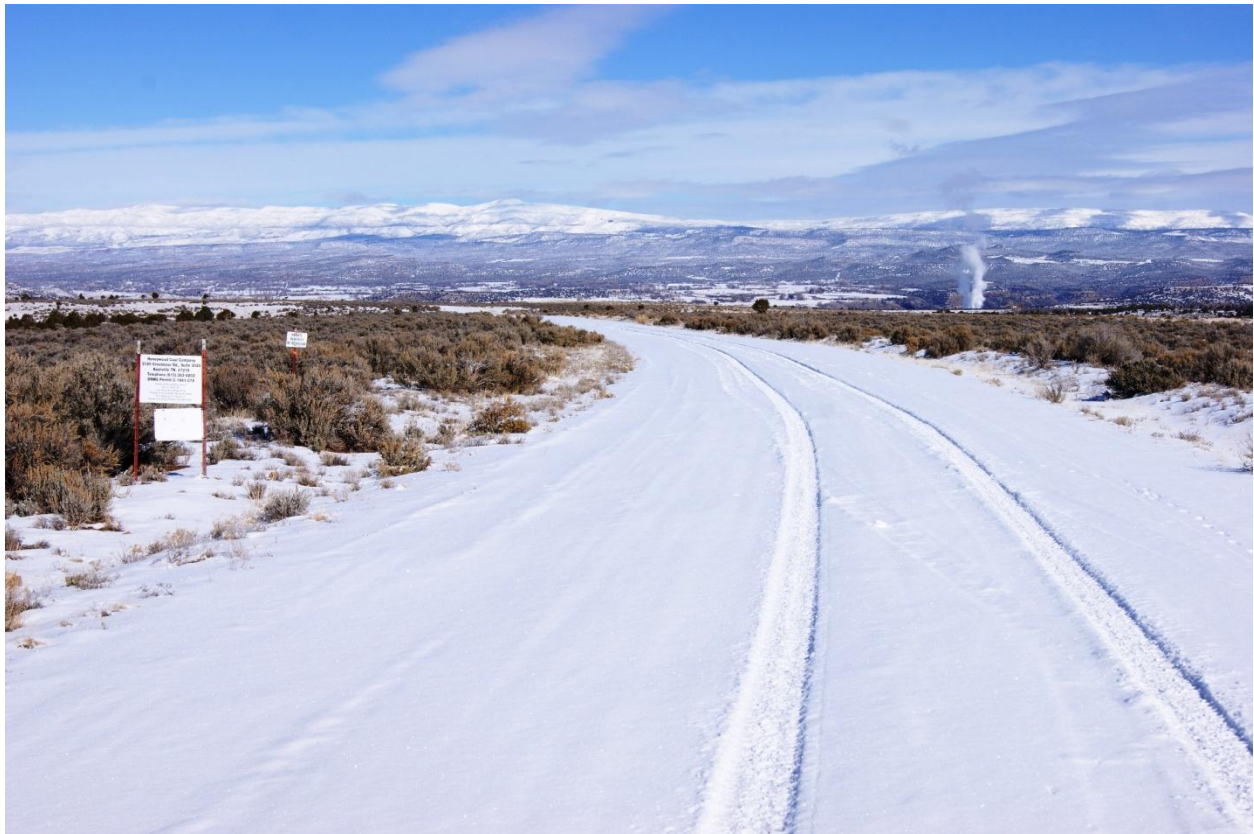
Photo 3 – Permit entrance, looking N; Nucla Generating Station steam plume center-right

- The roads were covered with snow (Photo 3), except on the south-facing access to Pond B (Photo 4), where the exposed areas were muddy.
- All of the roads within the permit area were passable by vehicle, with the exception of access to Pond B was accomplished on-foot.
