**COLORADO DIVISION OF RECLAMATION, MINING AND SAFETY  
COAL PROGRAM INSPECTION REPORT**

| <b>Permit Number:</b> C-2010-089<br><b>Mine Name:</b> New Horizon North Mine<br><b>Operator:</b> Western Fuels-Colorado, LLC<br><b>Operator Address:</b><br>Mr. David G Anderson<br>12050 N. Pecos St., Suite 100<br>Westminster, CO 80234 | <b>County:</b> Montrose<br><b>Operation Type:</b> Surface<br><b>Permit Status:</b> Active<br><b>Ownership:</b> Private |

| <b>Inspection Start Date:</b> March 29, 2013<br><b>Inspection Start Time:</b> 08:40<br><b>Inspection End Date:</b> March 29, 2013<br><b>Inspection End Time:</b> 12:30 | | <b>Inspection Type:</b> Coal Complete Inspection<br><b>Inspection Reason:</b> Normal I&E Program<br><b>Weather:</b> Clear | |

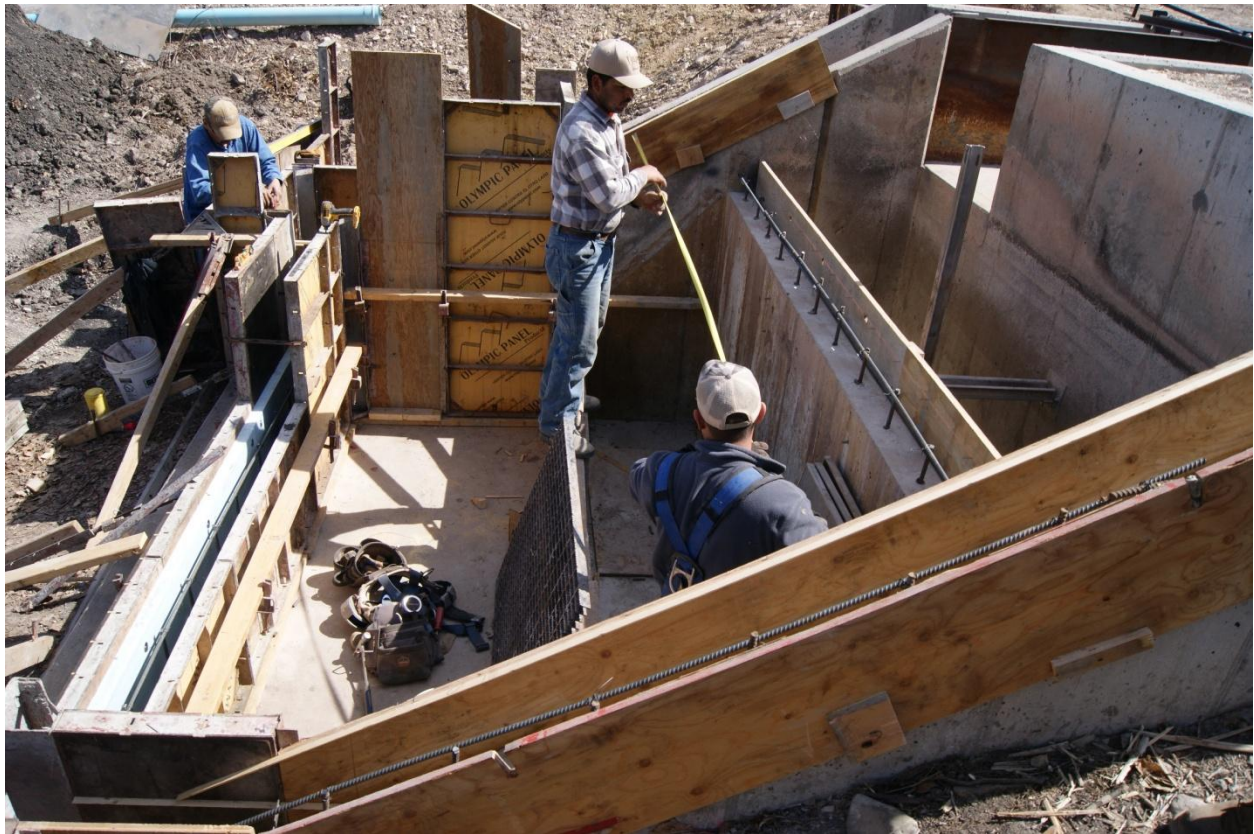
- A complex concrete division box was constructed in 2011 on the Second Park Lateral ditch northeast of the permit area. The box was designed to divide the flow in the ditch between the shares that formerly crossed the NH North permit area in an open ditch and the portion that belongs to other shareholders. The ditch crossing of Meehan and Garvey properties was confined to a black HDPE pipe and diverted around the southern perimeter of the permit area.

- During the 2012 irrigation season, certain challenges arose, and Mr. Gubka explained that WFC has hired a contractor to modify the division box with the addition of additional screens, among other things. A crew was working on the placement of concrete forms at the time of our inspection (Photo 1).
- A second modification to the CCC Ditch involved relocation of the Parshall flume to a point on the ditch further upstream of the division box (Photo ). This move was made in order to allow the velocity of the flow to be reduced somewhat, prior to the ditch's entering the division box.
- Mr. Gubka said that the CCC Ditch will be turned "ON" on April 15, 2013.
- Pond NHN-001 was dry at the time of the inspection.

Photo 1 – Construction crew at Second Park Lateral ditch division box

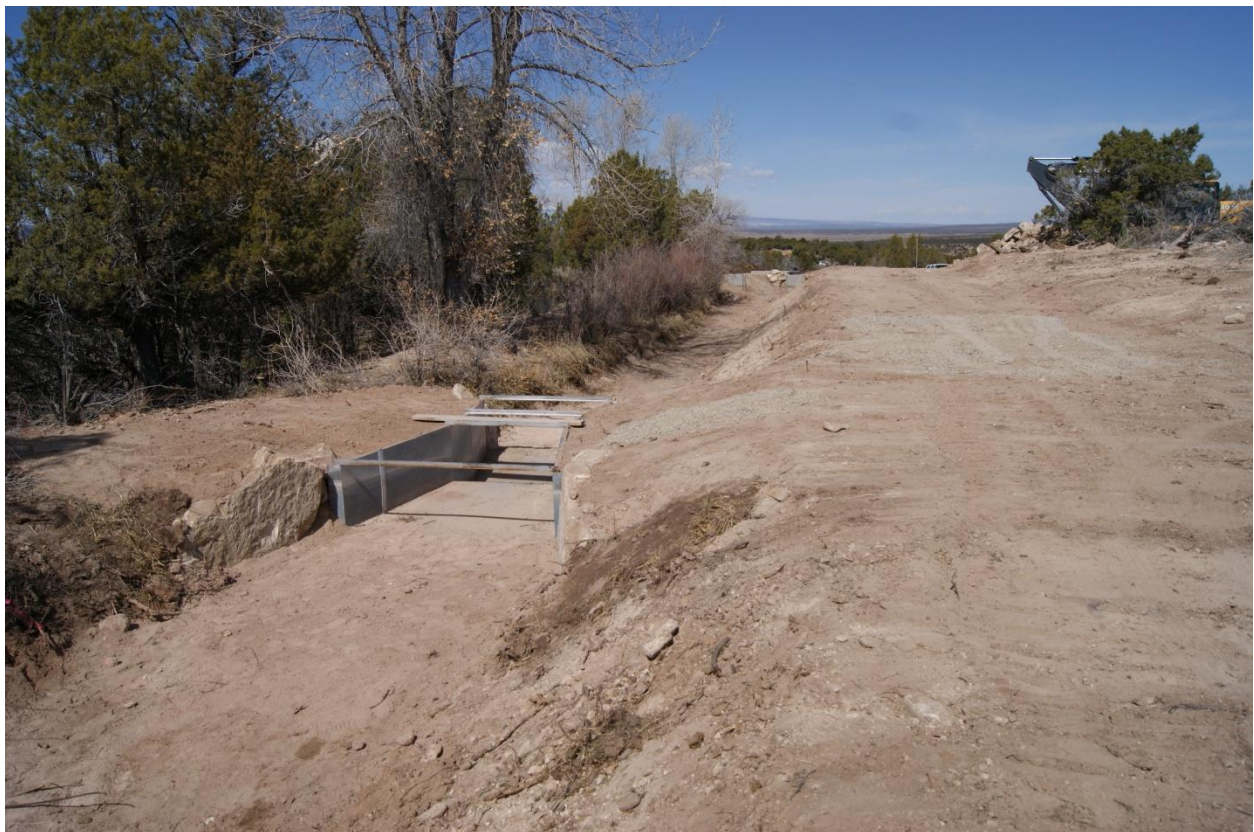
Photo 2 – Second Park Lateral ditch and Parshall flume, looking downstream toward box

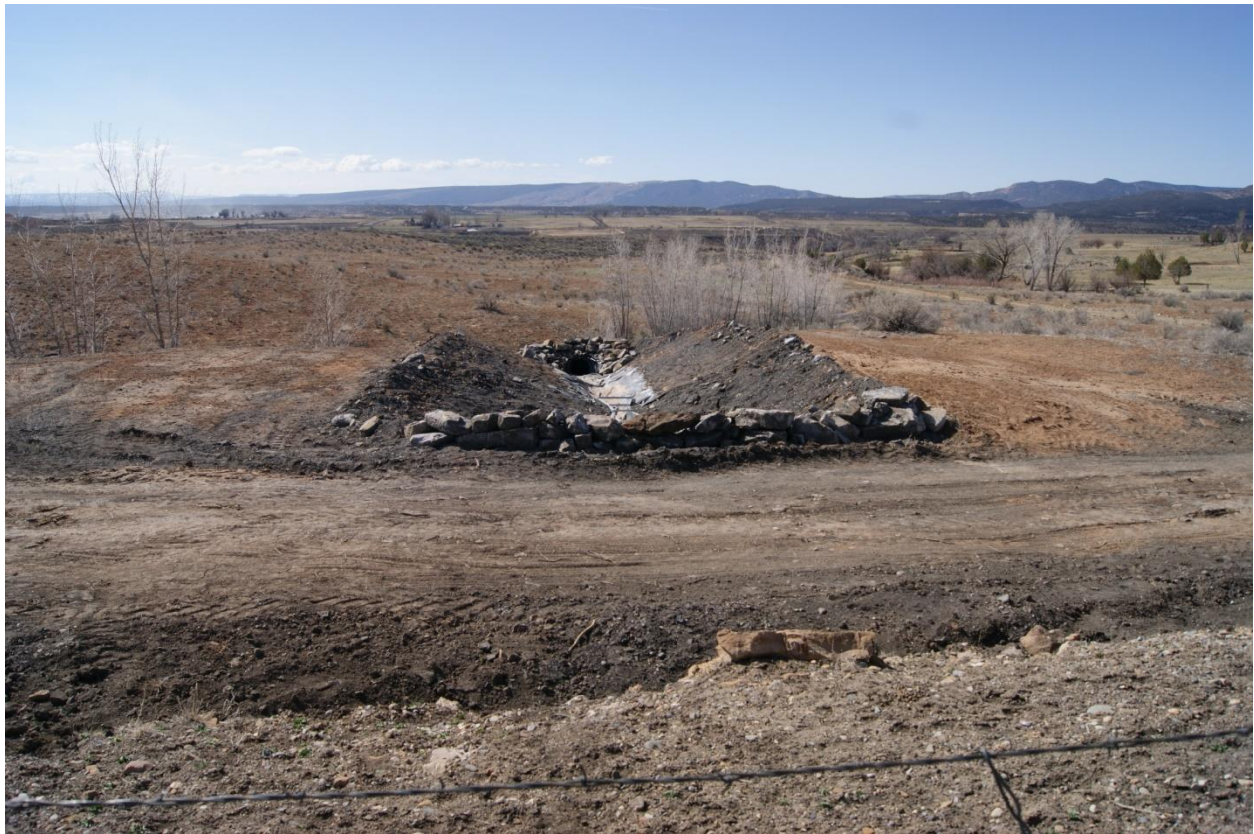
- The primary spillway for Pond NHN-001 discharges into a pre-existing 24" culvert pipe that passes beneath County Road AA, which forms the southern boundary of the permit area. We observed that an area south of the county road, outside of the permit area, has been disturbed to construct a Parshall flume and associated ditch for the purpose of measuring and sampling any flow leaving the pond (a requirement of the mine's discharge permit). This disturbance (Photos 3 and 4) is outside of the approved permit boundary.
- NOV CV-2013-003 is being issued for, "Failure to confine surface coal mining and reclamation operations to lands within the permit area." See the Enforcement section below for details.

Photo 3 – Pond NHN-001 outflow ditch, looking S from AA Road

In accordance with 2.08.4(2)(c), submit a Technical Revision application for an incidental permit boundary revision to incorporate the disturbed area into the permit. The application shall comply with the requirements set for in 2.03.6(1).

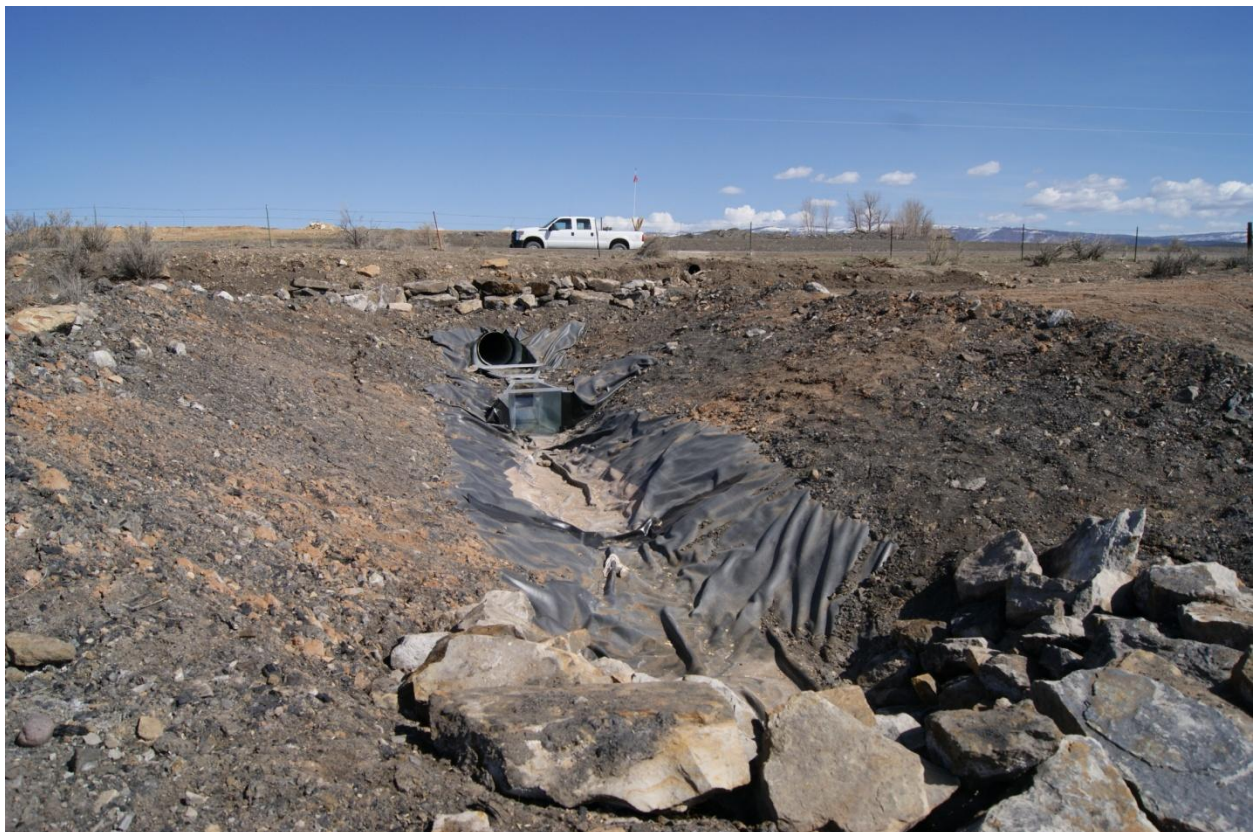
Photo 4 – Ditch and flume, looking north toward AA Road
