COLORADO DIVISION OF RECLAMATION, MINING AND SAFETY COAL PROGRAM INSPECTION REPORT

Permit Number: X-2008-142-12 Mine Name: NH North GW Monitoring Wells Operator: Western Fuels-Colorado, LLC Operator Address: David Anderson 12050 N. Pecos Street Westminster, Co 80234	County: Montrose Operation Type: Coal exploration Permit Status: Inactive Ownership: Private
Operator Representative Present: David Anderson	
Operator Representative Signature: (Field Issuance Only)

Inspection Start Date: April 23, 2013 Inspection Start Time: 09:30 Inspection End Date: April 23, 2013 Inspection End Time: 10:00	Inspection Type: Surety Release Inspection Inspection Reason: Surety Release Requested Weather: Clear
Joint Inspection Agency: None	Joint Inspection Contacts:
Post Inspection Agency: None	Post Inspection Contacts:
Inspector(s): Elliott R. Russell Jason D. Musick	Inspector's Signature:

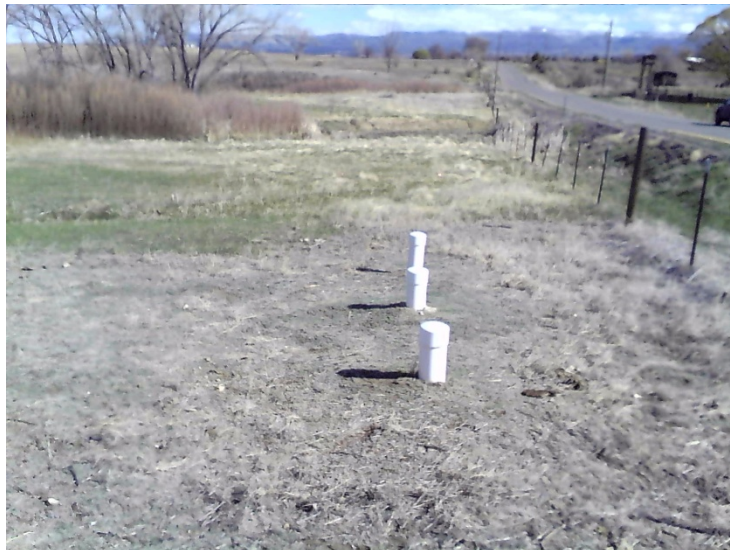
East Nest

All 3 sites were well vegetated, with some sites exhibiting more vegetation than others at the time of the inspection. All sites showed no signs of erosion, evidence of noxious/invasive species, or any other problems. Exploration did not consist of pad or road construction. No evidence of disturbance, resulting from drilling the pilot holes, was found after thoroughly searching each site.
