COLORADO DIVISION OF RECLAMATION, MINING AND SAFETY COAL PROGRAM INSPECTION REPORT

Permit Number: C-1981-013 Mine Name: Golden Eagle Mine Operator: New Elk Coal Company, LLC Operator Address: Mr Ron Thompson 12250 State Highway 12 Weston, CO 81091	County: Las Animas Operation Type: Underground Permit Status: Permanent Cessation Ownership: Private
	Operator Representative Present: Ron Thompson
Operator Representative Signature: (Field Issuance Only)

Inspection Start Date: April 29, 2013 Inspection Start Time: 13:00 Inspection End Date: April 29, 2013 Inspection End Time: 17:30	Inspection Type: Coal Complete Inspection Inspection Reason: Normal I&E Program Weather: Clear	
Joint Inspection Agency: None	Joint Inspection Contacts:	
Post Inspection Agency: None	Post Inspection Contacts:	
Inspector(s): Leigh D. Simmons Daniel I. Hernandez	Inspector's Signature:

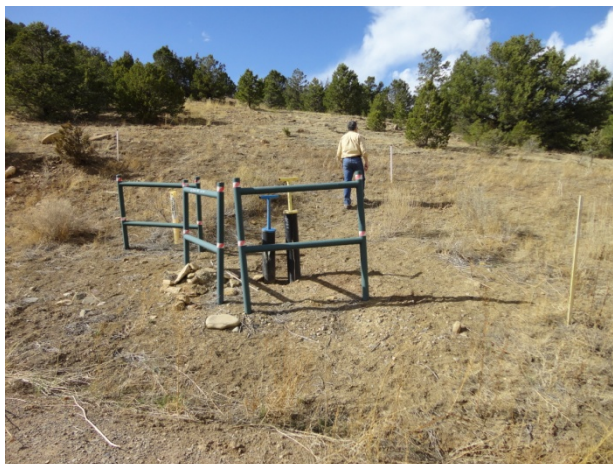
Photo 2: South eastern edge of site

The valves shown in photo 2 appear to be associated with gas pipelines. The valves are located outside of the permit boundary. Rule 2.10.3(e) requires that any pipelines within the permit boundary be displayed on a map. **NECC should verify the location of the pipeline and, if necessary, include it on the map to be submitted with TR57.**

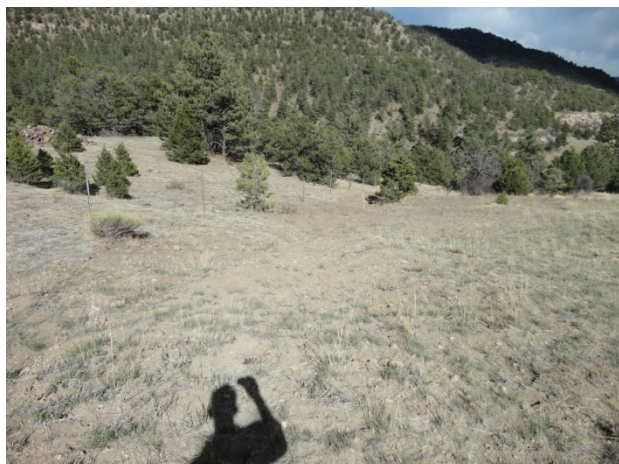
Photo 3: North eastern edge of site – potential for rills to form

The entire site was well drained there was no evidence of any significant erosion. The potential remains for rills to form in the natural drainage at the north-eastern edge of the site, adjacent to the firewood operation. This area will continue to be monitored although there were no problems at the time of the inspection.
