COLORADO DIVISION OF RECLAMATION, MINING AND SAFETY COAL PROGRAM INSPECTION REPORT

Permit Number: C-1981-013 Mine Name: Golden Eagle Mine Operator: New Elk Coal Company, LLC Operator Address: Mr Ron Thompson 12250 State Highway 12 Weston, CO 81091	County: Las Animas Operation Type: Underground Permit Status: Permanent Cessation Ownership: Private
	Operator Representative Present: Brian Wilson
Operator Representative Signature: (Field Issuance Only) N/A – Report Issued from Denver Office

Inspection Start Date: May 23, 2013 Inspection Start Time: 07:00 Inspection End Date: May 23, 2013 Inspection End Time: 07:20	Inspection Type: Coal Partial Inspection Inspection Reason: Normal I&E Program Weather: Clear
Joint Inspection Agency: None	Joint Inspection Contacts: None
Post Inspection Agency: None	Post Inspection Contacts: None
Inspector(s): James R. Stark	Inspector's Signature:

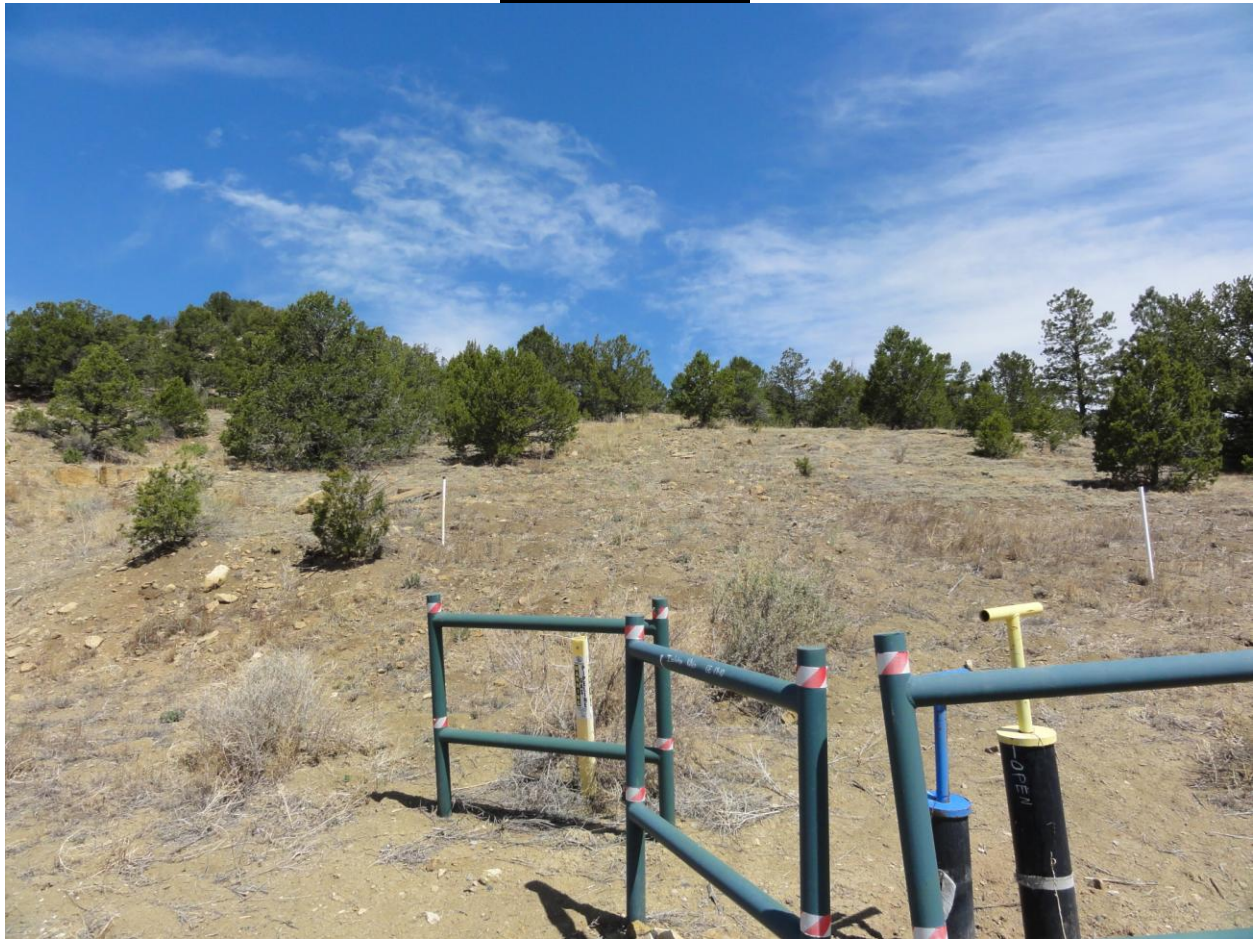
Golden Eagle Mine site

- The only part of the mine that remains is a reclaimed ventilation shaft site. The site is approximately one acre. The site was well vegetated and stable and no erosional problems were noted. The site is an SAE and there were no problems with sediment off-site. The cool season grasses were all growing well and there were no noxious weeds noted at the time of the inspection.
