**COLORADO DIVISION OF RECLAMATION, MINING AND SAFETY  
COAL PROGRAM INSPECTION REPORT**

<b>Permit Number:</b> C-1981-010 <b>Mine Name:</b> Trapper Mine <b>Operator:</b> Trapper Mining, Inc. <b>Operator Address:</b> Mr. Forrest V Luke P.O. Box 187 Craig, CO 81626	<b>County:</b> Moffat <b>Operation Type:</b> Surface <b>Permit Status:</b> Active <b>Ownership:</b> Federal
	<b>Operator Representative Present:</b>  Graham Roberts
<b>Operator Representative Signature:</b> (Field Issuance Only)

<b>Inspection Start Date:</b> June 5, 2013 <b>Inspection Start Time:</b> 07:30 <b>Inspection End Date:</b> June 5, 2013 <b>Inspection End Time:</b> 16:30	<b>Inspection Type:</b> Coal Partial Inspection <b>Inspection Reason:</b> Normal I&E Program <b>Weather:</b> Clear
<b>Joint Inspection Agency:</b>  None	<b>Joint Inspection Contacts:</b>
<b>Post Inspection Agency:</b>  None	<b>Post Inspection Contacts:</b>
<b>Inspector(s):</b>  Jared L. Ebert  Carla V. Demasters	<b>Inspector's Signature:</b>

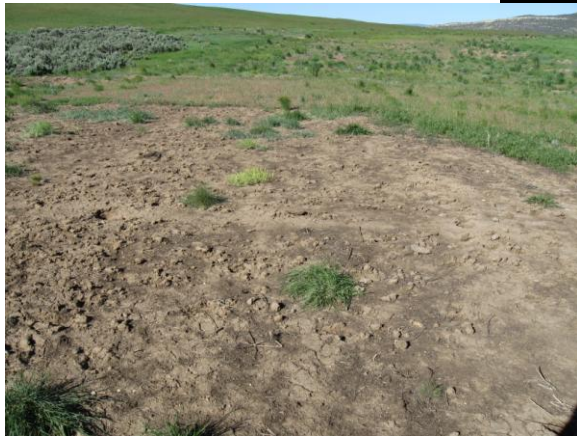
Parcel A-C-04

Perennial grass development on A-C-04 is good, and is mostly dominated by the cool season grass sheep fescue. Other perennial cool season grasses noted included great basin wildrye, western wheatgrass, pubescent wheatgrass and the introduced species bulbous bluegrass. Perennial forbs noted include arrowleaf balsamroot and cicer milkvetch. Annual/biennial forbs noted included tumble mustard and alyssum. Shrub presence was minimal in this area. A few rosettes of the Colorado List B noxious weeds Canada thistle and musk thistle were also noted. A portion of the western A-C-04 parcel had been recently disturbed by some truck traffic. This area consisted of mostly bare soil with annual/biennial forbs including pennycress, tumble mustard, alyssum, blue mustard as well as cheatgrass.

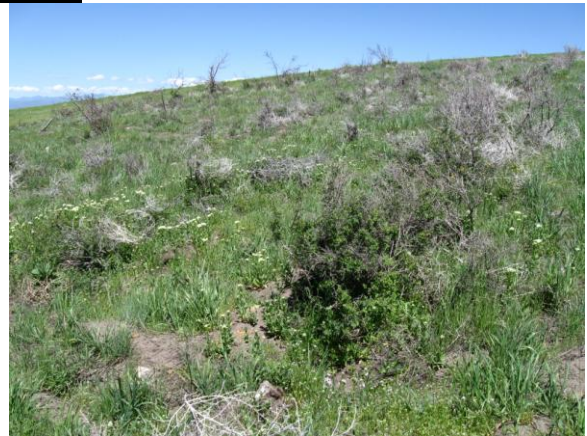
Shrub clump SC-F-10B

Development of perennial grasses and forbs was excellent in this Shrub Clump. In the areas seen, die off of transplanted shrubs appeared to have affected all but the mountain snowberry shrubs and a few chokecherries, which were already leafed out.

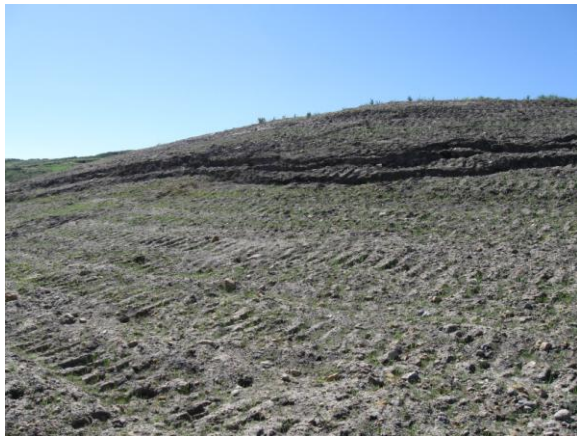
A slump event had disturbed about 30% of this parcel in the past, which has now been regraded. The undisturbed portion of this parcel had excellent development of perennial grasses including great basin wildrye, pubescent wheatgrass, green needlegrass and big bluegrass. Perennial forbs were also well developed and included Lewis flax, western yarrow and the native forbs dragonhead mint and twogrooved milkvetch. Big sagebrush was also establishing well.

Several years ago a slump occurred in a reclaimed area above D Pit. A portion of the slump occurred in Parcel E-AB-08. Trapper regraded this slump area last fall. Minor settling cracks were observed in portions of the regraded scarp area.

Parcel E-AB-08; Slump Area above D Pit.  
Recent settling cracks.

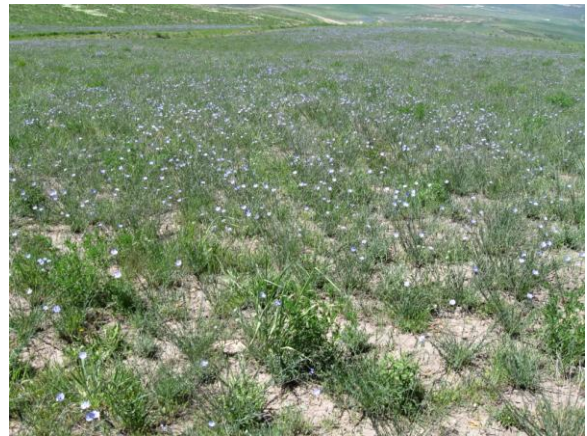
Parcel F-AB-09.

Revegetation was in excellent condition at F-AB-09 – which had a diverse mix of perennial forbs (including Lewis flax (very abundant), western yarrow, alfalfa and small burnet) and cool season perennial grasses (including mountain brome, Kentucky bluegrass and Idaho fescue). Stands of big sagebrush were also developing well.

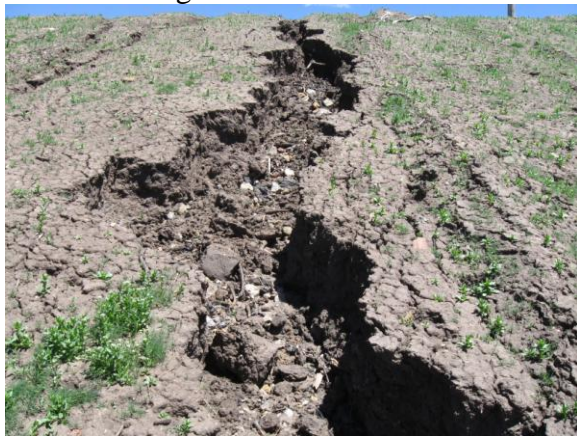
Large rills were observed on the north side of the top bench of the Horse Gulch Fill. These rills will need to be repaired.

North end of the top bench of the Horse  
Gulch fill. Large rill.
