**COLORADO DIVISION OF RECLAMATION, MINING AND SAFETY
MINERALS PROGRAM INSPECTION REPORT
PHONE: (303) 866-3567**

MINE NAME: Wanakah Mine	MINE/PROSPECTING ID#: P-2013-010	MINERAL: Au, Ag, Cu, Zn, Pb	COUNTY: Ouray
INSPECTION TYPE: Multi Person Inspection	INSPECTOR(S): Wallace H. Erickson, G. Russell Means	INSP. DATE: June 4, 2013	INSP. TIME: 17:50
OPERATOR: Ouray 79 Mining, LLC	OPERATOR REPRESENTATIVE: Rick Wilson, Bob Larson	TYPE OF OPERATION: MP - Mineral Prospecting

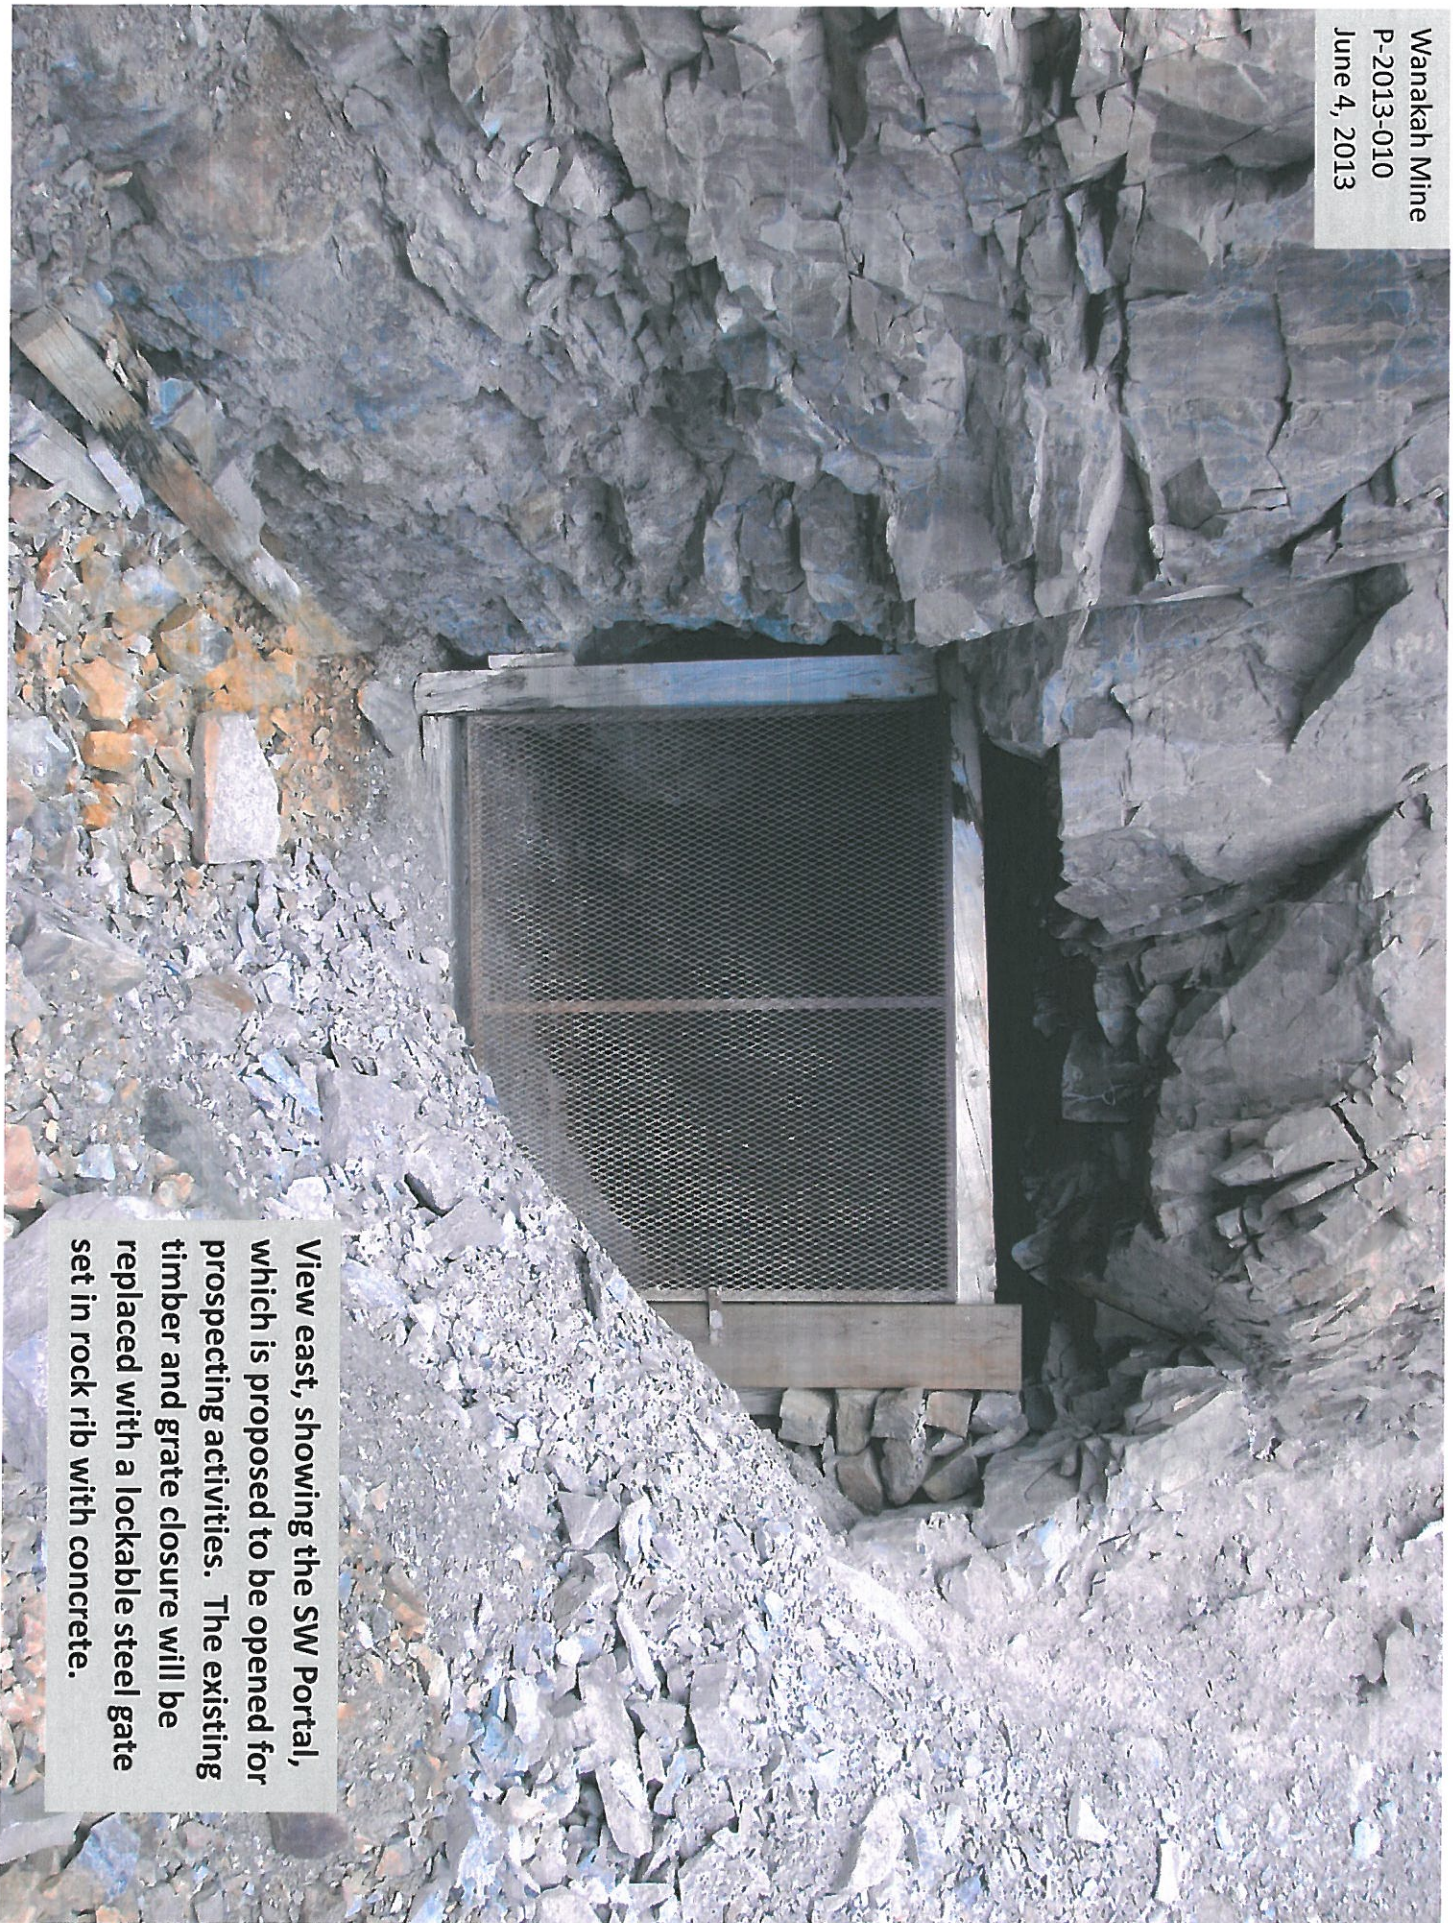
Wanakah Mine
P-2013-010
June 4, 2013

A photograph showing a view east into a mine portal. A large, rectangular metal grate gate is set into a rough, uneven rock wall. The gate is made of a dark, perforated metal mesh. The surrounding rock is dark and jagged, with some lighter-colored debris and gravel on the floor. The lighting is somewhat dim, highlighting the texture of the rock and the structure of the gate.

View east, showing the SW Portal, which is proposed to be opened for prospecting activities. The existing timber and grate closure will be replaced with a lockable steel gate set in rock rib with concrete.

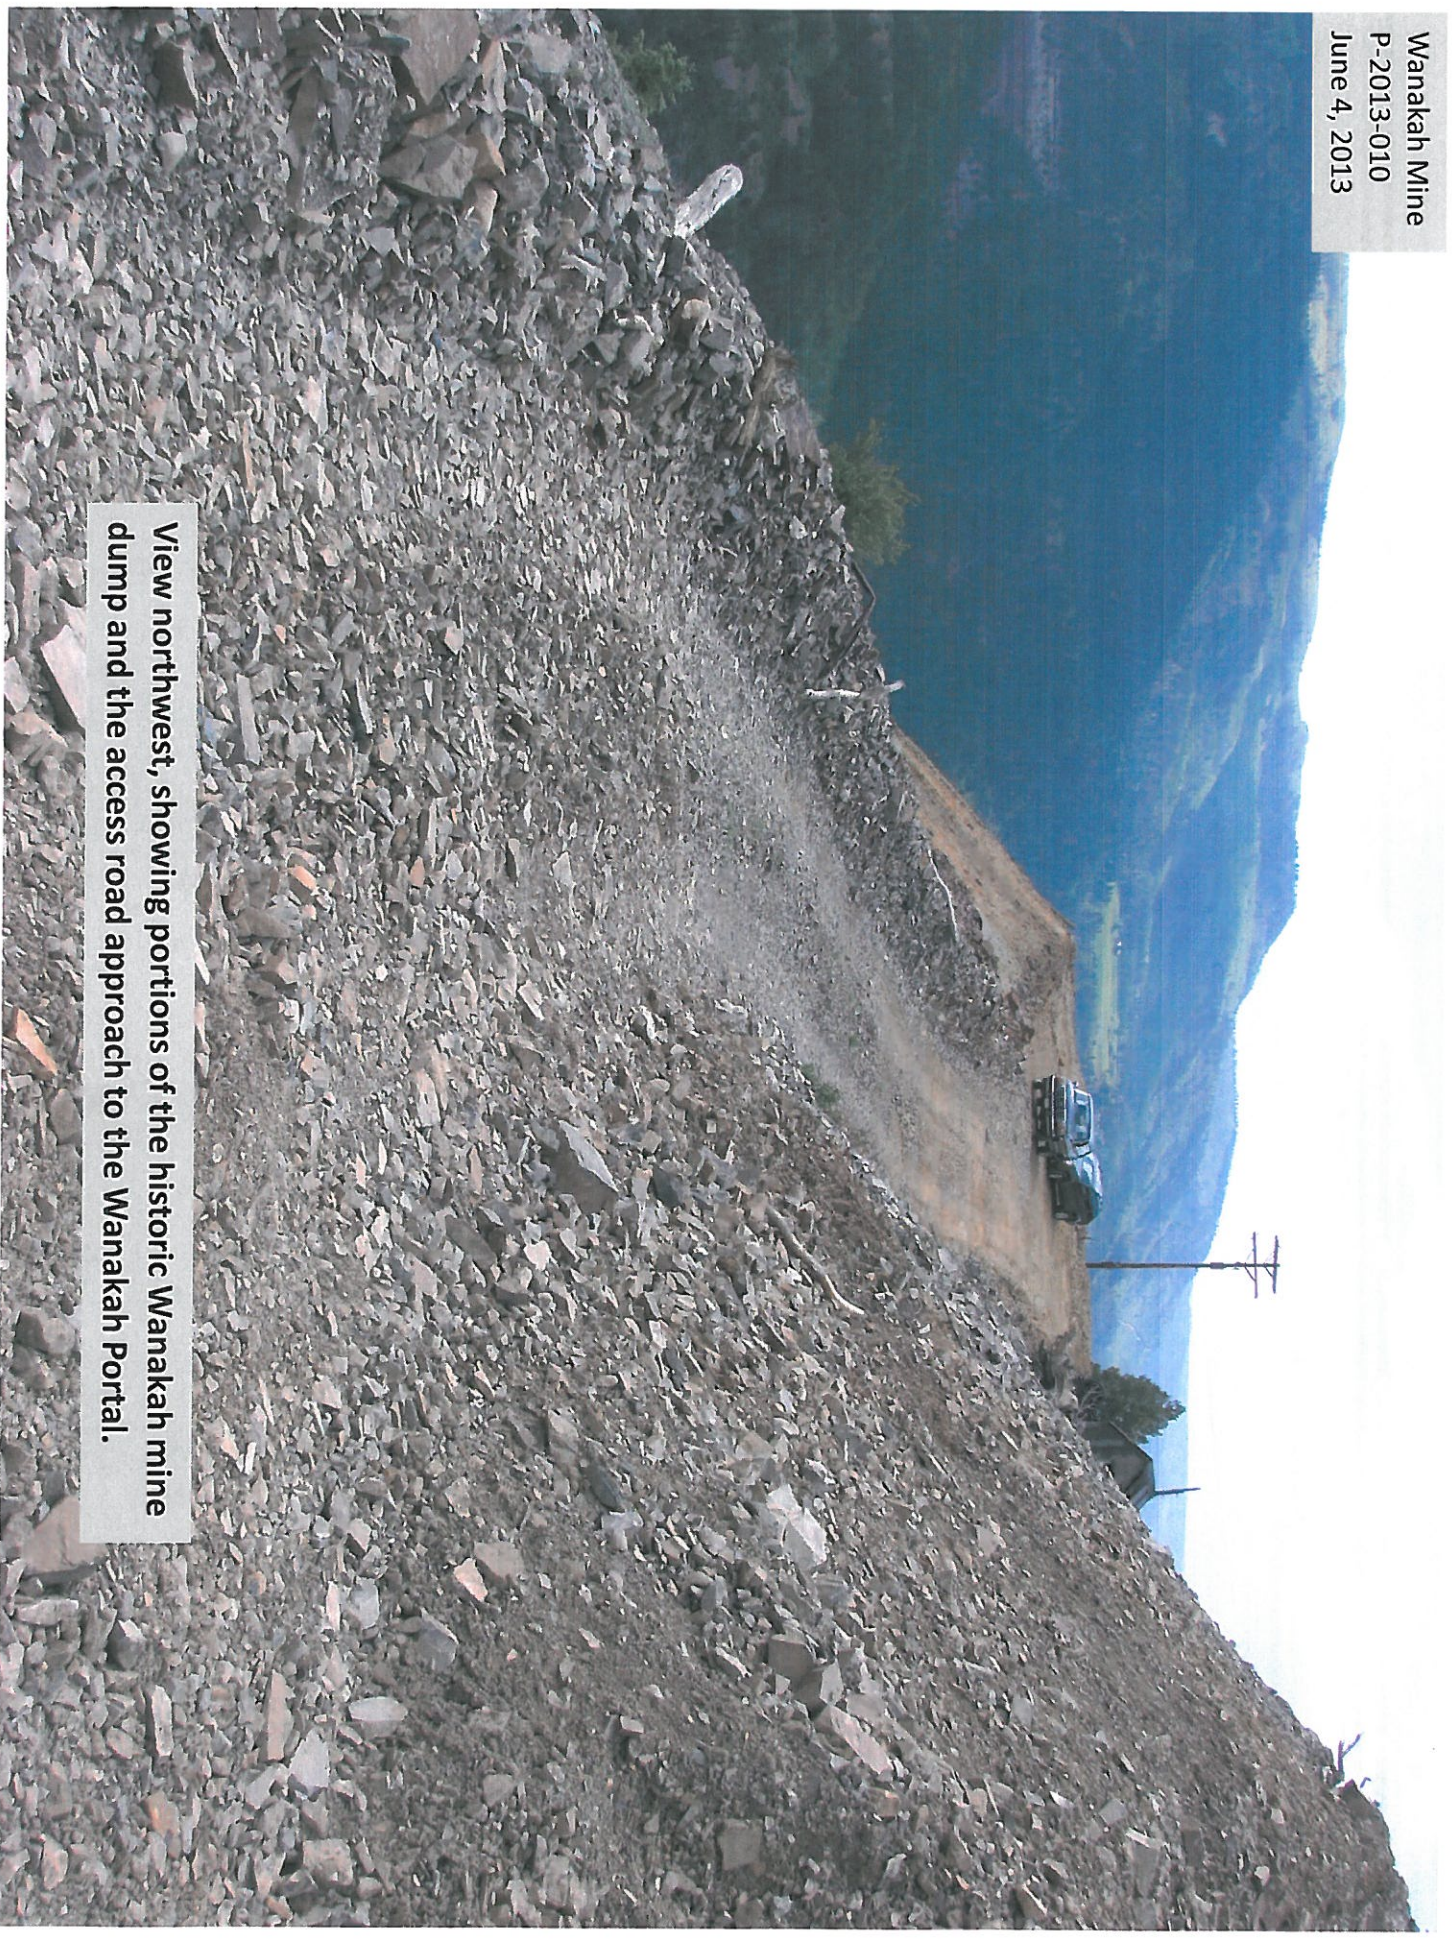
View northwest, showing portions of the historic Wanakah mine dump and the access road approach to the Wanakah Portal.

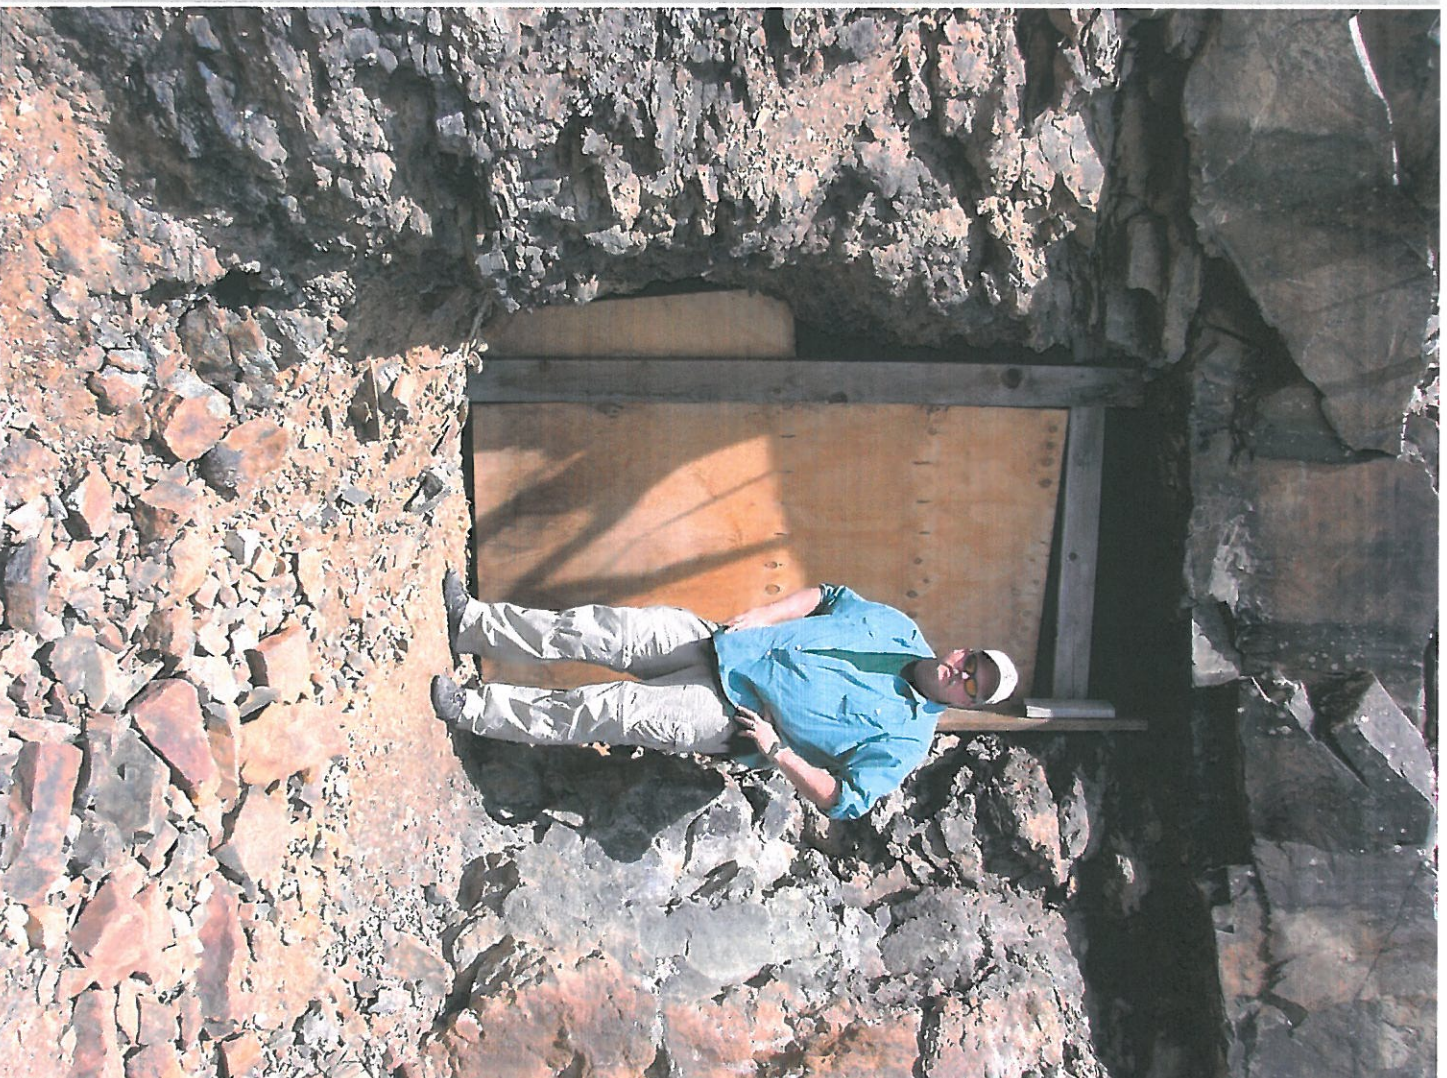
View east, showing the Wanakah Portal, which is proposed to be opened for prospecting activities. The existing timber and plywood closure will be replaced with a lockable steel gate set in rock rib with concrete.

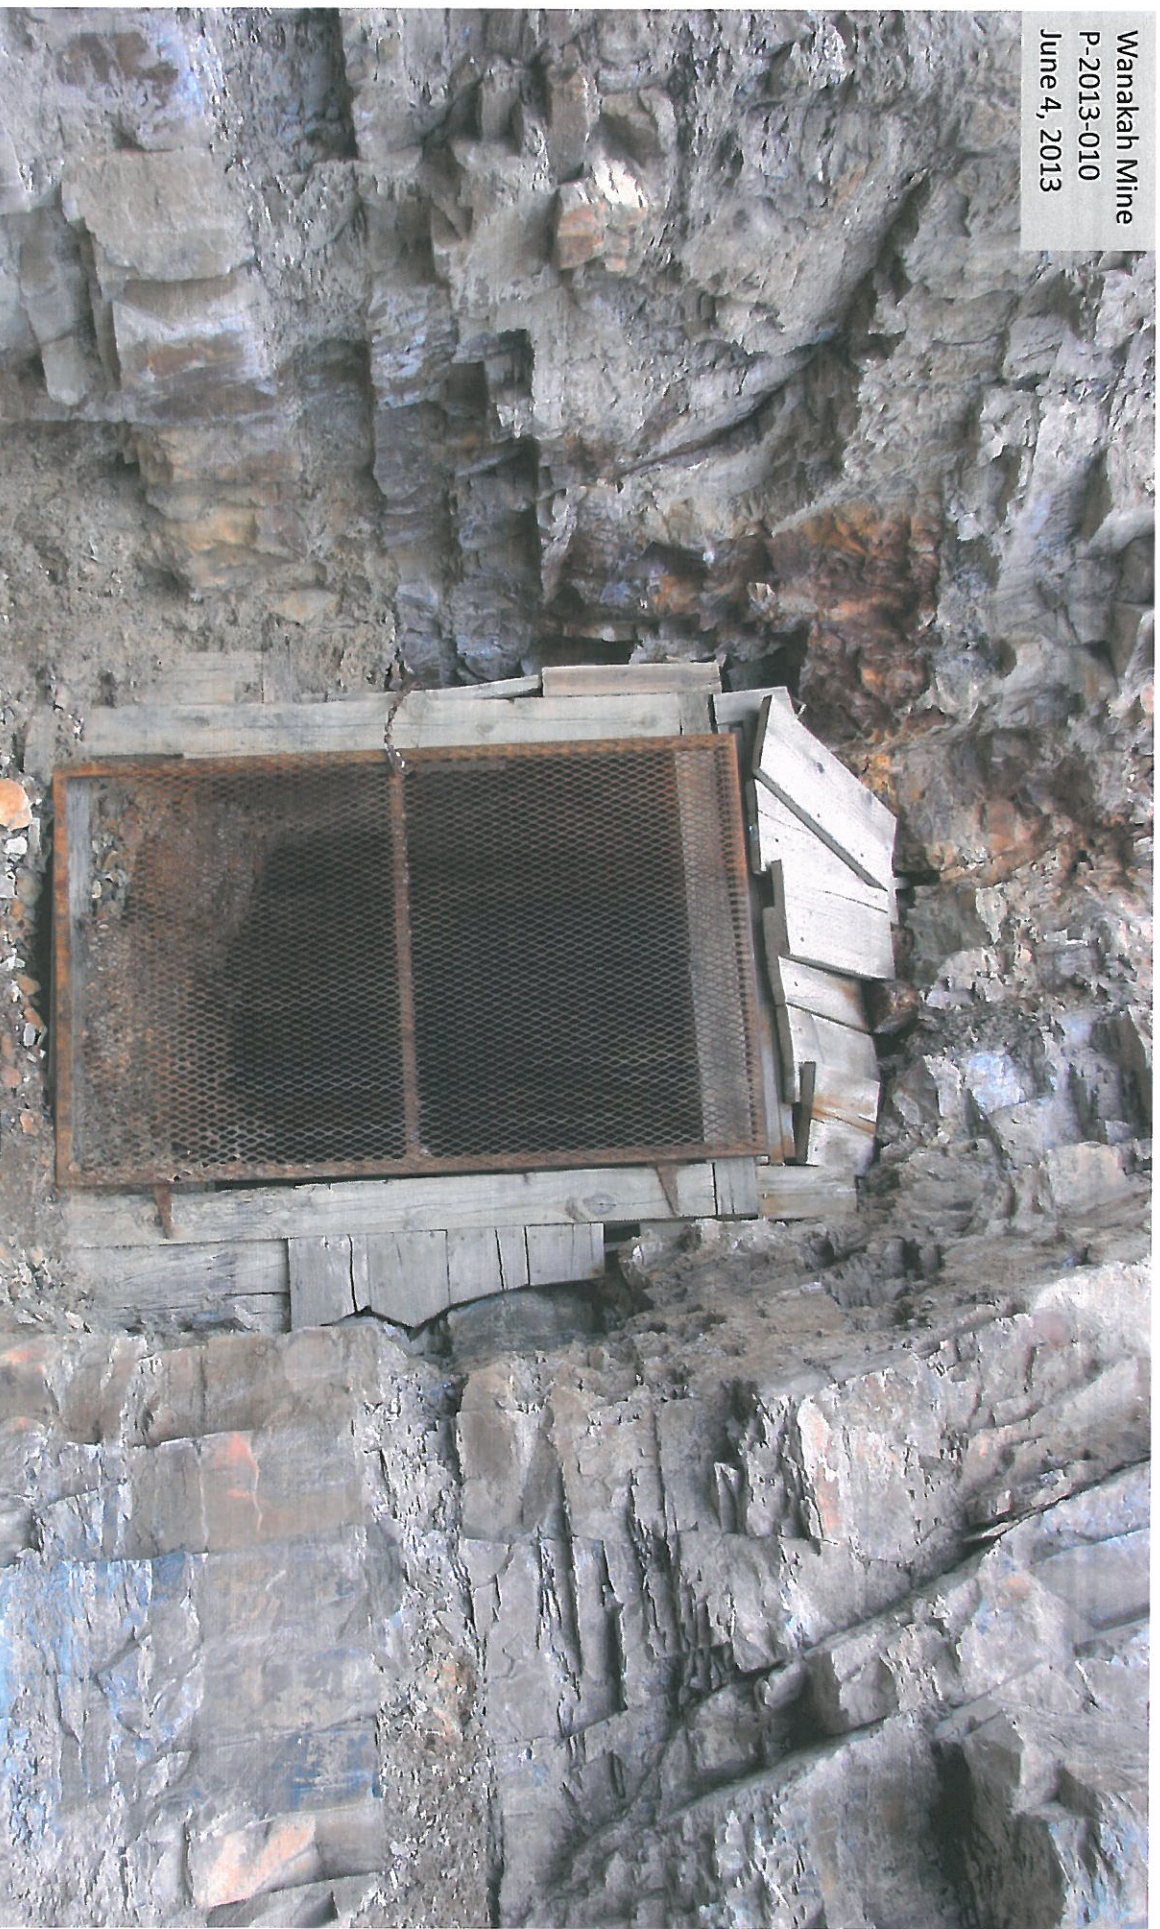
View east, showing the Bright Diamond Portal, which is to be opened for prospecting activities. The existing timber and grate closure will be replaced by a lockable steel gate set in rock rib with concrete.

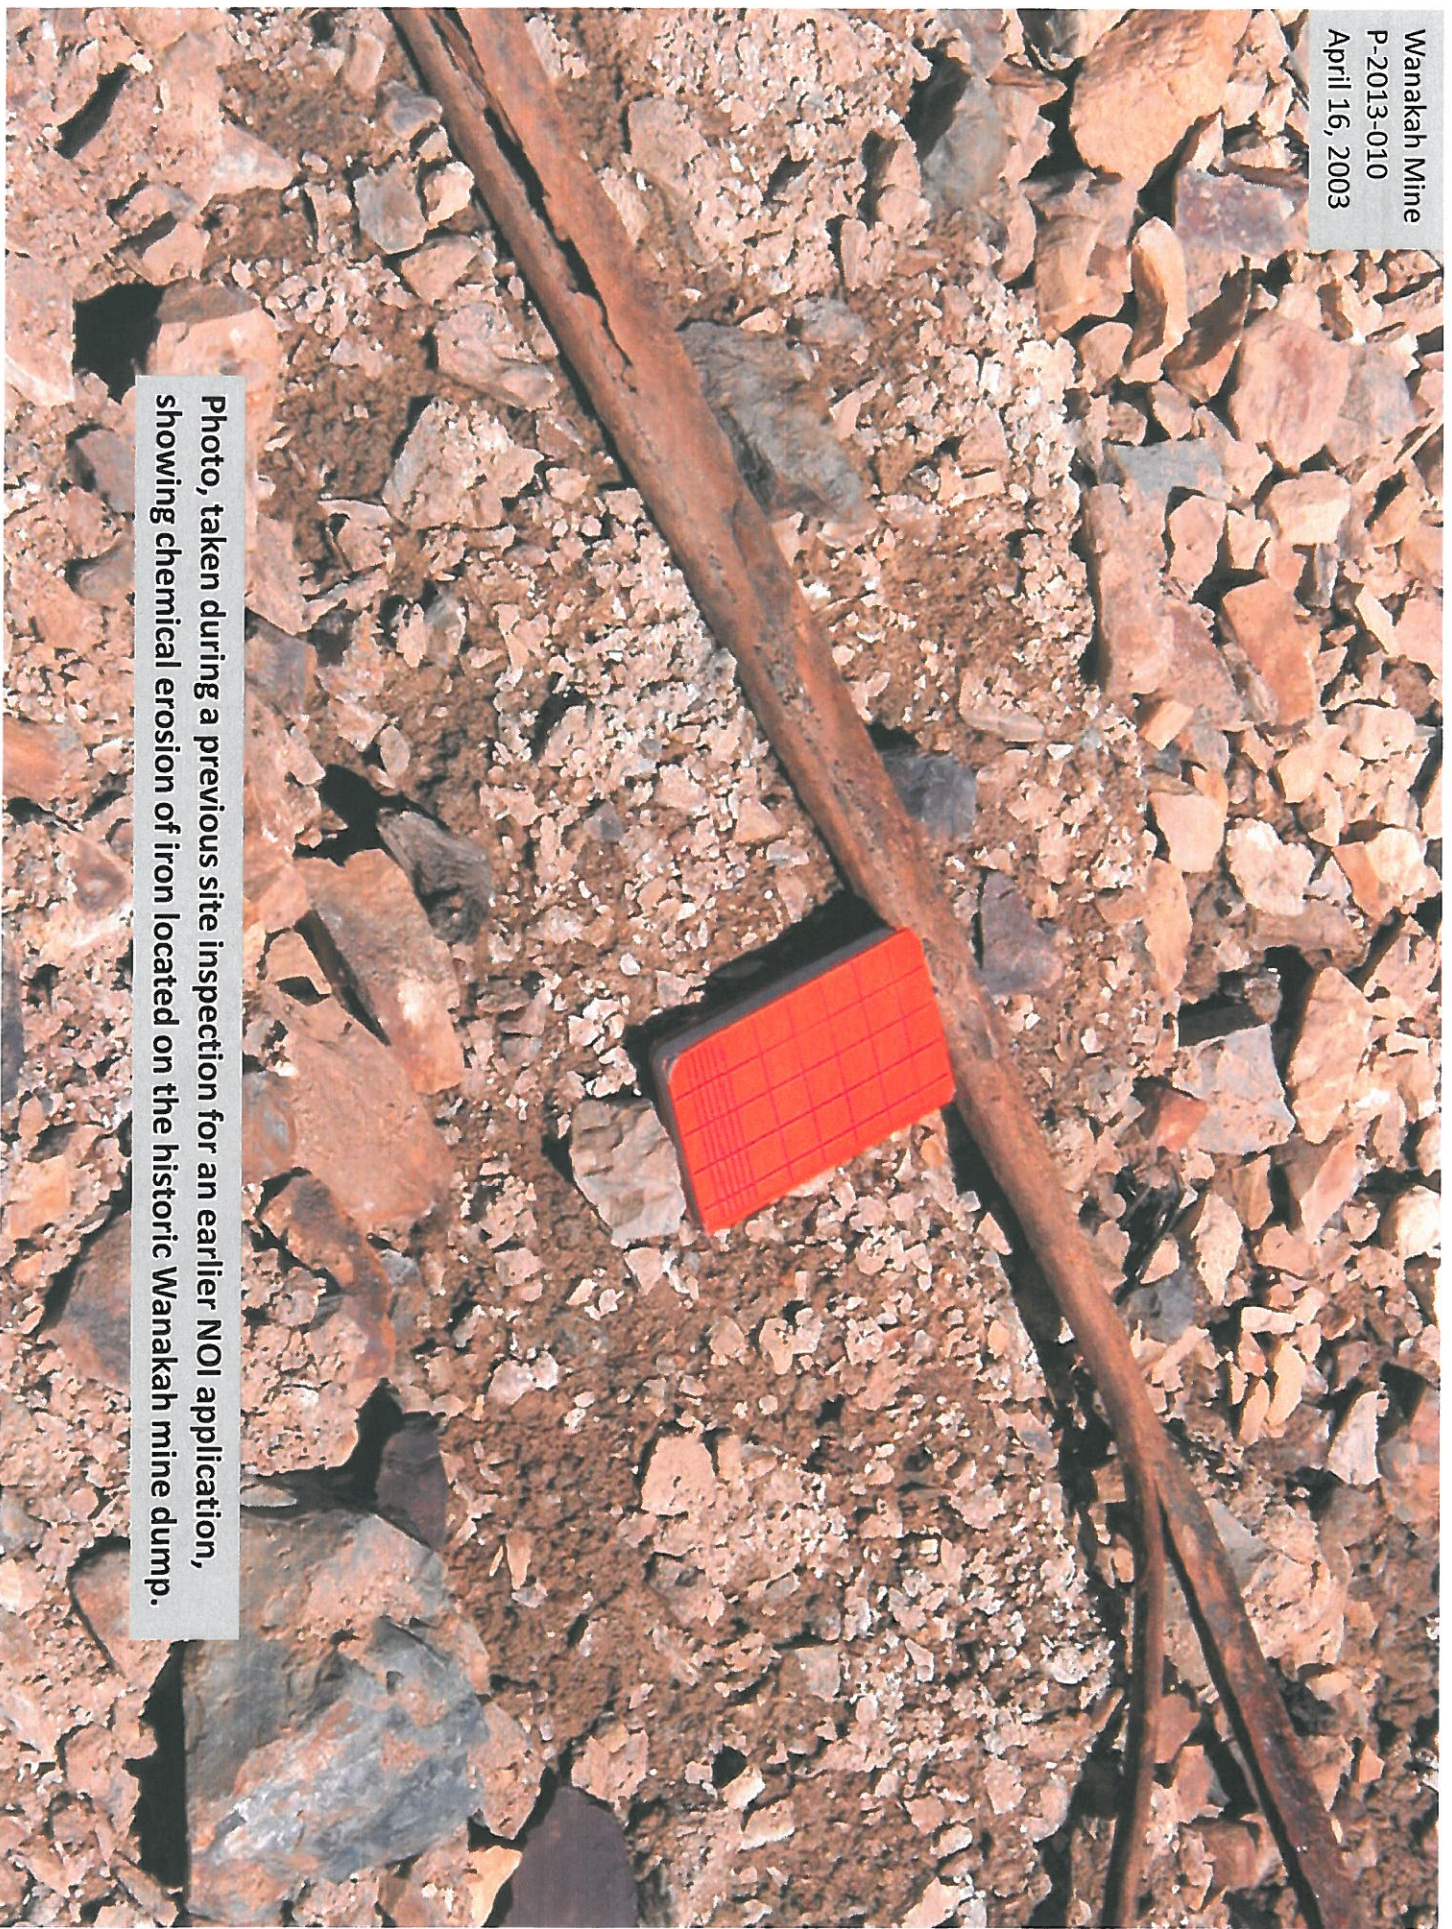
Wanakah Mine
P-2013-010
April 16, 2003

There is an abundance of waste rock materials on site resulting from the historic operation. The mine waste observed on surface exhibited potential to generate acid and/or toxic producing materials and be a potential source of acid mine drainage. As shown in one of the enclosed photos, site conditions appear corrosive to iron implements. The Division will require the Prospector to commit to minimizing any/all contact with the historic mine waste materials on surface. Additionally, if the Prospector desires to develop the mine and pursue a mining permit the Division will require the Applicant to demonstrate the proposed mining operation is not a Designated Mining Operation, pursuant to Rules 1.1(1), 1.1(2), and 1.1(14). If it cannot be demonstrated the mining activities will not have the potential for acid generation, an appropriate 110d or 112d application with an appropriate Environmental Protection Plan, as described under Section 34-32-103(3.5) and Rule 6.4.21, shall be required.

Photo, taken during a previous site inspection for an earlier NOI application, showing chemical erosion of iron located on the historic Wanakah mine dump.
