COLORADO DIVISION OF RECLAMATION, MINING AND SAFETY COAL PROGRAM INSPECTION REPORT

Permit Number: C-1981-038 Mine Name: Bowie No. 1 Mine Operator: Bowie Resources, LLC Operator Address: Mr Basil Bear	County: Delta Operation Type: Underground Permit Status: Active Ownership: Federal		
P.O. Box 1488	Operator Representative Present:		
Paonia, CO 81428	None Present		
Operator Representative Signature: (Field Issuance Only)

This was a partial inspection of the loadout area of the Bowie No. 1 Mine conducted by Susan Burgmaier of DRMS. No representative of Bowie Resources, LLC (operator of the mine) was present during the inspection. Weather conditions were clear and warm; ground conditions were very dry.

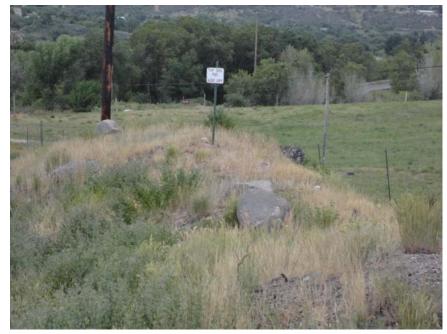
The topsoil stockpile on the west end of the East Loadout was stable and properly identified, but there was

Number of <u>Partial</u> Inspection this Fiscal Year: 11 Number of Complete Inspections this Fiscal Year: 4 a lot of cheatgrass on the pile.

Topsoil stockpile on west end of East Loadout

Cheatgrass was observed on the West Loadout stockpile area, East Loadout west topsoil stockpile, and just east of the gravel storage area at the East Loadout. The operator should work toward eradicating the cheatgrass on site.

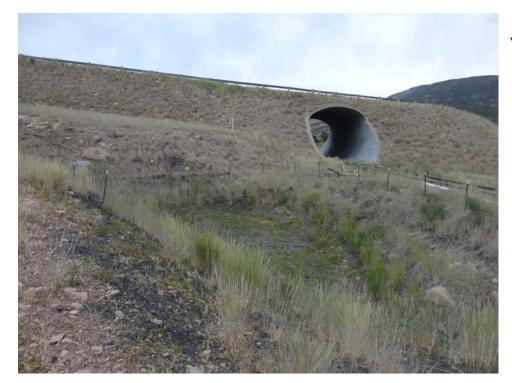
The two loadout sediment ponds and the sewage lagoon were all dry. All ditches and culverts were clear and dry, and the outslope berm on the East Loadout was in place. The berm on the downhill (south) side of the gravel storage area had been repaired, so that runoff off of the gravel area will be retained on site. The grass filter small area exemption on the east end of the mine was in good condition; vegetation was adequate to filter runoff from the gravel surfaced disturbed area.

West Loadout Pond

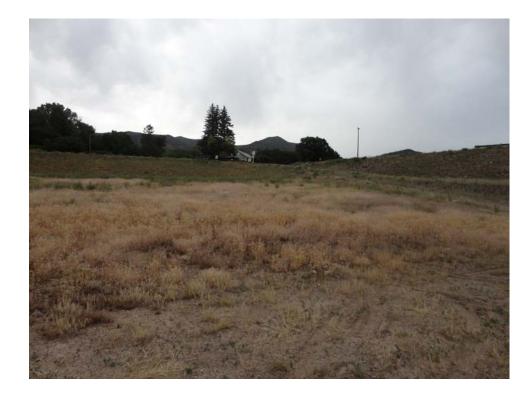
Cheatgrass on coal stockpile pad of West Loadout
