COLORADO DIVISION OF RECLAMATION, MINING AND SAFETY COAL PROGRAM INSPECTION REPORT

Permit Number: X-2006-109-13 Mine Name: Colowyo 2006-2007 Reserve Def Drilling Program Operator: RTEA -Colowyo Mine Operator Address: Mr Chris McCourt 5731 State Highway 13 Meeker, CO 81641	County: Moffat Operation Type: Coal exploration Permit Status: Inactive Ownership: Federal
	Operator Representative Present: Tony Tennyson, Kurt Blunt
Operator Representative Signature: (Field Issuance Only)

Inspection Start Date: June 12, 2013 Inspection Start Time: 08:00 Inspection End Date: June 19, 2013 Inspection End Time: 14:00		Inspection Type: Coal Exploration Inspection Inspection Reason: Surety Release Requested Weather: Clear	
Joint Inspection Agency: None		Joint Inspection Contacts: 	
Post Inspection Agency: None		Post Inspection Contacts: 	
Inspector(s): Elliott R. Russell	Inspector's Signature:

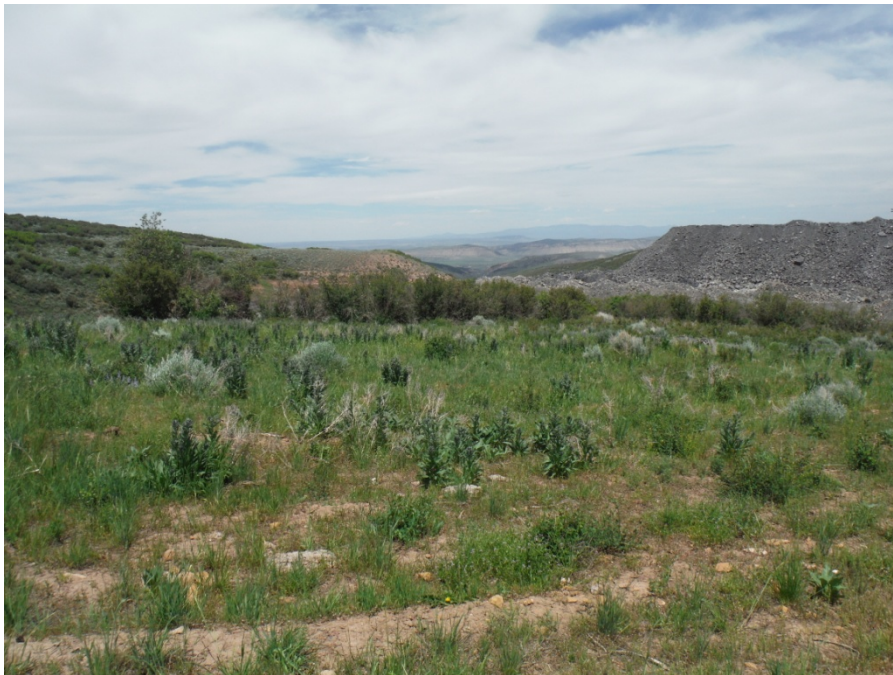
The sites and access roads to ST-07-01 and ST-07-03 had appropriate ground cover, showed no signs of erosion nor any other problems as a result of exploration except that the areas were dominated by **Houndstongue**, a List B noxious weed species.

ST-07-01, Houndstongue dominates reclaimed pad

The Division recommends the management of these noxious species and possibly reseeding the pads and access roads before the Division can release of bond associated with revegetating these areas.

Based on this inspection, the Division determines that the exploration activities associated with X-2006-109-13 have been adequately reclaimed, except the vegetation at the sites and access roads to **ST-07-01** and **ST-07-03**. The Division recommends the release of all other exploration activities associated with this NOI.

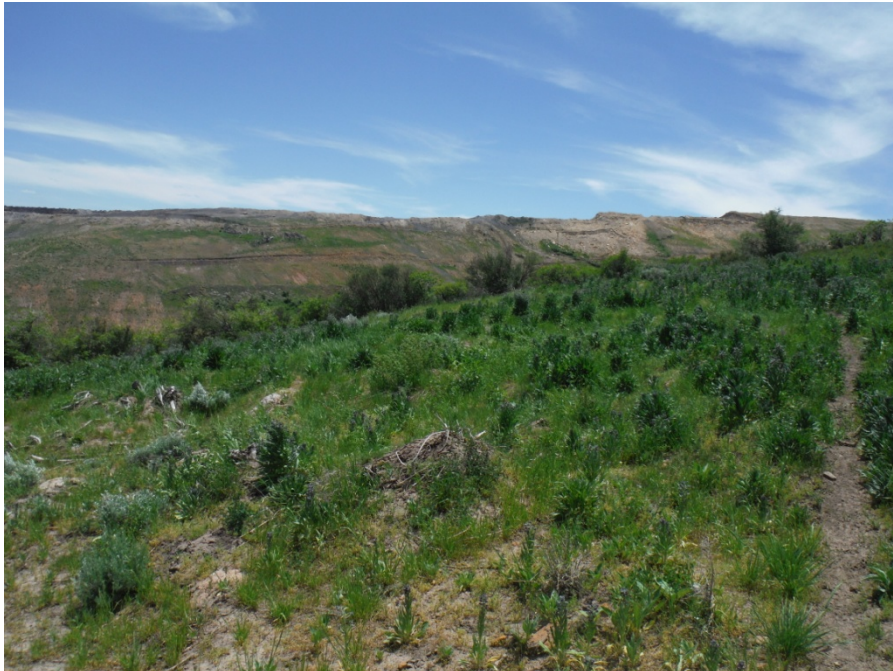
ST-07-03, Houndstongue dominates reclaimed pad

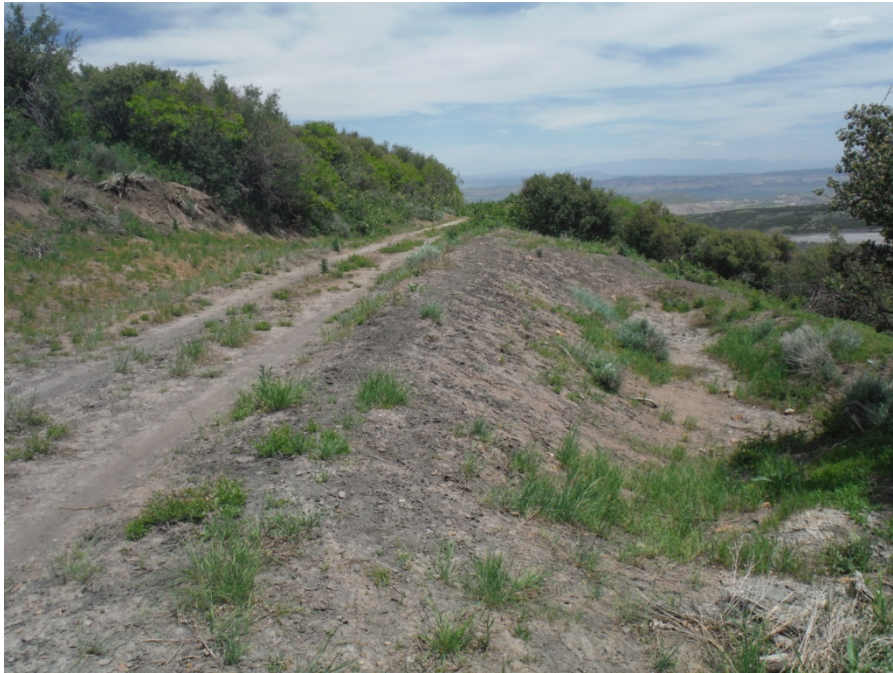
Sites ST-07-07 and ST-07-11 were drilled along an access road to the west of the South Taylor Pit. These two sites were well vegetated at the time of the inspection. All areas of disturbance showed no signs of erosion, evidence of

noxious/invasive species, or any other problems as a result of exploration.

A borehole marker could not be found at all four sites.
