COLORADO DIVISION OF RECLAMATION, MINING AND SAFETY COAL PROGRAM INSPECTION REPORT

Permit Number: X-2005-109-11 Mine Name: Colowyo 2005 Reserve Def Drilling Program Operator: Kennecott Energy - Colowyo Mine Operator Address: Mr Chris McCourt 5731 State Highway 13 Meeker, CO 81641	County: Moffat Operation Type: Coal exploration Permit Status: Inactive Ownership: Federal
Operator Representative Present: Tony Tennyson, Kurt Blunt	
Operator Representative Signature: (Field Issuance Only)

Inspection Start Date: June 12, 2013 Inspection Start Time: 08:00 Inspection End Date: June 19, 2013 Inspection End Time: 14:00		Inspection Type: Coal Exploration Inspection Inspection Reason: Surety Release Requested Weather: Clear	
Joint Inspection Agency: None		Joint Inspection Contacts:	
Post Inspection Agency: None		Post Inspection Contacts:	
Inspector(s): Elliott R. Russell	Inspector's Signature:

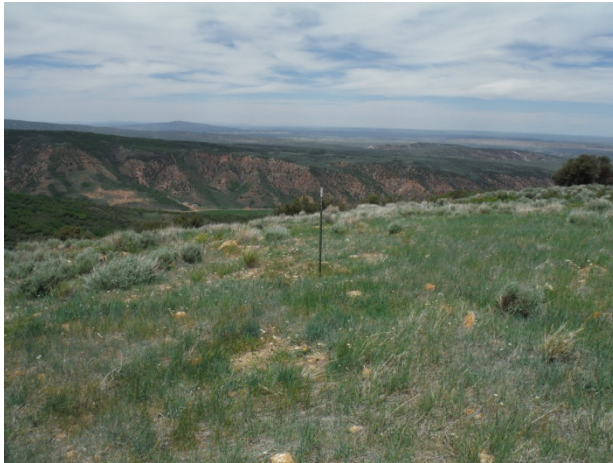
The majority of all exploration the sites had an approved borehole marker, which was a metal t-post indicating where the hole was located. These posts had an aluminum tag with the site ID stamped into it.

LW-05-10, example picture of site with a borehole marker

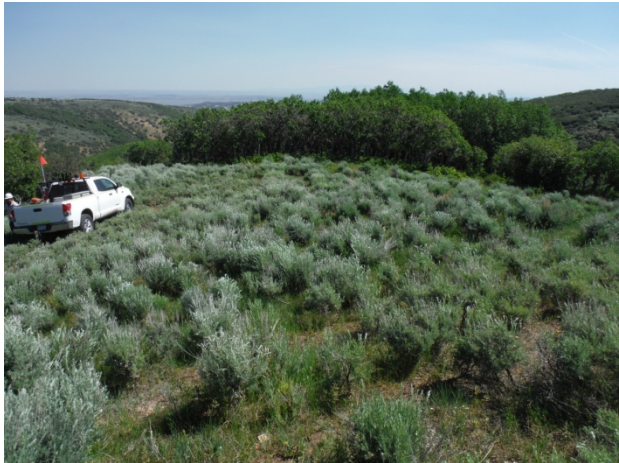
C-05-24, example picture of site where a borehole marker could not be found

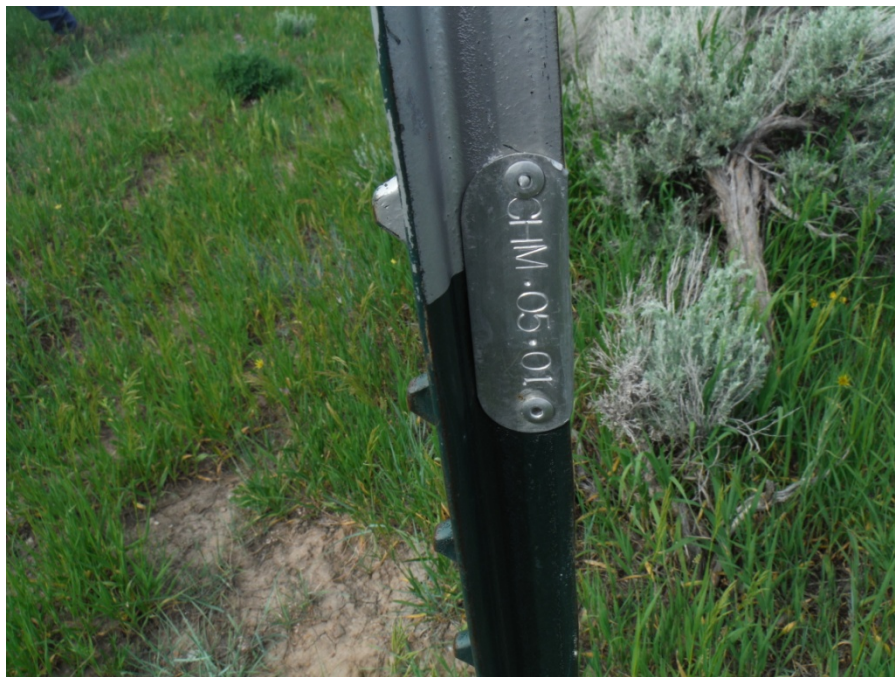
CHM-05-01, example picture of tag on borehole marker

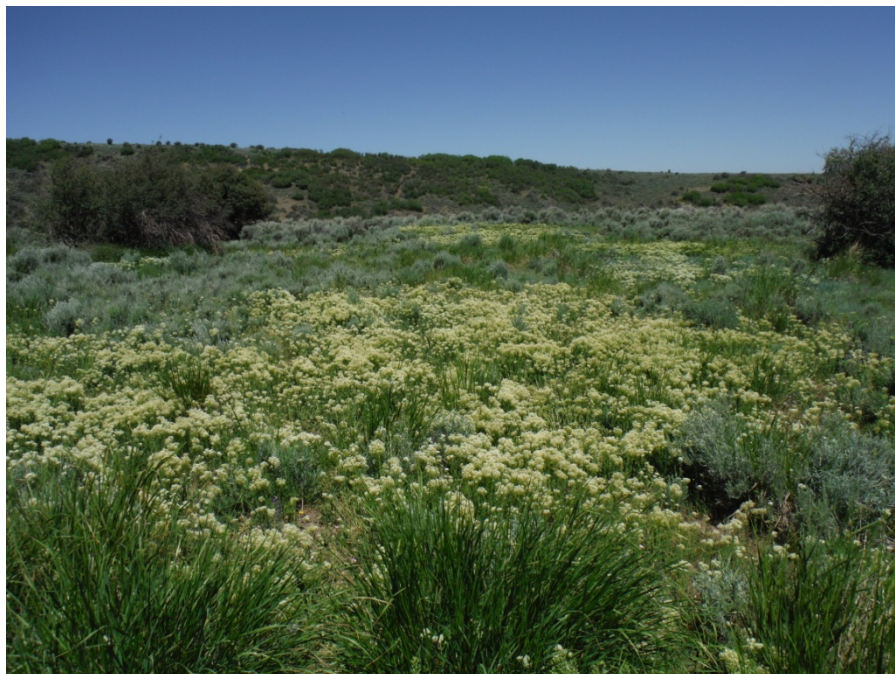
- Site **C-05-07** was dominated by Hoary cress, a List B noxious weed species, also known as Whitetop.
- Site **CHM-05-03** was dominated by Downy brome, a List C noxious weed species.
- Site **LW-05-08** was dominated by Houndstongue, a List B noxious weed species.

C-05-07, Whitetop dominates reclaimed pad

The Division recommends the management of these noxious species and possibly reseeding the pads before the Division can release of bond associated with revegetating these pads.

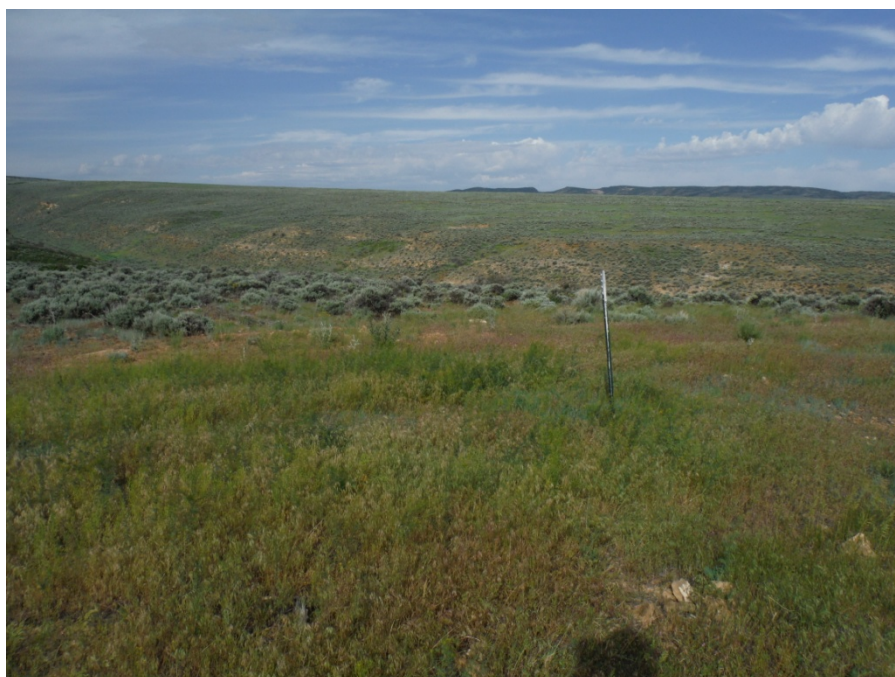
CHM-05-03, Cheatgrass dominates reclaimed pad

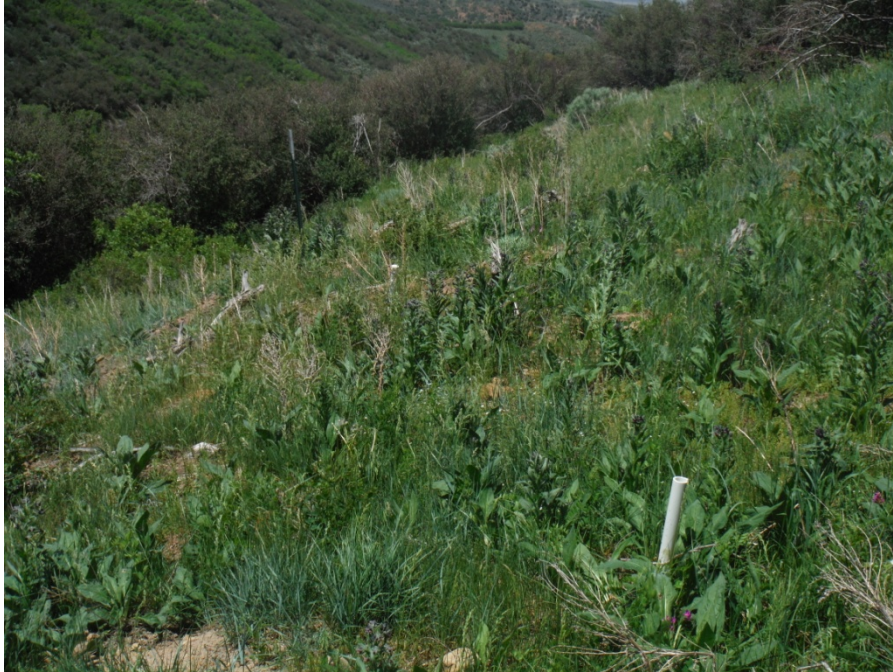
Three 2" PVC pipes, approximately 8" tall, were located on **LW-05-08** and one was located on the east edge of **LW-05-11**. These will need to be removed to achieve final bond release.

LW-05-08, Houndstongue dominates reclaimed pad. PVC pipes present at site

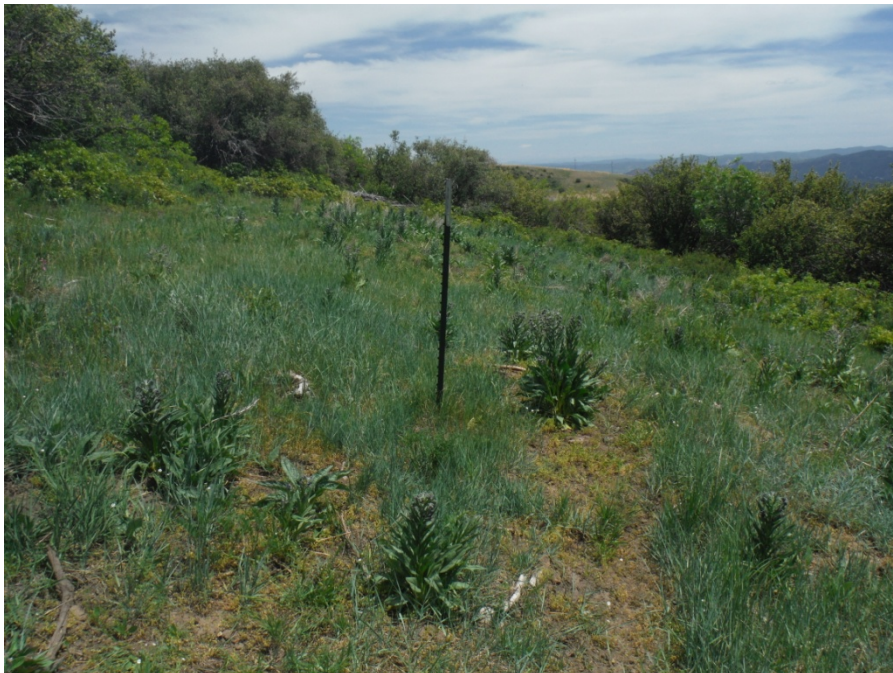
- Site **LW-05-16** was dominated by Houndstongue, a List B noxious weed species.

LW-05-16, Houndstongue dominates reclaimed pad

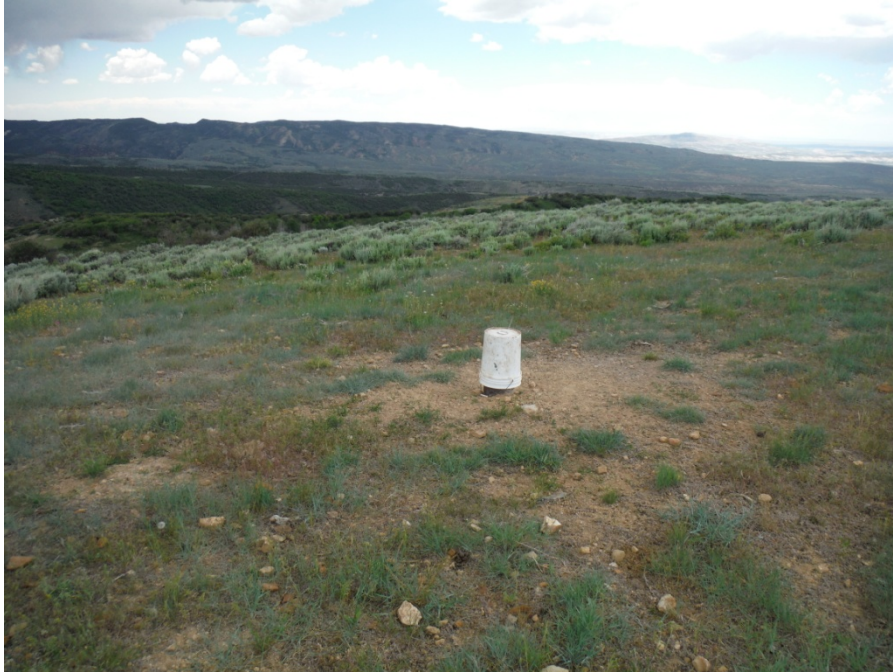
The drill pad of **C-05-33** was reclaimed and showed no signs of erosion, evidence of noxious/invasive species, or any other problems as a result of exploration, except for one monitoring well that remains.

C-05-33, 1 monitoring well remains

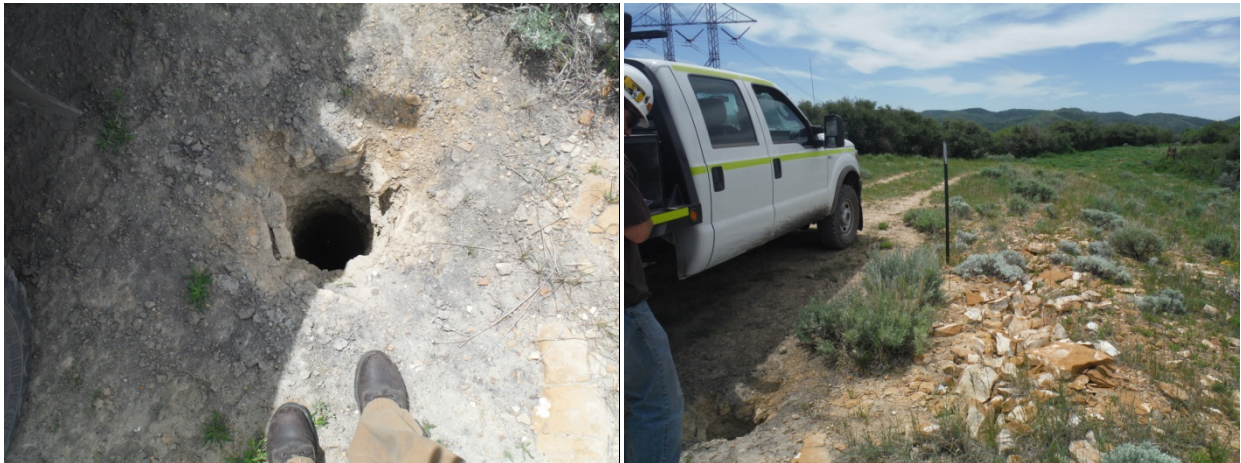
The drill pad of **LW-05-15** was reclaimed and showed no signs of erosion, evidence of noxious/invasive species, or any other problems as a result of exploration, except for an open borehole that remains. This hole was located on the west side of the access road on Sherriff's Ridge, 10' north of the t-post marker for the pad. This hole is approximately 15' deep and 8" in diameter and will need to be properly sealed to achieve final bond release.

Two pictures of LW-05-15, open borehole found
