COLORADO DIVISION OF RECLAMATION, MINING AND SAFETY COAL PROGRAM INSPECTION REPORT

Permit Number: X-2005-226-00 Mine Name: Northfield Project Operator: Northfield Partners, LLC Operator Address: Mr Scott Leonhart PO Box 260678 Littleton, CO 80163-0678	County: Fremont Operation Type: Coal exploration Permit Status: Inactive Ownership: Private
Operator Representative Present: Angela Bellantoni, Nick Bellino	
Operator Representative Signature: (Field Issuance Only)

Inspection Start Date: June 25, 2013 Inspection Start Time: 09:00 Inspection End Date: June 25, 2013 Inspection End Time: 12:00		Inspection Type: Coal Exploration Inspection Inspection Reason: Surety Release Requested Weather: Clear	
Joint Inspection Agency: None		Joint Inspection Contacts:	
Post Inspection Agency: None		Post Inspection Contacts:	
Inspector(s): Elliott R. Russell Jason D. Musick	Inspector's Signature:

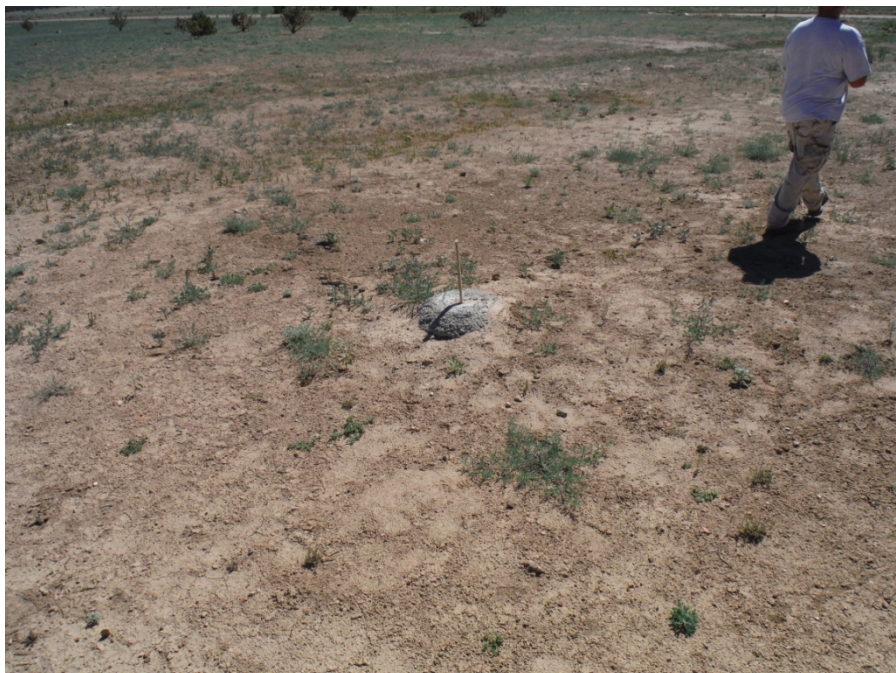
BC-06

Sites BC-01, BC-03, BC-04, BC-05, BC-06, NF-04, NF-05B, and NF-06 were adequately vegetated at the time of the inspection, with some sites exhibiting more vegetation than others. All areas of disturbance showed no signs of erosion, evidence of noxious/invasive species, or any other problems as a result of exploration. The majority of these sites had a concrete surface cap as a borehole marker, with a few of these sites having a wood lath in the concrete.

Based on this inspection, the Division determines that the exploration activities associated with X-2005-226-00 have been adequately reclaimed, except the monitoring well that remains at BC-02 and sites and wells at NF-01, NF-02, and NF-03. The Division recommends the release of all other exploration activities associated with this NOI.

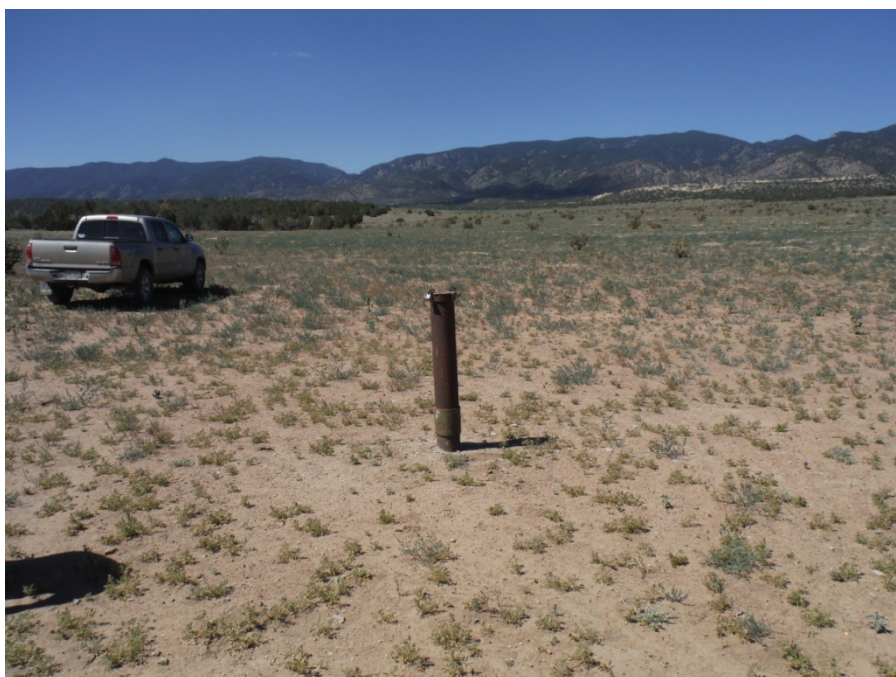
BC-02 was drilled in regards for a reserve box cut. The drill pad was reclaimed and showed no signs of erosion, evidence of noxious/invasive species, or any other problems as a result of exploration, except for the one monitoring well that remains.

BC-02, monitoring well remains
