## COLORADO DIVISION OF RECLAMATION, MINING AND SAFETY COAL PROGRAM INSPECTION REPORT

| <b>Permit Number:</b> C-1981-013<br><b>Mine Name:</b> Golden Eagle Mine<br><b>Operator:</b> New Elk Coal Company, LLC<br><b>Operator Address:</b><br>Mr Ron Thompson<br>12250 State Highway 12<br>Weston, CO 81091 | <b>County:</b> Las Animas<br><b>Operation Type:</b> Underground<br><b>Permit Status:</b> Permanent Cessation<br><b>Ownership:</b> Private |

| <b>Inspection Start Date:</b> July 23, 2013<br><b>Inspection Start Time:</b> 12:48<br><b>Inspection End Date:</b> July 23, 2013<br><b>Inspection End Time:</b> 17:00 | <b>Inspection Type:</b> Coal Complete Inspection<br><b>Inspection Reason:</b> Normal I&E Program<br><b>Weather:</b> Cloudy | |

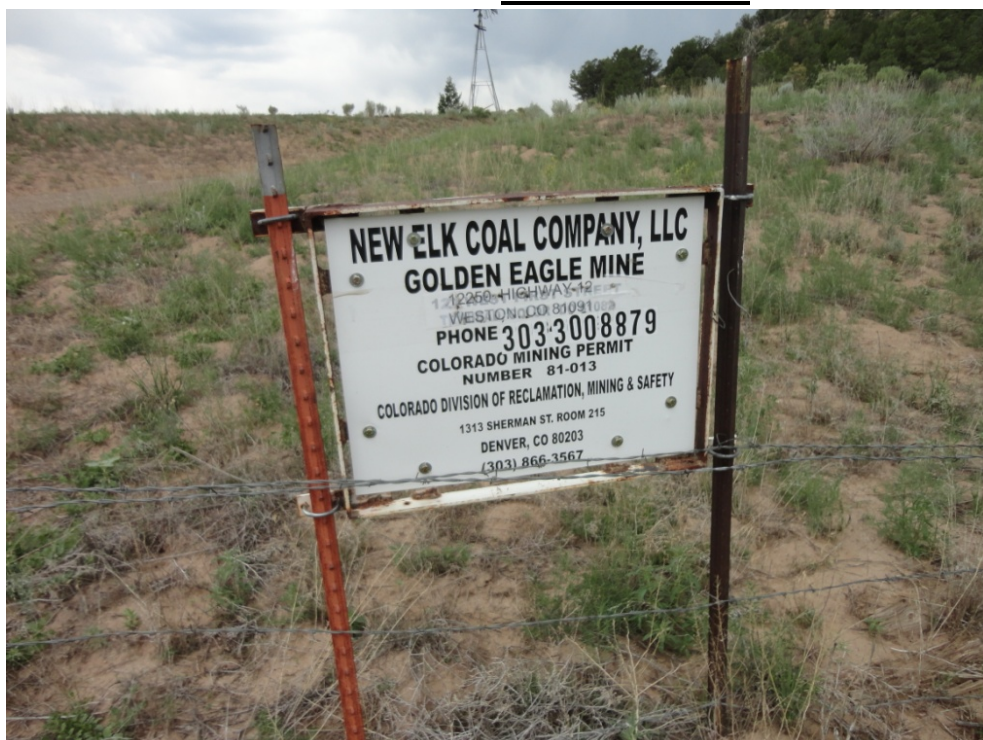
Photo 1: Mine ID sign

The mine ID sign was in compliance, although the temporary alterations made with paper and clear tape are deteriorating with exposure to the weather. A permanent sign should be put in place soon.

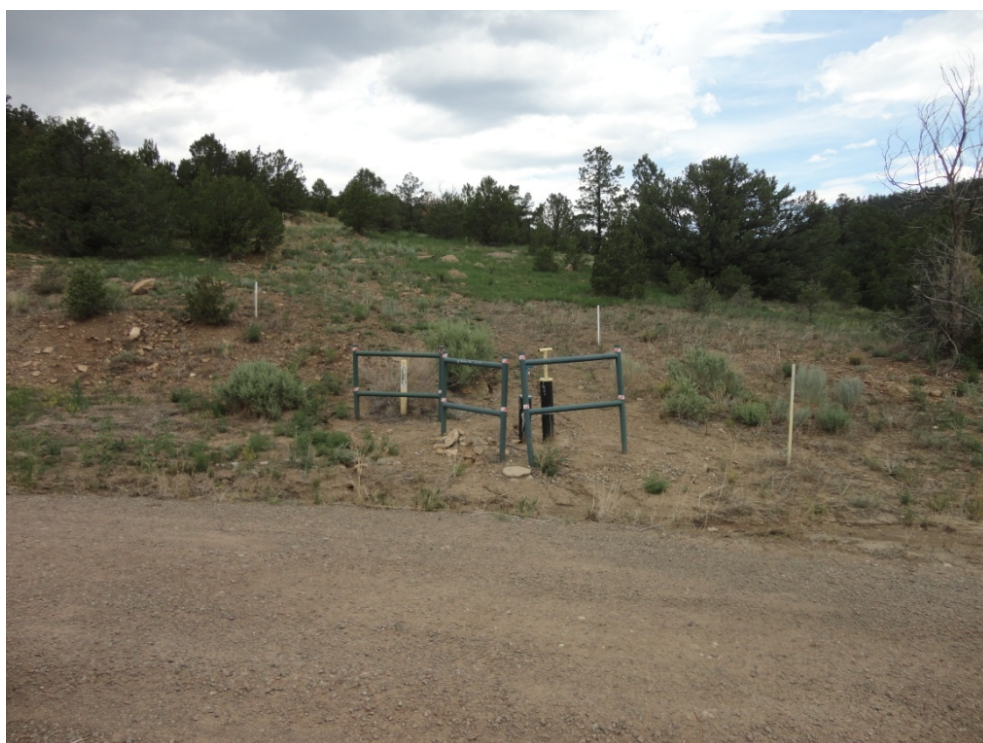
Photo 2: Gas line valves

The valves shown in photo 2 of the April 29th inspection report, and again below, are associated with gas pipelines. The valves are located outside of the disturbance boundary, but are within the permit boundary. Rule 2.10.3(e) requires that any pipelines within the permit boundary be displayed on a map. **NECC should verify the location of the pipeline and ensure that it is included on a map to be submitted with TR57.**

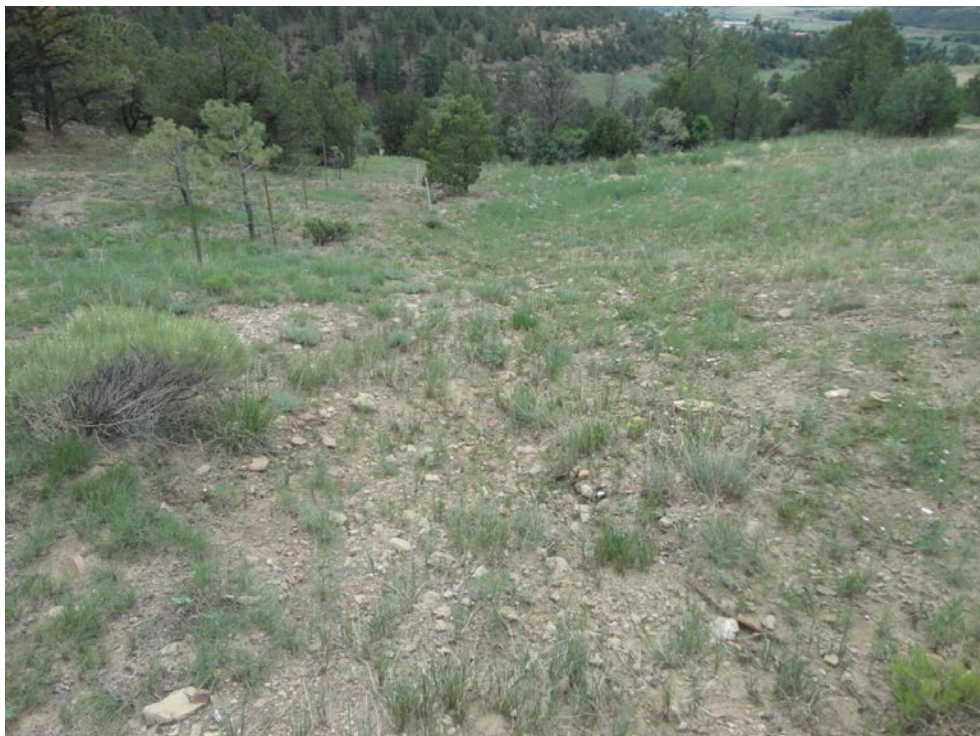
Photo 3: Natural drainage at NE edge of site

The site was well drained, with no muddy patches, despite the recent rain. At the north-eastern edge of the site, adjacent to the firewood operation, there was some erosion in the natural drainage. This area had previously been noted as worthy of observation; the recent rain appears to have accelerated erosion. The pictures below show that some of the runoff contributing to the main erosive gully is from the neighboring property, hence, not the responsibility of NECC. However, rills and a small gully have formed with the Golden Eagle disturbed area boundary markers. **These should be repaired, and flow control structures, such as straw wattles, should be installed to prevent further damage.**
