Colorado Water Conservation Board

Water Plan Grant Application

Name of Applicant	Uncompahgre Watershed Partnership (UWP)	
Name of Water Project	Governor Basin Restoration Project	
CWP Grant Request Amount		\$ 33,250.00
Idarado NRD Funds		\$ 67,250.00
Ouray Silver Mines, Inc		\$ 73,000.00
Applicant Funding Contribution		\$ 9,535.00
Total Project Cost		\$ 184,535.00

NATURAL RESOURCE DAMAGES FUND PROJECT PROPOSAL: GOVERNOR BASIN RESTORATION PROJECT IN OURAY COUNTY, COLORADO

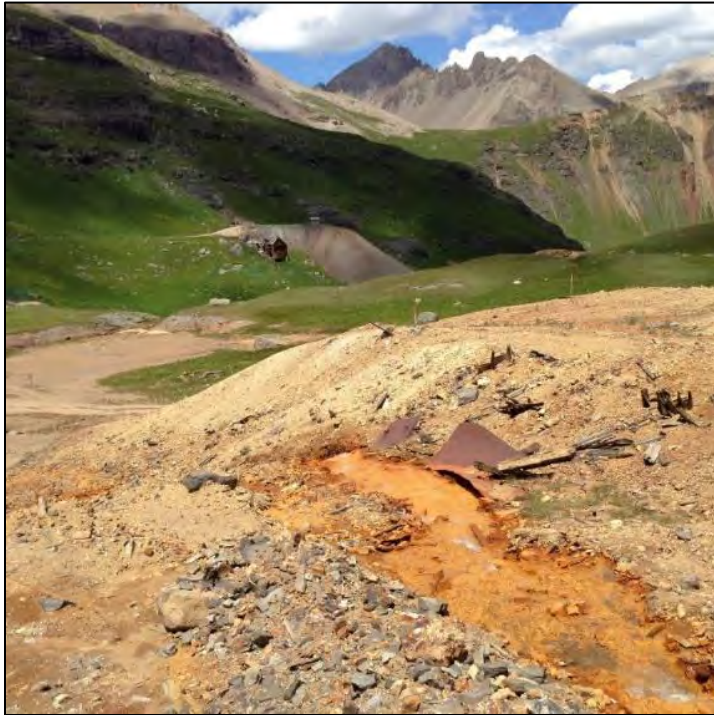
View from the Terrible #3 Adit drainage channel. The foreground of the photo characterizes resource damage common throughout the project area. Left of center, drainage from the Terrible Mine flows into Governor Creek. The background of the photo includes alpine tundra characteristic of the San Juan Mountains. Photo credit: Jeff Litteral, DRMS.

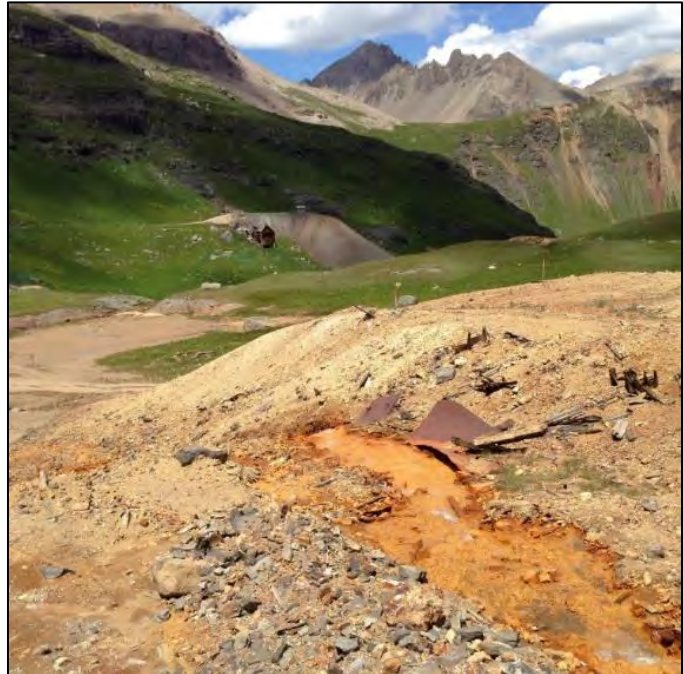
Photo 1. View from the Terrible #3 Adit drainage channel. The foreground of the photo characterizes resource damage common throughout the project area. Left of center, drainage from the Terrible Mine flows into Governor Creek. The background of the photo includes alpine tundra characteristic of the San Juan Mountains. Photo credit: Jeff Litteral, DRMS

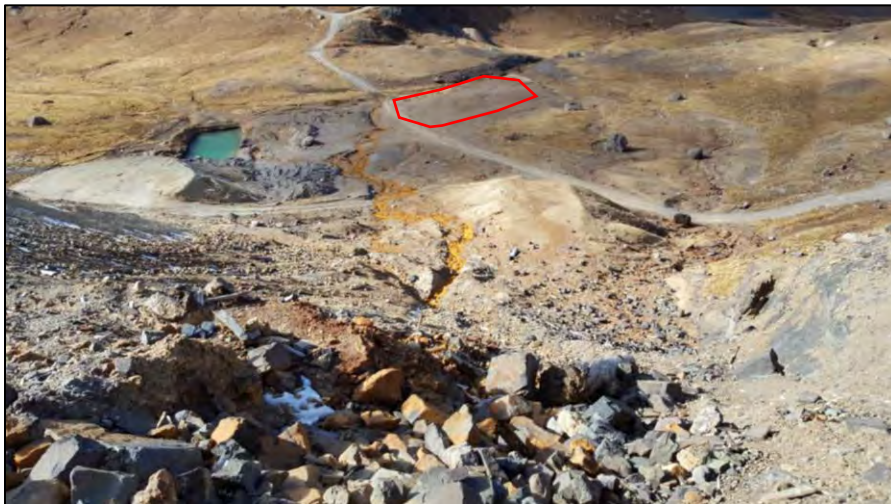
Photo 2. View of tailings near Governor Basin Road. The tailings limit plant growth in the area. The red polygon shows the approximate area of the USFS claim.
