Lower Elkhead Creek Restoration Project, Phase I Trout Unlimited

Colorado Watershed Restoration Program Application

DESIGN & GEOMORPHOLOGY REPORT

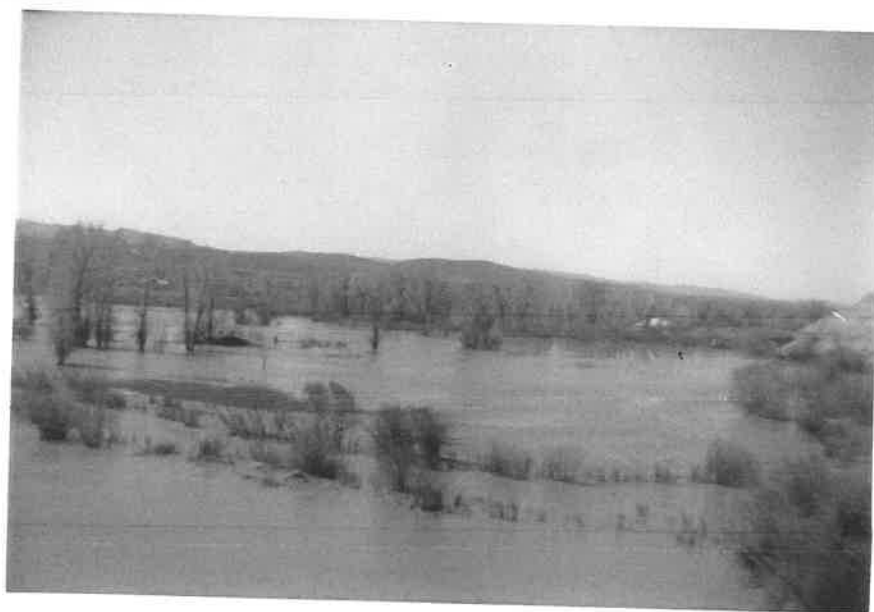
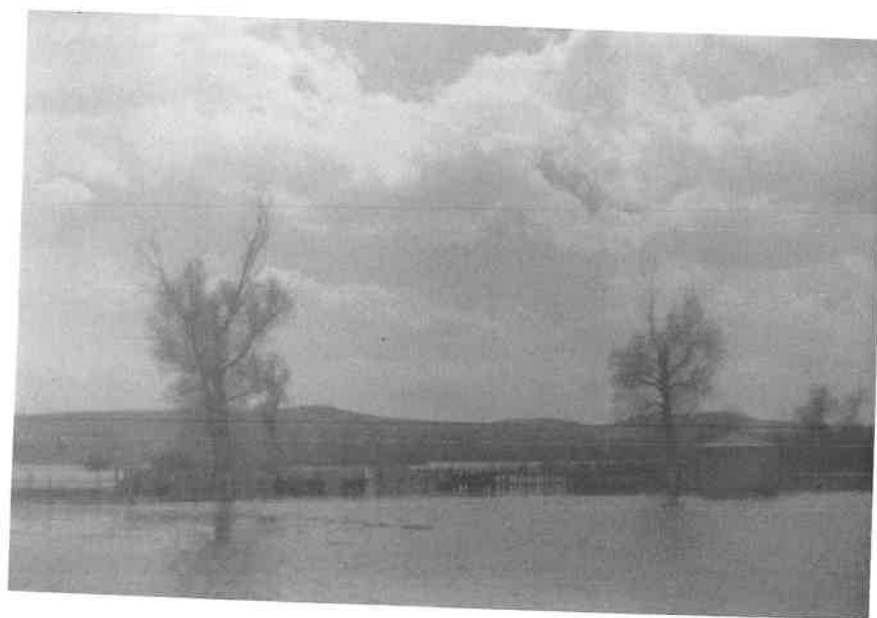
Photos of lower Elkhead Creek taken in 1970 (pre-Elkhead Reservoir) by a landowner residing on the creek. Photos suggest high floodplain connectivity, frequent inundation, and presence of riparian vegetation.

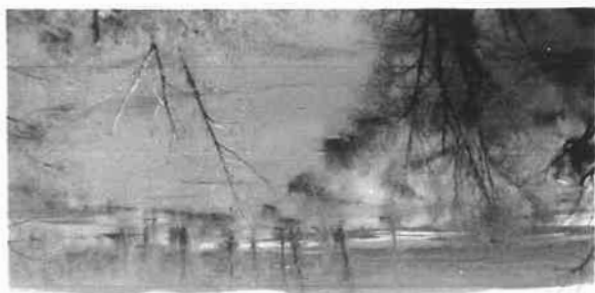
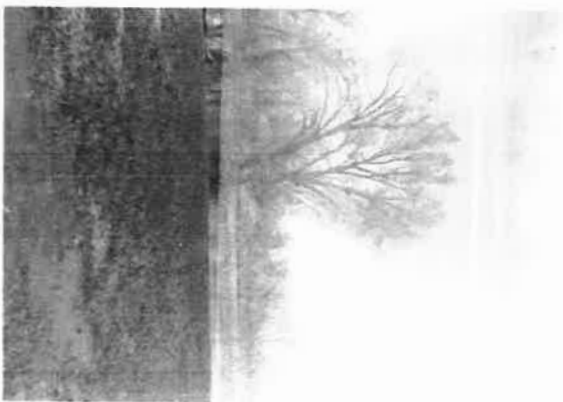
Photos of lower Elkhead Creek taken in 1970 (pre-Elkhead Reservoir) by a landowner residing on the creek. Photos suggest high floodplain connectivity, frequent inundation, and presence of riparian vegetation.

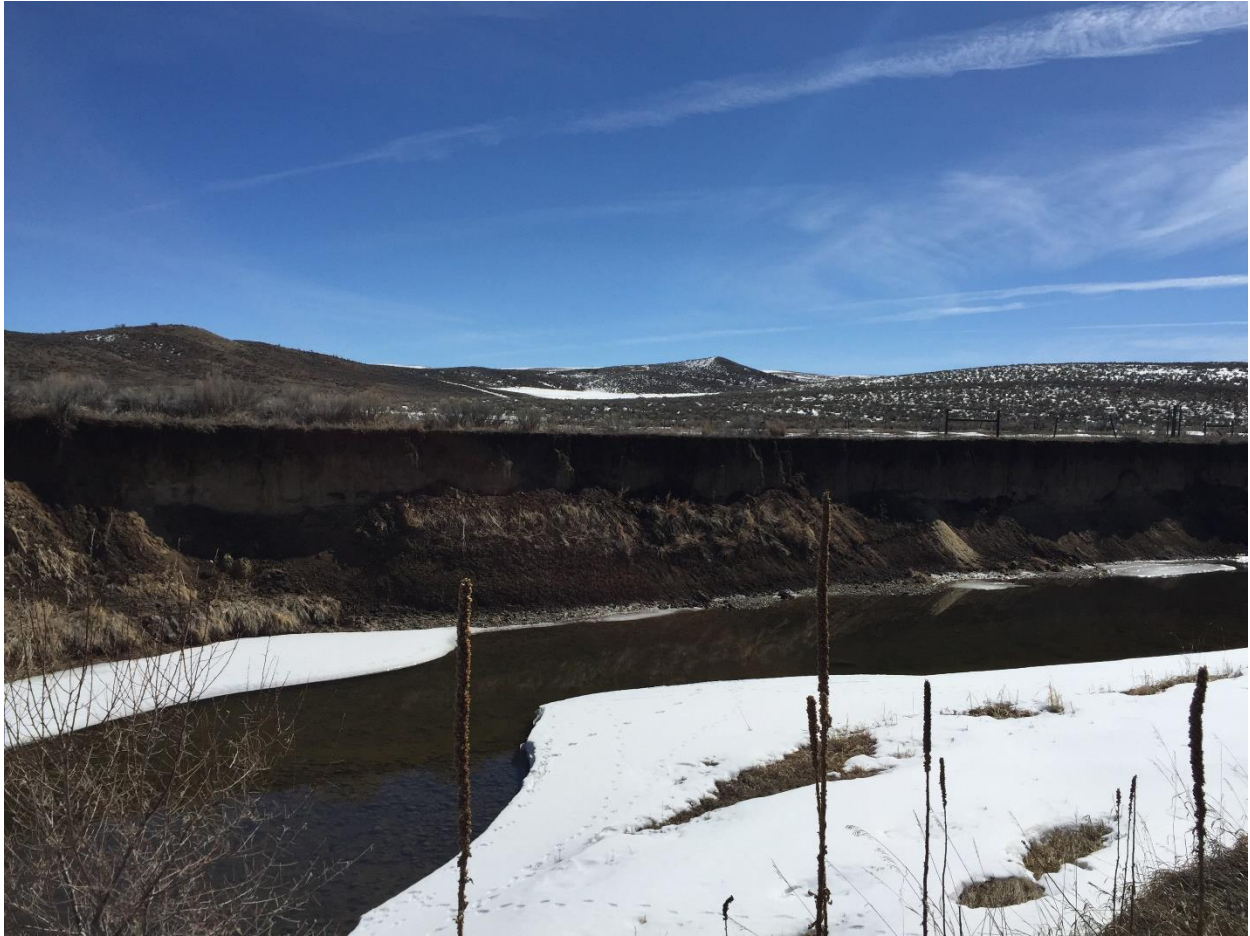
1. Steep vertical banks and floodplain disconnection.

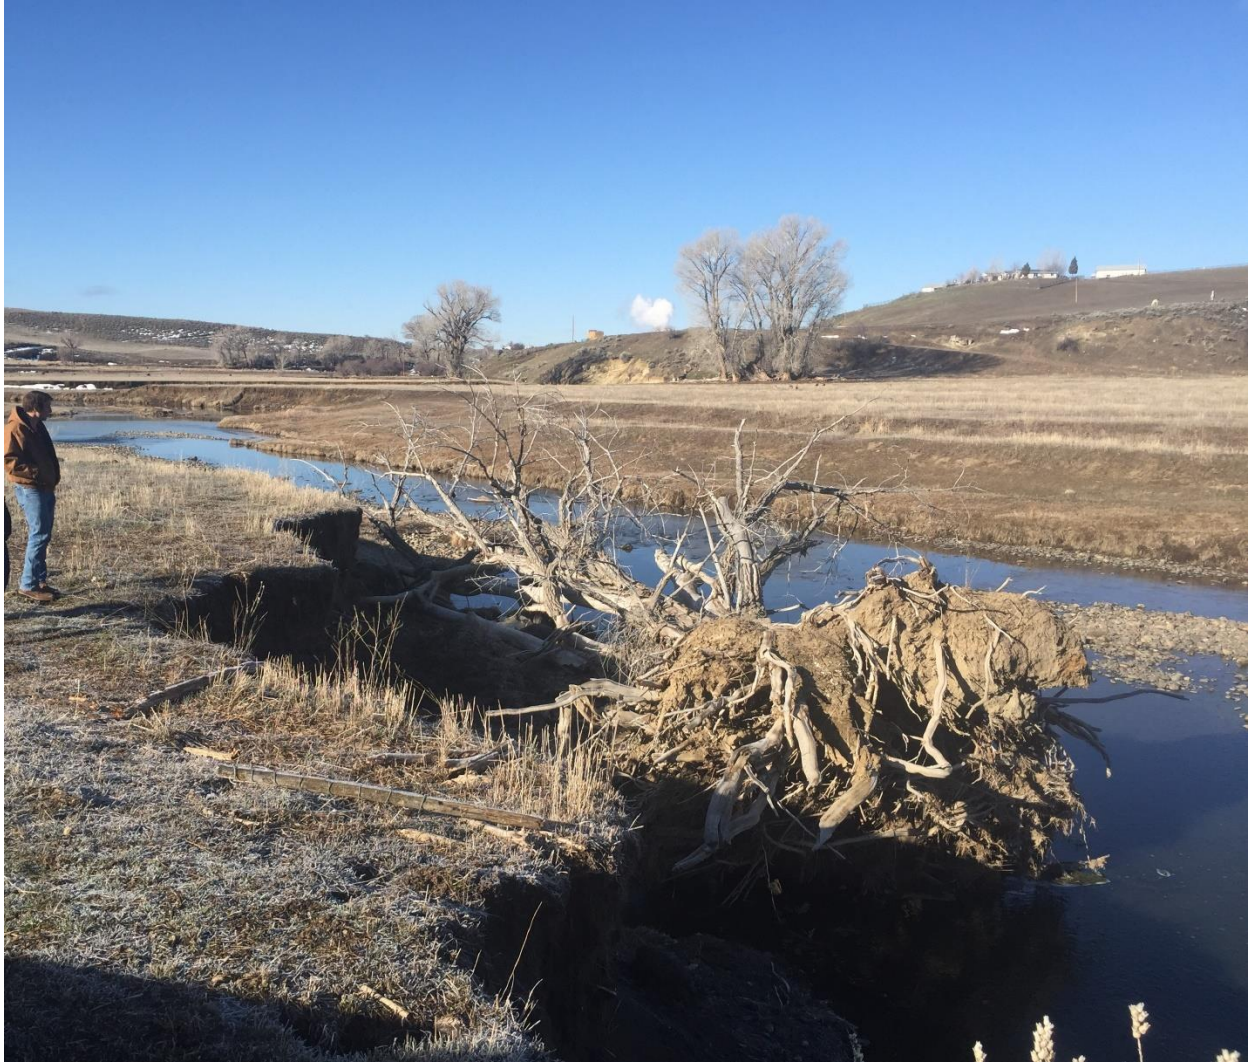
2. Continued bank erosion and loss of bank stabilizing vegetation.

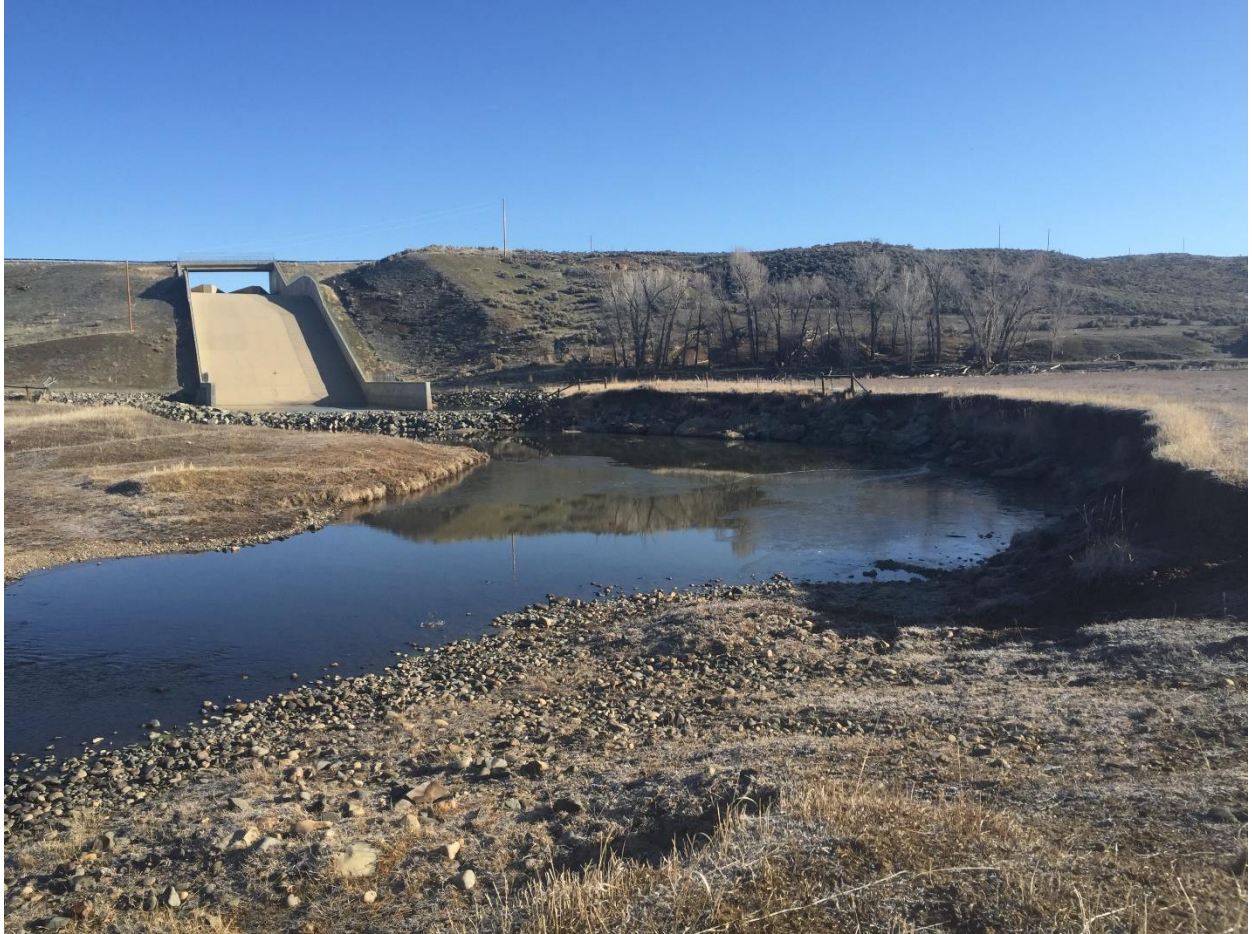
3. Looking upstream at the Elkhead Reservoir spillway and adjacent agricultural land.

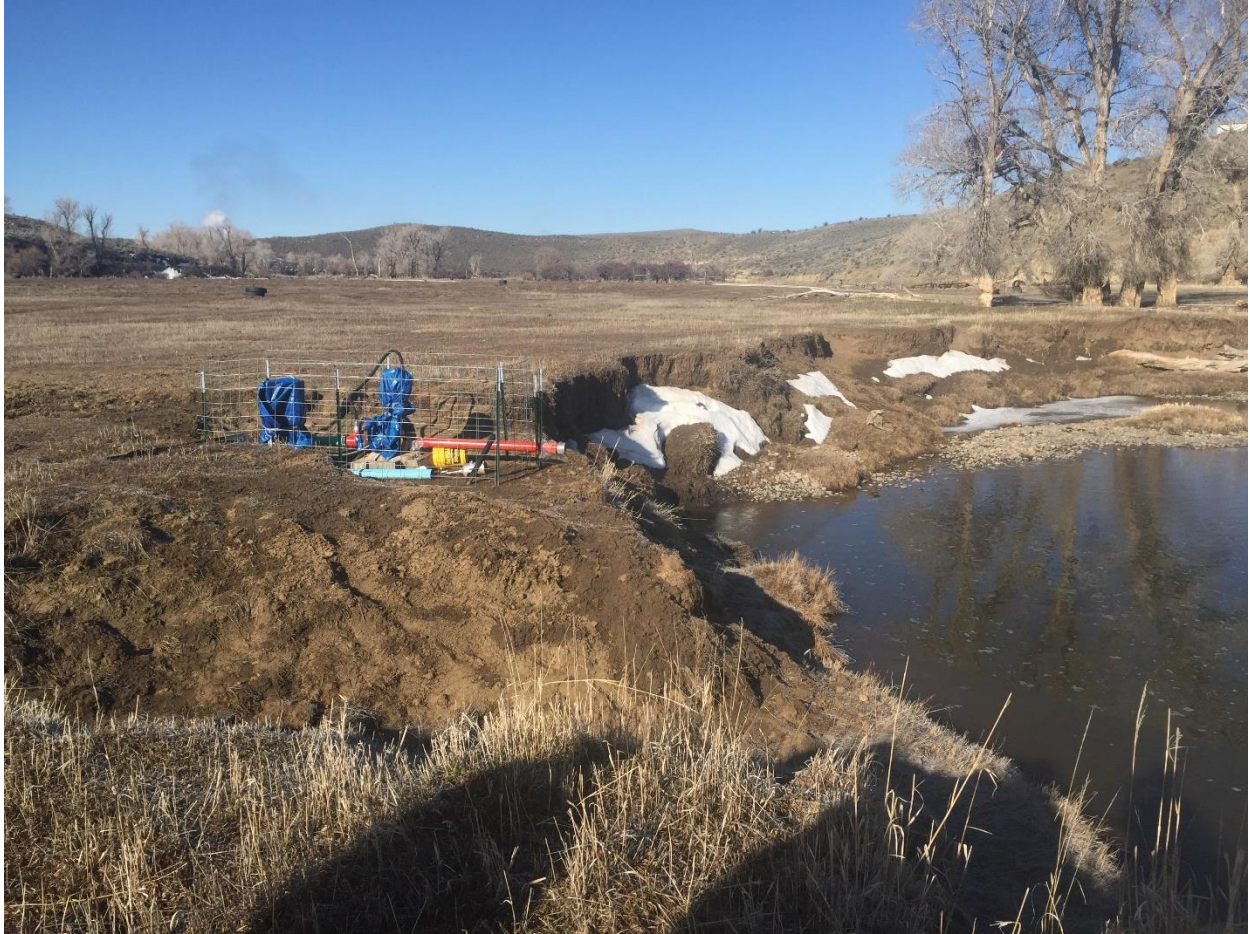
4. Excessive erosion putting existing irrigation infrastructure at risk.

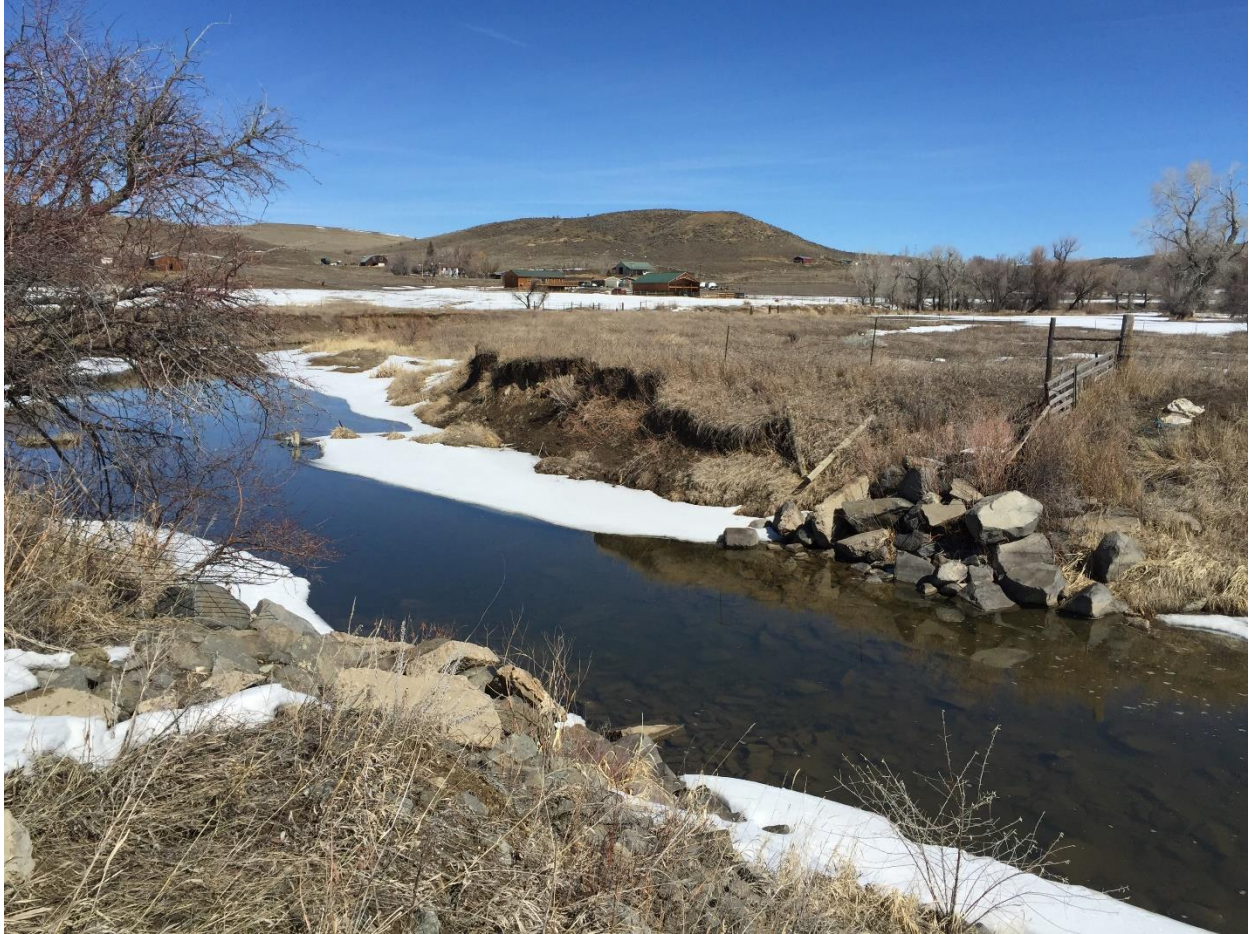
5. Location of where an irrigation pipeline used to cross the creek but was washed away.

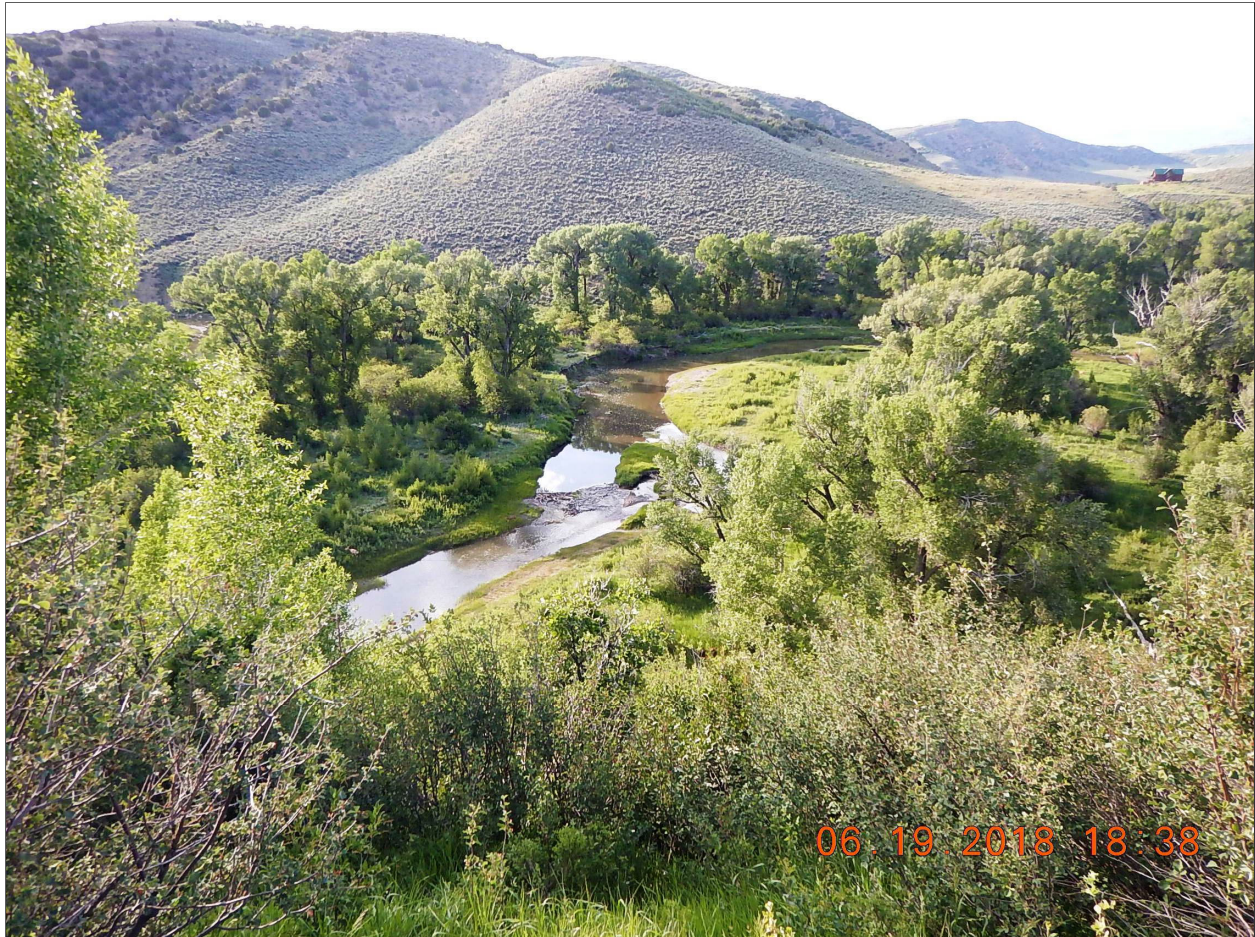
Photo 1: Cottonwood Trees on Elkhead Creek upstream of the reservoir (Photo by: TJ Burr, NRCS)

As part of the stream evolution or during the history of settlement in the valley, cottonwood groves disappeared. There are still remnants of large cottonwood trees in places on the floodplain.

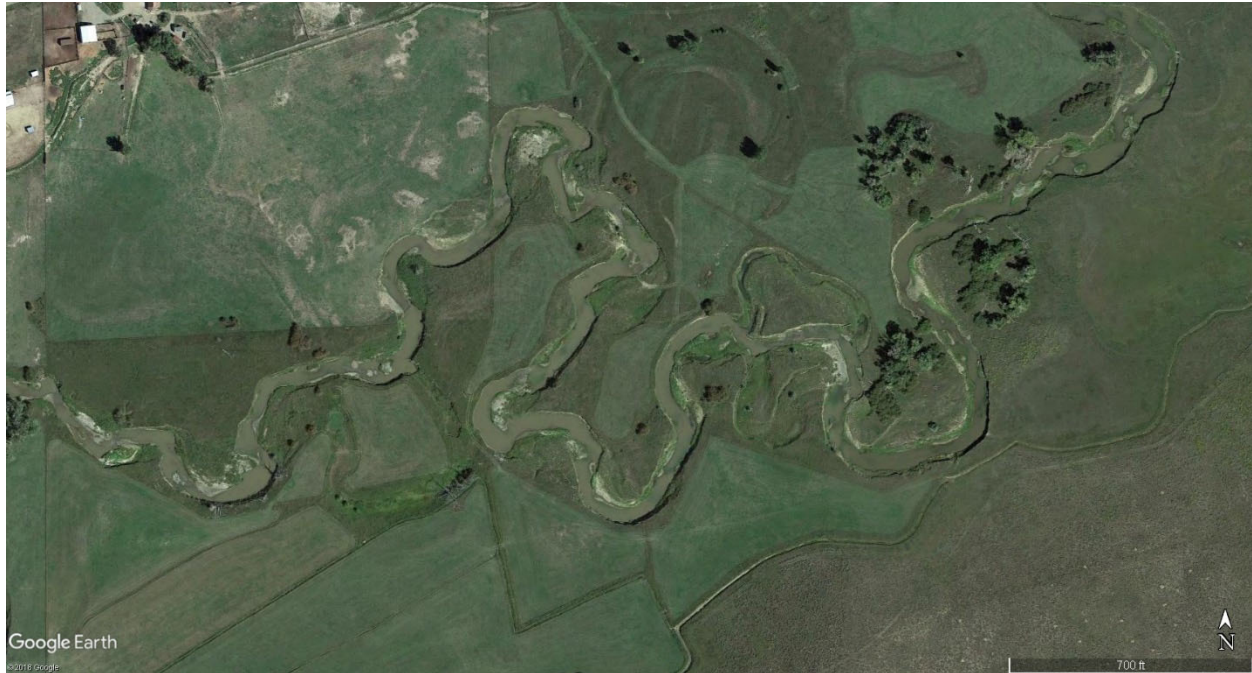
Image 1: Aerial image showing the scarcity of cottonwood trees

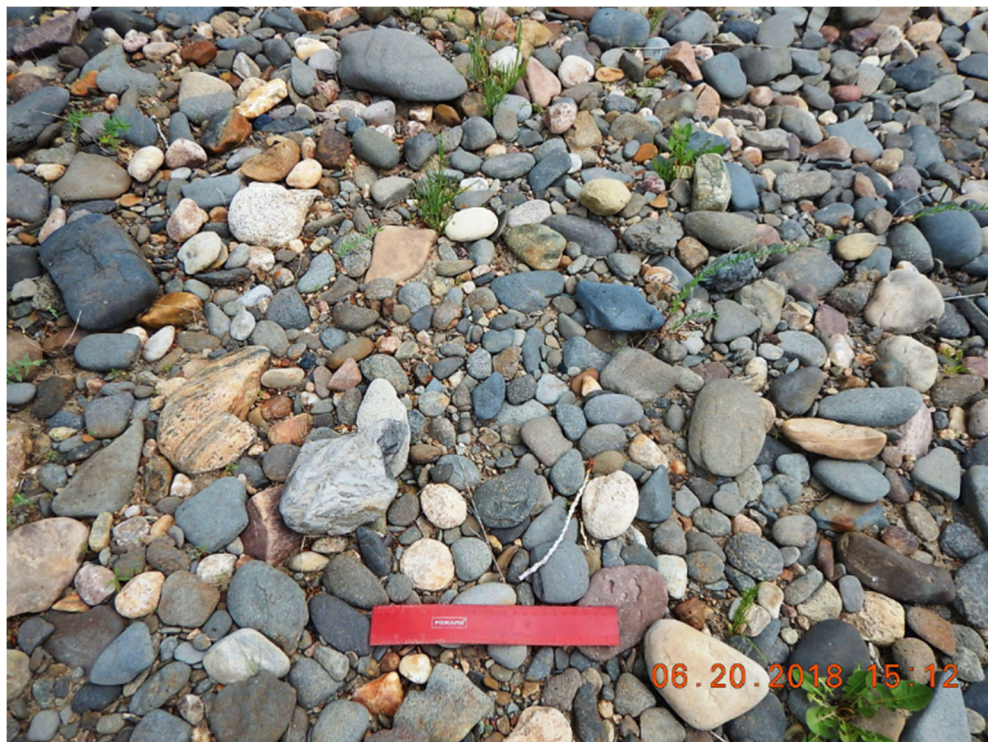
Image 2: Typical point bar material consisting of mostly gravel and cobble (TJ Burr, NRCS)

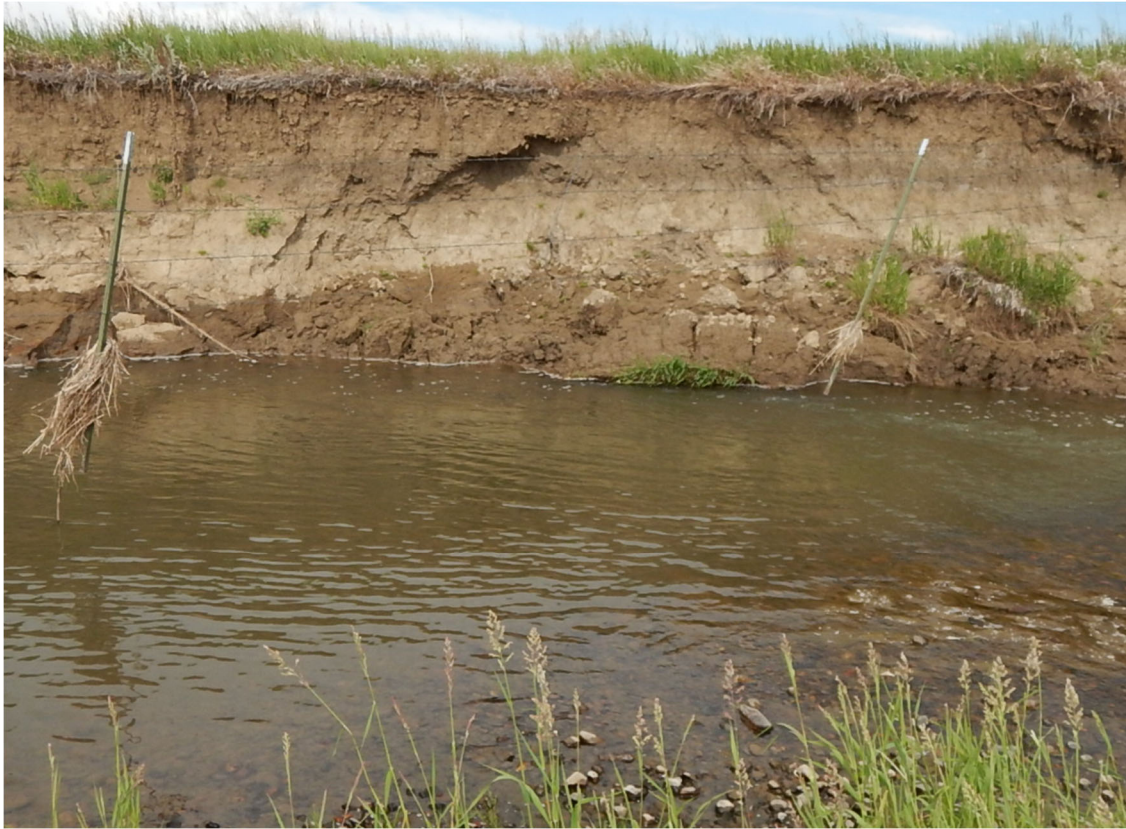
Image 3: Typical bank material and sloughing. Coarser material is found below the water level (TJ Burr, NRCS)

The streambanks consist of alluvial silts, sands, gravel, and cobble deposited throughout time. Most of the upper soil horizons consist of fine-grained sandy-loam material.

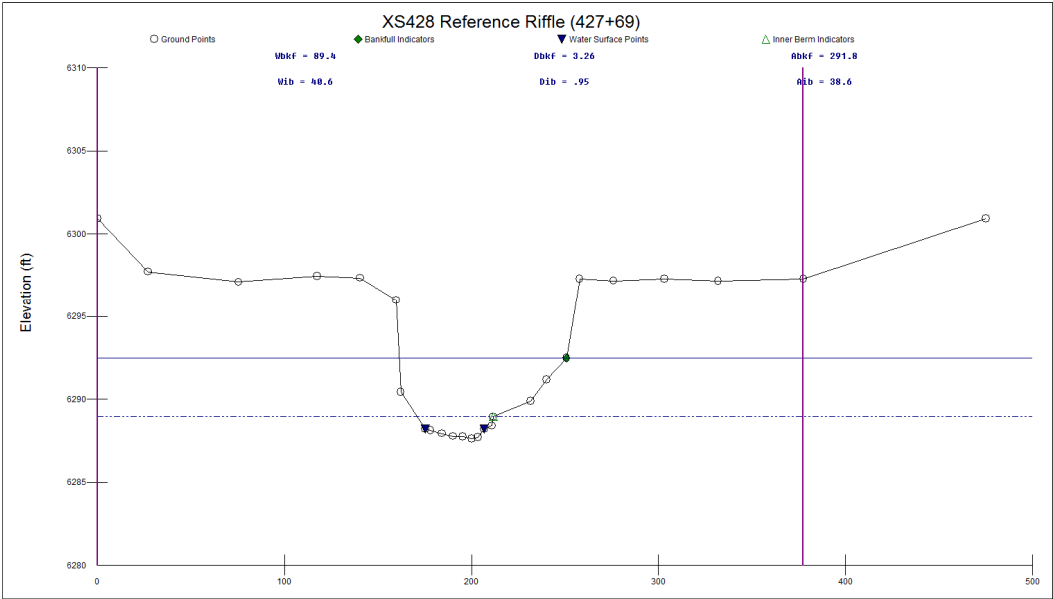
Figure 4: Riffle cross section 428, representative riffle

We collected and analyzed survey data from 18 cross-sections within the project reaches spanning approximately 5 miles. The channel hydraulics is based on the most representative riffle cross-section. RiverMorph software was used to make calculations and identify the natural bankfull features.

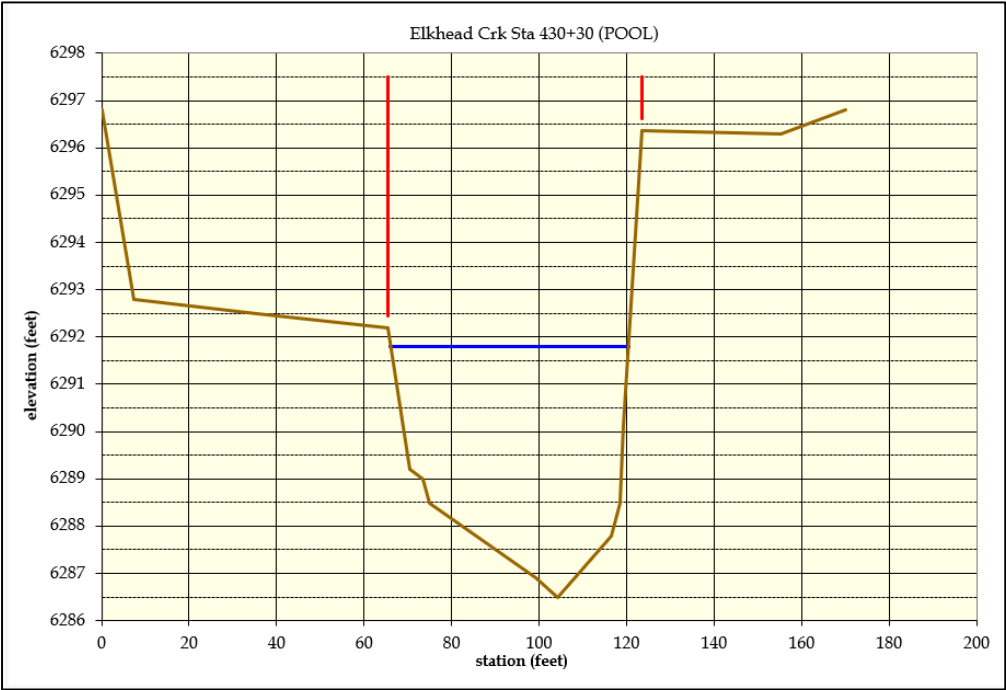
Figure 5: Pool cross section from O'Neal project site
