The Bureau of Land Management (BLM) is writing this letter to formally communicate its recommendation for an instream flow water right on Kinney Creek, located in Water Division 5.

## Stream Surveys July 2019

Kinney Creek – Water Code: 23527

# FIELD DATA FOR INSTREAM FLOW DETERMINATIONS

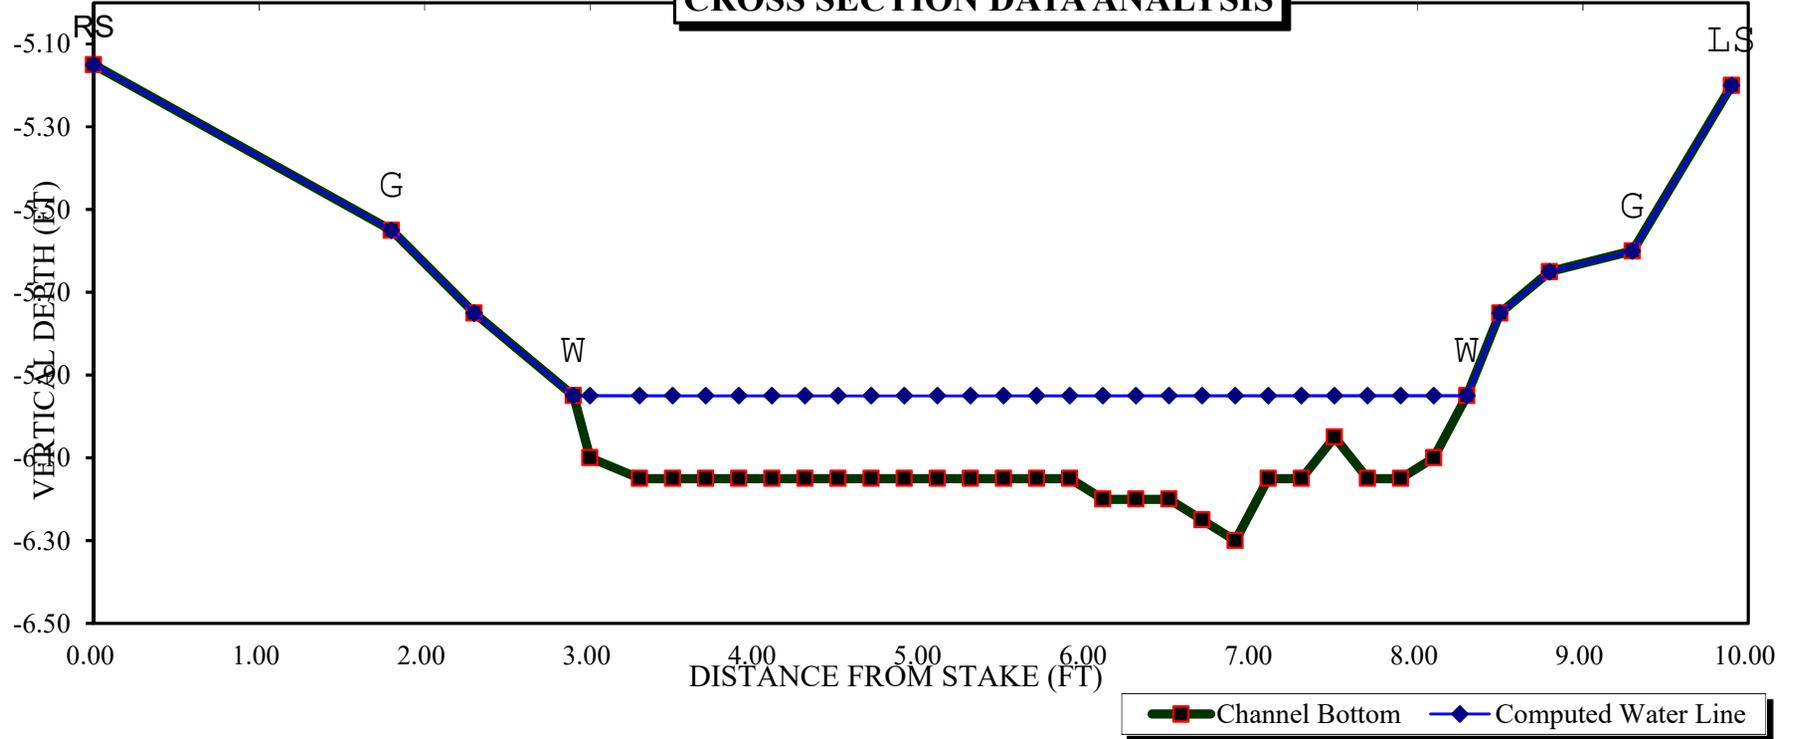
## CROSS SECTION DATA ANALYSIS

# Kinnev Creek
