Monitor Creek Executive Summary

CWCB STAFF INSTREAM FLOW RECOMMENDATION March 15-16, 2023

Water Division 4
Monitor Creek ISF Recommendation

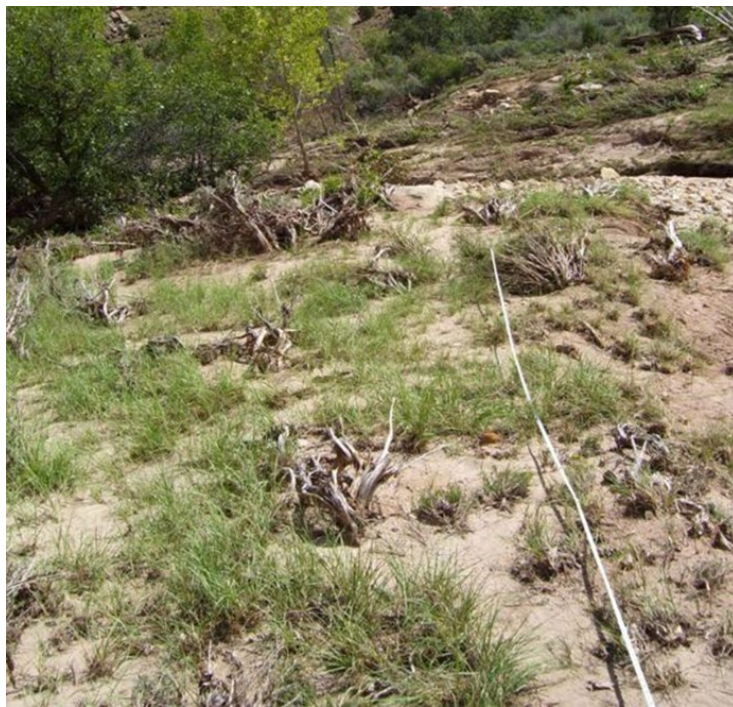
Figure 5. Photograph showing evidence of a high-flow event that pushed over vegetation on the floodplain in 2006.

AECOM surveyed the location of large piles of woody debris deposited by previous very infrequent high-flow events on the floodplain of the modeled stream site. The HEC-RAS model was used to estimate the flow necessary to reach the locations of the debris piles. This modeling work estimated that a flow of 1,960 cfs would reach the minimum elevation of the debris. The BLM estimated that some of the debris piles were deposited within the last ten years. BLM staff are also aware of a substantial event that occurred in 2006 (Figure 5; Jedd Sondergard, BLM staff, personal communication on 4/6/2021). The observation of large piles of debris on the floodplain demonstrates that very high-flow events do occur and that these events can inundate large portions of the floodplain. The StreamStats peak flow statistics estimate that an event capable of reaching the lower elevation flood debris would likely occur very infrequently, at more than a 100-year event.
