**BEFORE THE COLORADO WATER CONSERVATION BOARD  
DEPARTMENT OF NATURAL RESOURCES, STATE OF COLORADO**

**IN THE MATTER OF PROPOSED INSTREAM FLOW APPROPRIATION  
DIVISION 6: MILK CREEK**

**PREHEARING STATEMENT OF WESTERN RESOURCE ADVOCATES**

## Milk Creek Executive Summary

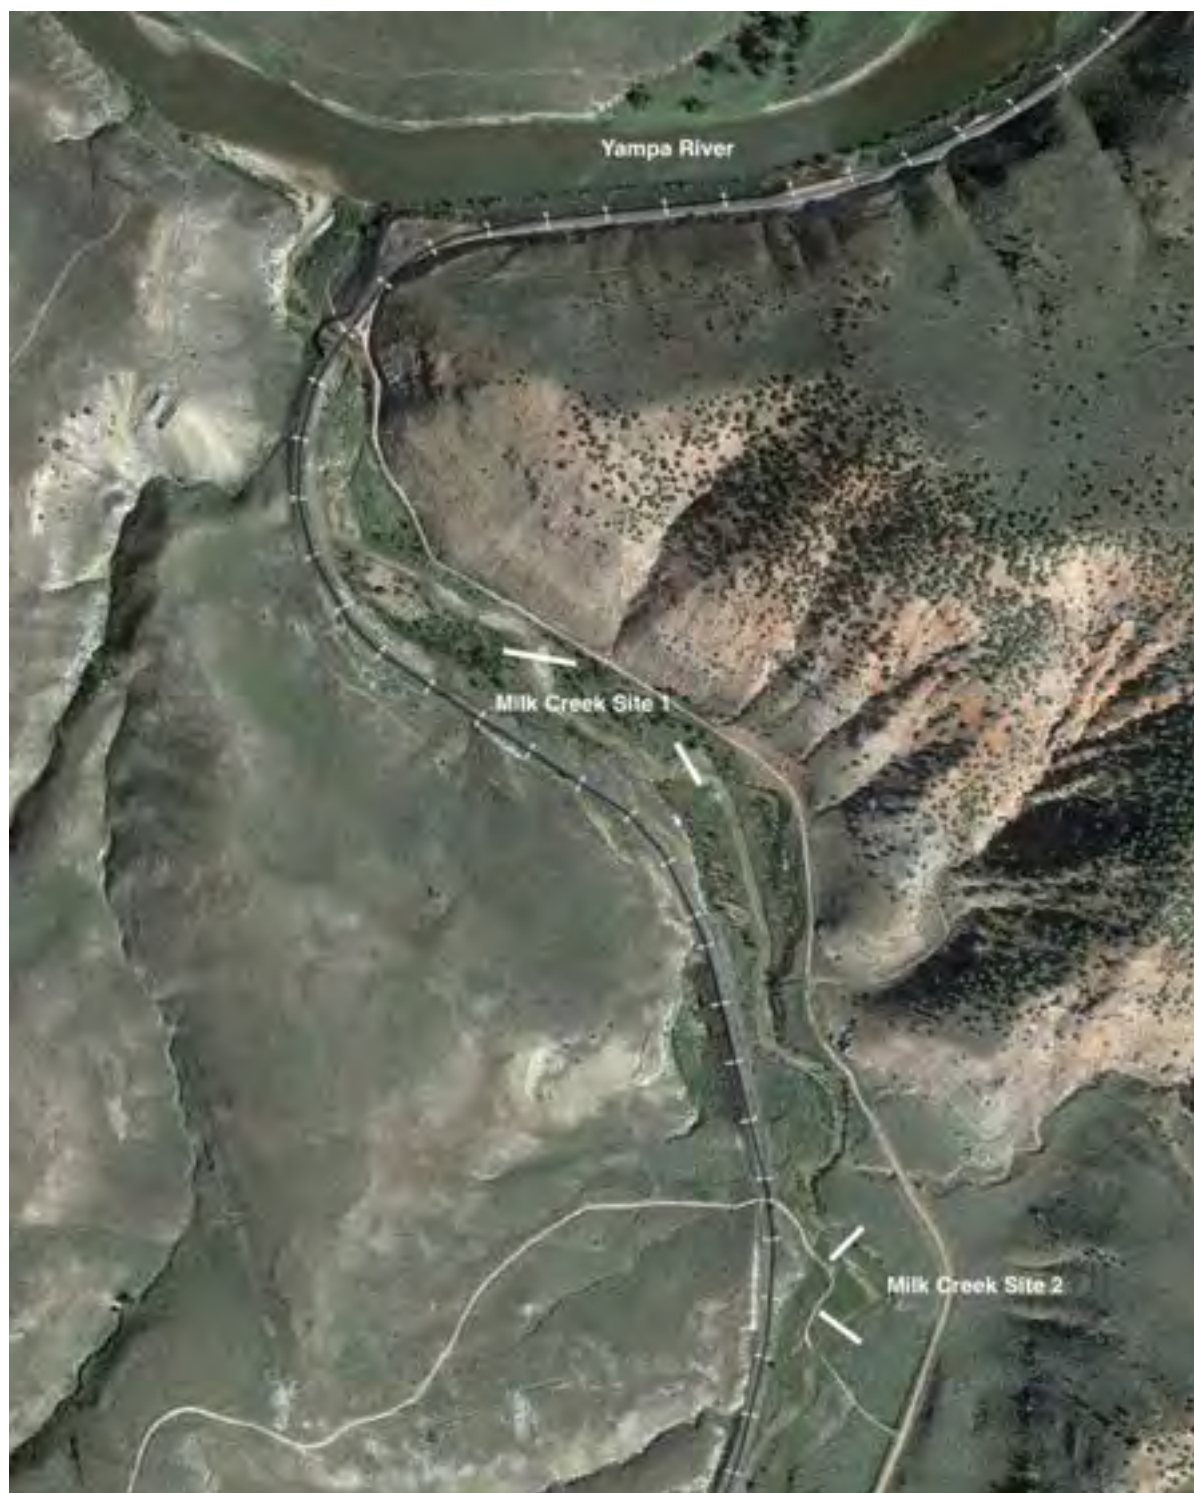
**Figure 1. Milk Creek Study Sites (Source: Google Earth).**
