Huddleston-Berry
Engineering & Testing, LLC

Subject: Summary of Instrumentation Monitoring
3rd Quarter 2021
Bowie Coal Waste Disposal Area No. 3
Paonia, Colorado

SUBJECT: Summary Report, 3rd Quarter 2021, Vibrating Wire Piezometers
July – September 2021, Bowie Mine #2
Coal Waste Disposal Area (CWDA) #3

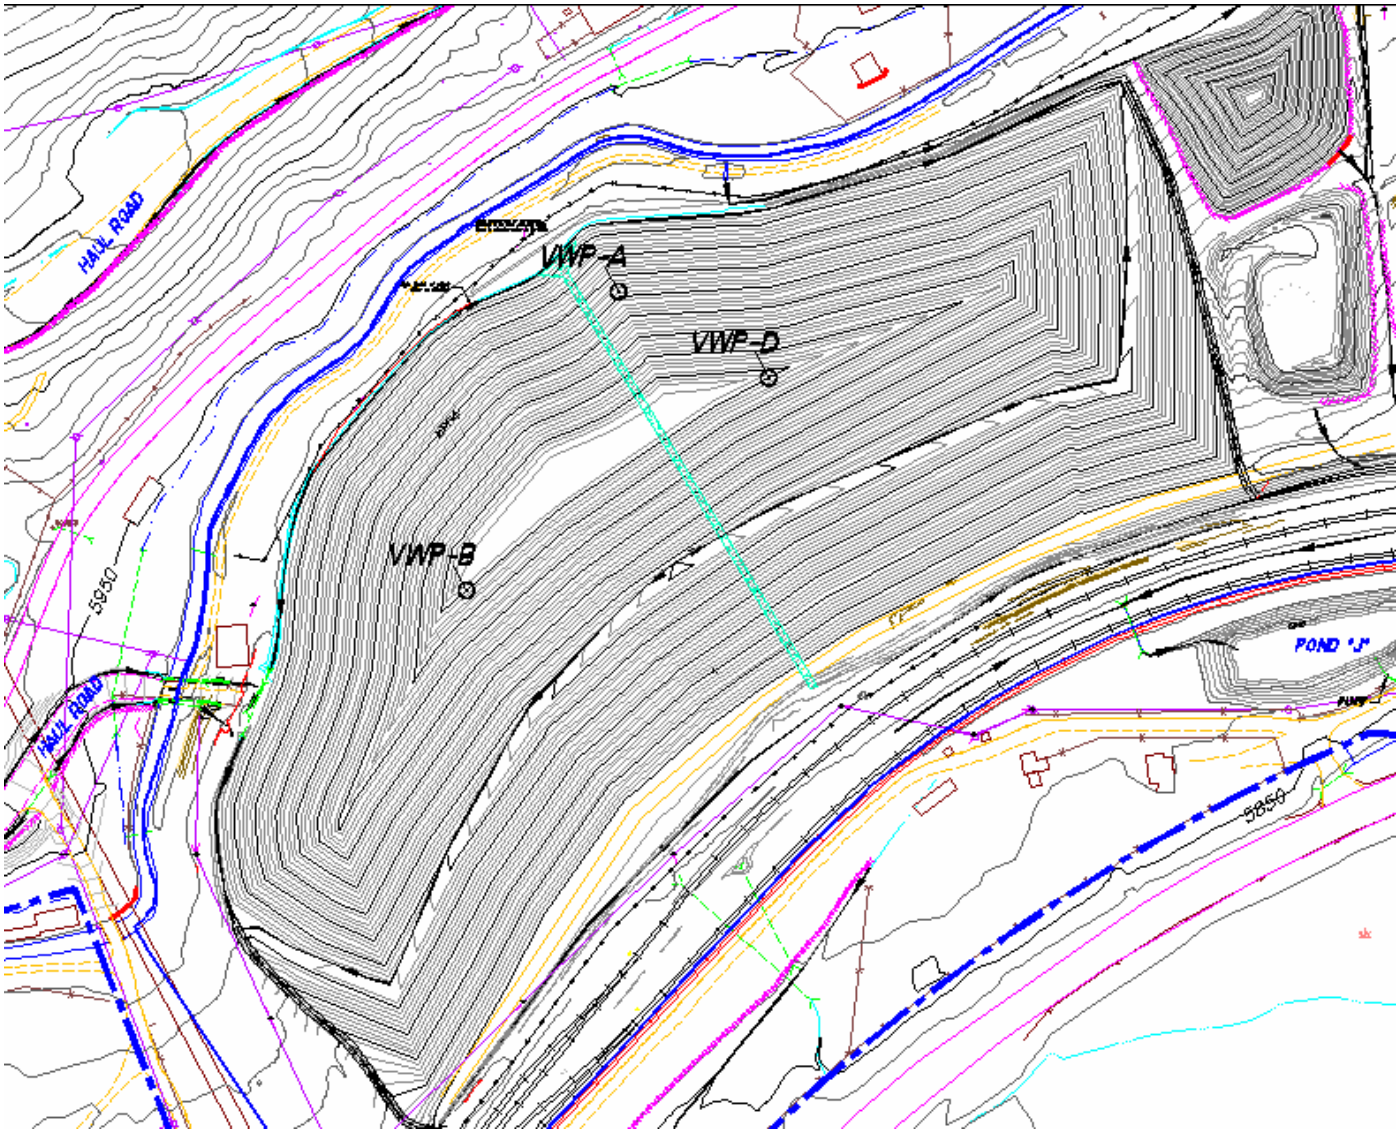
Five vibrating wire piezometers were installed in CWDA No. 3 in October 2014. The piezometers were installed at three locations within the footprint of the gob pile as shown on the attached figure. Monitoring of the functioning piezometers was completed by Buckhorn Engineering (Buckhorn) on September 21st, 2021. The attached monitoring report prepared by Buckhorn includes the piezometer monitoring data and the data is summarized in the following table.

HAUL ROAD
VWP-A
VWP-D
VWP-B
5950
HAUL ROAD
POND "J"
5850
