# Tarryall Creek Ranch 2009 Riparian Restoration Project

*Project summary and initial monitoring results*

*Mark Beardsley, M.S. EcoMetrics LLC October 16, 2009*

# Tarryall Creek Ranch Riparian Restoration Project 2009 Phase 1

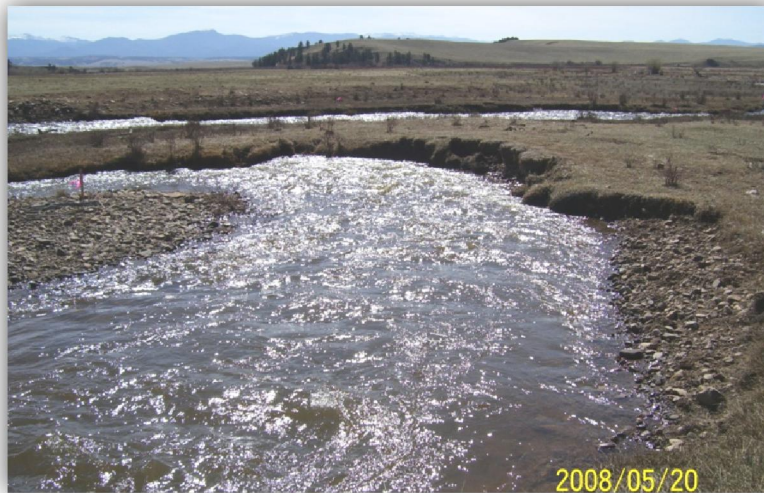
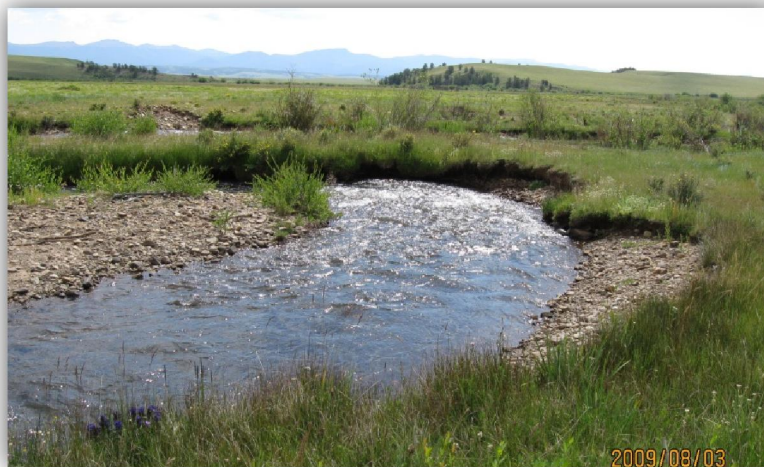
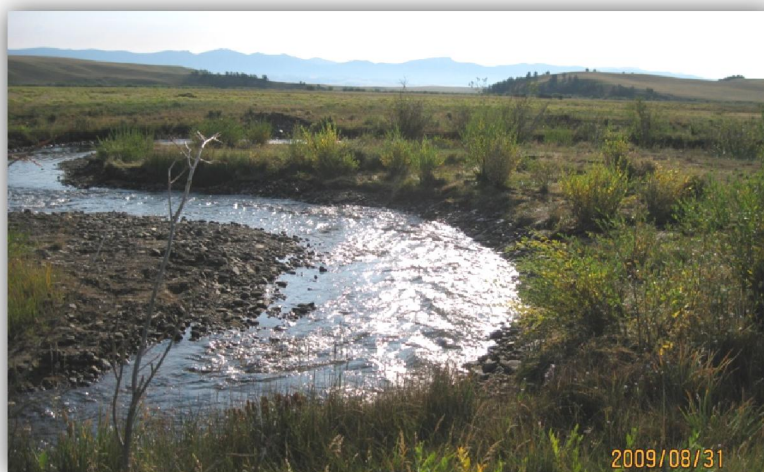
Figure 3: A new bench was created on this rapidly eroding bank during phase 2. The bench was planted with willows and wetland sod, and the channel was realigned to decrease near-bank stress. The bank will eventually continue to erode, but at a slower natural rate now that the appropriate vegetation will be in place.

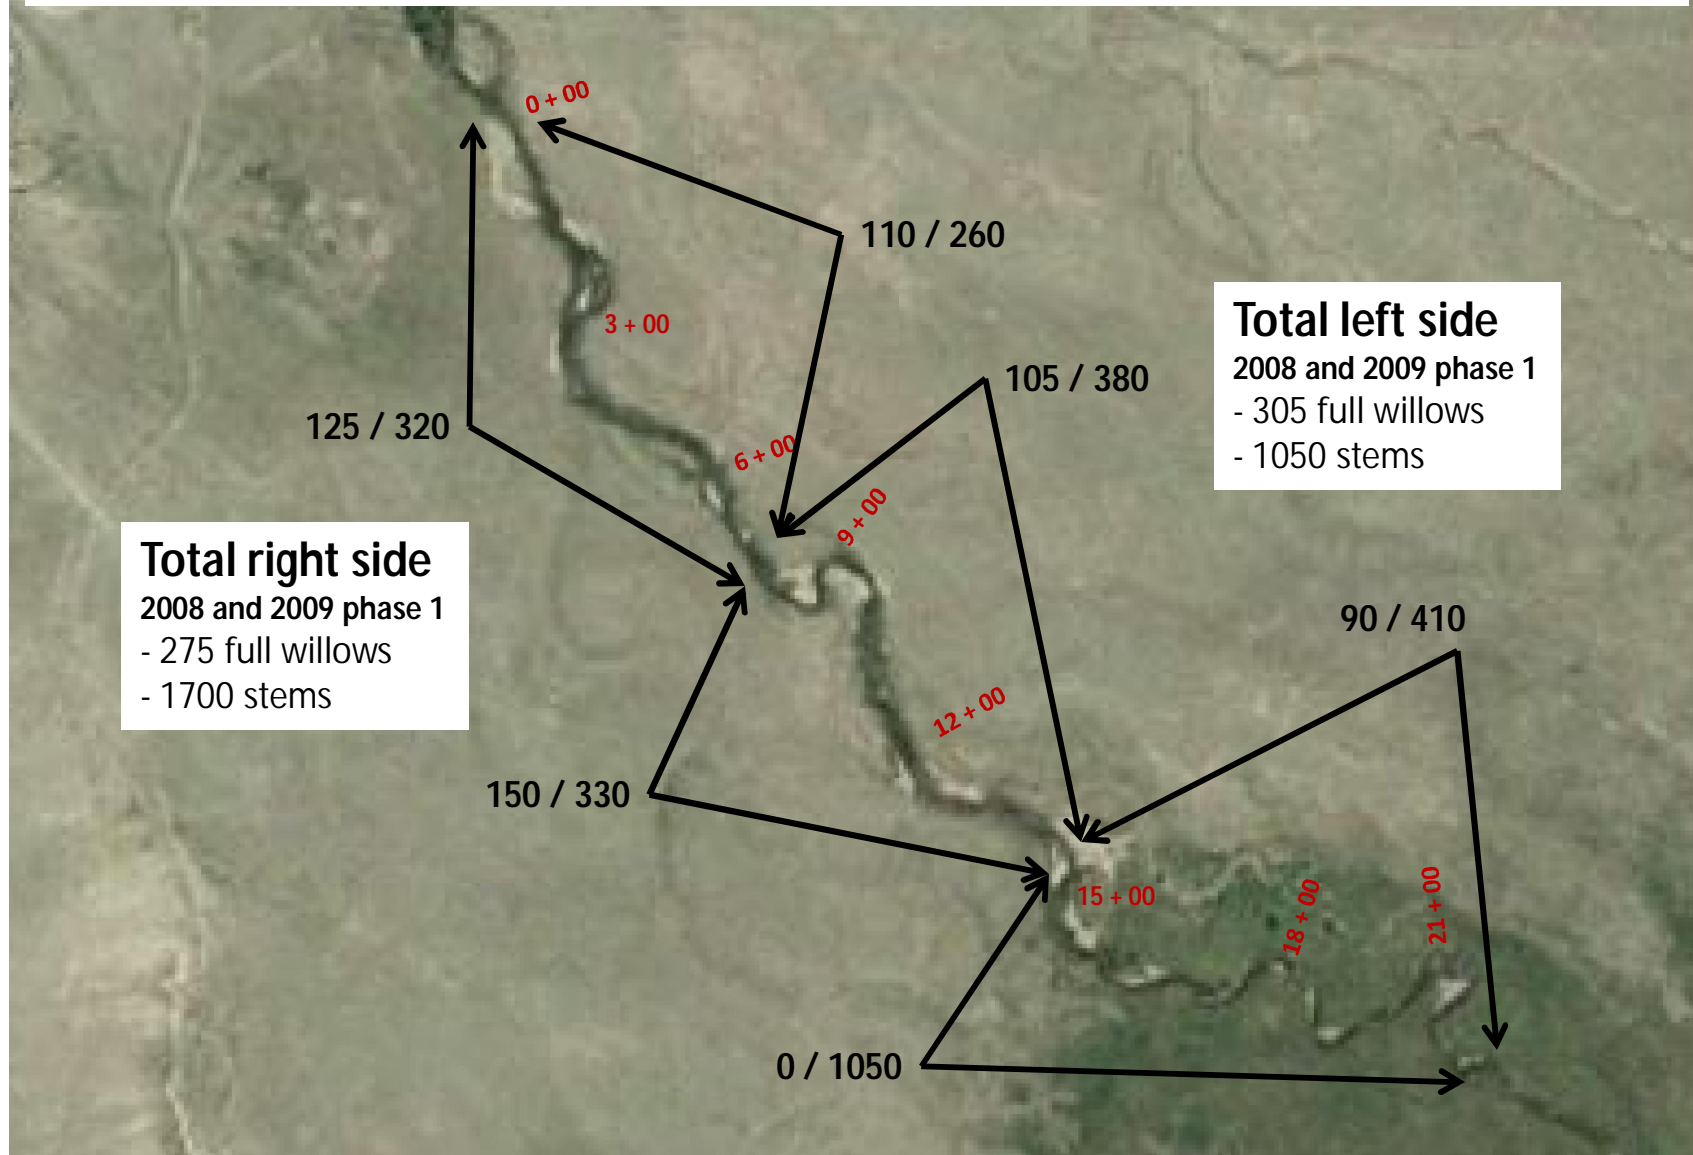
## Actual willow plantings completed during 2008 pilot phase and 2009 phase 1

Approximately 580 full willows and 2750 stems have been planted on the project reach.  
For each segment, counts are shown as (# full willows / # stems).

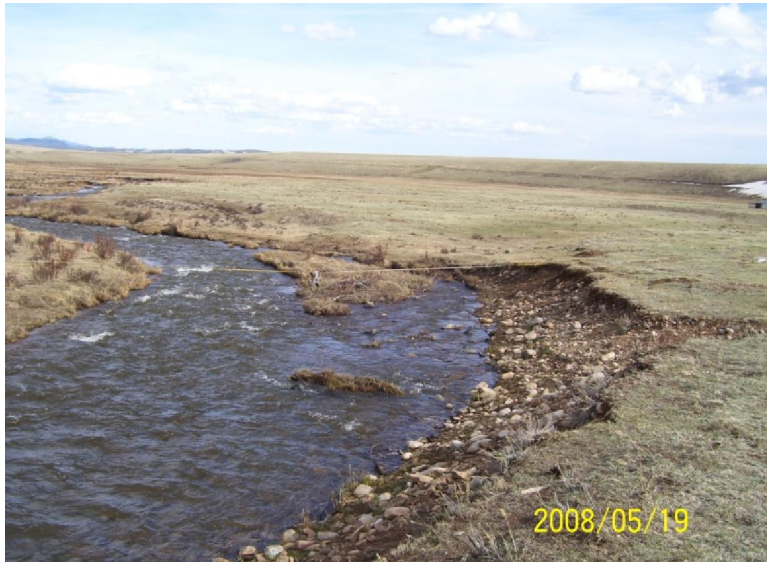
## Bankfull bench 0340R

Before-after photos (left) show how cutting a bench into the steep terrace on the right bank provided space to plant willows and wetland sod. Note that no alterations were made to the stream bed or low banks during phase 1.

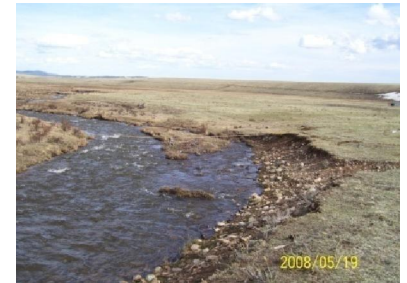
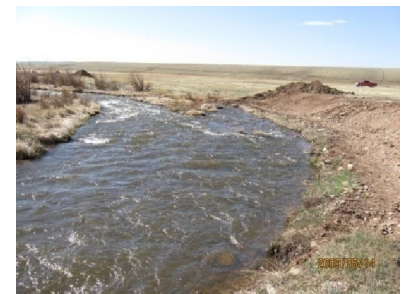
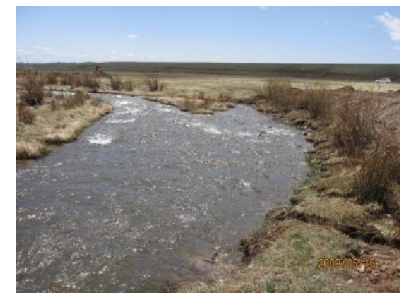
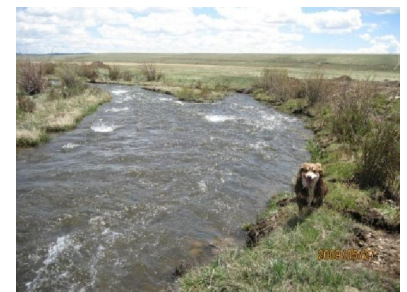
The sequence of photos on the right show stages (from top to bottom) in the construction of the bench. The bench was later completed (5-29-09) with additional sod, seed, and fabric on the backslope.

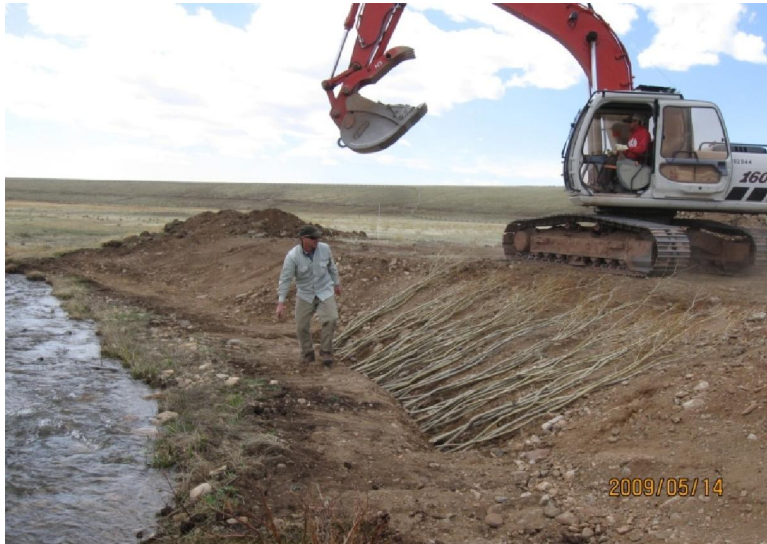
On bench 340R, rocky soil made it difficult to plant dormant willow stems deep enough to be effective. As an alternative, 60 dormant 8-foot willow stems were harvested to make 12 bundles that could be planted with the excavator.

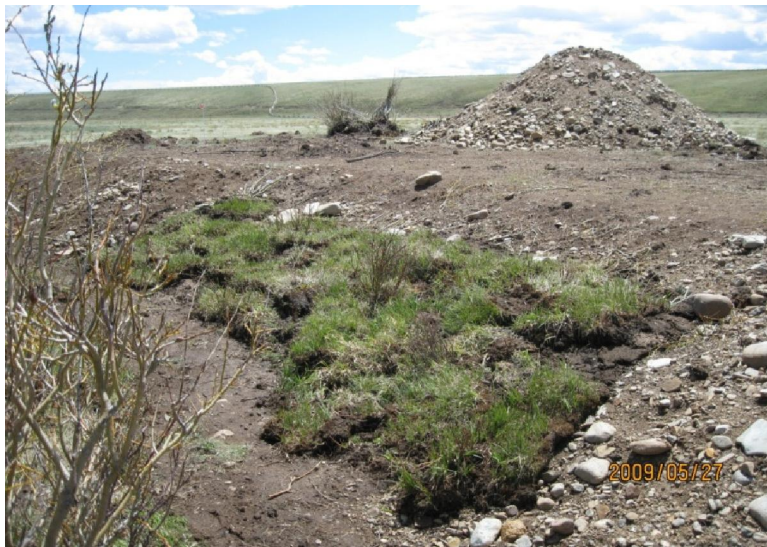
Planted bundles were backfilled with top soil, covered by transplanted riparian sod, and trimmed at the top.

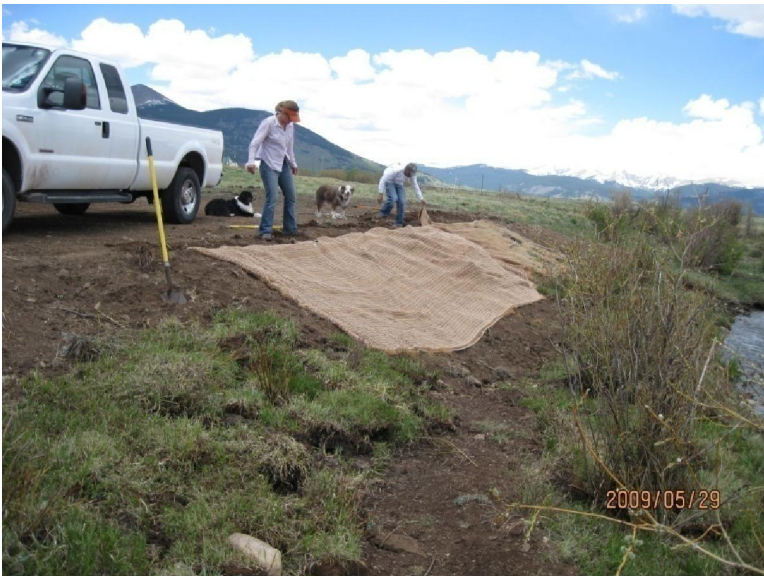
Where deemed necessary (Bench 340R), erosion-control fabric was placed over seeded backslopes for protection.

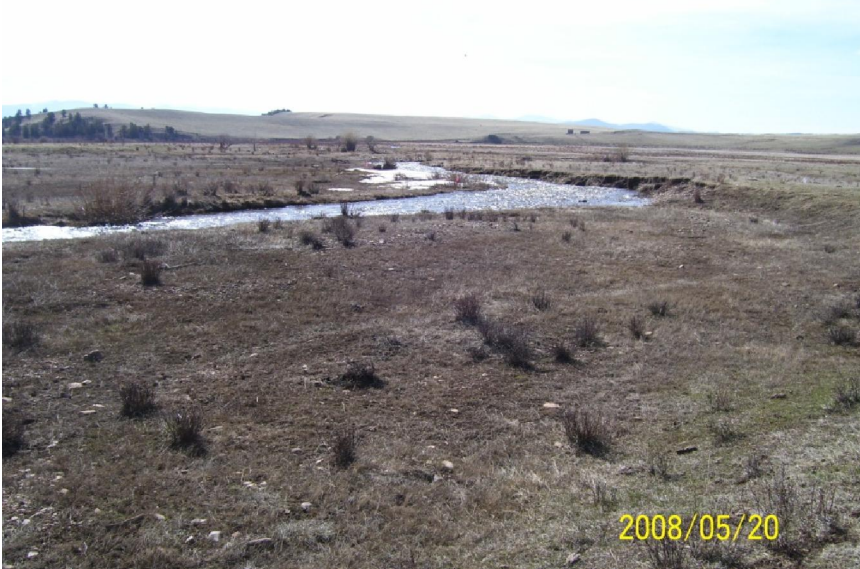
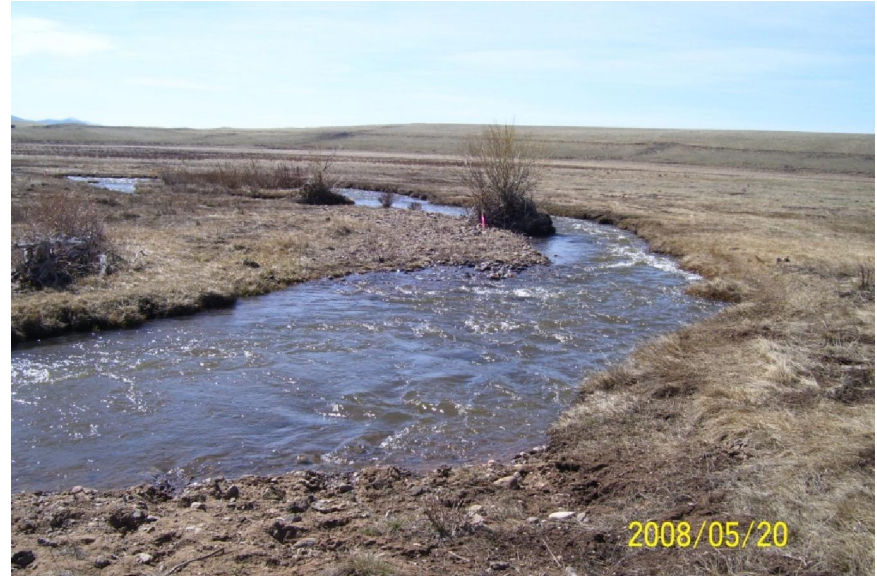
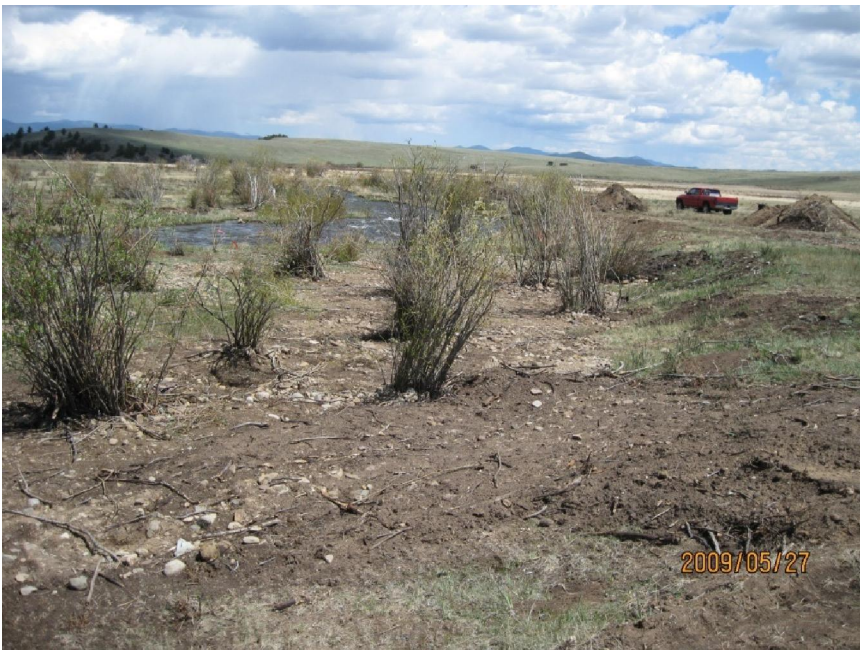
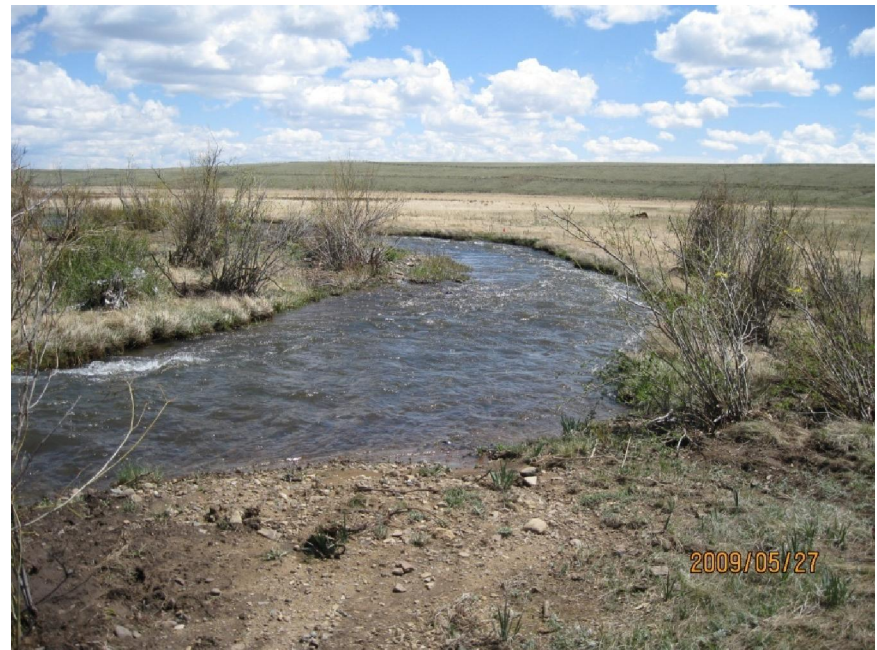
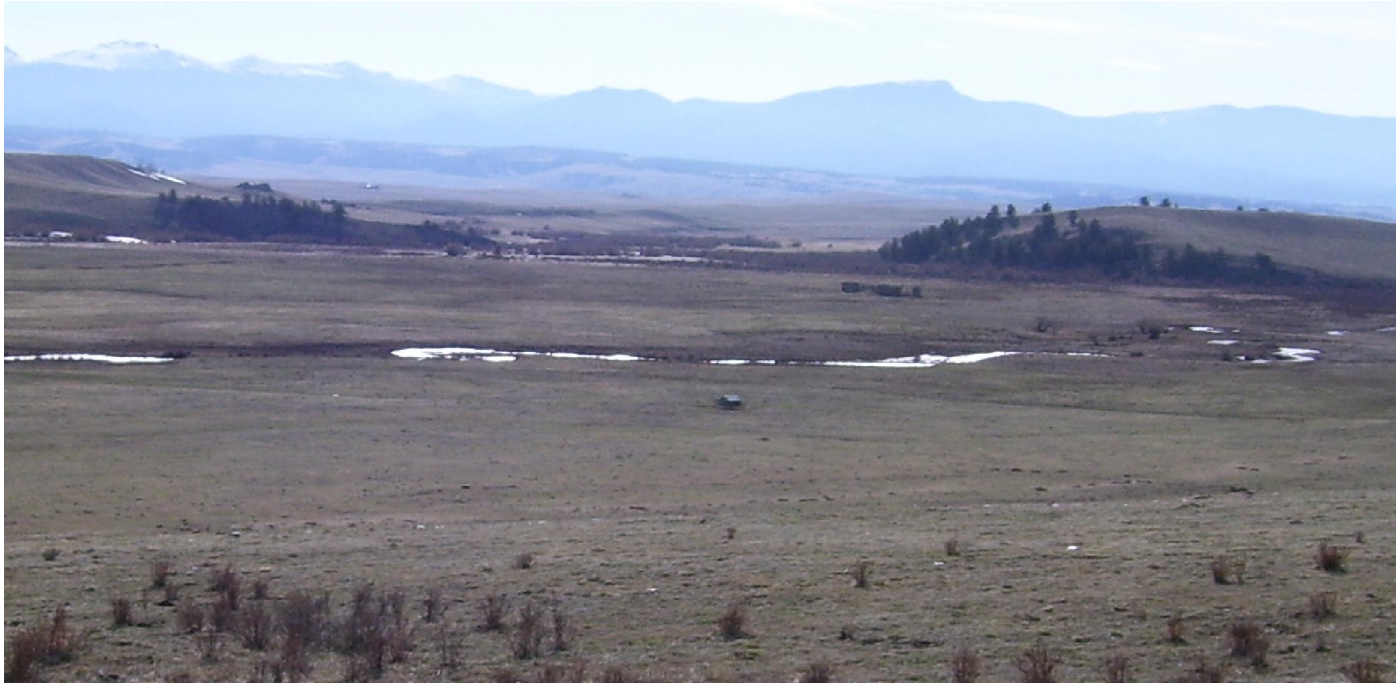
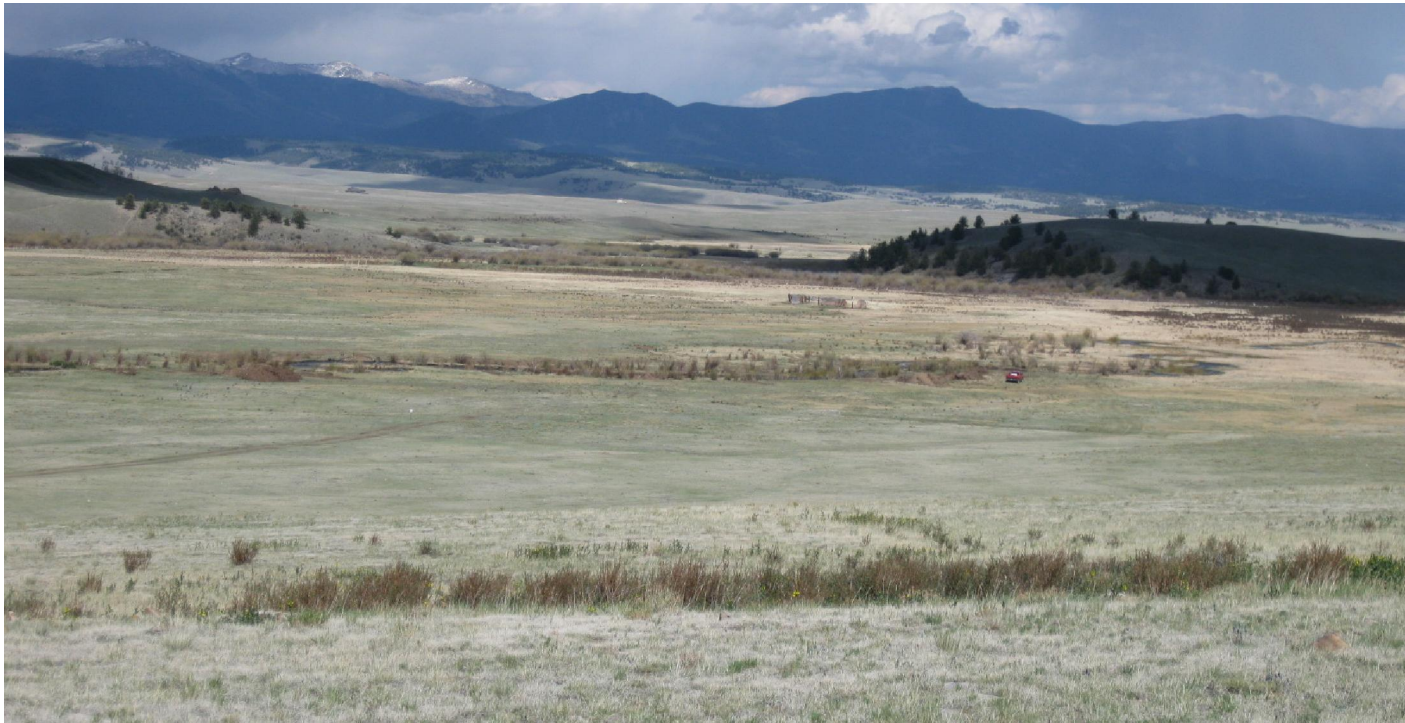
And a few more before-after shots
